LAND NORTHWEST  
OF THE ANCHOR INN  
Whittonstall  
Northumberland

Archaeological Monitoring

Project 189-17-HS | November 2019

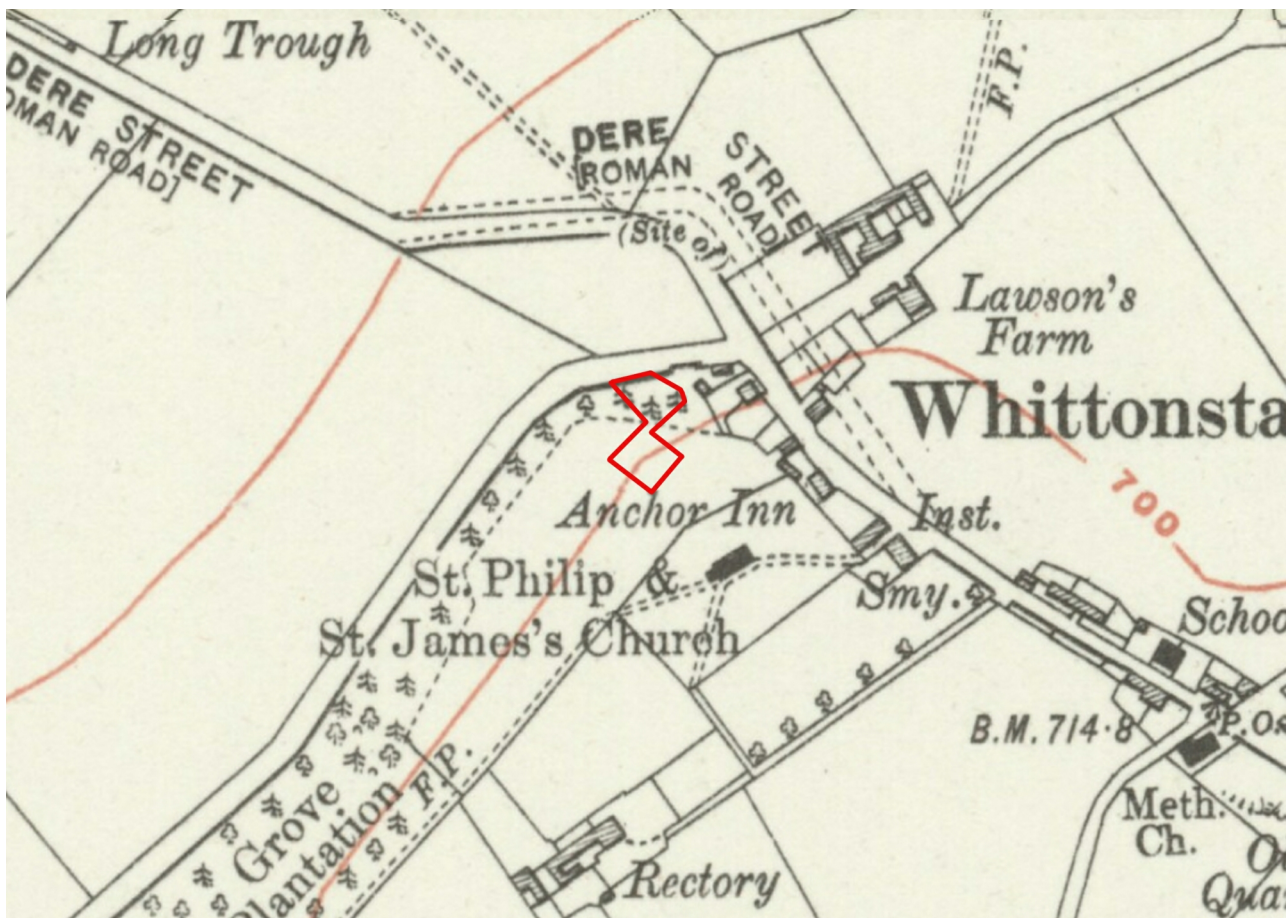
Plate 2. Extract from the 1921 Ordnance Survey map. The site boundary and service run is marked in red.

2.2.3 Dere Street is marked on modern Ordnance Survey mapping as running beneath the route of the B6309 to the northwest of Whittonstall cutting directly through the village and then rejoining the route of the modern road to the east of the village. However, the historic mapping pre 1950s (see Plate 2) suggests that rather than run straight, the line of Dere Street kinks to the northeast before

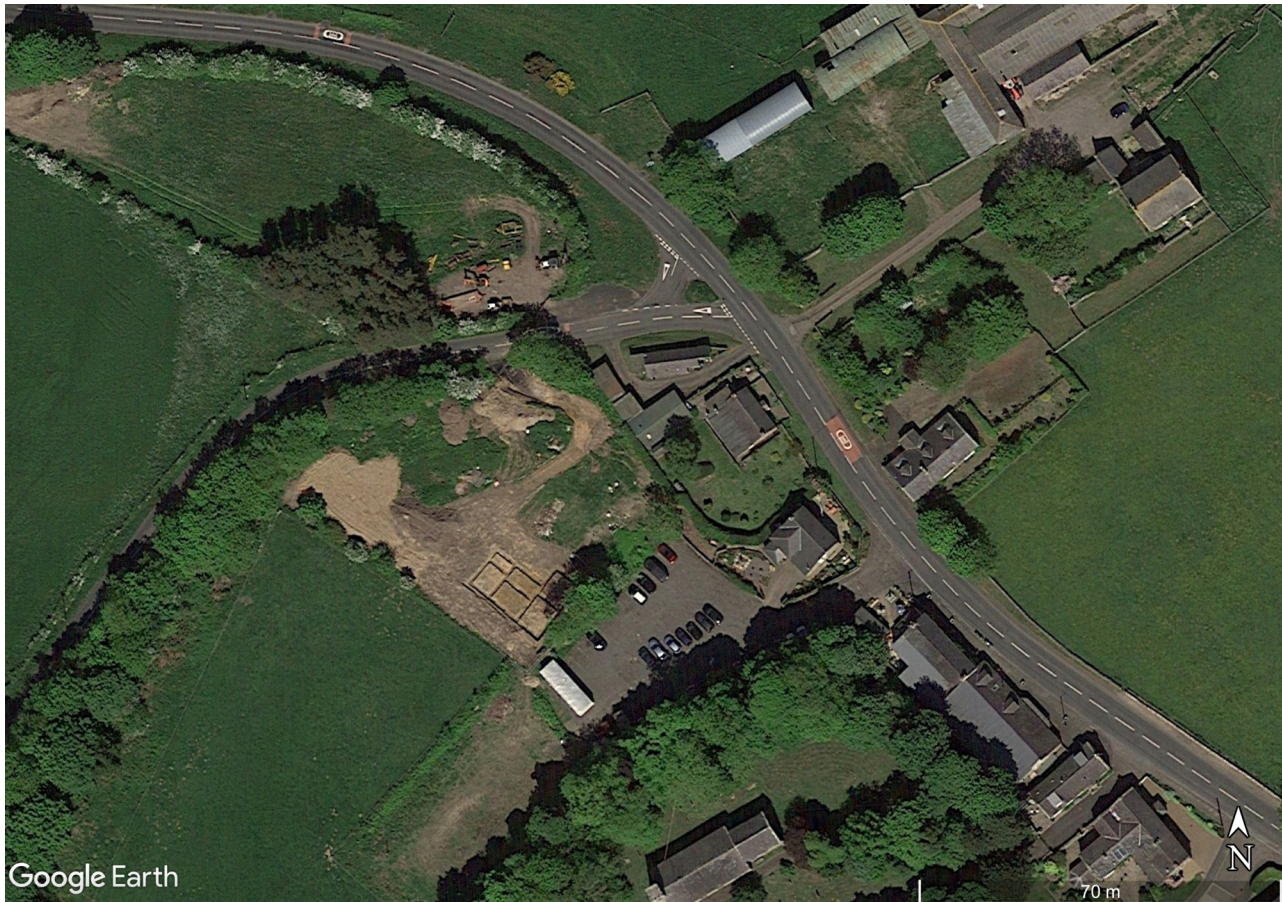
Plate 3. Aerial view of the site in late May 2018 (dataset ©2019 Google).

3.1.1 The scheme of works consisted of monitoring the excavation of house foundations, the line of the site access track and service runs on three separate occasions (17<sup>th</sup>-18<sup>th</sup> May 2018, 18<sup>th</sup> June 2019 and 23<sup>rd</sup> July 2019). Plate 3 shows aerial imagery taken on the 27<sup>th</sup> May 2018, nine days after completion of the initial watching brief. The extent of the surface clearance, the route of the access track and the location of the house foundations can be seen. Figure 4 shows a plan of the overall extent of the works.

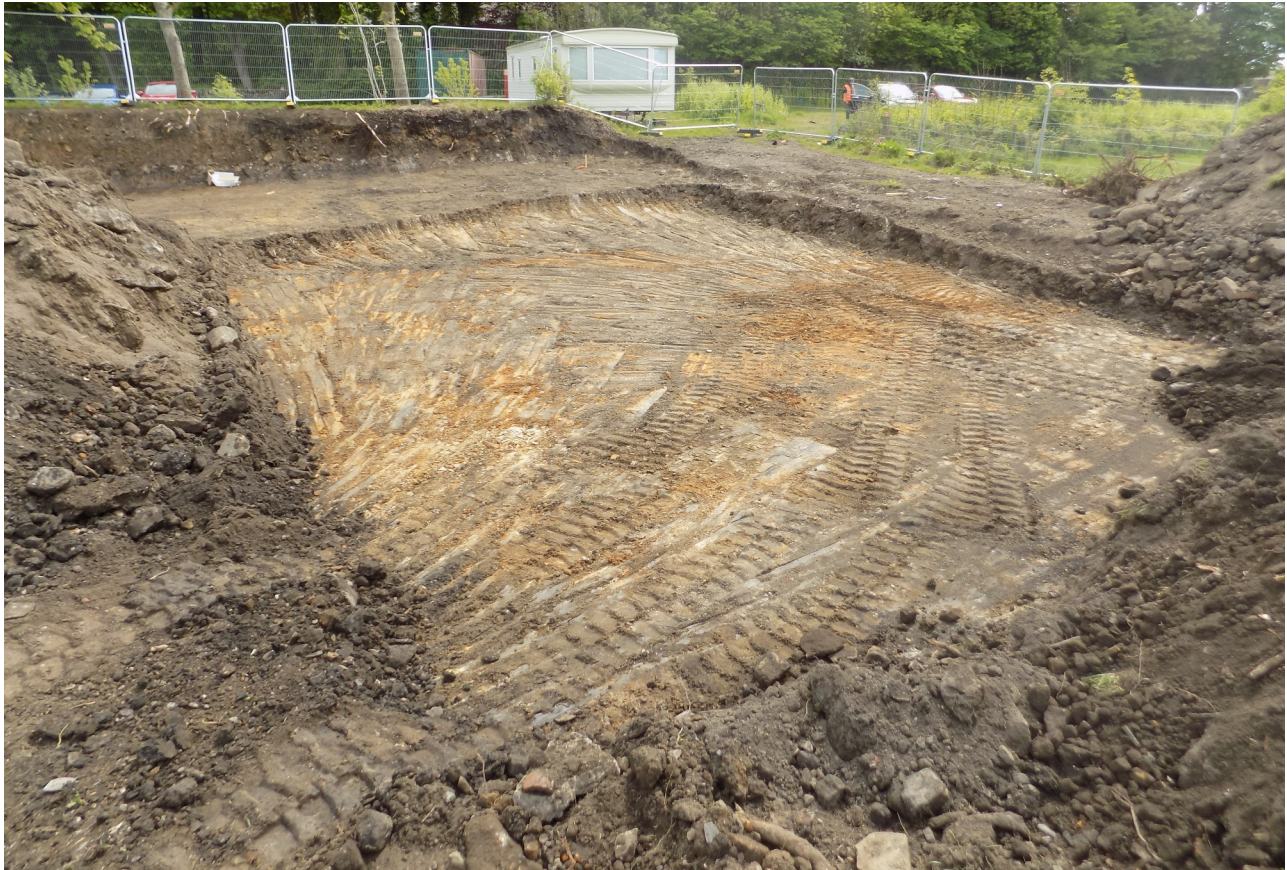
Plate 4 (above). The platform strip for the house foundations, looking southeast.

3.2.2 The watching brief comprised the observation of the stripping of a platform 17.54m long by 13.26m wide down to the natural clay substrate (G1). The overburden (1) consisted of mixed loamy clay,

with small to medium stones and frequent items of modern debris. No archaeological deposits, structures or artefacts were observed during the excavation of the house foundations, and as such it was deemed that the cutting of the foundation trenches within that cleared platform could continue unimpeded. The platform strip can be seen on Plate 4.

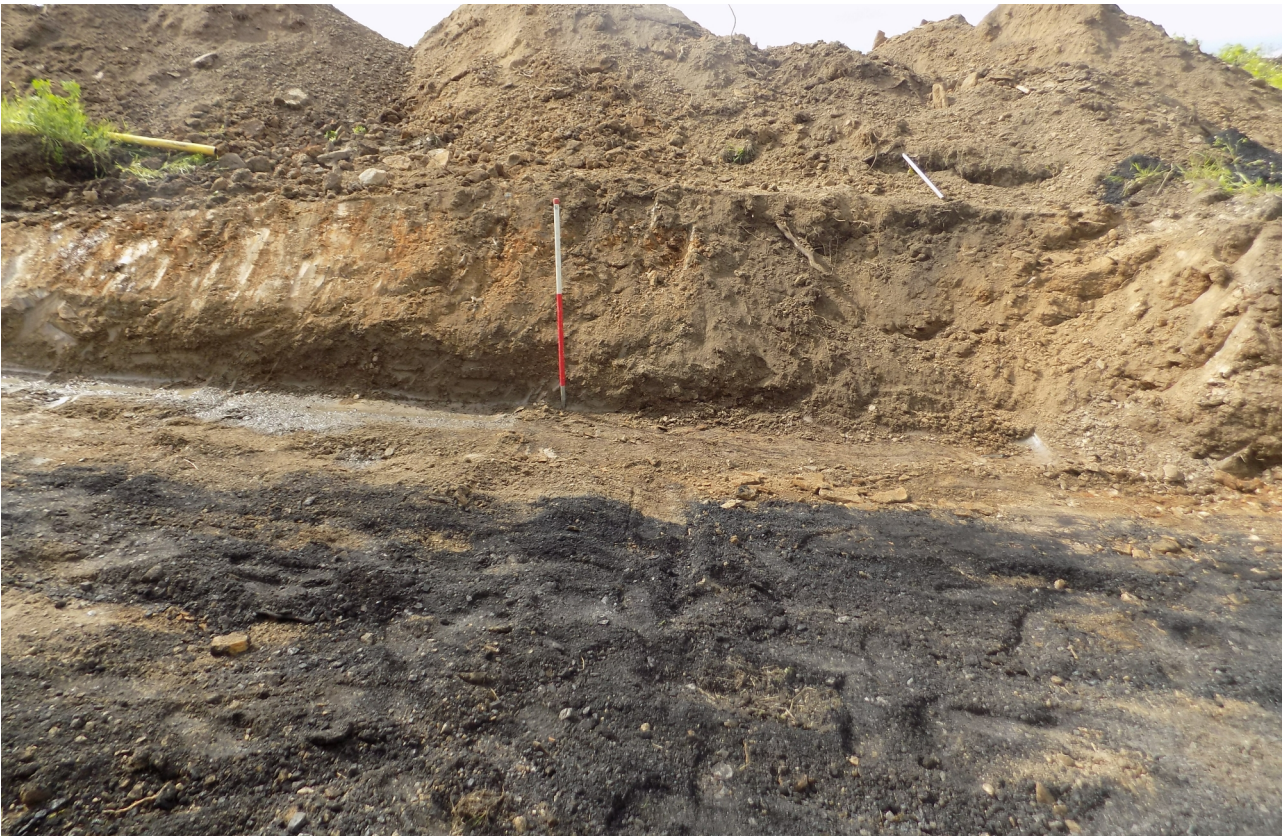
Plate 5. The access road cut looking west by the entrance from the road to the north.

- 3.2.3 The monitoring of the access road required stripping between 1m of overburden (to the north by the roadside, see Plate 5) and 0.15m on the area adjacent to the house platform. As with the platform, the road strip overburden (1) was a mixed loamy clay, with small to medium stones and frequent items of modern debris. This was found to lie over sandy yellow-grey clay (G1) with frequent inclusions of coal with occasional banded spurs of natural laminated sandstone.

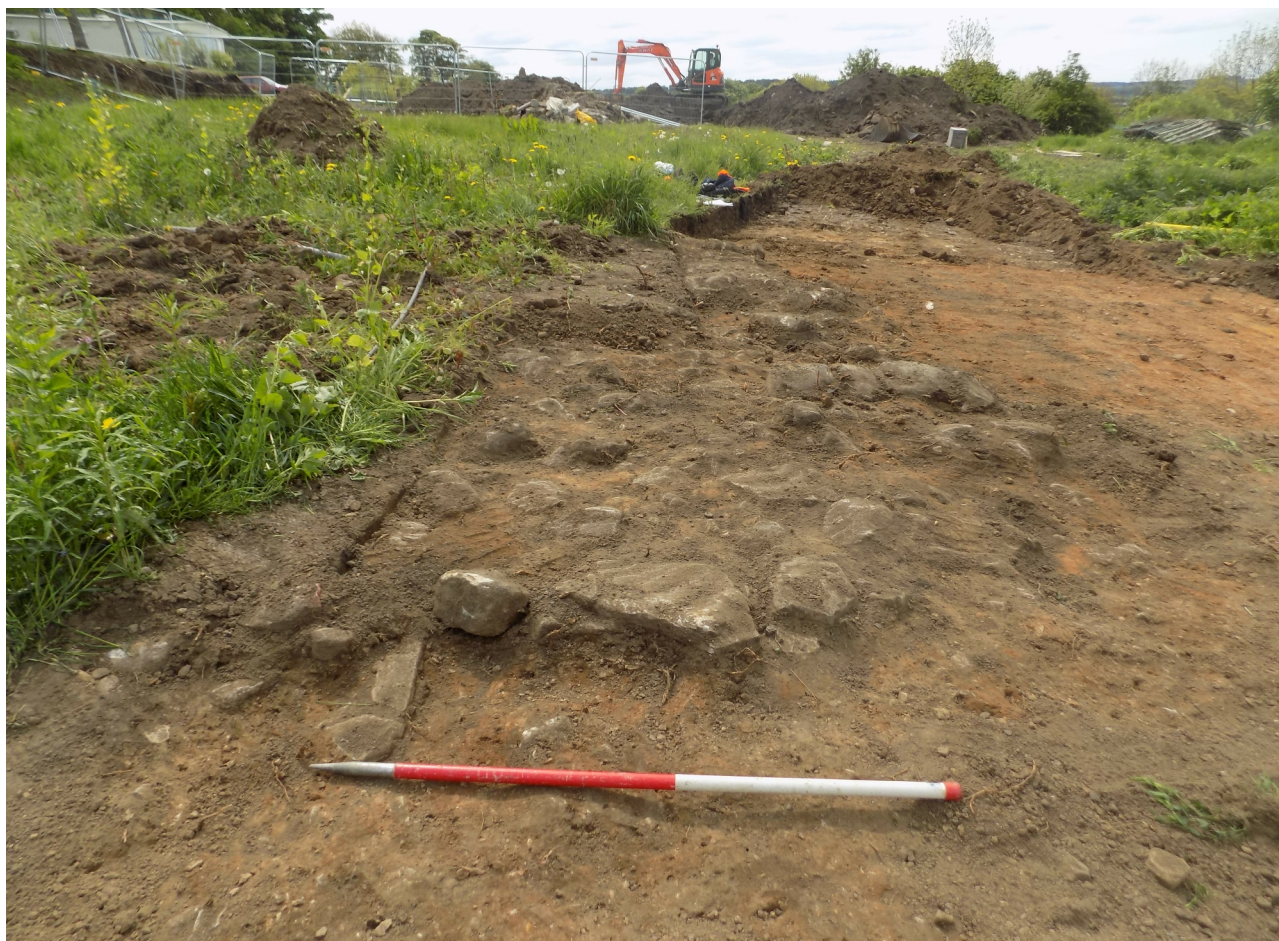
Plate 6 (above). The truncated remains of Dere Street, looking west toward the house platform.

- 3.2.4 The access track was cut southeast from the road entrance for 26m (plan view) before turning to the southwest to head toward the house platform. At the turning point, remnants of Dere Street were noted on the southeastern side of the access track: degraded wooden pegs were also observed along its section, suggesting that at some point in antiquity the area re-dug for the access road had already been disturbed. Certainly, the southern edge of the road had also been truncated due to a sewer line and associated septic tank cutting through it (See Figure 5). This section of Dere Street lay outside the impact of the overall development, but as it was exposed by the excavation of the access road a 2m long area was cleaned and recorded (see Plate .

- 3.2.5 **Dere Street:** The remains of Dere Street [F1] consisted of a single course (2) of mixed limestone and sandstones, rounded to sub-rounded and showing wear on the upper surface. The road surface lay directly on top of the natural clay substrate. No definitive dressing material remained, though during cleaning small patches of gravel (3) were observed. The road appeared to be truncated on its northern side, with no camber. There was no evidence of a roadside ditch running across the access track in this area, though the truncated nature of the northern edge of the road coupled with the further investigation area for such a feature lying outside of the development area meant that the presence of such a feature could not be ascertained. The small section of

road that was cleaned and recorded measured 5.4m wide, though its truncation would suggest a wider feature.

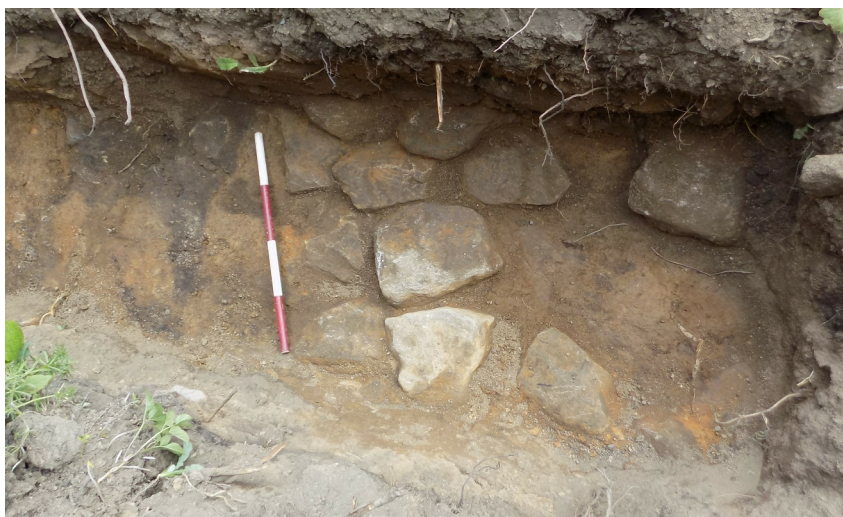
Plate 7 (right). The truncated remains of Dere Street within the slip trench, looking north.

3.3.2 The trench measured 5.5m long, 0.6m deep and 0.7m wide. The western 1.9m contained the remains of Dere Street road surface [F1], truncated again along the northern edge (see Plate 7). As with the road section noted to the

north, the stones were laid directly on top of the natural substrate but in this case the stones still formed part of a semi-coherent flagged surface, though again no dressing material was observed.

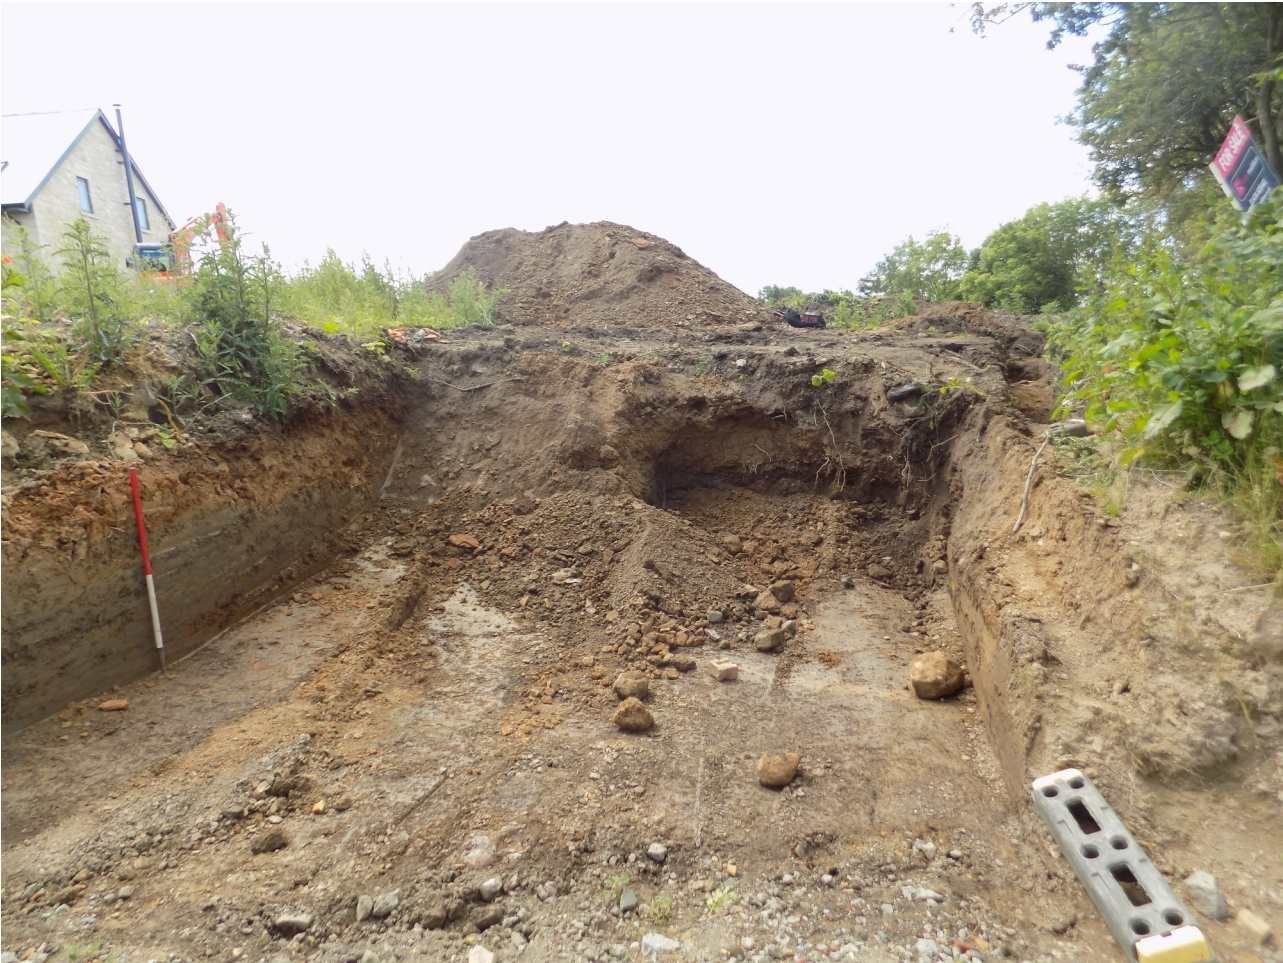
Plate 8. The bin store area, looking southwest.

3.3.3 The excavation for the bin store measured 3.4m long by 3.9m wide and 1.6m deep (at its southwestern edge), cut into the bank-side at the western edge of the access track (see Plate 8). No archaeological remains were noted within this area, so the road surface and any other related remains must have been removed in antiquity.

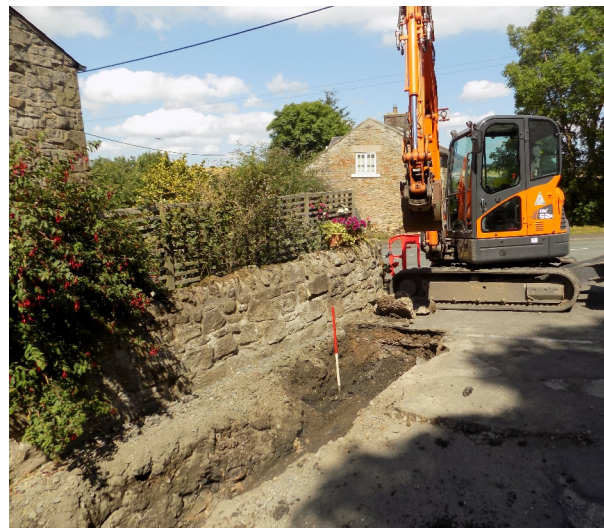
Plate 9. The northeastern end of the service run overlooking the B6309.

3.4.1 On the 23<sup>rd</sup> July 2019, the service run was cut through the Anchor Inn carpark. The monitoring was undertaken by Mick Coates. The run lay 1m to the south of the boundary wall belonging to housing north of the carpark and followed the wall line until reaching a connector point directly west of the Inn by the B6309. Its western end terminated by the boundary wall, where it would be connected to an above ground supply through the wall.

3.4.2 The trench measured 0.6m deep, 0.7m wide and 39m long. Below the layers of tarmac carpark/carpark access road surface was a mixed deposit of soils, clay, ash, brick and 20<sup>th</sup> century debris debris (4). This appeared to form the packing material beneath the modern surface, and was not breached for the length of the service run. As such, no archaeological material was noted within this section of the monitoring scheme.
