MORPETH CASTLE GATEHOUSE

Morpeth, Northumberland

Archaeological Monitoring

Project 246-18-HS | May 2019

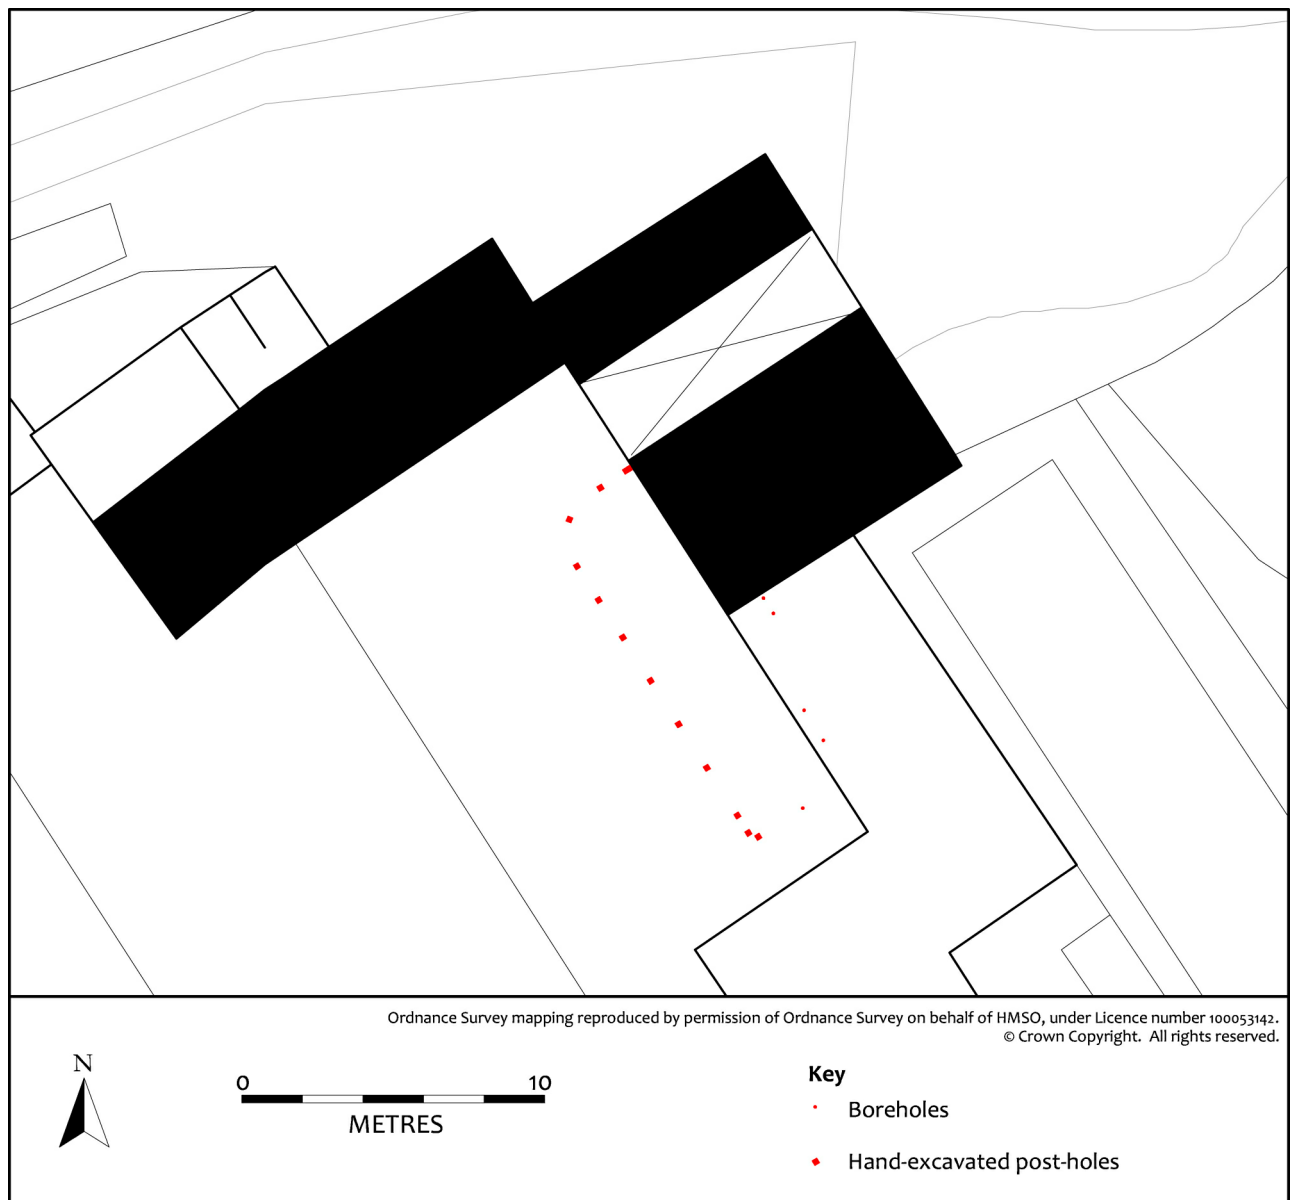
Figure 3. The location of the post-holes.

3.1.1 The scheme of works consisted of the excavation of twelve post-holes by hand along the edge of the verge in the main southwestern yard, and the excavation of a further five bore-holes in the stone steps and cobbled area to the southeast of the main building. Figure 3 (above) shows the location.

3.1.2 These post-holes would hold the main posts for the new proposed handrails.

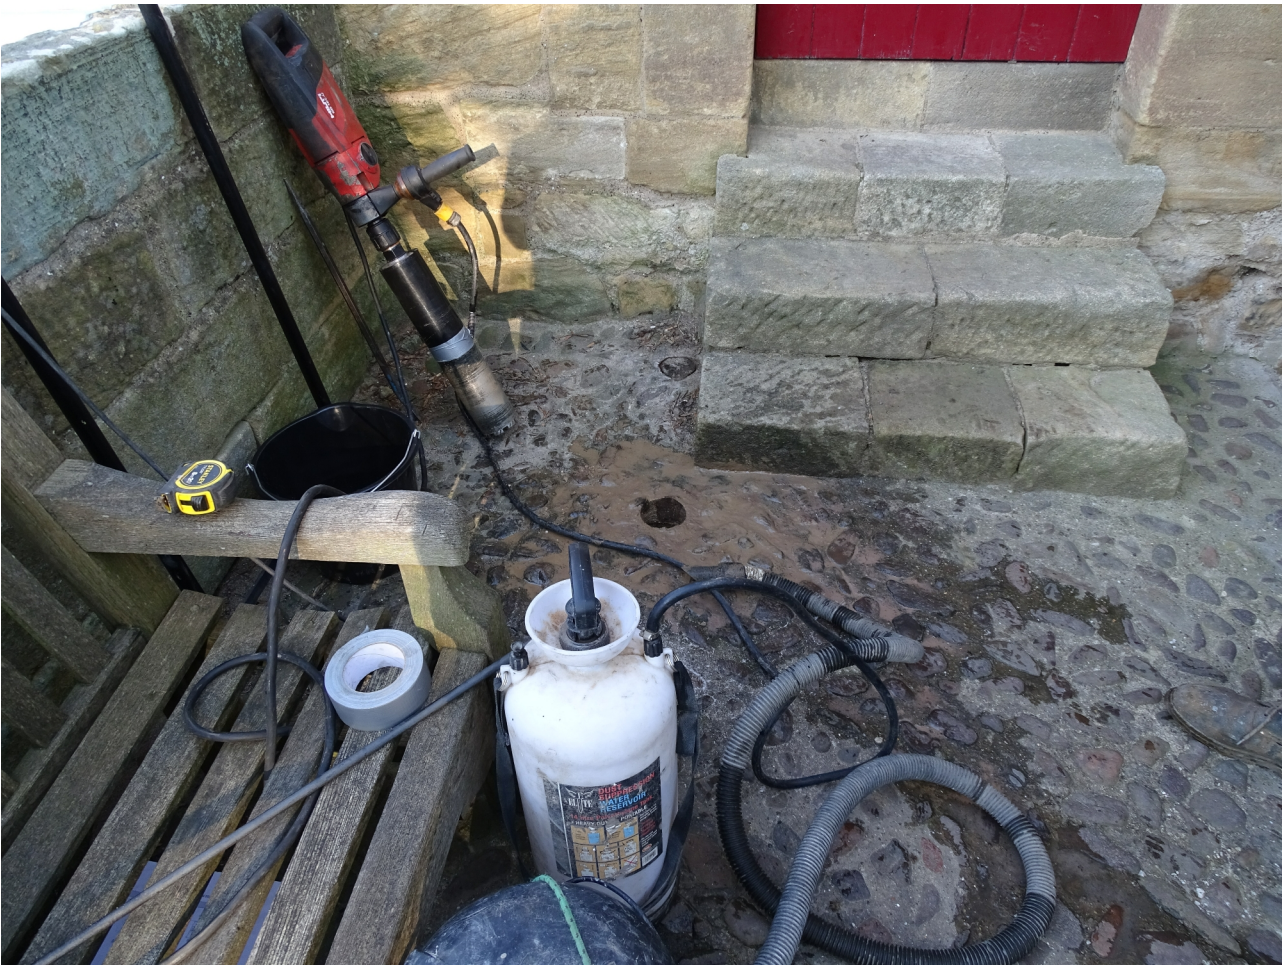
Plate 2. The boreholes to the west of the main steps.

3.2.1 Five boreholes were drilled in the area southeast of the main building. Two were located to the west of the main steps into the building, two to the east of the border wall and a further within the steps leading down to the yard.

3.2.2 The boreholes had a diameter of 0.1m and were excavated to a depth of 0.28m. Plate 2 shows the boreholes in-situ by the main entrance, with Plate 3 showing an example depth.

3.2.3 The cores removed to allow the posts to be placed were of solid concrete in all five cases, presumably a result of the 1988 consolidation scheme.

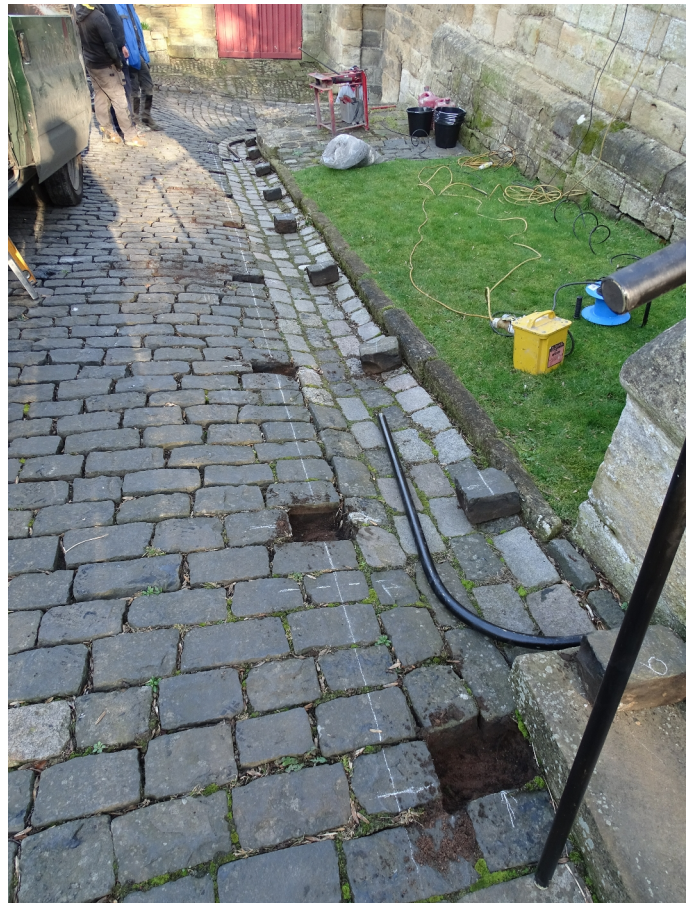
Plate 4 (above). The hand-dug post-holes along the verge, looking north.

3.3.1 Twelve post-holes were excavated by hand by the drain verge along the eastern edge of the yard.

3.3.2 The holes were excavated by first removing a single slab/cobble and then excavating beneath it by hand.

3.3.3 As such, the post-holes varied in size and width depending on the stone size removed, but averaged 0.18m square.

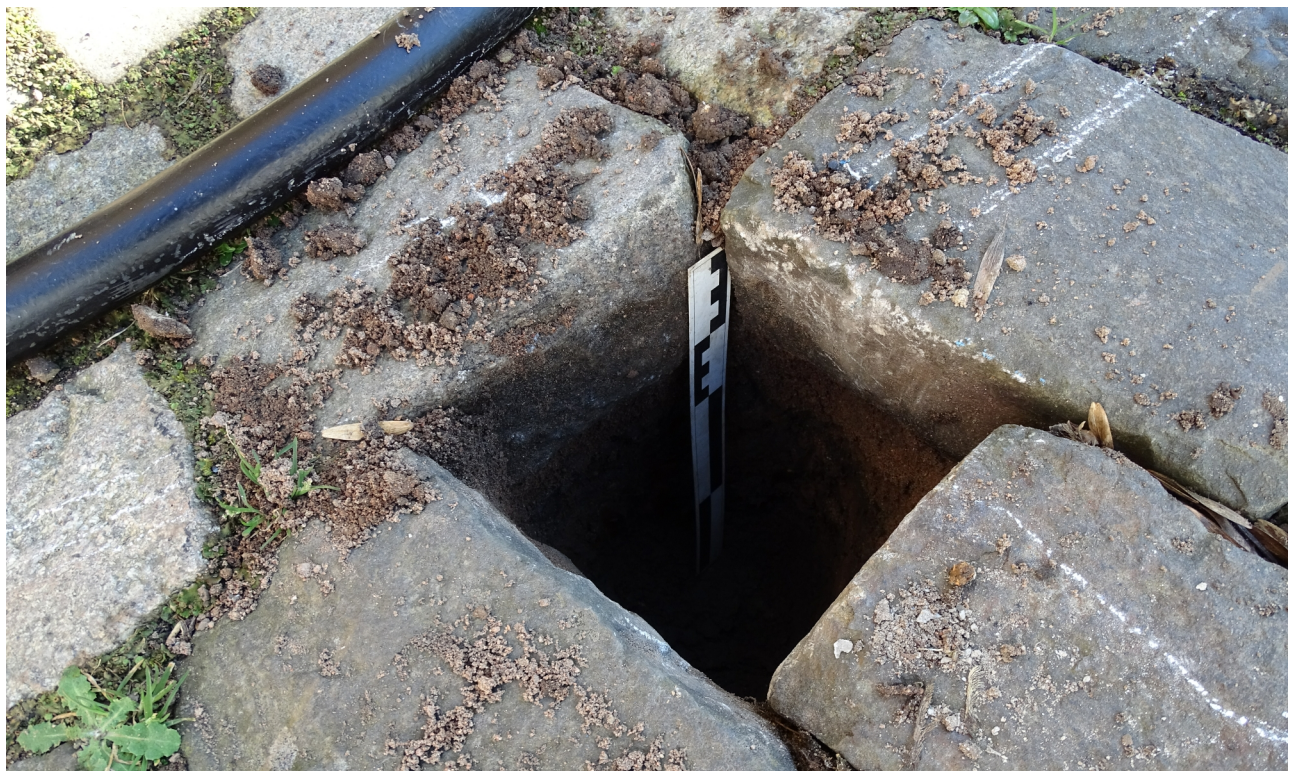
Plate 5 (below). One of the post-holes showing excavated depth.

3.3.4 Each post-hole was excavated to a depth of approximately 0.3m. Beneath the slabs was a base layer of sand, with dark grey-brown sandy soil beneath, which included modern late 20th century debris.

3.3.5 Plate 5 shows an example of one of the hand-dug post-hole depths.
