LAND EAST OF HILLCREST  
Tow House, Bardon Mill  
Northumberland

Archaeological Evaluation

Project 297-20-EVA | April 2020

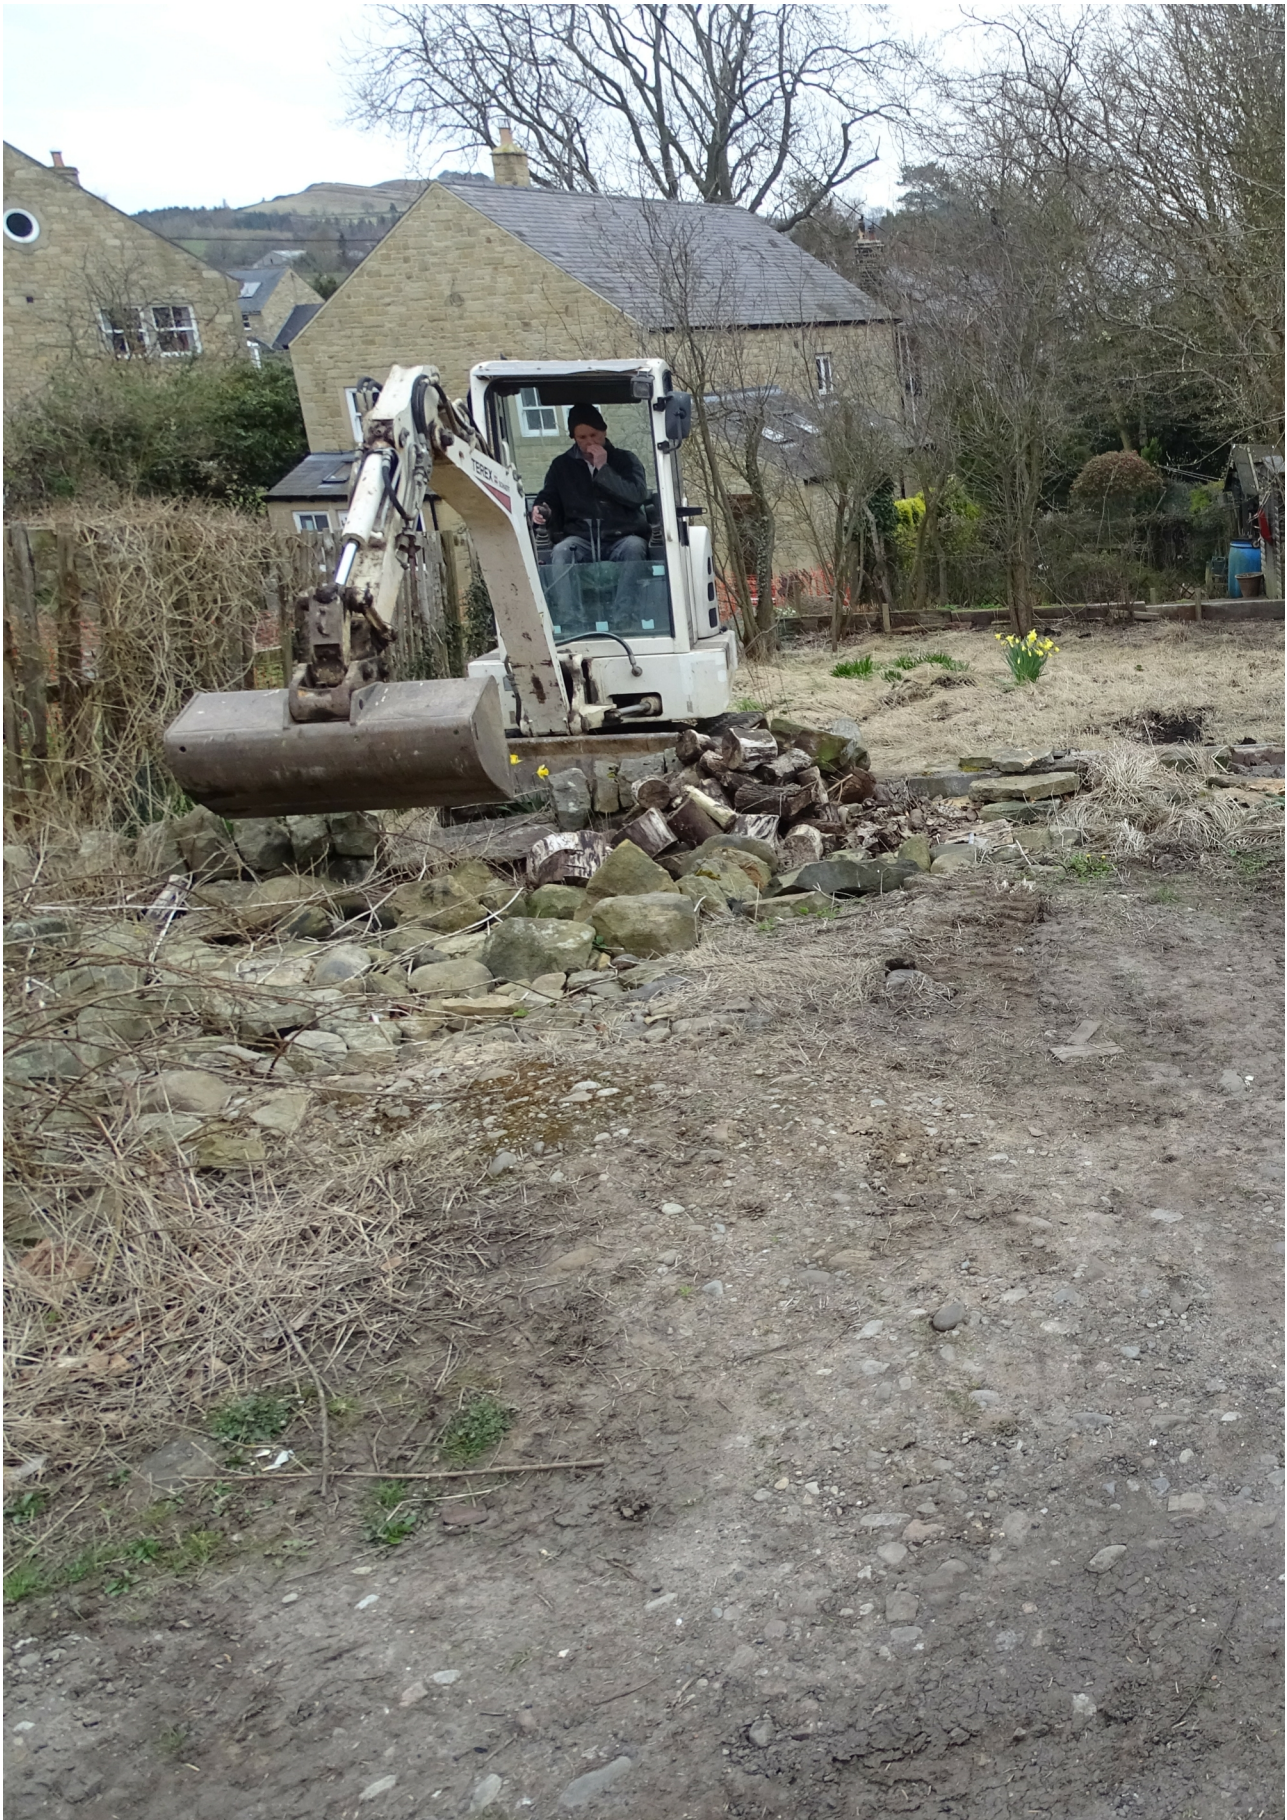
Plate 3. The development area looking northeast.

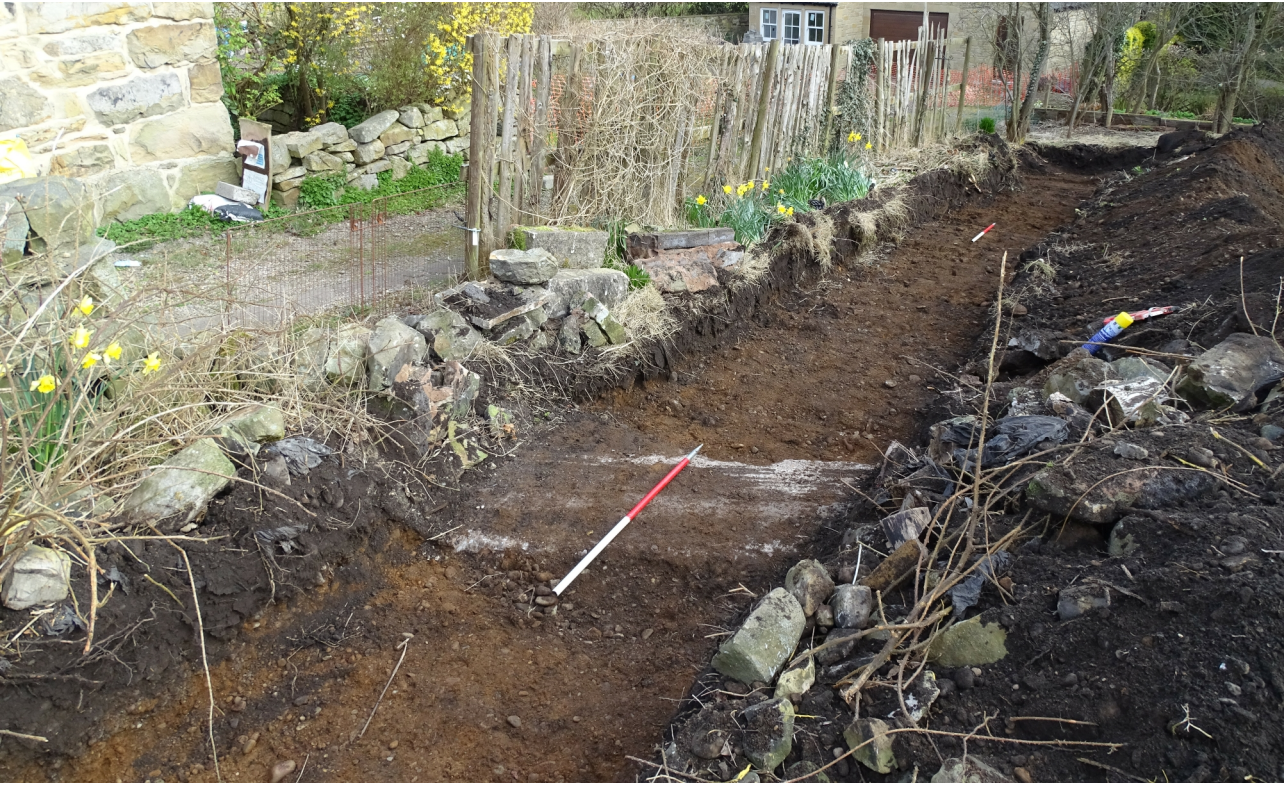
Plate 4 (above). The long arm of the trench looking north. The concrete foundation and remains of the drystone wall can be seen.

- 3.2.4 The natural geology noted within the evaluation trench was orange to mid-brown in colour and comprised mainly loose gravels and sandy clay.
- 3.2.5 2.1m northeast of the southwestern extent of the trench was a concrete foundation for a drystone wall. The foundation cut into the natural geology and measured 0.7m wide. To the south of this wall was an old area of overgrown hardstanding.

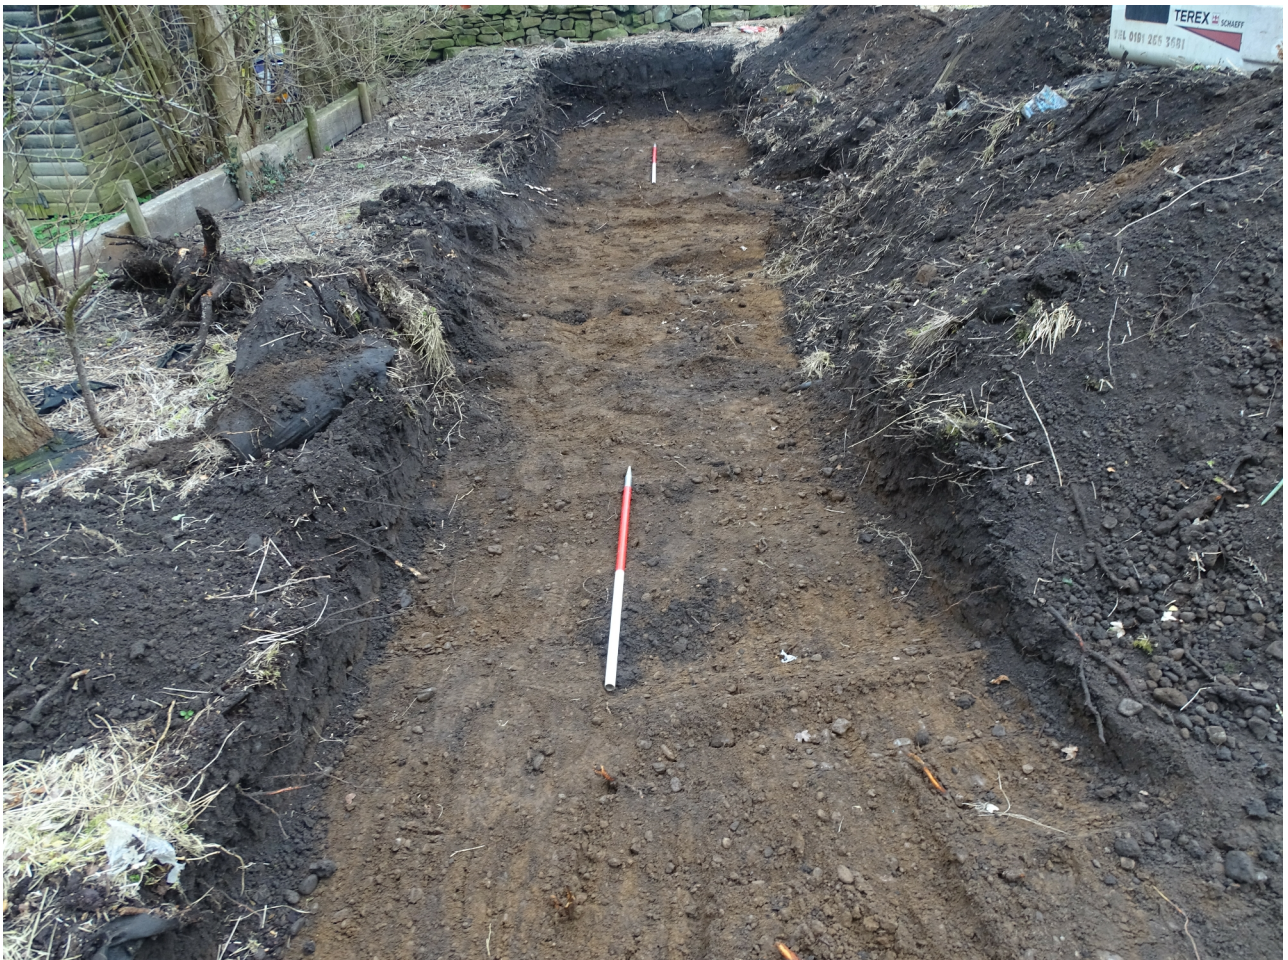
Plate 5 (below). The short leg of the trench looking southeast.

- 3.2.2 The southeast-northwest aligned arm measured 10.4m long, 2m wide and again averaged a depth of 0.50m.
- 3.2.3 The overburden across the site contained lumps of sandstone from the collapsed drystone wall, (localised around the wall line in the southwester extent of the trench) with loose mixed dark soils containing small stones, plastic, modern brick fragments and glass. The overburden averaged 0.50m in depth across the evaluation area.

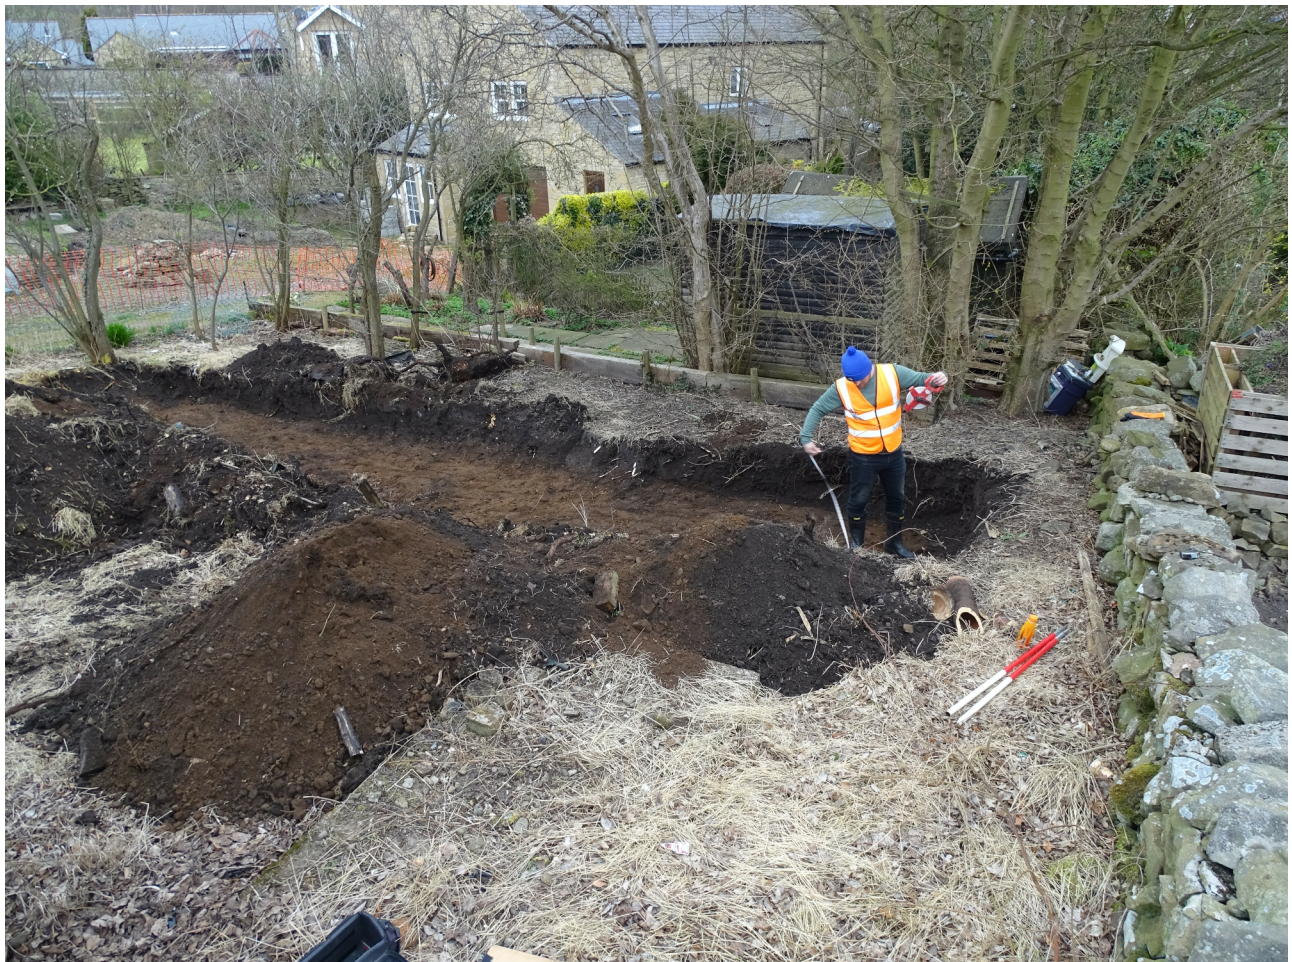
- 3.2.6 The sewer inlet for an old septic tank crossed the trench in the northeast-southwest direction in the eastern extent of the trench.
- 3.2.7 **No archaeological deposits, features or background material was noted within the evaluation area.**

Plate 6 (below). The short leg of the trench looking northeast during cleaning.
