LAND NORTH OF FAIRFIELDS PHASE 3

Longframlington
Northumberland

Archaeological Evaluation

Project 318-20-EVA | July 2020

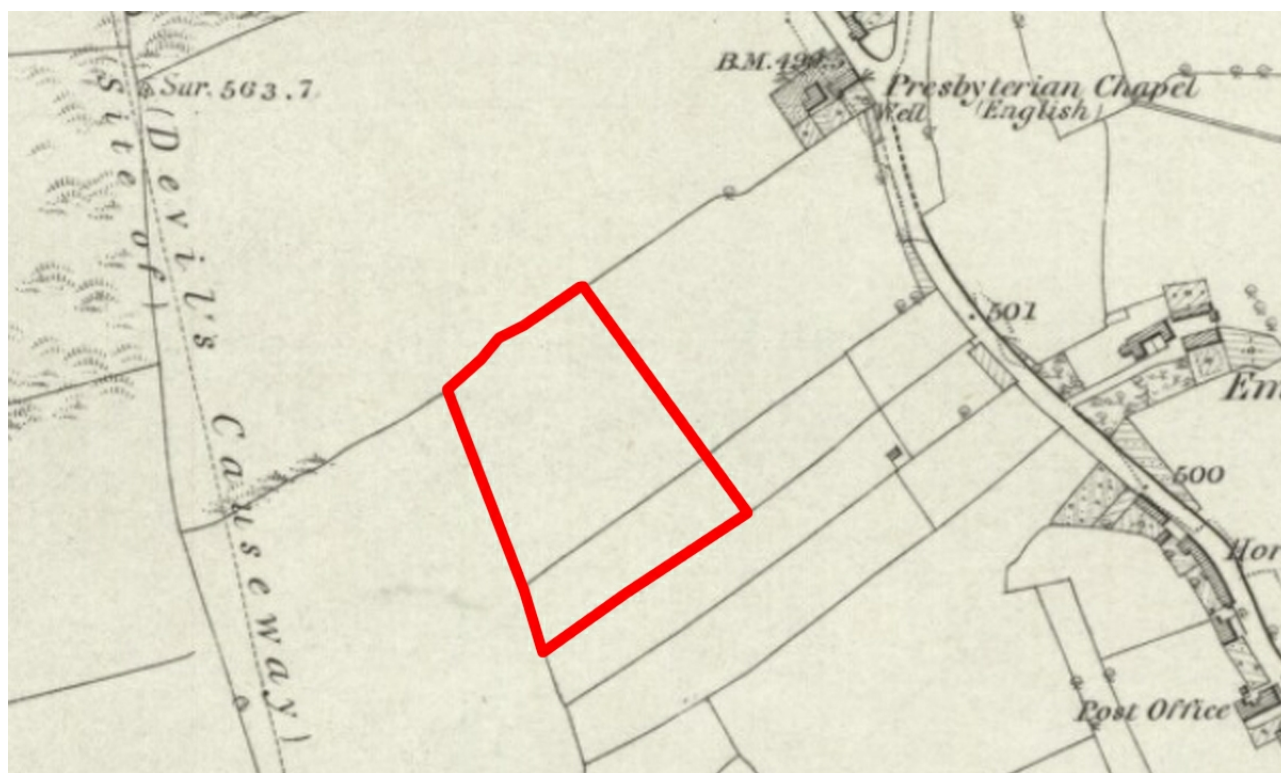
Plate 2. Extract from the 1864 Ordnance Survey map. The proposed development area is outlined in red.

- 2.4.1 Historic mapping from 1864, 1867, 1897, 1923 and 1974. All showed the field as pasture with no notable post-19th century features. Plate 2 shows an extract from the 1864 Ordnance mapping, with the development area highlighted in red.

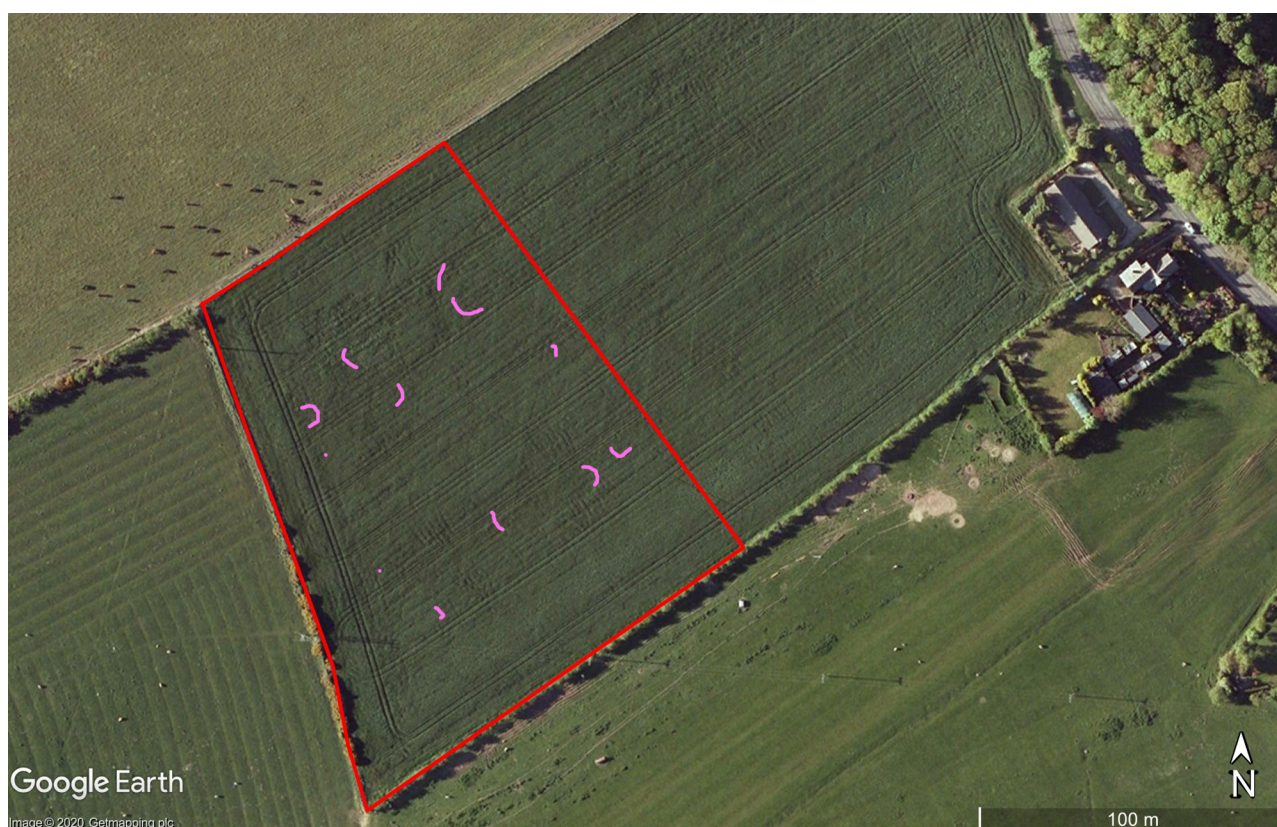
Plate 3. Aerial image (dataset © 2020 Getmapping PLC), with potential cropmarks marked in magenta.

- 2.5.1 *Aerial photographic evidence:* Combining the 2002 and 2006 Google Earth Pro images a number of potential anomalies could be seen as faint cropmarks, including two sub-rectangular enclosures and old field boundaries. Later photography also shows a series of north-south aligned field drains covering the development area. Infra red-imagery does not highlight any features of significance.

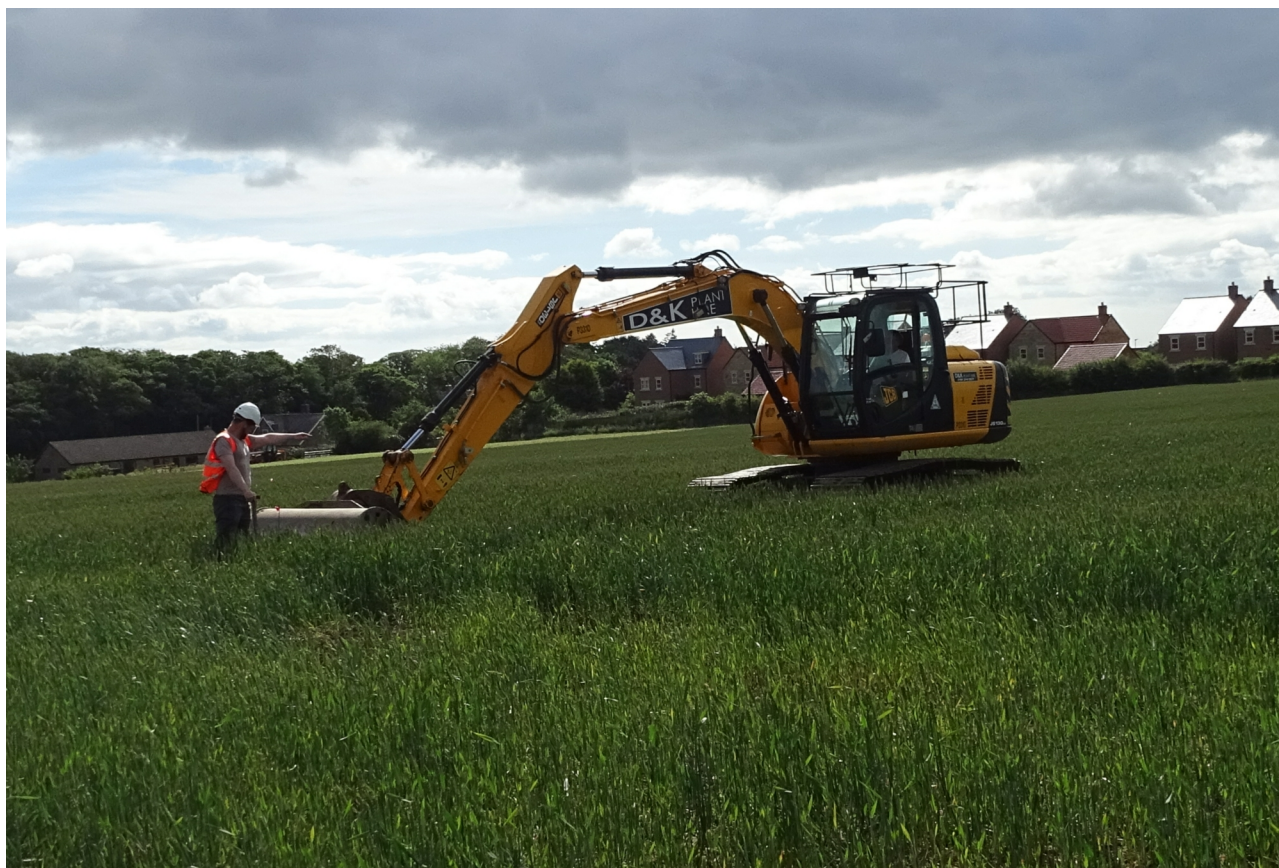
Plate 4. Trench excavations underway under constant archaeological supervision

- 3.1.2 The trenches were plotted on site by Tony Liddell, Principal Archaeologist for Vindomora Solutions Ltd utilising a Leica GPS Rover, and then excavated by a JS130 mechanical tracked excavator with a 1.8m wide toothless ditching bucket under constant archaeological supervision. Trenches were opened until the afternoon of each working day, and then backfilled with the machine and gate to the field secured at the end of each day.

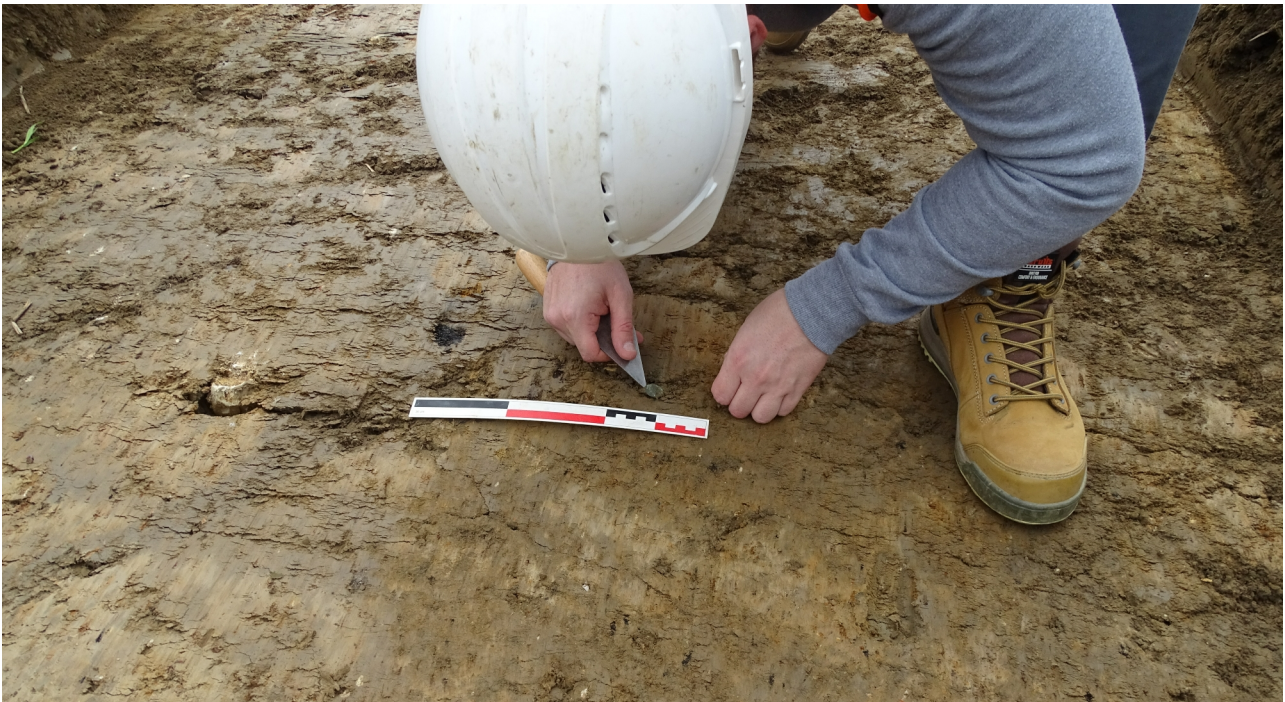
Plate 5. Recovering the copper alloy button.

3.5.2 A degraded copper alloy button, likely early 20th century in date was recovered from the upper horizon of the southern furrow remnant in Trench 9.
