LAND AT THE FORMER CARLEY HILL PRIMARY SCHOOL

Carley Hill
Sunderland

Archaeological Desk-based Assessment

Project 323-20-DBA | September 2020

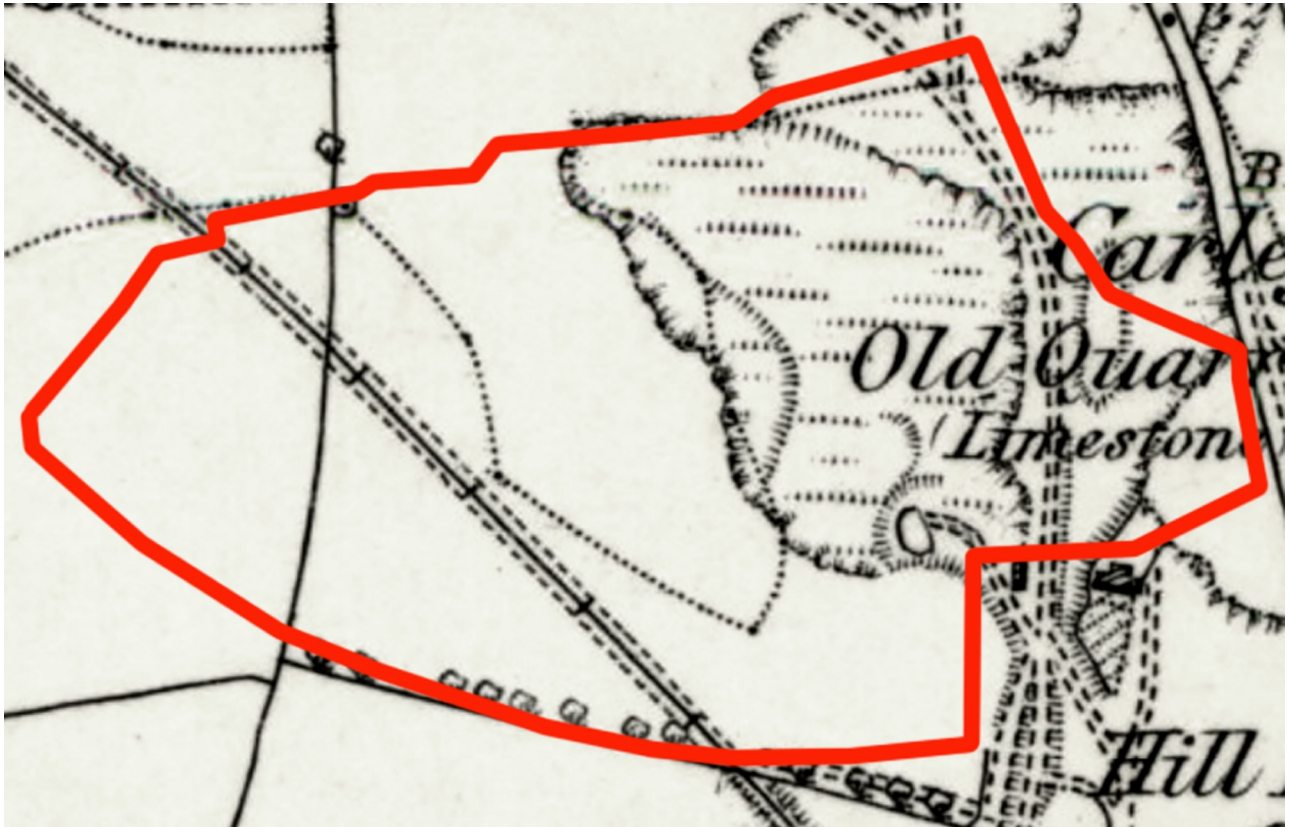
Plate 2. Extract from the 1862 Ordnance Survey map with the proposed development area outlined in red.

3.2.2 As well as the quarry, the map also shows the line of the late 18th century waggonway (HER 2676, see Section 2.12.7) which connected the limestone quarry northwest of the development area (HER 2675) to the Wear Lime Works (HER 2679) so the south, cutting northwest-southeast through the western section of the PDA.

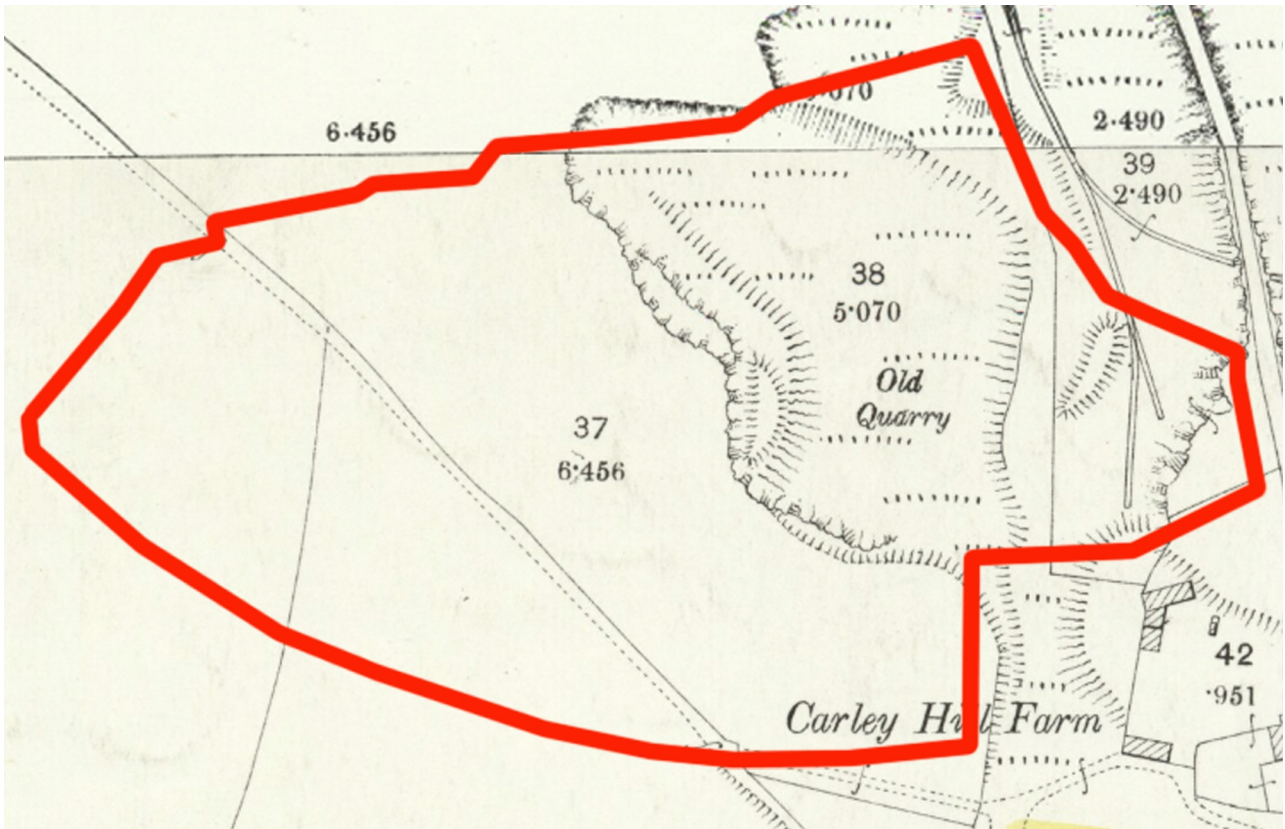
Plate 3. Extract from the 1897 Ordnance Survey map with the proposed development area outlined in red.

3.2.3 By the time the 1897 Ordnance Survey map (Plate 3) was published (surveyed in 1895), further rail sidings had moved into the eastern extent of the development area (re-using the backfilled quarry) with the Carley Hill waggonway (HER 2682, see Section 2.12.8) altering course. The southern section of the old quarry had also been further backfilled and footpaths removed, and the 18th century waggonway previously noted running northwest-southeast through the western segment of the

site had also been removed and was by then a field boundary with a marked foot-path to the south of it.

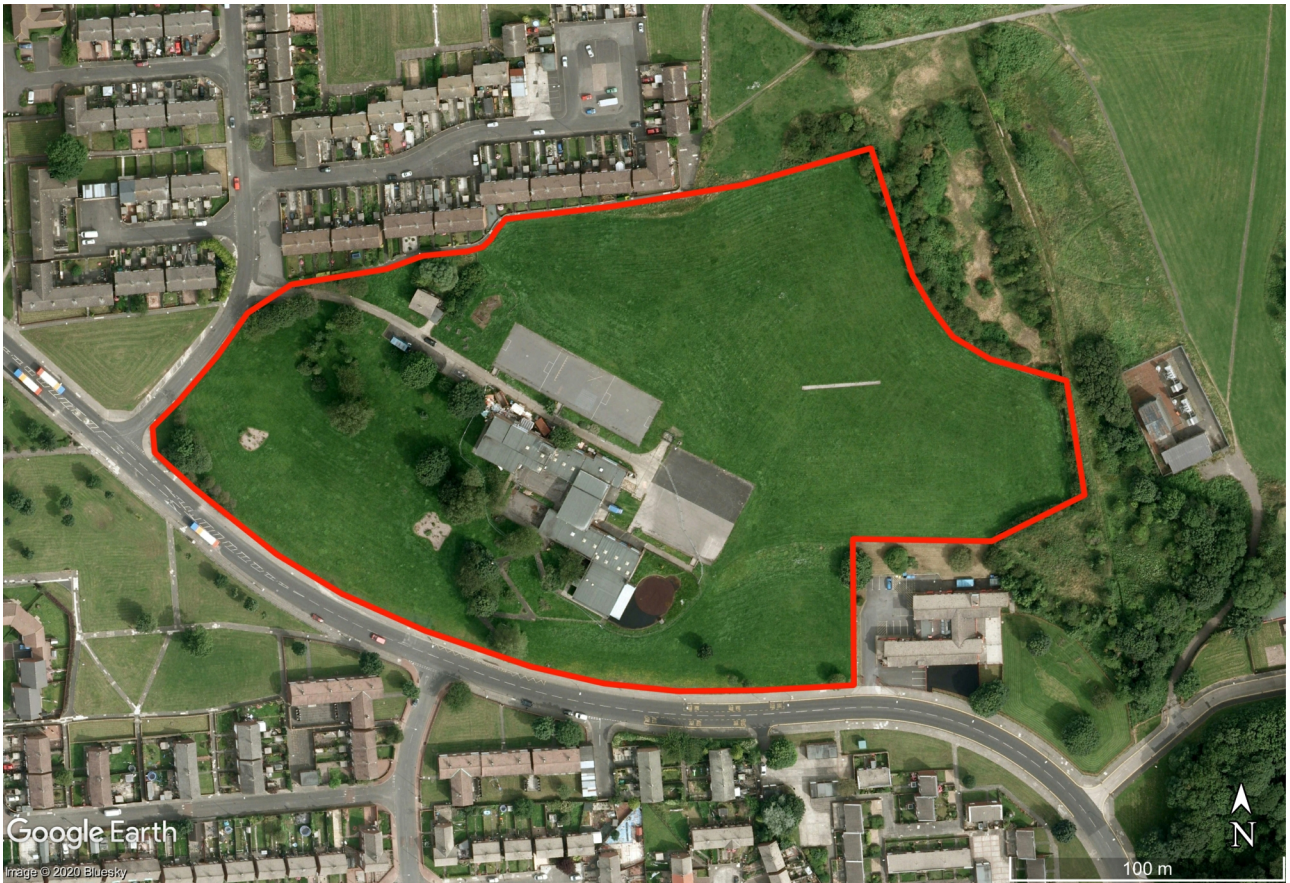
Plate 6. Aerial view of the proposed development area in April 2012 (dataset © 2020 Bluesky)

- 3.4.1 *Plates 6-8* show the aerial photography of the site available at the time of the assessment being produced.
- 3.4.2 *Plate 6* shows the site as it was in 2012, eight years after the school had closed. Between the 1966 Ordnance mapping and the extent of the buildings on this aerial image, we can extrapolate the extent of damage on any archaeological remains present caused by modern school foundations (see Section 4).

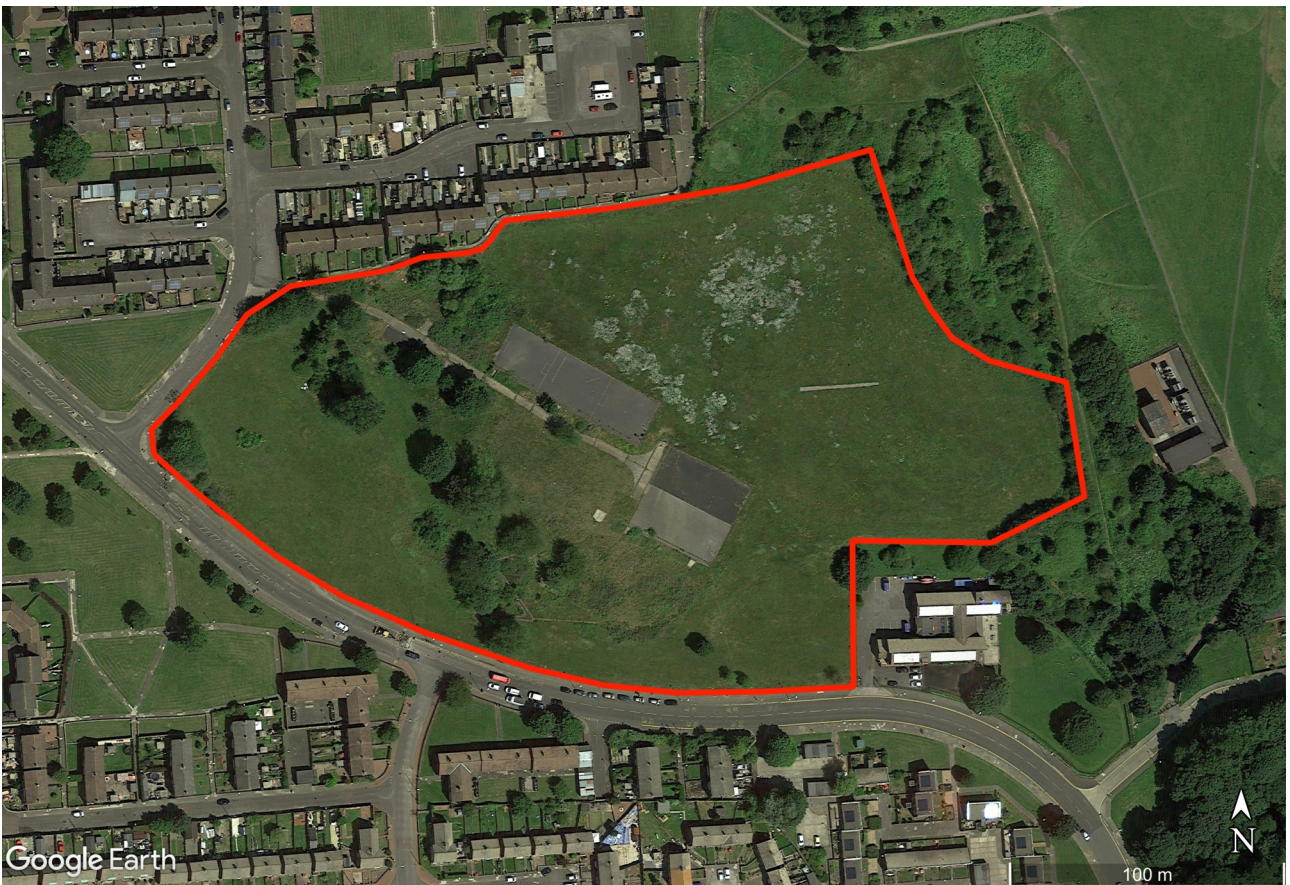
Plate 7. Aerial view of the proposed development area in April 2017 (dataset © 2020 Google)

- 3.4.3 Plate 7 shows the site in 2017, after the school has been demolished. Debris from the demolition can be seen north of the tarmac hard standing areas (left *in-situ*).
- 3.4.4 Plate 8 shows the site in April 2018: the disturbed ground of the backfilled quarry and subsequent levelling of school demolition deposits north of the hard-standing shows as disturbed and uneven against the land to the south of the tarmac areas.

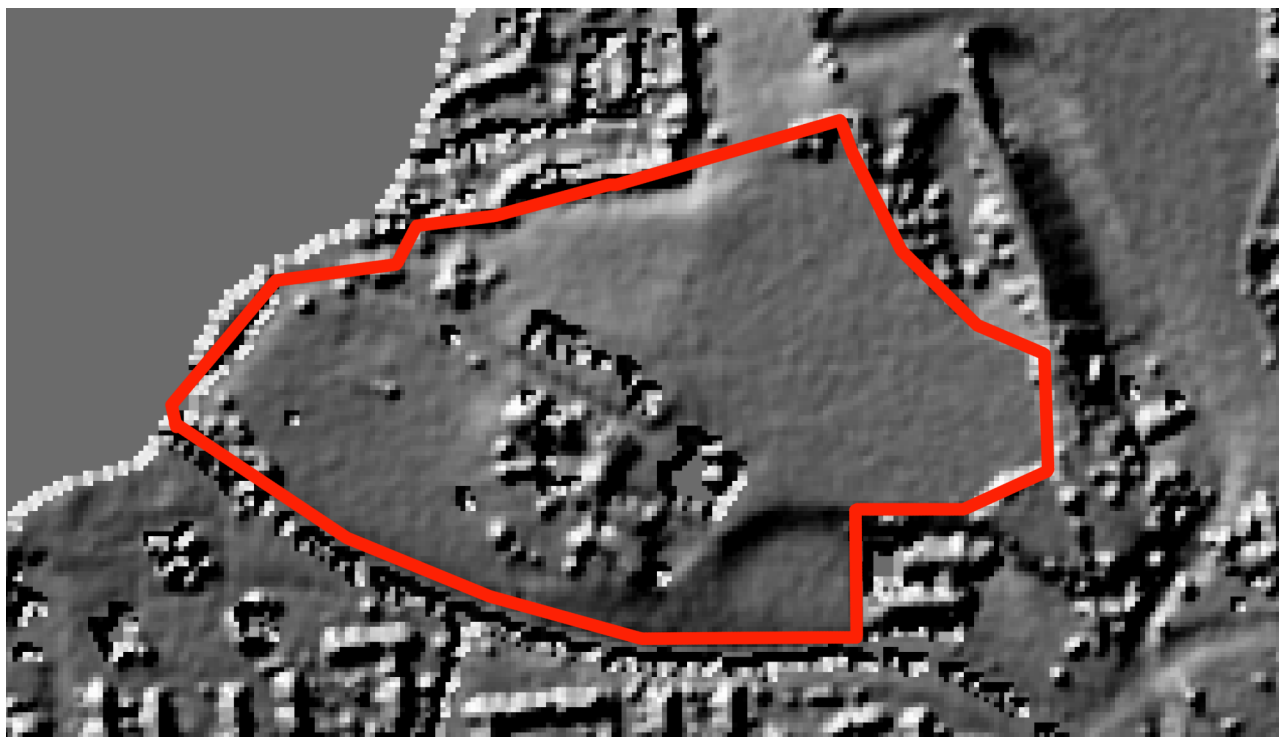
Plate 9. LIDAR of the PDA

- 3.4.4 The sharp decline and fall to the south from the quarried area in the southeastern section is evident on the LIDAR: no further features are notable from the data due to the poor resolution of the dataset.
