**THE RANCH**  
**LAND SOUTH OF CULLODEN TERRACE**

Grants Houses, Horden  
County Durham

Archaeological Monitoring

Project 353-20-MON | April 2021

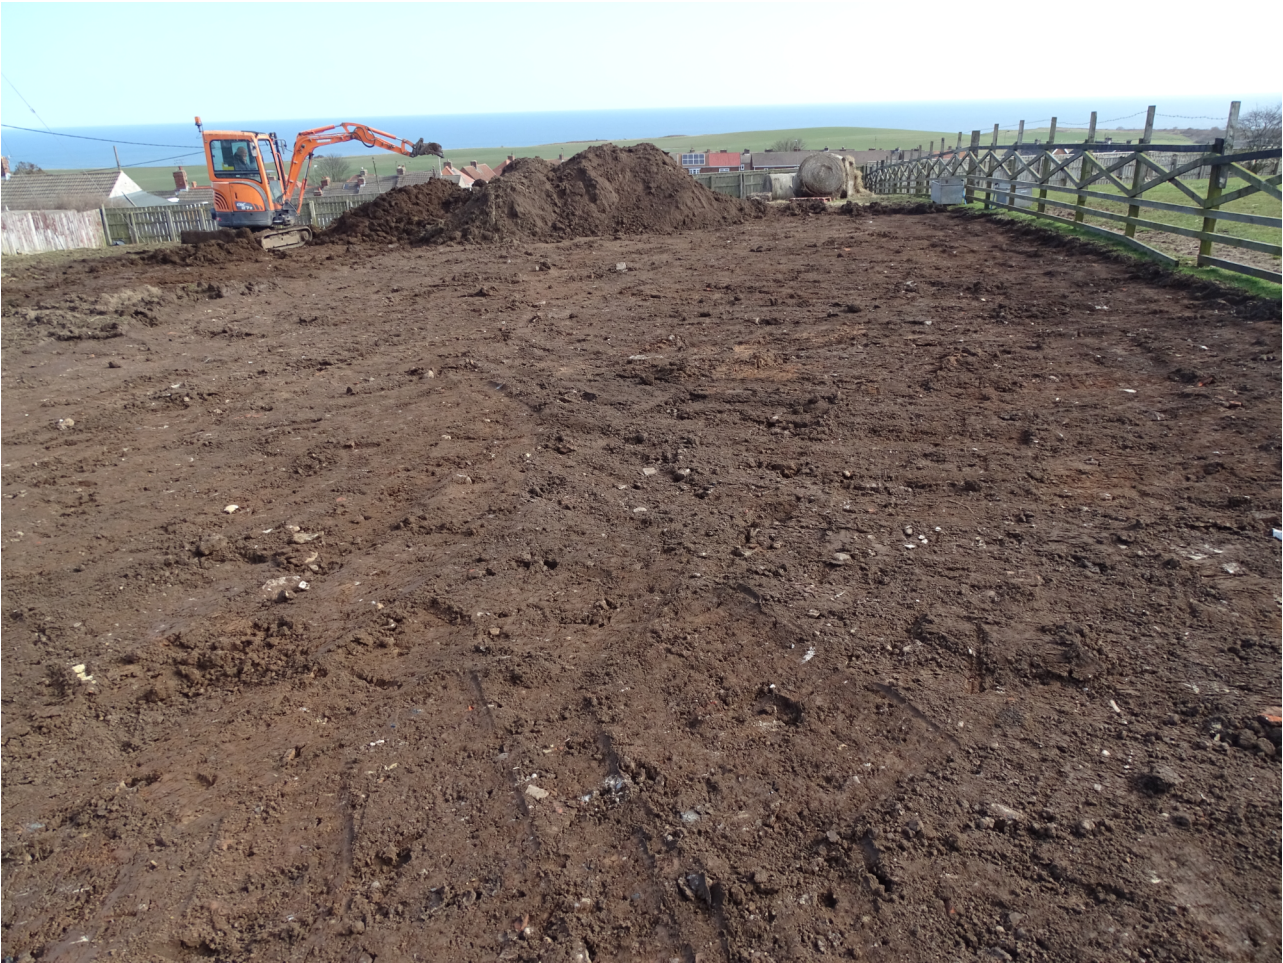
Plate 4. Observing the initial topsoil strip, looking east.

3.2.1 Modern turf and topsoil (1) averaged between 0.20m and 0.25m thick, with inclusions of general small stones and gravels mixed with an assortment of modern materials in the form of plastic tubing, tin cans, and numerous small sherds of early modern glazed ceramics as well as random nails and car parts. The upper surface of turf had suffered heavy disruption from animal movement across the development area. The area of topsoil removal measured approximately 23m<sup>2</sup> and was only initially removed to the upper surface of subsoil deposit (2).

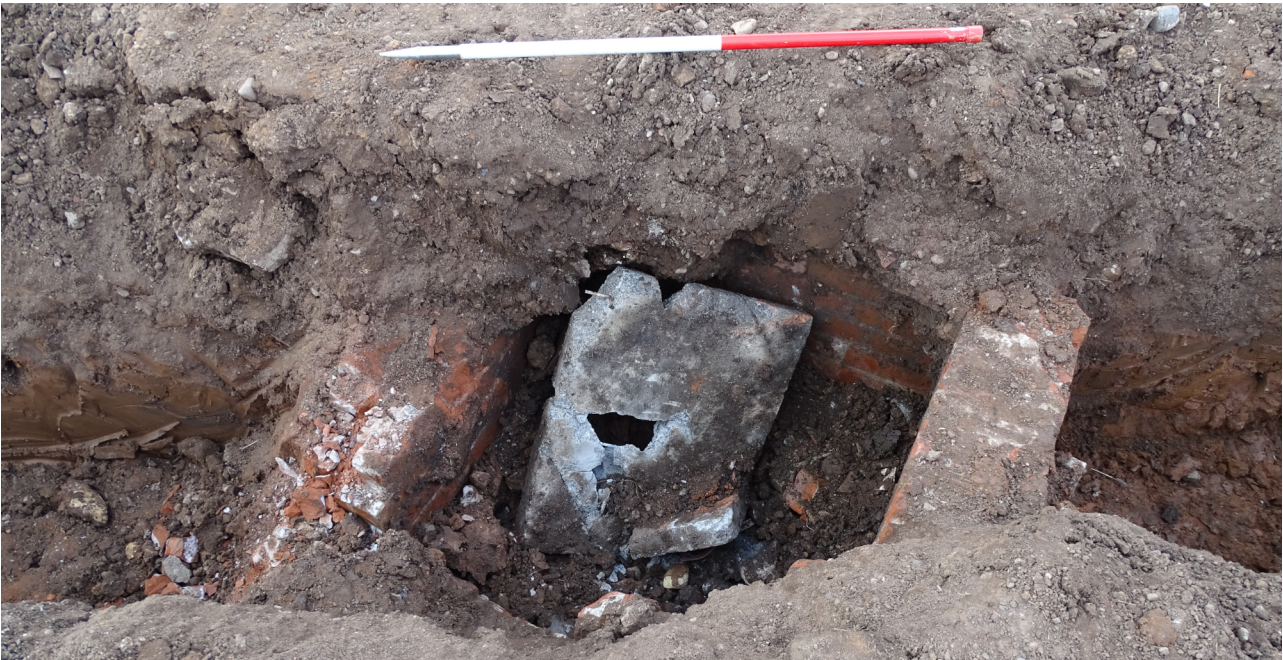
Plate 5. Manhole A looking west.

north-south aligned arms of the trench network system (see Figure 3). Manhole A was a mortared single brick skin construction with an apparent benched interior and measured 1.4m on its northwest by southeast axis with the base unobserved due to contractor's depth achievement. The feature was noted to have been backfilled with modern demolition materials. The upper extent of the manhole was observed to be 0.45m below the modern field surface. Manhole B was a mortared single brick skin construction with a definite benched interior and measured 1.2m on its northwest by southeast axis with the base unobserved due to contractor's depth achievement. This feature again was observed to be backfilled with modern demolition materials. The depth of Manhole B was observed to be 0.5m below the modern surface. Both manholes were cut into natural substrate.

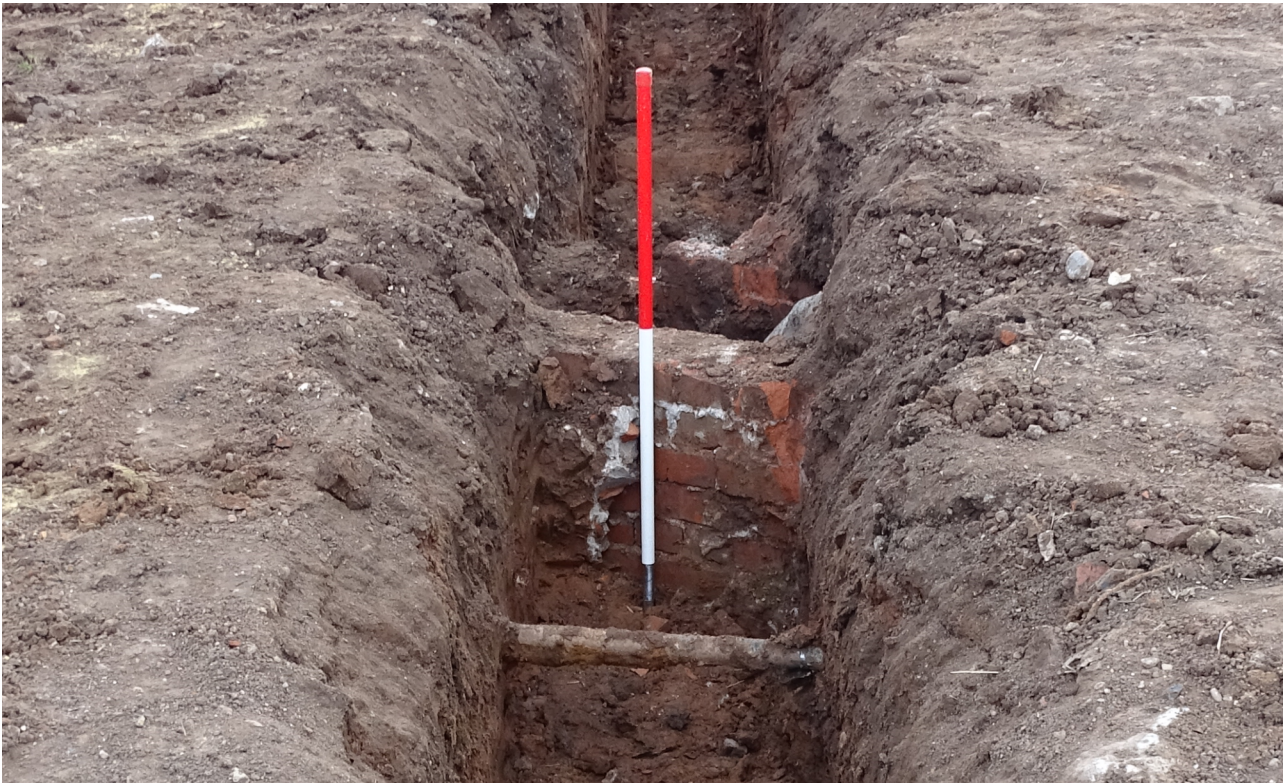
3.3.5 0.6m north of Manhole A a decommissioned steel conduit (0.08m in diameter) of unknown

Plate 7. The conduit with Manhole A beyond, looking south.

utilisation was observed. This service was observed at a depth of 0.5m below the modern surface, and was set parallel to Manhole A at a northwest-southeast alignment. The conduit was noted running out of the excavation area to the west.

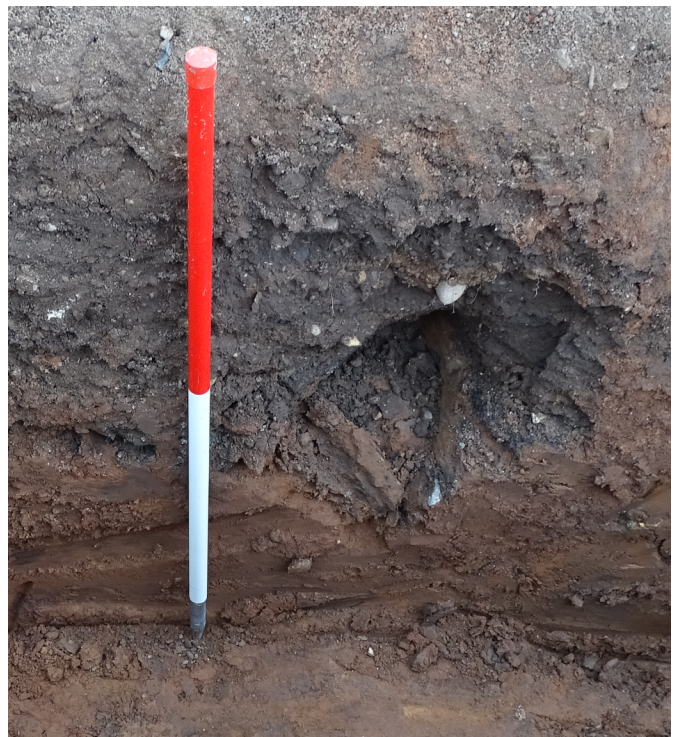
- 3.3.6 Located at the extreme southwest corner of the development area was a salt glazed ceramic sewer drain, observed at a depth of 1m below the modern ground surface. This service was initially observed emerging from the north-south aligned arm of the trench network system at its southwestern corner, then continuing in a northwest by southeastern direction through the extreme southern arm of the network and observed continuing through the limit of excavation to the southeast.

Plate 8. The glazed drain looking north.

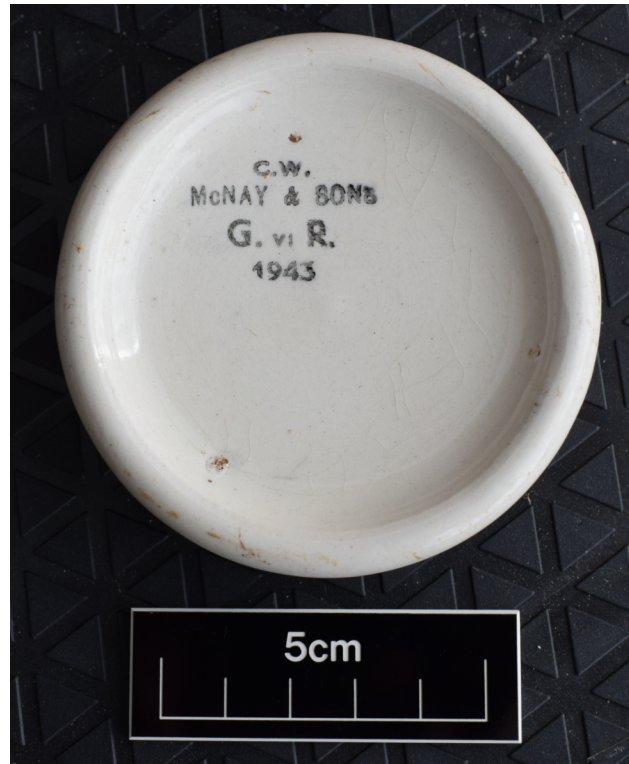
4.1.2 Numerous early modern and modern ceramic sherds were noted within the topsoil and mixed subsoil of the site, the most notable being sherds of a railway mug base with maker's stamp, reading "C.W. McNAY & SONS G.vi R. 1943". This date is approximately the construction date for the former miners' hostel.

Plate 9. 1943 McNay & Sons railway mug base.
