GLA/SITE/3/4

Glastonbury Abbey Excavations 1956

7th August - 30th August

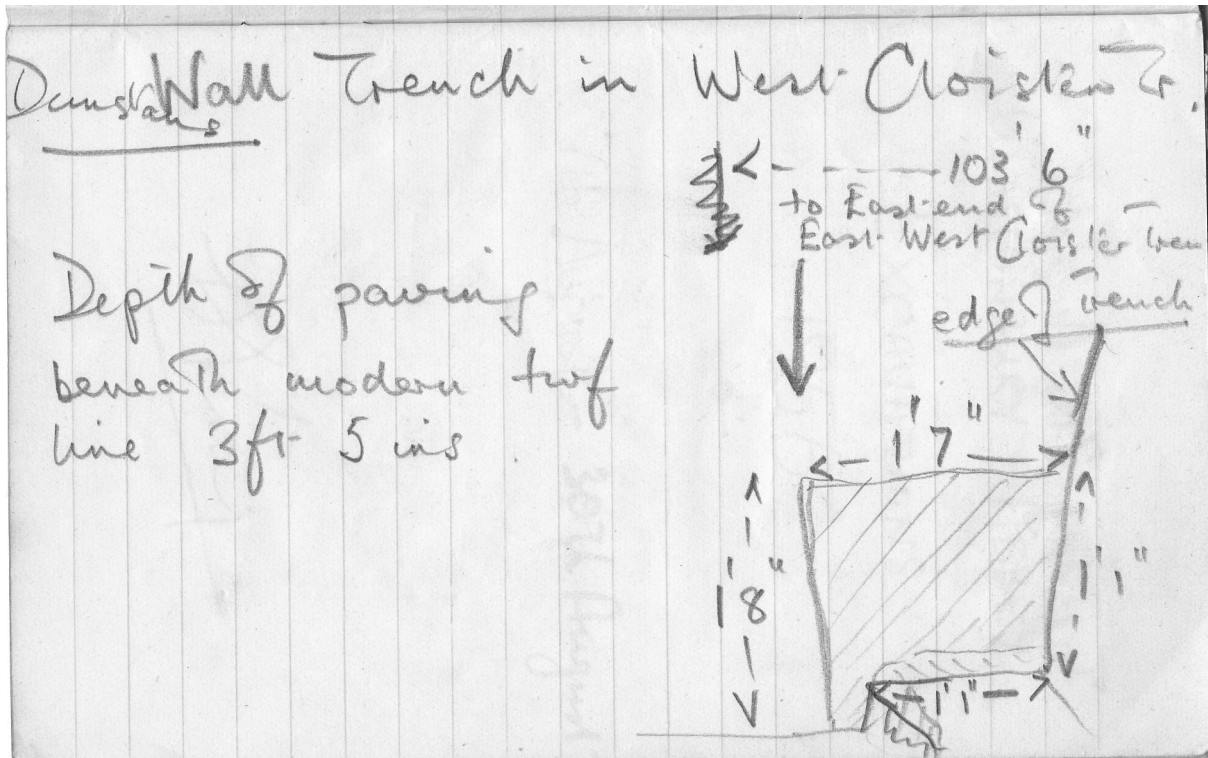
Wall trench in W cloister trench.

Wall trench in West Cloister. Depth of paving beneath modern turf line 3ft 5ins.

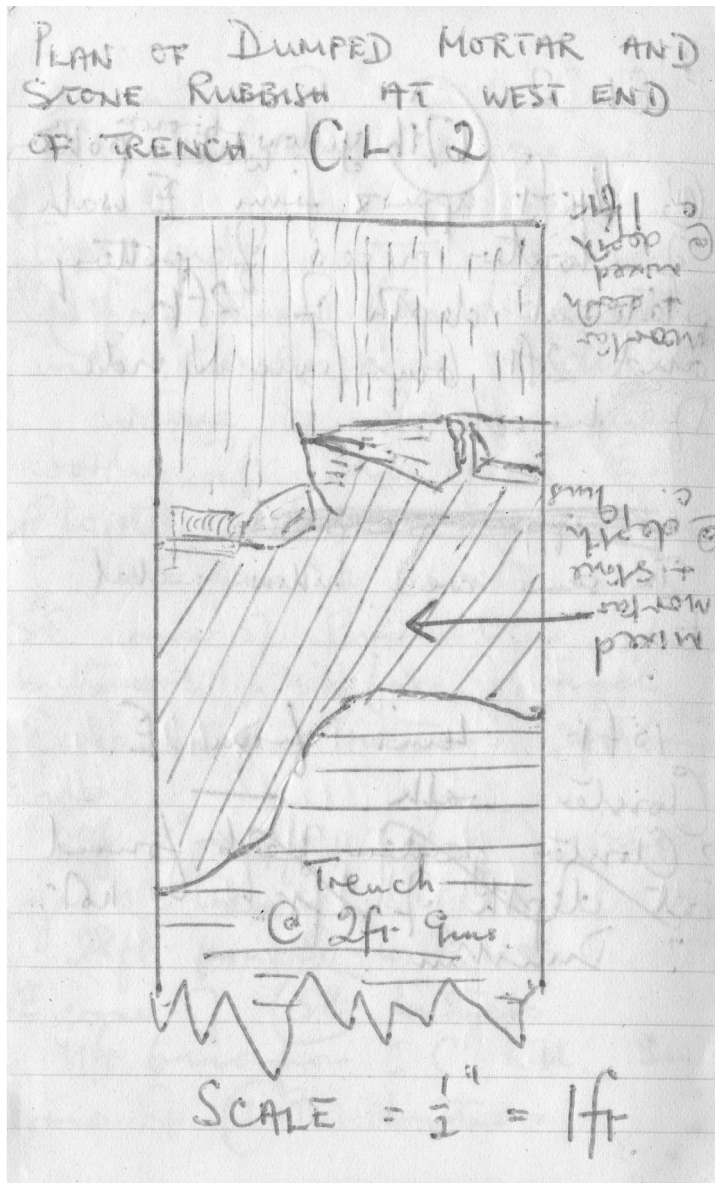
Plan of dumped mortar and stone rubbish at W end of CL2.

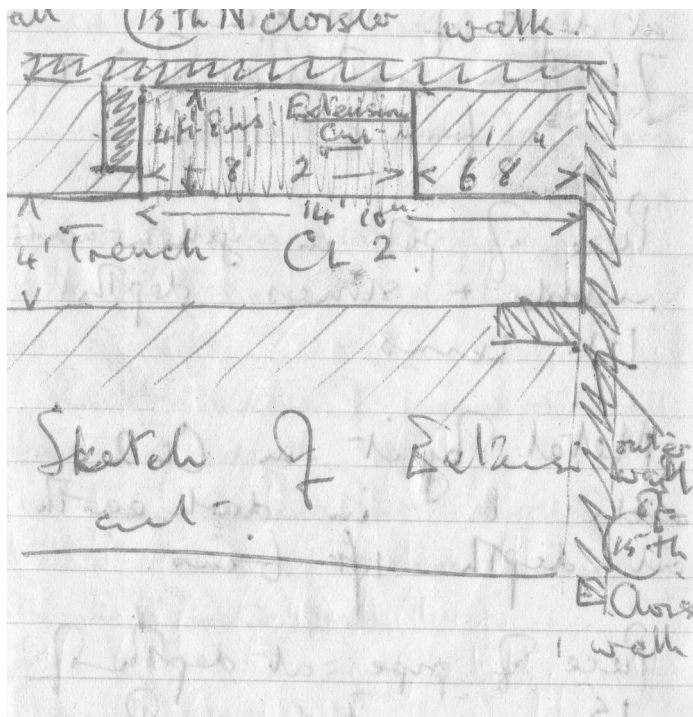
Plan of north cloister trench extension 1.

Extension 1 into N face 6'8" – 14'10" from E cloister walk. Extends 4'8" to outer wall 15thC N cloister walk.

In CL2 Extension 1.

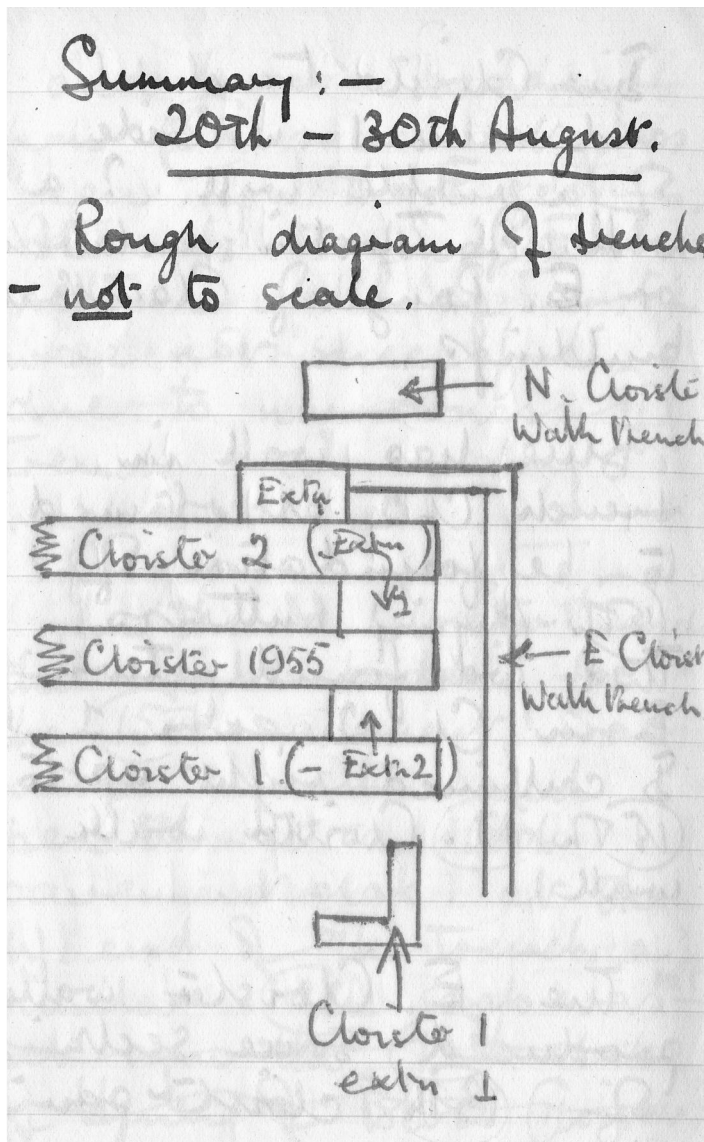
Cloister trench plan.

Summary – 20th-30th August. Rough diagram of trenches – not to scale.

In Cloister Trench 1 and extension 1 W side of a rubble wall ? A wall of Turstin's church or E range of Claustral buildings.

Blue lias wall in trench CL2, ascertained to be foundation of 15th century flying buttress. This was found returning E in CL2 extension 1, continued right up to 15th century N. Cloister walk wall. The E Cloister walk produced some sections of 13th century cloister paving...
