GLA/SITE/3/10

Glastonbury Abbey Excavations, 1957

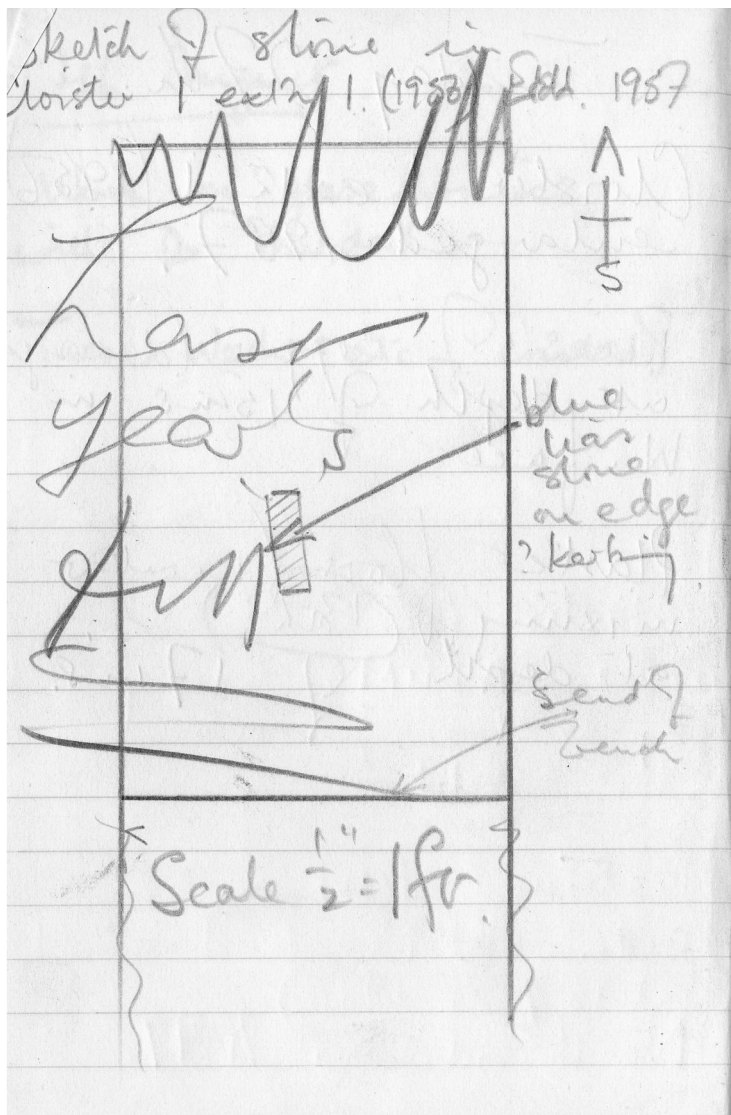
Page 3

Cloister 1 extension 1 (1956) enlarged 1957. Section 56

Pieces of copper (decayed) [F:SF4110] at depth of 15 inches in W. face. Plaster floor (mortar mixing) [C:3112] 13th century at depth of 17 ins.
