**GLA/SITE/3/28**

**RALSTON**

**Glastonbury 1957 & 1959**

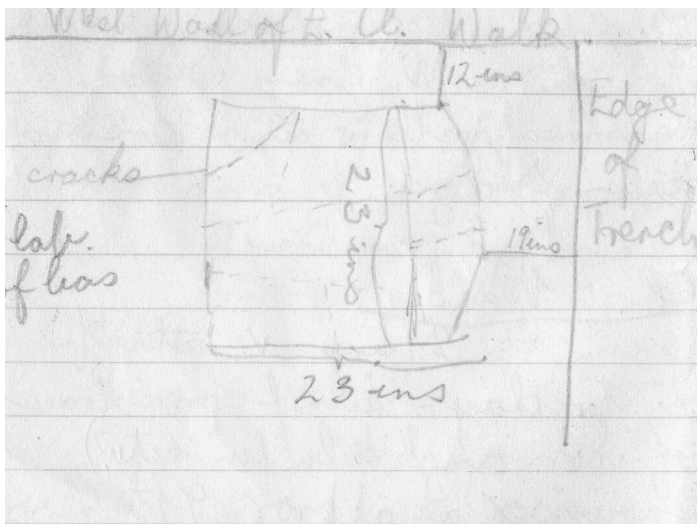
Sunk to 21ins very stiff dirty clay – kiln frags traces of iron and kiln (in situ?) showing at approx 9 ft from W.

Kiln showing also at foot from W end definitely in situ.

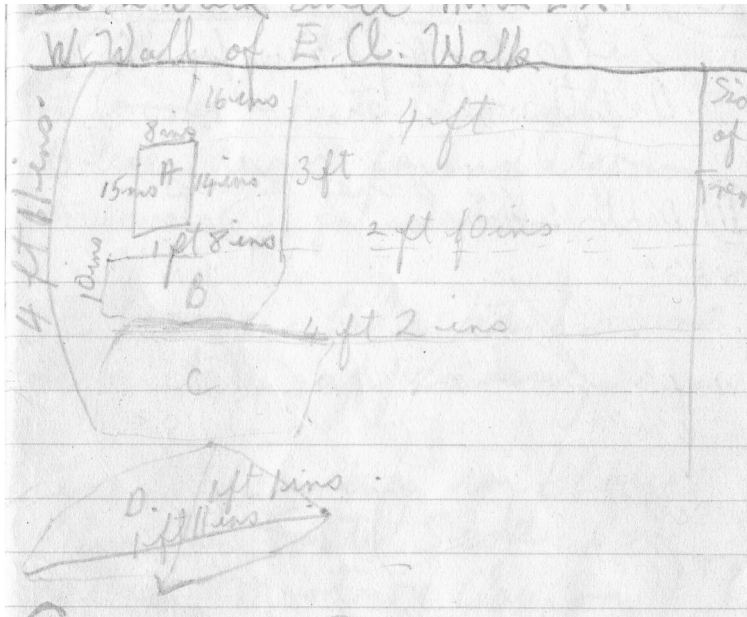
Sketch plan of west wall within CLE walk trench.

- A. 16ins from W – 2ft 8ins. 4ft-48ins from N side of trench. Depth 7ins at W. 3ins at E. Freestone.
- B. Tor burr. 3ft-3ft 10ins from N. 2ft10ins -4ft 6ins from N. Depth: N- 4ins. S – 6ins.

- C. Tor burr. 3ft11 ins – 4ft 10ins from W, 2ft 10 ins – 4ft 5 ins from N. Depth 6 ins
- D. Depth 4 ins. Blue Lias.

Stones proved to be drain cover. Some blue lias and some Tor burr.

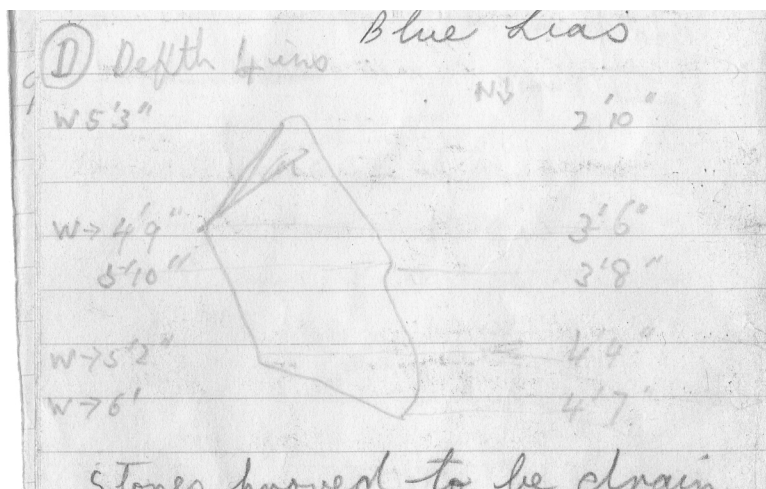
Sketch of blue lias.

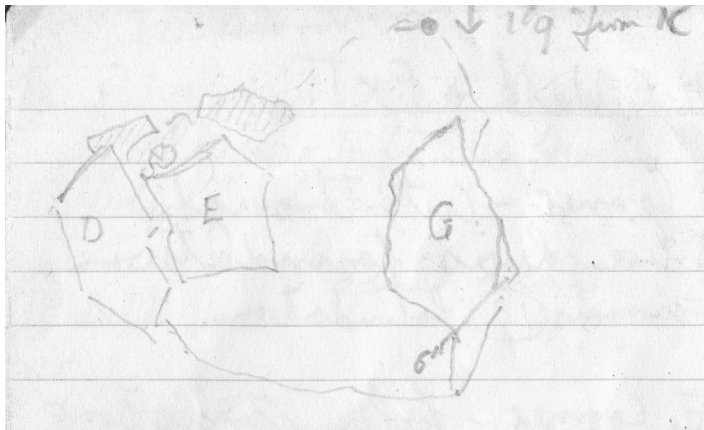
Sketch plan of stones.

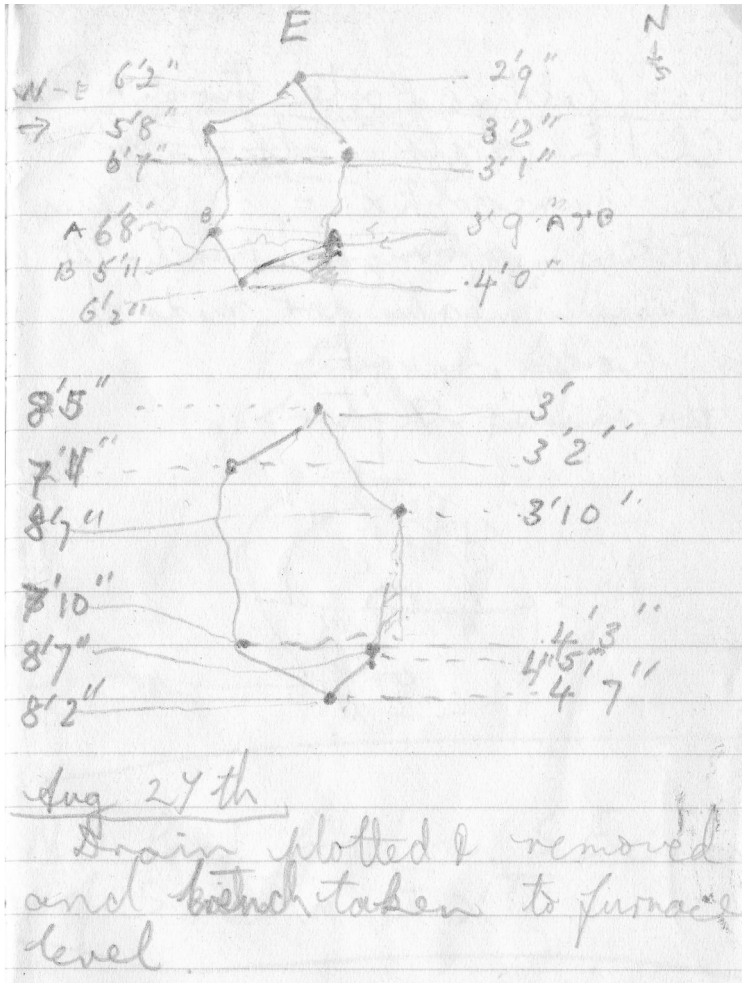
Sketch plan of stones.

Aug 27th. Drain plotted and removed and trench taken to furnace level.

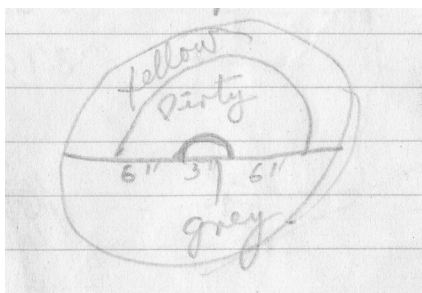
Scaffolding hole through kiln, CLE walk south ext SE corner of Ext – 8ft 2 ins NE corner of original trench – 9 ft. Measurements for middle of hole.

Diameter 2 ft.

Sketch plan of scaffold-hole through glass furnace.

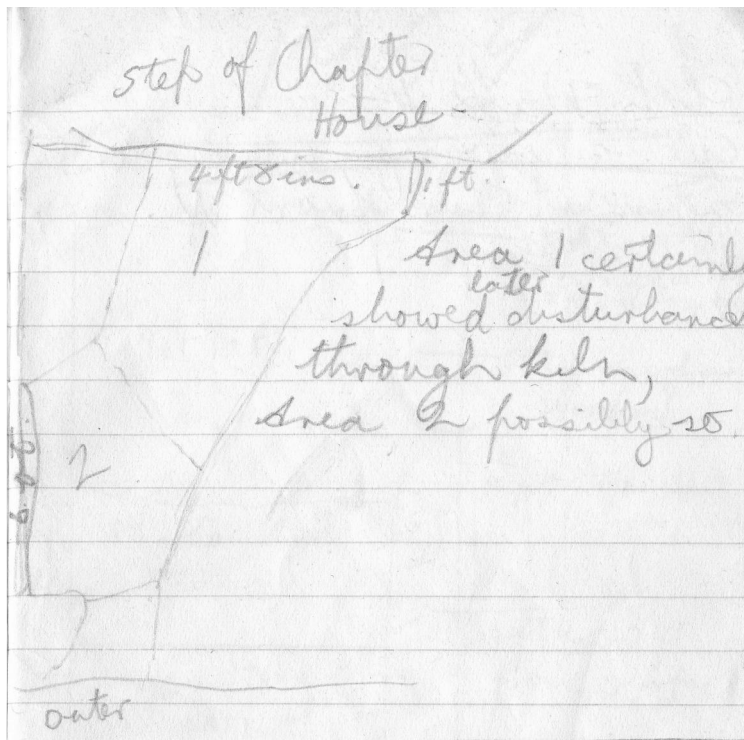
Sketch plan showing area of disturbance near chapter house step.

Note: Area 1 certainly showed later disturbance through kiln, Area 2 possibly to.

N.B Post-hole in SE corner of south ext

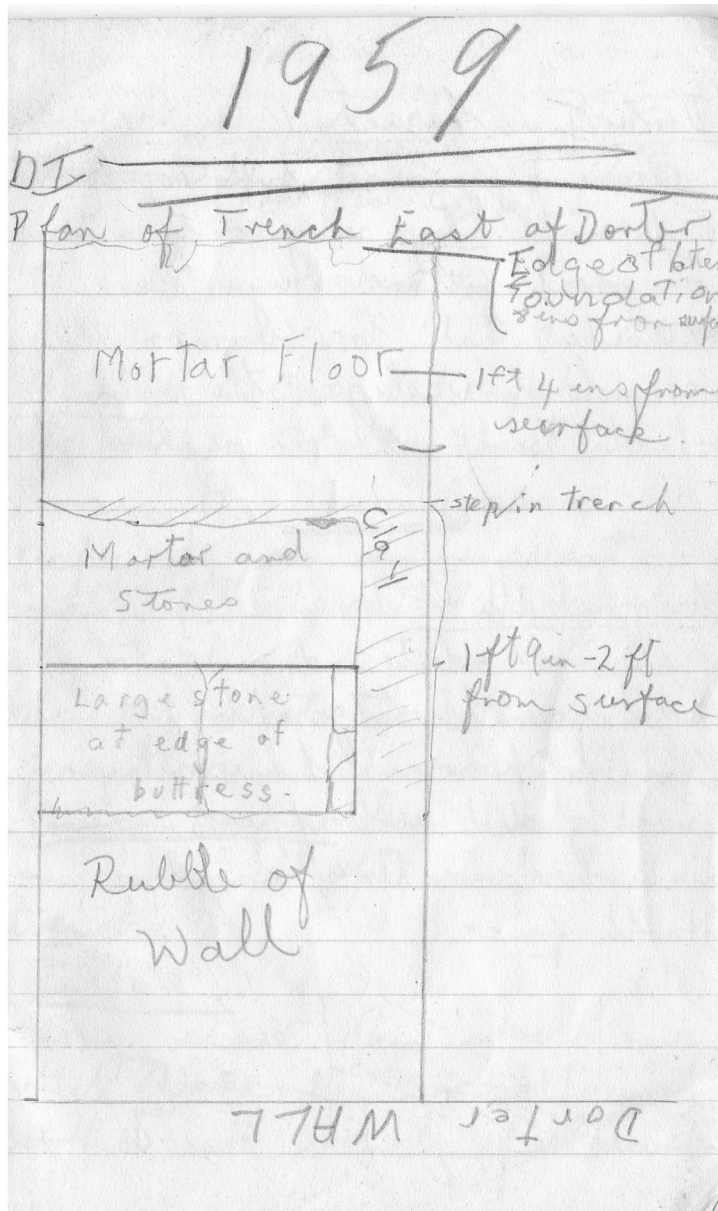
D1. Section 65

Sketch plan of trench E of dorter.

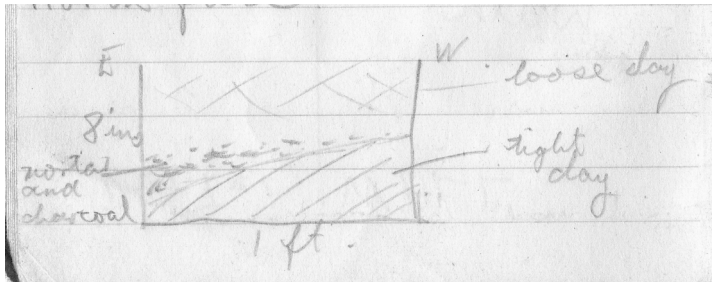
Cleaned late drain at high level for photograph. Silt appears to have 3 layers which did not appear in disturbed earth and tiles in North Face

Sketch section in D1.

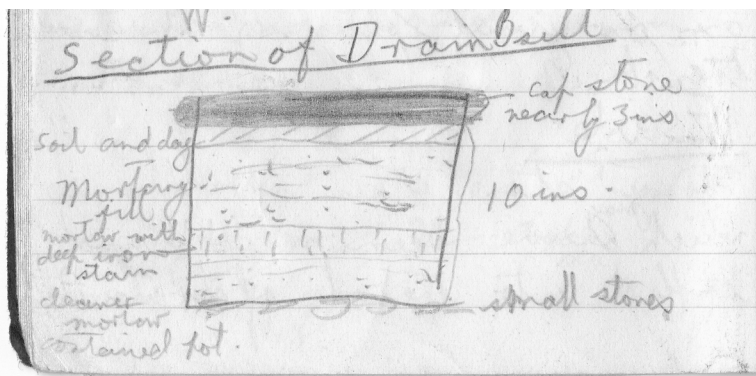
West side of Drain B

Face made up of small stones flat on inner face but many pointed on outer face. This may have been to act as a retaining wall.

Sketch section of drain B.

The west side of Drain B was then taken down and proved to be much more solidly built than appeared from the top.

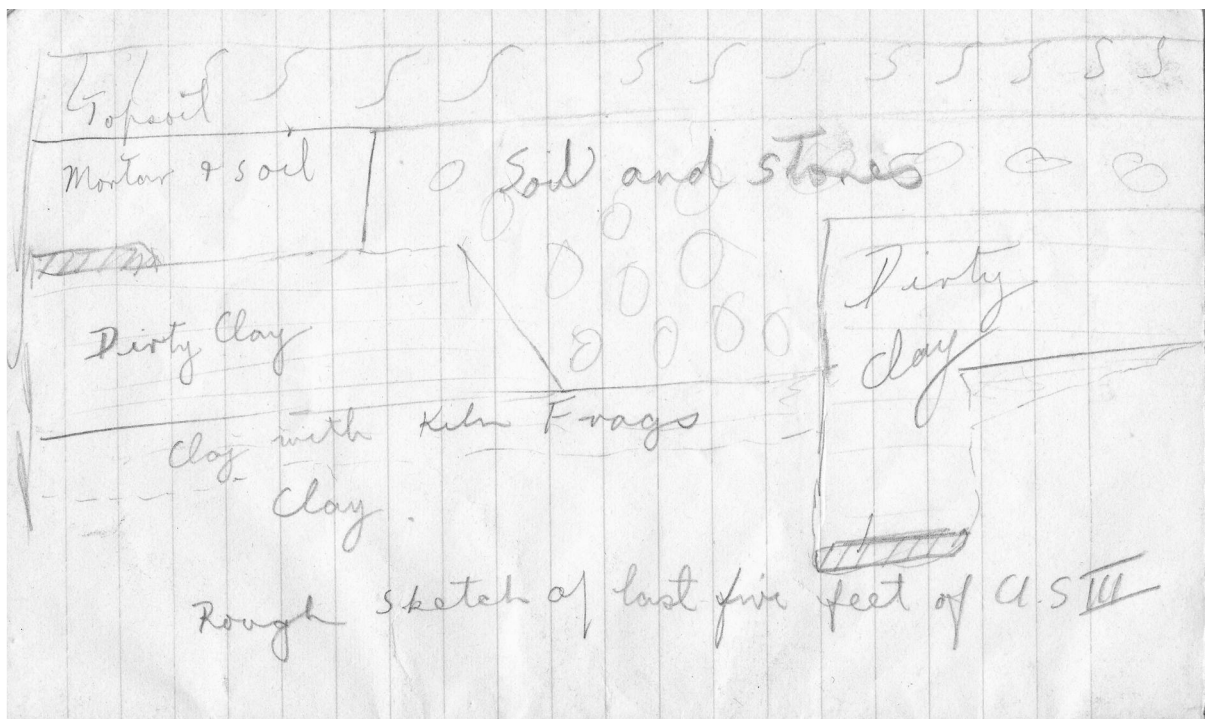
CLS 3.

Stratigraphy in CLS III

- 1) turf and topsoil [C:5500]
- 2) Soil and stones [C:5512], 13th century make-up
- 3) Dirty clay [C:5517] 12th century make-up. Descended into 2 post-holes [C:5516] & [C:5514]

- 4) Clay with kiln frags [C:5518]
- 5) Cleaner clay at bottom of trench [C:5519] still producing worn pot [F:BF5500]
- 6) Two mortar levels [C:5509] & [C:5511] cut-in associated with high level stones at north end of trench and ?stair foundation ?[C:5510] outside buttresses [C:5507] & [C:5508].
- 7) Rubble layer measured on appropriate page associated with dirty clay layer [C:5517]
- 8) S. End, two buttresses 13th century [C:5508] and 14th century [C:5507] on plan and section. Carrol wall written off.

Sketch section of CLS3.
