GLA/SITE/3/35

M.I. Needham

1959, 1963 & 1964

Glastonbury 1959

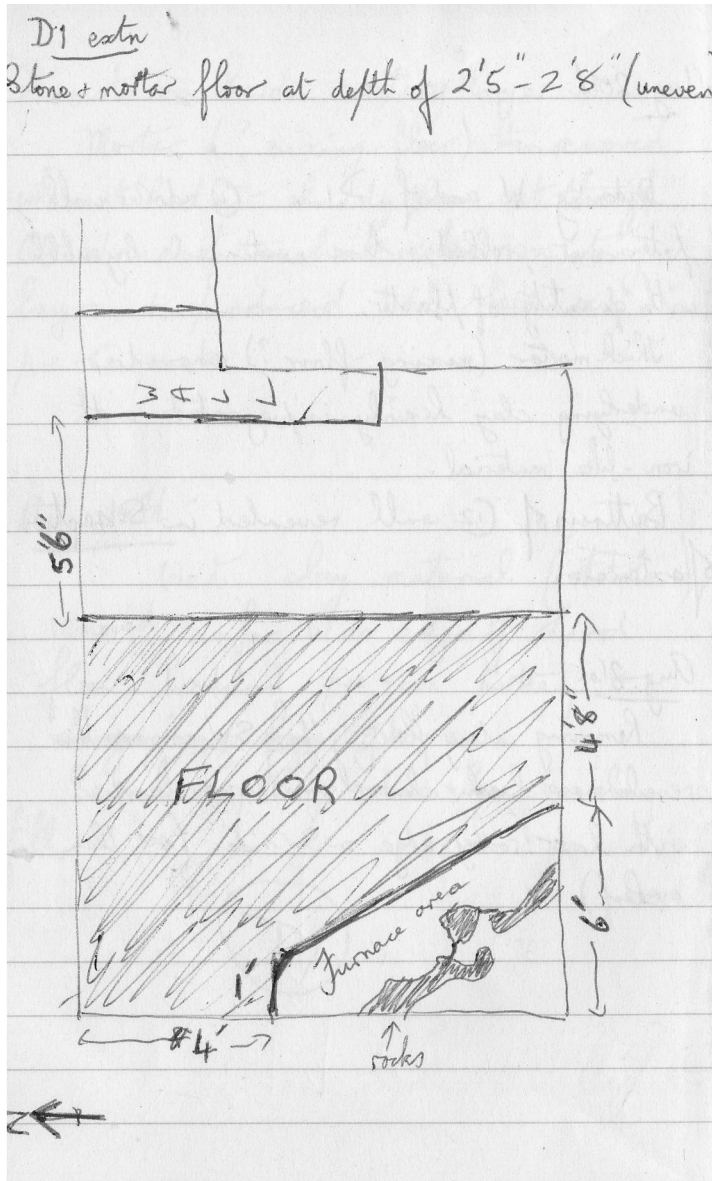
Sketch plan of furnace material in D1 Ext.

Removing stony floor [C:5243]. In SW corner this reveals mass of ash and charcoal in narrow band with harder rocky edge on SW side (see plan overleaf) [C:5255] & [5256].

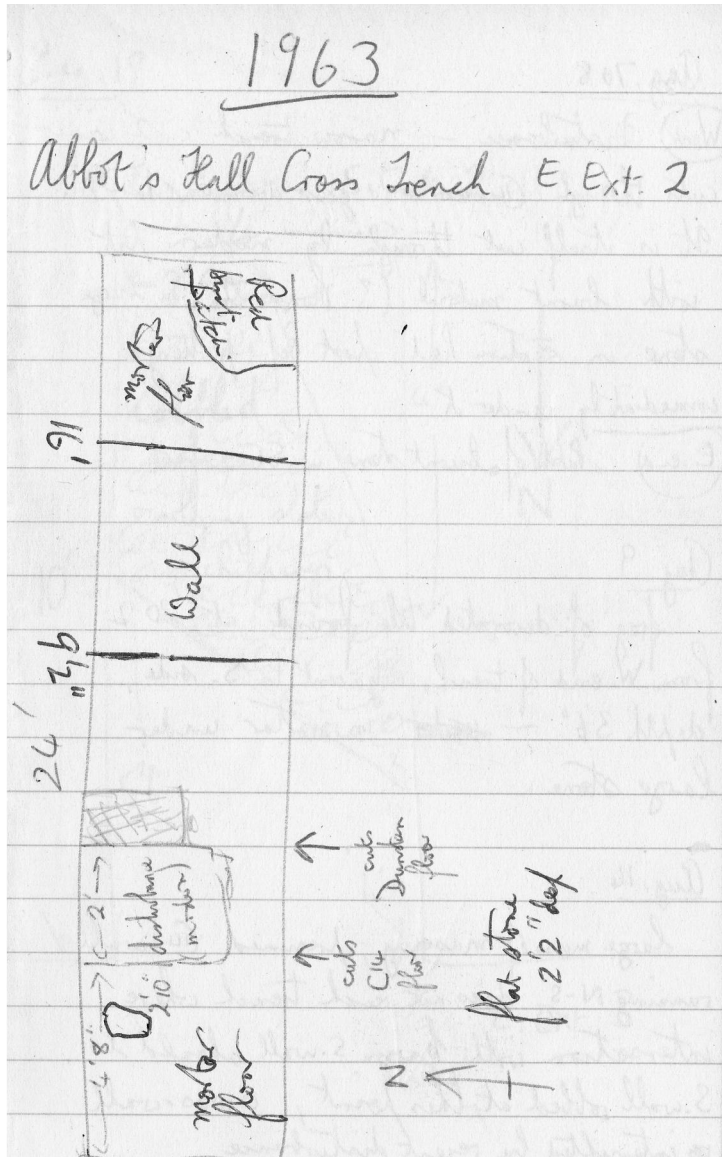
Sketch plan of AHCT E Ext 2.

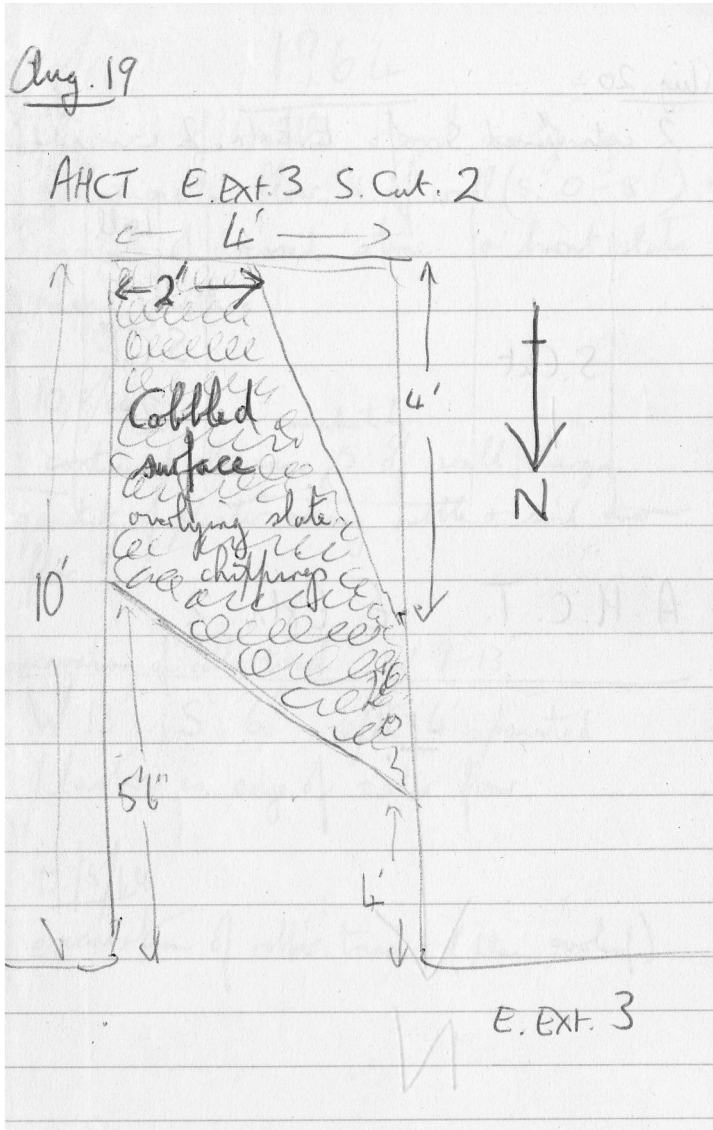
Sketch plan of AHCT E Ext 3 S Cut 2.

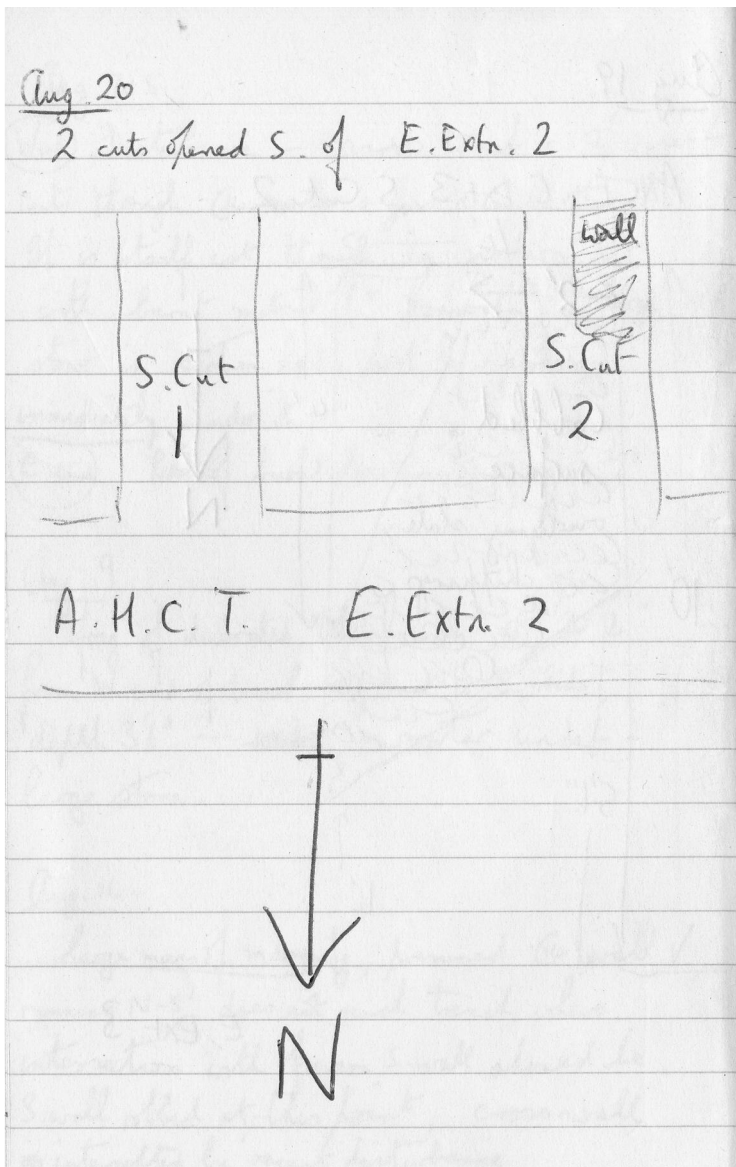
Plan of AHCT E Ext 2 with S cuts 1 & 2.

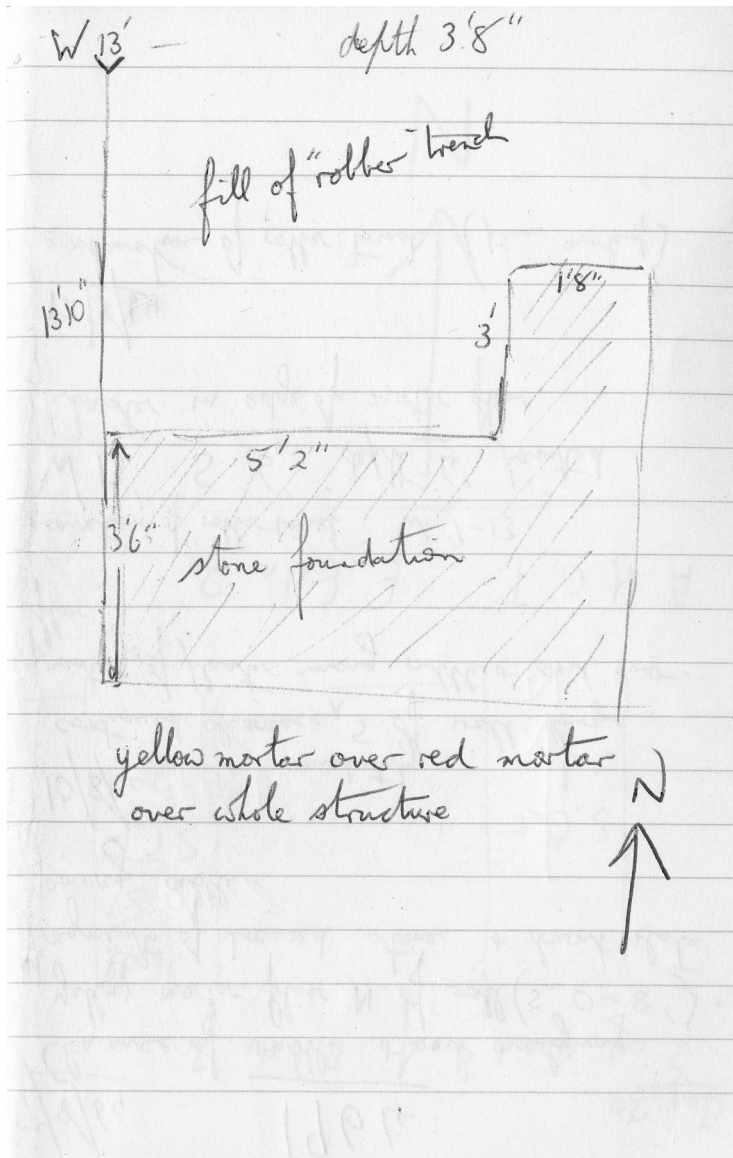
Plan of robber trench.

Excavation of robber trench (plan overleaf)

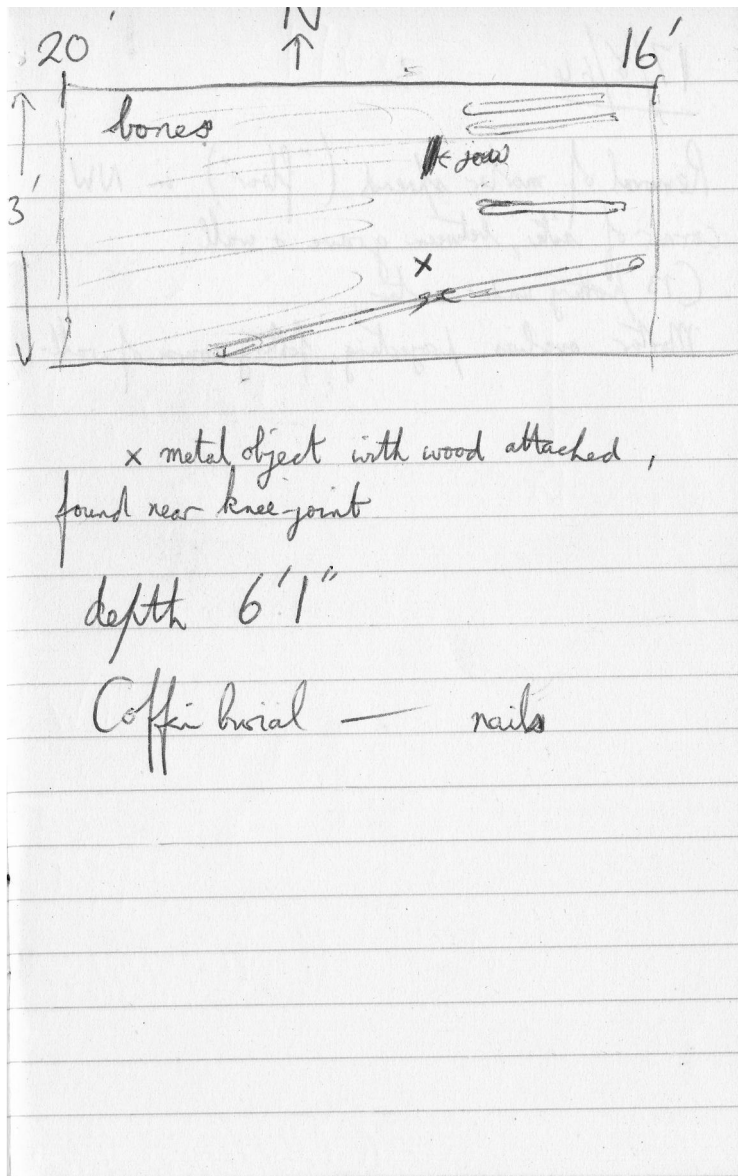
Sketch plan of coffin burial.
