An Archaeological Evaluation on Land at Sandilands, Fen Road, East Kirkby, Lincolnshire

Site Code: EKSF 13

Figure 1: Site and Trench Location

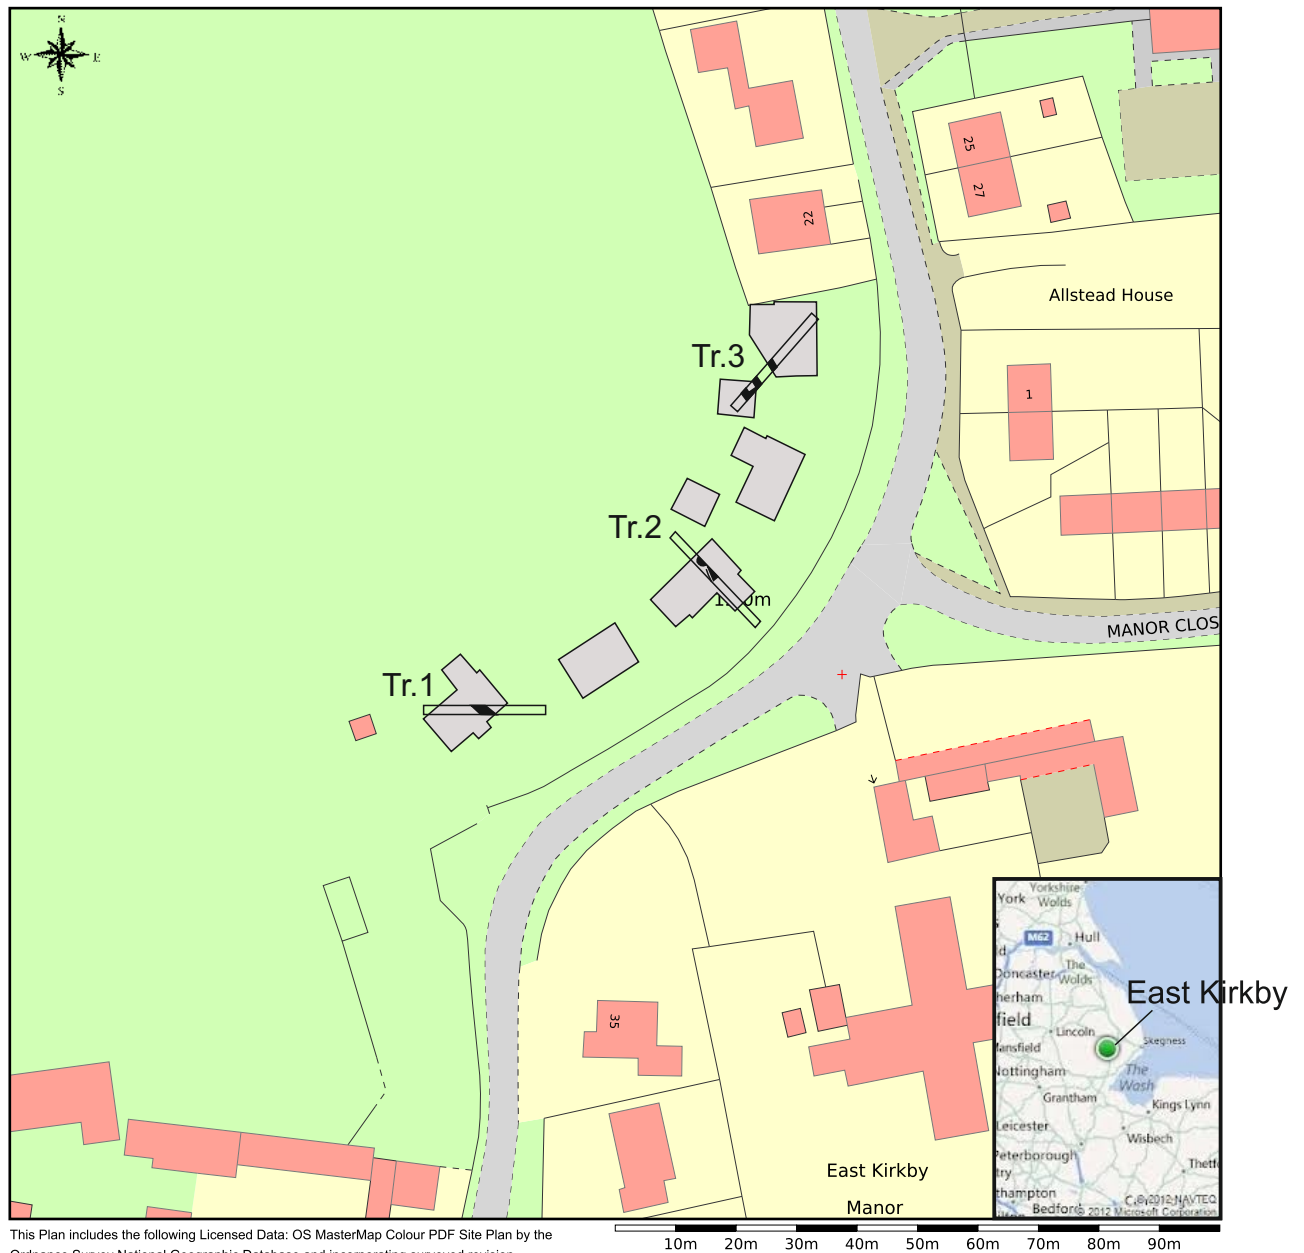
All recording points were accurately tied into the National Grid and located on the 1:1250 map of the area (Fig. 1). The trenches were levelled with respect to OD obtained from a spot height marked on a purchased drawing of Fen Rd, measuring 12m AOD.

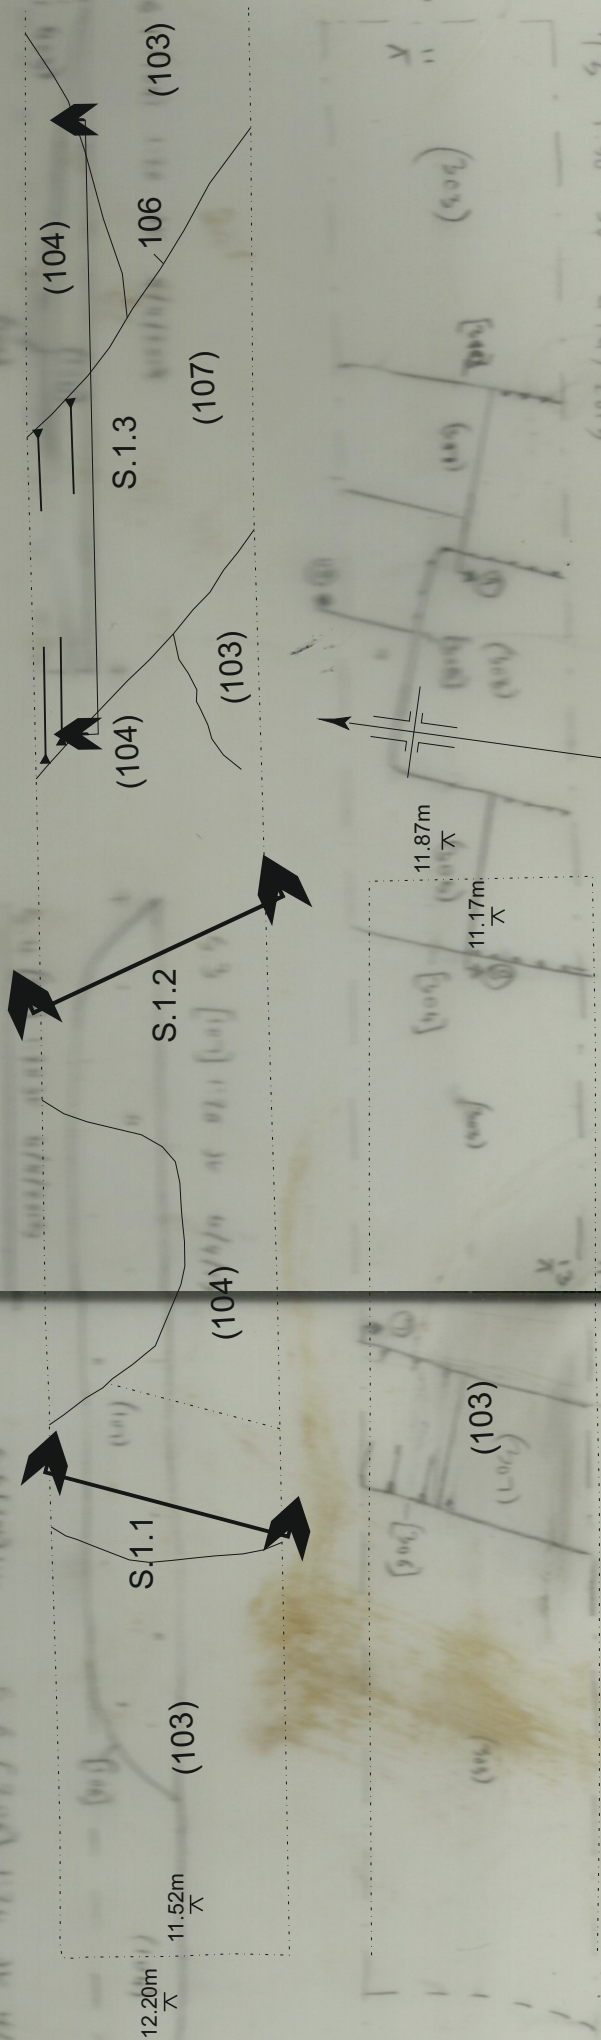
Section 1.1 East facing section across deposit (104)

At the western end of the trench the earliest deposit encountered was moderately compact c. 0.10m thick light grey sandy silt (104). Two sections were placed across this deposit (Fig. 2; S. 1.1 & 1.2) which proved it was a natural silt. Deposit (105) which was seen beneath (104) was another natural silt.

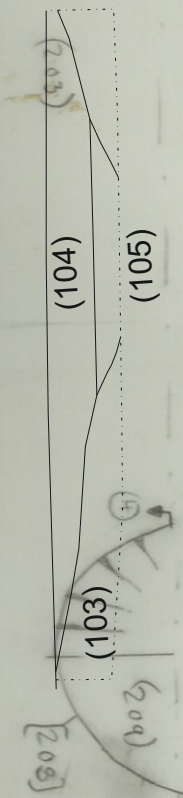
Section 1.3 North facing section of ditch 106

Ditch 106 was orientated on a north-west south-east alignment 1.50m wide and 0.22m deep with concave sides and a gently rounded base (Fig. 2; S. 1.3). It was filled by compact dark brown sandy clay loam (107) with occasional flint nodules and one rim sherd of medieval pot dated to the late 15th to mid 16th century. It was sealed by subsoil (102).

The large ditch in Trench 1 contained a medieval pot rim which was dated between the late 15th to mid 16th century providing a *terminus post quem* for when the ditch went out of use. It is possible that this ditch was a tenement boundary ditch associated with a medieval dwelling, which may have fronted onto Fen Road. The ditch within Trench 3 orientated on a similar alignment was also probably a medieval tenement boundary ditch. The archaeological evidence may indicate medieval dwellings once fronted onto this part of Fen Rd. The gully and pit are also indicative of settlement and the small u-shaped ditch was interpreted as a robbed wall which may have been a small workshop or outbuilding to a larger dwelling closer to the road.

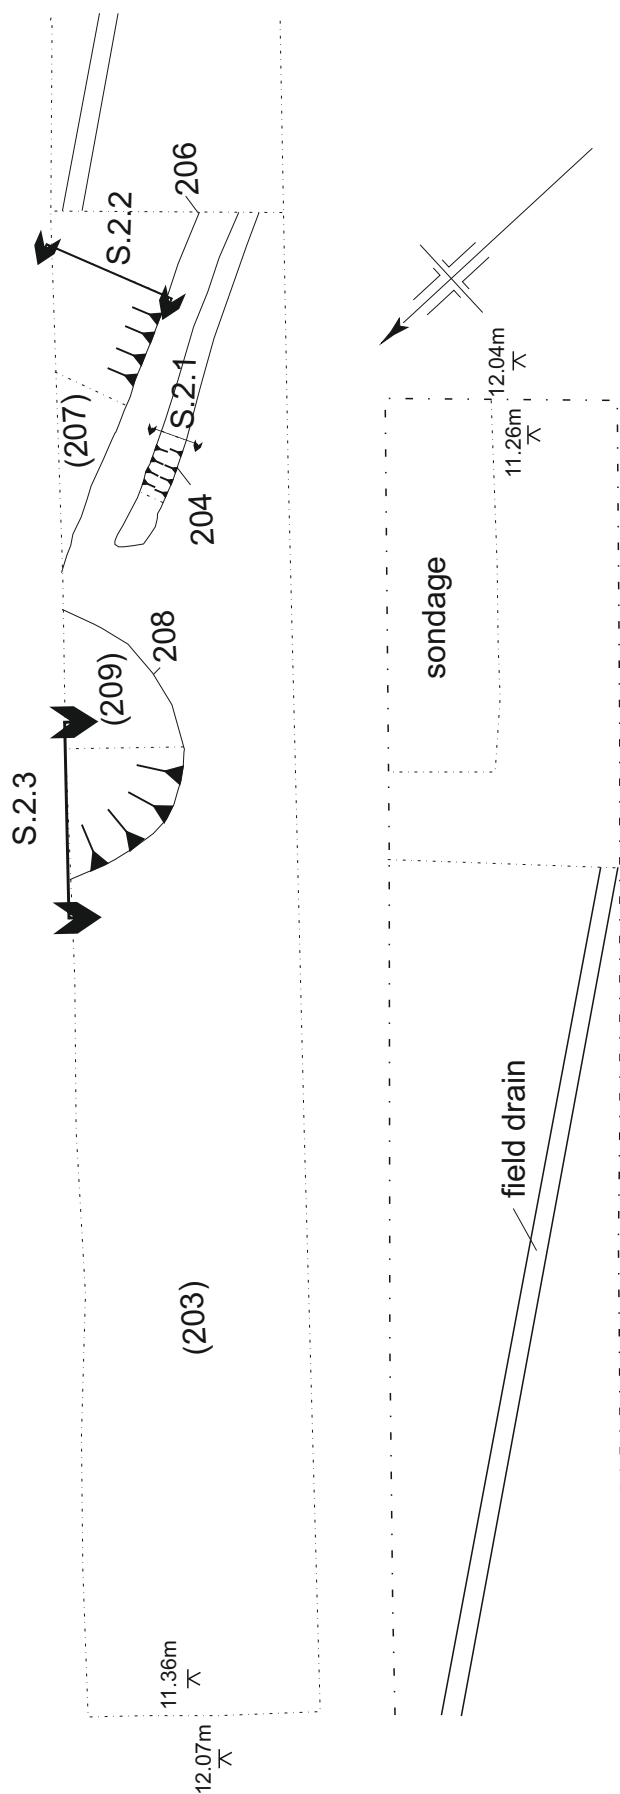
Section 2.1 North facing section of gully 204

Ditch/gully 204 was 0.25m wide and 0.04m deep orientated on a north-west south-east direction with gradual break of slope at the top of the cut forming concave sides and flat base (Fig 3; S. 2.1). It was filled by friable dark grey sandy silt (205) with a gritty texture. The ditch/gully was sealed by subsoil (202).

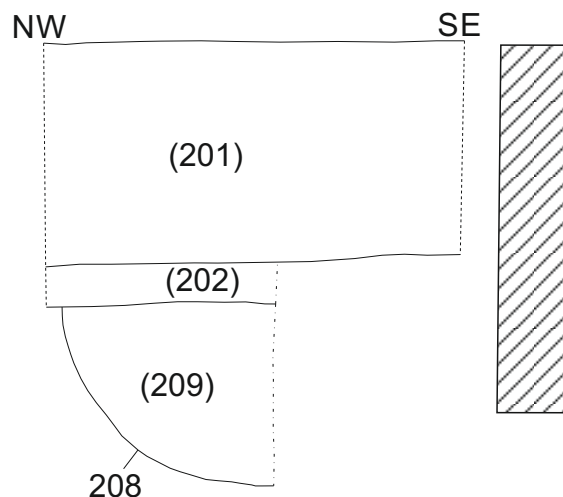
Figure 3: Plan and sections of Trench 2

The earliest deposit revealed within the trench was the natural clay (203). Overlying the natural was 0.15-0.20m thick moderately compact dark greyish brown silty clay sand subsoil with occasional small pebble inclusions (202). The latest deposit was 0.45m thick dark greyish brown sandy silt ploughsoil (201).

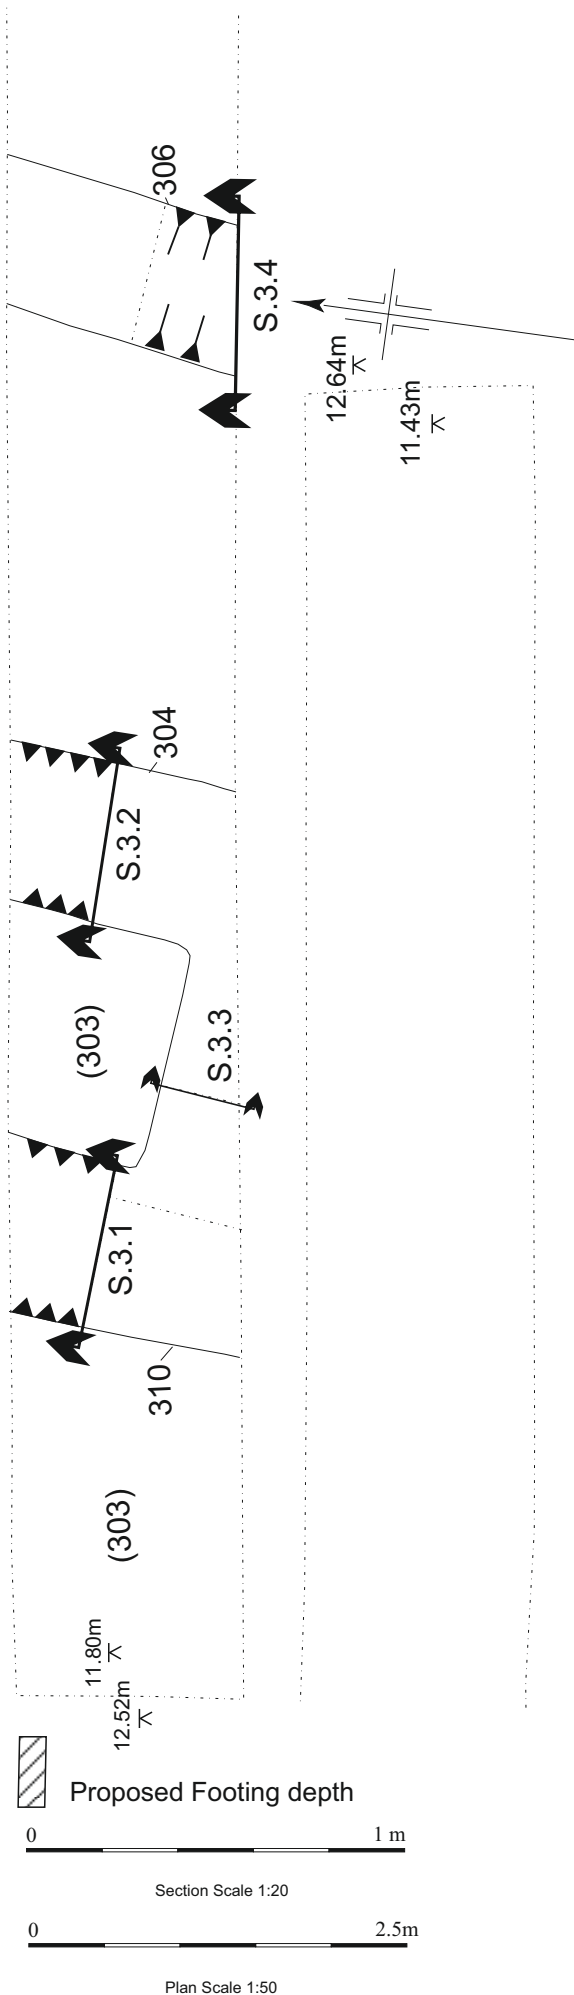
Section 3.1 North facing section of footing trench

Wall trench 304=308=310 was rectangular in shape with almost vertical sides and a flat base (Fig. 4; S. 3.1-3.3). It width of the trench was c. 1m wide and 0.35m deep, filled by dark brownish grey silty clay with dense concentrations of gravels and flints (305)=(309)=(311). Context (305) contained one sherd of late 13th to 14th century pottery. The wall had been completely robbed from this building. It was sealed by subsoil (302).

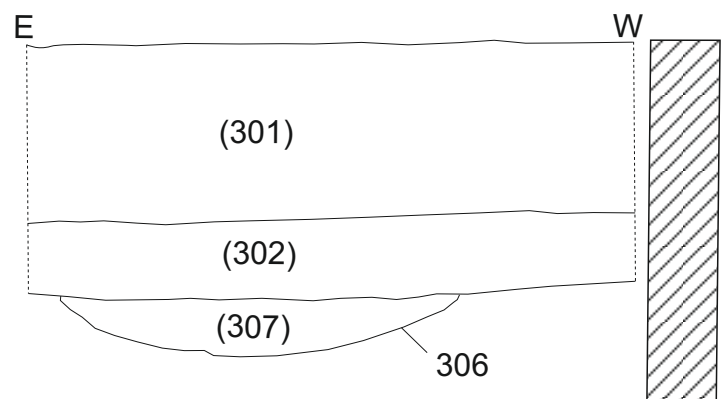
Section 3.4 North facing section of ditch 306

Ditch 306 was orientated on a north-east south-west direction with gradual sloping concave sides (Fig. 4; S. 3.4). It was 0.15m deep and c. 1.0m wide.

The ditch was filled by moderately compact dark brownish grey silty clay with rare gravels (307). It was sealed by subsoil (302).

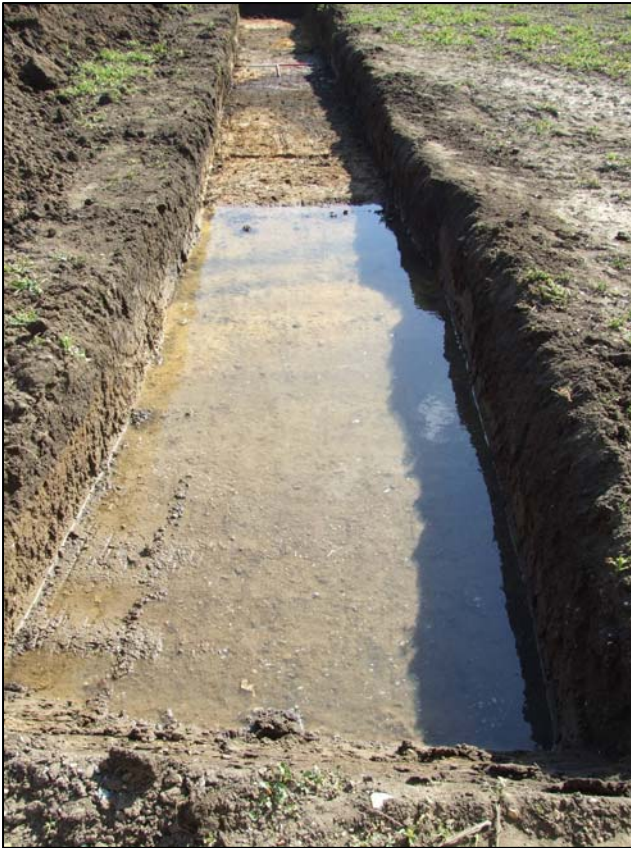
Plate 1; Trench 1 looking east

Trench 1 was excavated to a length of 20m (1.6m wide) and to varying depths of 0.60m (11.17m AOD) at the south-eastern end and 0.68m (11.52m AOD) at the north-western end.

The earliest deposit revealed within the trench was the natural clay (103). Overlying the natural was 0.20m thick moderately compact dark greyish brown silty clay sand subsoil with occasional small pebble inclusions (102). The latest deposit was 0.48m thick dark greyish brown sandy silt ploughsoil (101).

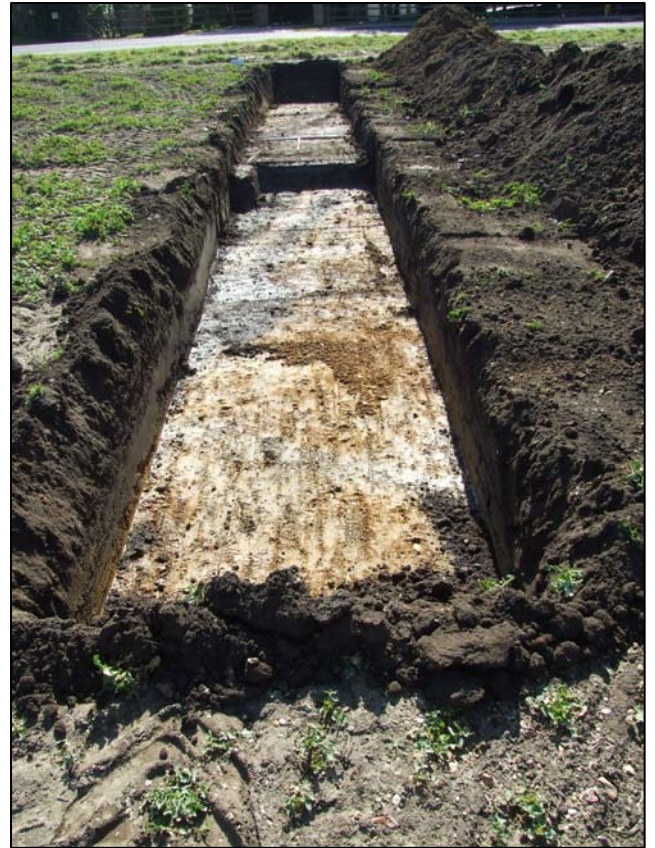
Plate 2; Trench 2 looking south-east

Trench 2 was excavated to a length of 20m (1.6m wide) and to varying depths of 0.71m (11.36m AOD) at the north-western end and 0.78m (11.26m AOD) at the south-eastern end.
