# Selected Plants, Ismays Road, Ivy Hatch, Sevenoaks, TN15 ONY

(Planning Ref: TM/13/01912/FL)

**Archaeological Watching Brief Report**

Prepared by Paul Riccoboni BA (Hons) Arch MlfA

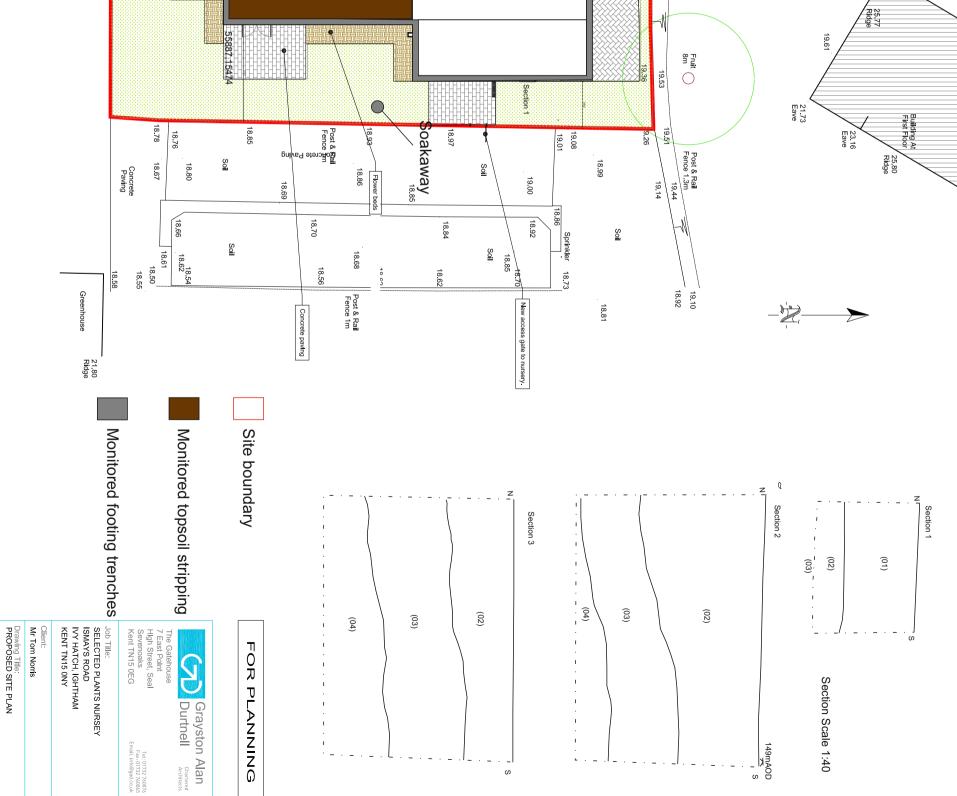
Plan Scale 1:200

\*Flooded Chamber MH CL 19.95 TOS 18.65 WL 19.89

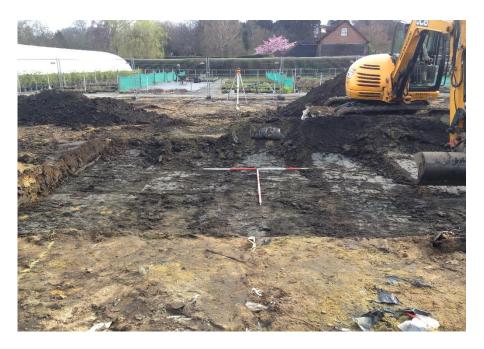
Photo 1: View east across site during initial topsoil stripping over foot print of new build

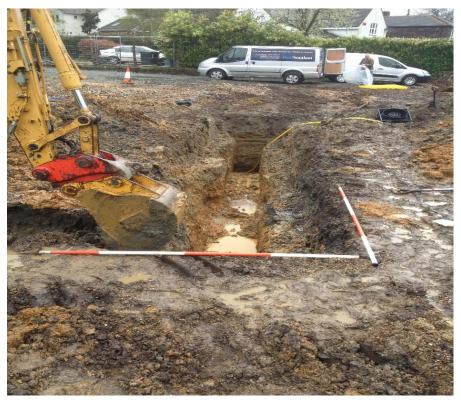
The watching brief was conducted during a period of wet weather. The site was saturated with water from a combination of burst overflow pipe coupled with heavy rain. This meant the trenches were unsafe to enter particularly as the sides of the trenches were often seen collapsing. All observations were made a safe distance from the top of the trenches.

Photo 2: View west during excavation of footing trenches with saturated ground visible

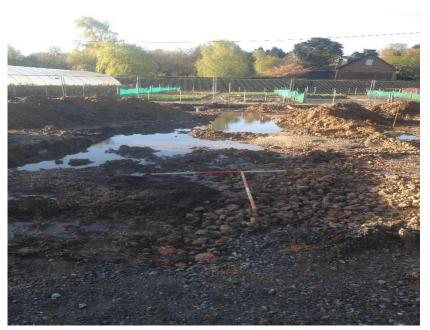
The watching brief do not reveal any archaeological features or finds. The site was subject to high water levels and the trenches were liable to collapse, making them unsafe to enter.

Photo 3View east across site showing areas affected by high water levels

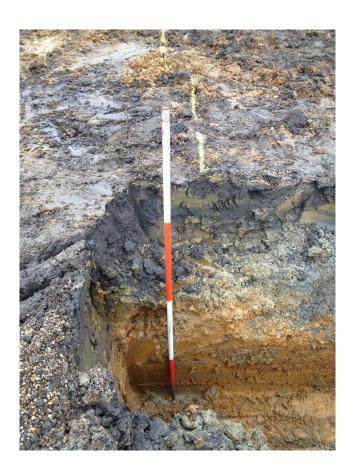
The general stratigraphy recorded within the trenches consisted of the following layers (earliest to latest). The natural substrate was encountered at the base of the trenches and was composed of firm mid orange clay silt with occasional grit throughout (04). Overlying this was 0.15m thick yellowish orange natural clay sand with fine grit (03). This was overlain by 0.20m thick mid blue grey sticky soft clay silt (02) with occasional debris from the garden centre included. The latest deposit was c.0.30m thick loosely compacted organic dark grey brown to black topsoil (01). This deposit had modern inclusions throughout such as modern tile and plant pot fragments.

Photo 4: east facing west section of N-S footing trench

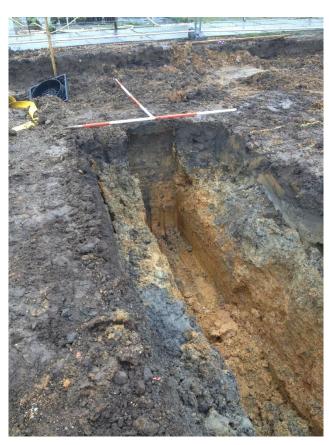
Photo 5 View of N-S footing trench
