Phase 14, East Leake Quarry, Nottinghamshire Archaeological Watching Brief

NGR: SK 563 251 Site Code: ELQ 08

LAS Report No. 1048 April 2008

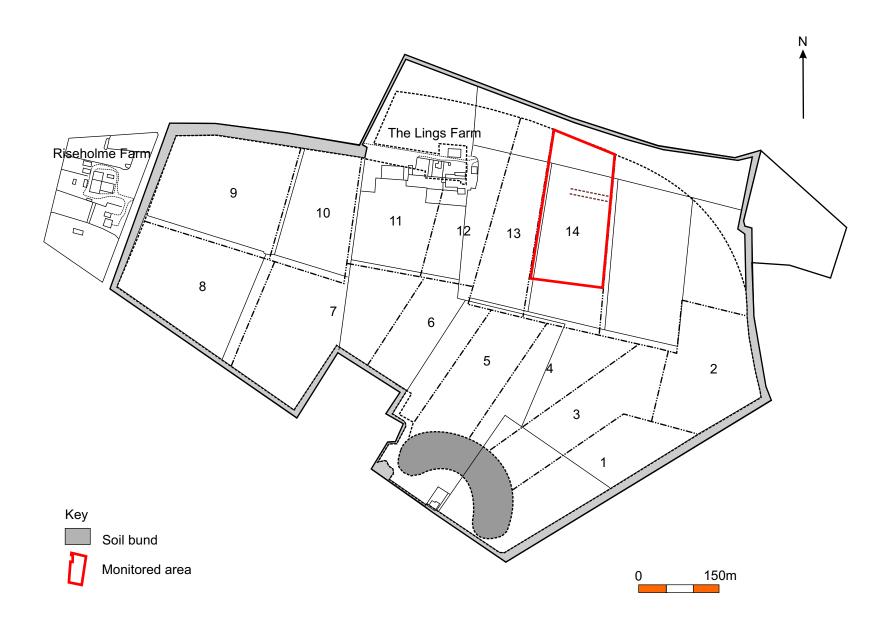
Fig. 2 East Leake Quarry, location of Phase 14 (based on a plan supplied by the client).

The extraction site is situated east of the floodplain of the River Soar, overlooking one of its tributaries. The monitored phase was located at the northern side of the quarry, east of Lings Farm (Fig. 2).

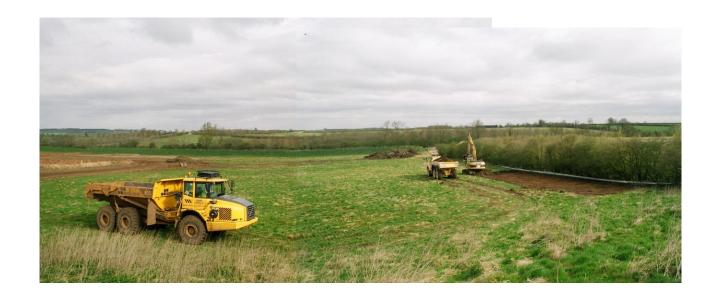
PI. 1 The monitored area, before topsoil removal (looking north).

The topsoil stripping was carried out using a machine with a 1.8m wide ditching bucket (Pls. 1 and 2. Each strip was about 15m wide. Context numbers were assigned to deposits by LAS for recording purposes, and these are used, in bold type, in the report text. The southern end of Phase 14 had been stripped of topsoil in May 2003 when no archaeological remains were seen (Tann and Pullen 2004).

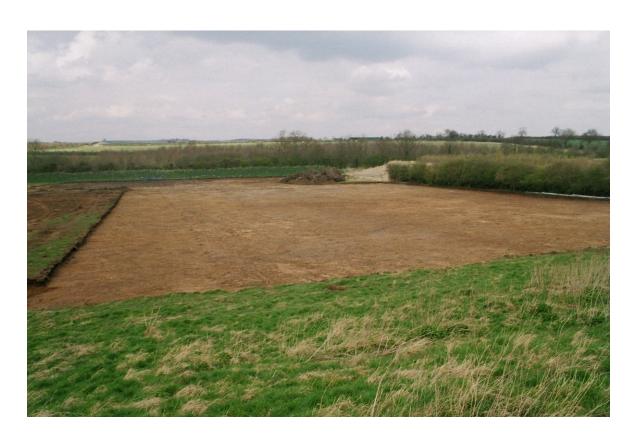
PI. 2 The monitored area, after topsoil removal (looking north).

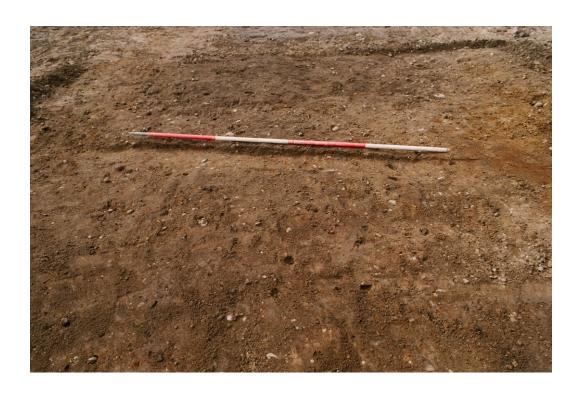
Vestigial traces of two shallow features, orientated east-west, were visible at the north-eastern part of the site (Pl. 3). They were about 2.5m wide and 4m apart, and were slightly curvilinear. Their survival appeared to be restricted to the lowest part of the field, and it is likely that colluvium (hill-washed material) had protected the features from total removal by ploughing. They also appeared to have cut more deeply into the underlying deposits in moister ground at the base of the slope. Similar features were recorded in Phase 13 (Tann 2007). In this location they may have been medieval plough furrows or ditches marking a former track leading eastwards from The Lings Farm.

Pl. 3 Section across one of the shallow linear features (looking west, scale 2m) $_{\rm I\!I}$
