**Programme of Archaeological Observation, Investigation  
and Recording within the Scheduled Ancient Monument of  
Lilleshall Abbey.**

**Lilleshall, Shropshire**

**October 2016**

**Herefordshire Archaeology Report No. HAR 365**

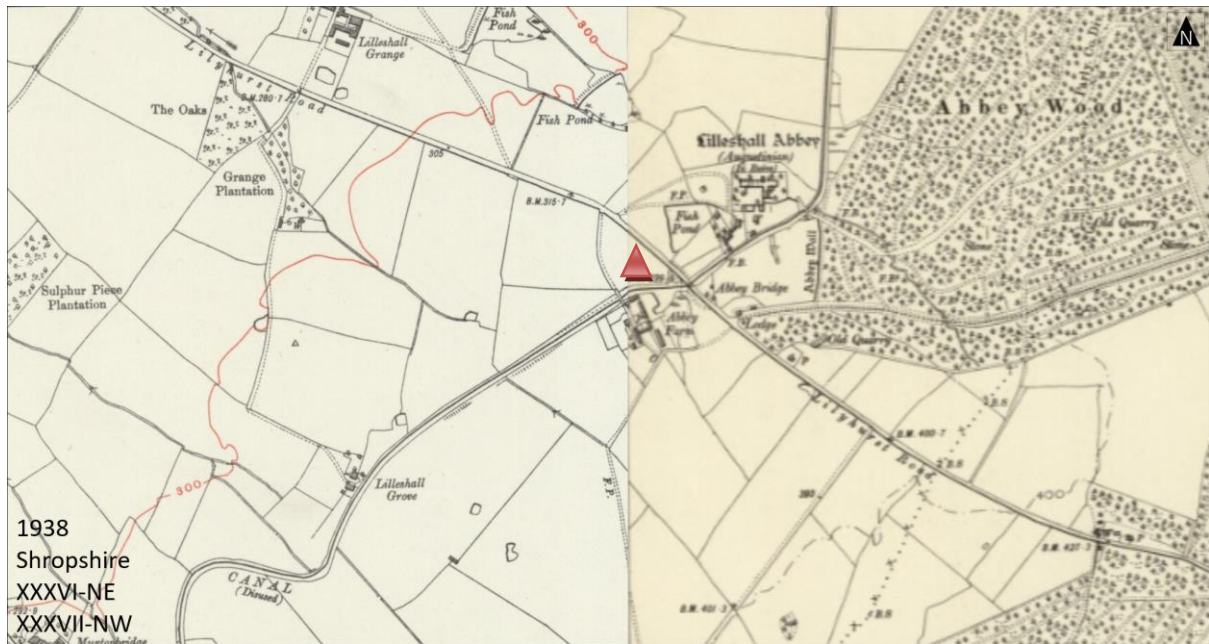
Figure. 4 1938 Shropshire map, showing area of unauthorised works.

The 1938 Ordnance Survey map shows that the canal is now disused, the line of trees recorded on the 1888 map are no longer represented the study area is again subdivided by the map edge, the filed boundary is shown to be free of features or buildings associated with Abbey Farm. (See Figure. 4)

**Figure. 4** *1938 Shropshire map, showing area of unauthorised works.*

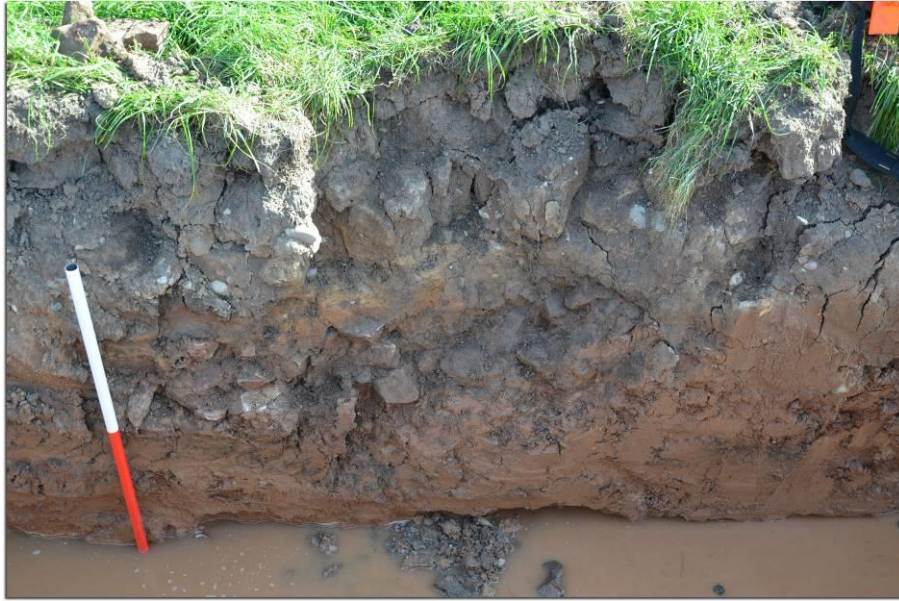
A single feature was identified (*See Figure. 3 & 6*), [1007] comprise of a gradually inclined cut aligned north south of approximately 1.60m in length, with a maximum depth of 0.35m, filled by (1008), a very stoney fill of medium to large angular stones, the feature was truncated by machine during the unauthorised excavation works. (*See Plate. 1*)

Plate. 1 Showing [1007], Sample Section 5, west facing section.

Within the unauthorised works a single feature was identified, [1007] formed a shallow cut feature with a stoney fill, truncated by the unauthorised works. The condition of the feature was such that it only remained as a trace within the section. It would be speculative to ascertain the dimensions or characteristic of the feature before the intervention of the unauthorised works.

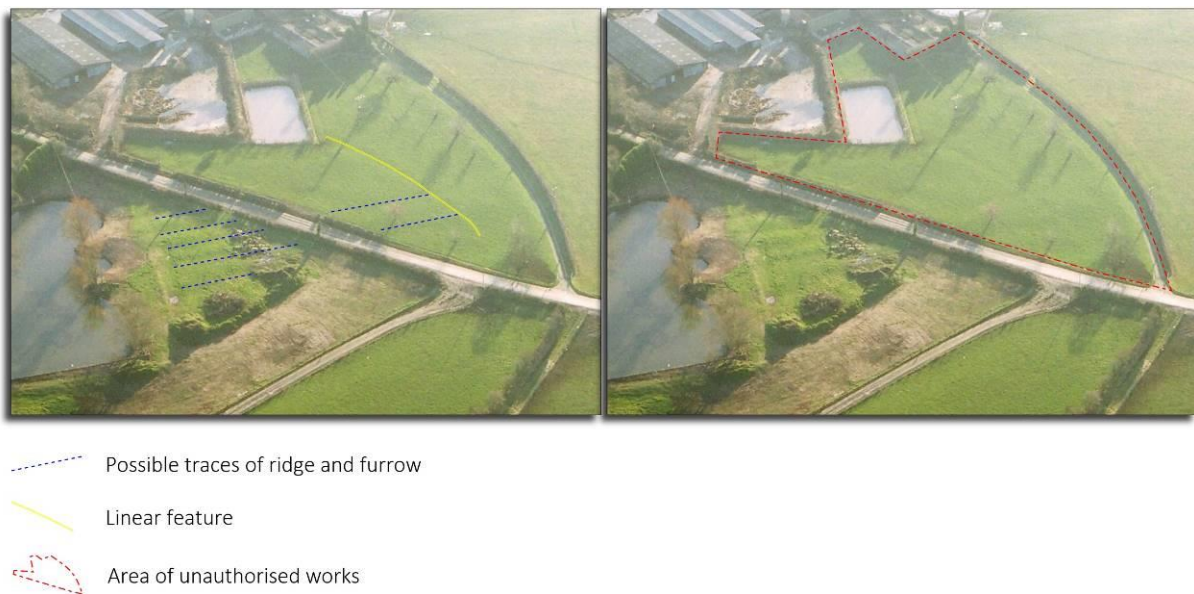
An oblique aerial view of the site shows a possible continuation of a series lines possible indicating ridge and furrow, starting to the east of the A518, aligned east-west and continuing into the area of unauthorised works.

A curving linear feature runs from the north-west corner of the large pond/reservoir and continues to the north boundary of the site. (See Figure. 8)

Figure. 8 Google Earth image, showing possible earth works within the area of unauthorised works.

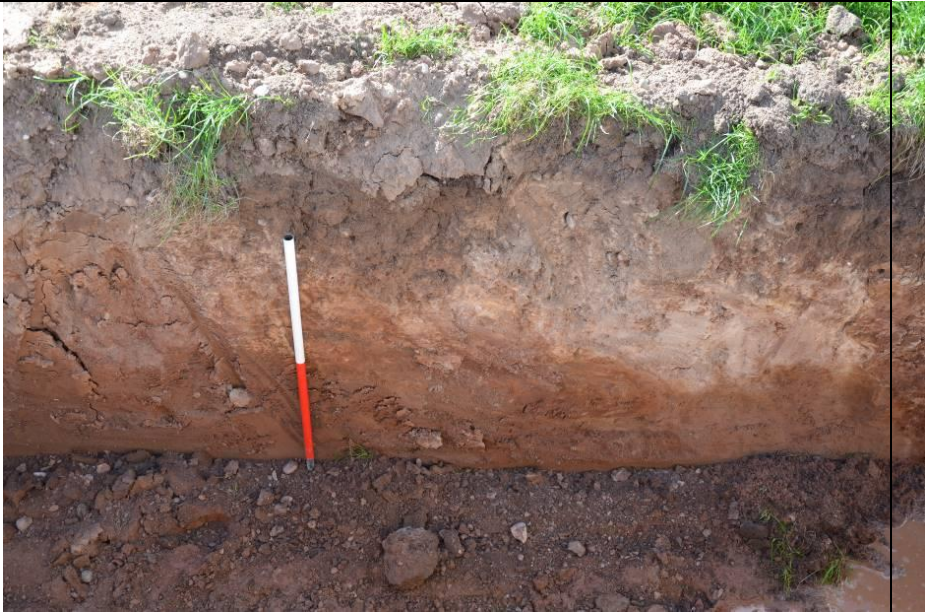
6

<b>Interpretation</b>					
<p>The stratigraphic sequence within the area sample was relatively different to the previous sample sections, a lack of subsoil was noted, the top soil directly overlaying the geological substrate, the geological substrate represented a change to the previous sequence with red clay and hard packed yellow sand forming vertical bands overlaying water logged sand deposits. No features of archaeological significance were observed.</p>
