## **Longtown Castles Project A Community Archaeology Project**

**Archaeological investigation and recording during  
2016: An interim report.**

HAR 364

**Grid reference: Longtown Castle NGR SO 3214 2915  
Ponthendre Castle NGR SO 3261 2810**

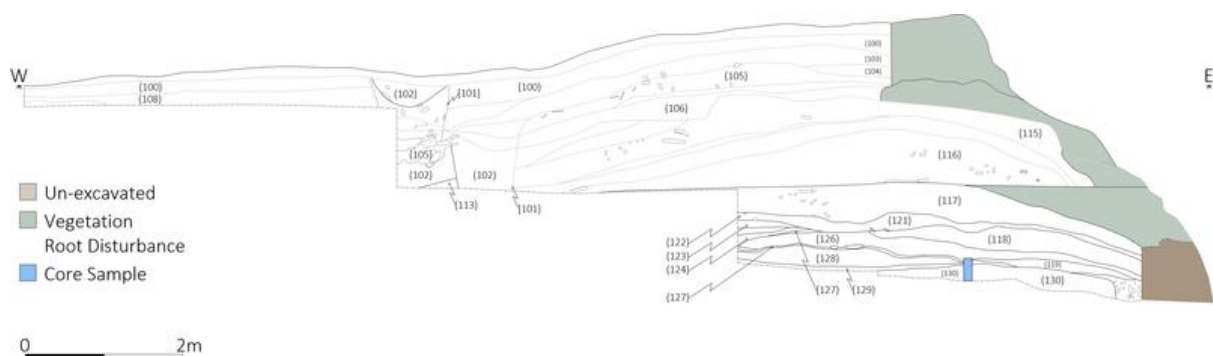
Figure 9: Section drawing of the excavated rampart section.

The earliest deposits encountered were of natural origin. Natural sandstone bedrock (context 133) was found at the eastern end of the trench just behind the front of the rampart. It was of

variable character with solid peaks of rock alternating with smaller slabby sandstone pieces increasing in size and frequency with depth. The interstices were all filled with sterile grey silt (context 130) which continued westwards (unexcavated) under the main body of the rampart and was identified as a buried soil. There was no evidence of any features (such as post-holes) cutting down into the natural surface from or through the overlying rampart, and no evidence was found for any retaining structure or revetment at the front of the rampart.

The earliest rampart material consisted of alternating thin layers of brown and grey silty clay, to a height of 0.55m above the natural surface, clearly recognisable as individual layers of stacked, decayed turf. These were excavated over a width of five metres westwards from the front of the rampart, but continued (unexcavated) further to the rear.

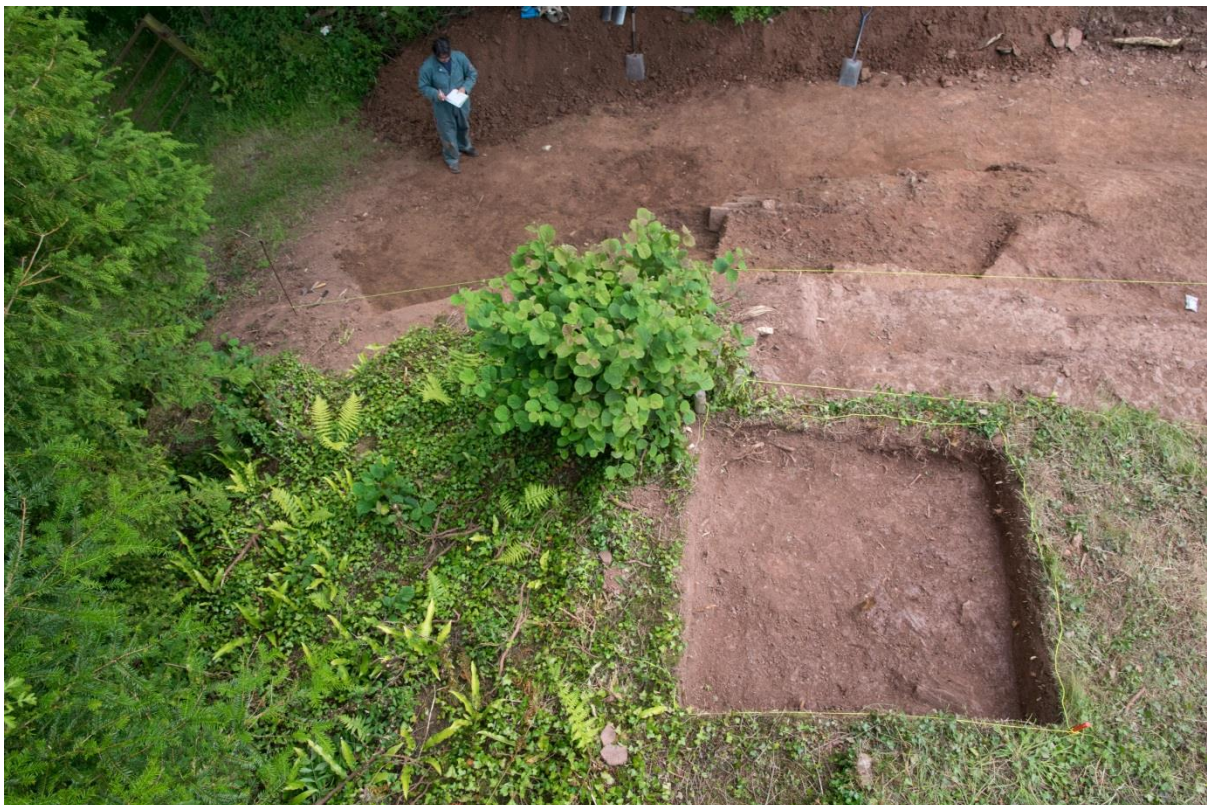
Plate 5: The excavation at the top of the rampart in relation to the section through it.

The summit of the rampart was examined, but only in a quite small area within the main trench and in a 1.5m-square extension to the north designed specifically to examine the surface of the uppermost rampart material. No trace was seen of any features that might have suggested a rampart-top defensive structure such as a palisade.

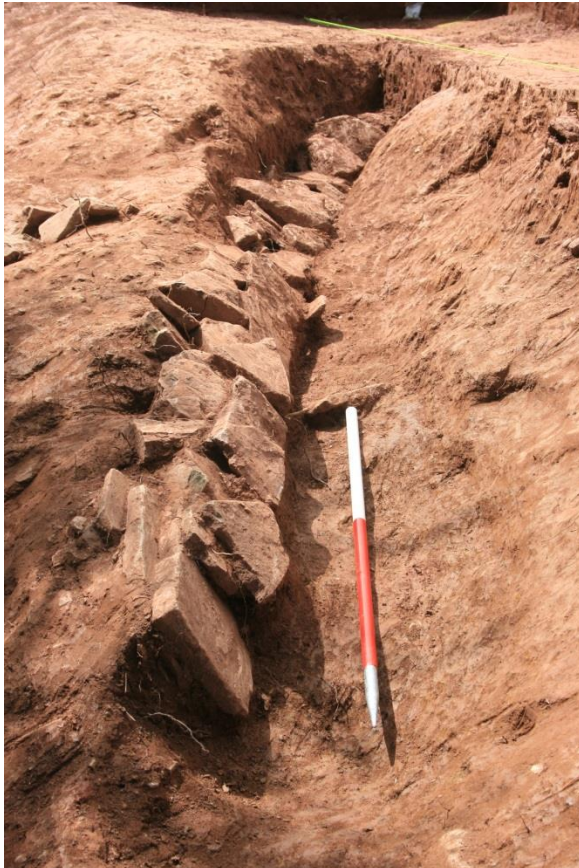
Plate 6: Detail of Post medieval stone lined drain cutting the rampart.

therefore cutting through even the turf layers at the base of the rampart sequence. Artefacts from its fill were indicative of a late 19<sup>th</sup>-century or early 20<sup>th</sup>-century date (including a brick with a stamped frog). It was presumably cut to drain the bailey interior, though the labour involved in its construction seemed disproportionate given that there is no known evidence of a waterlogging problem in modern times within the bailey interior.

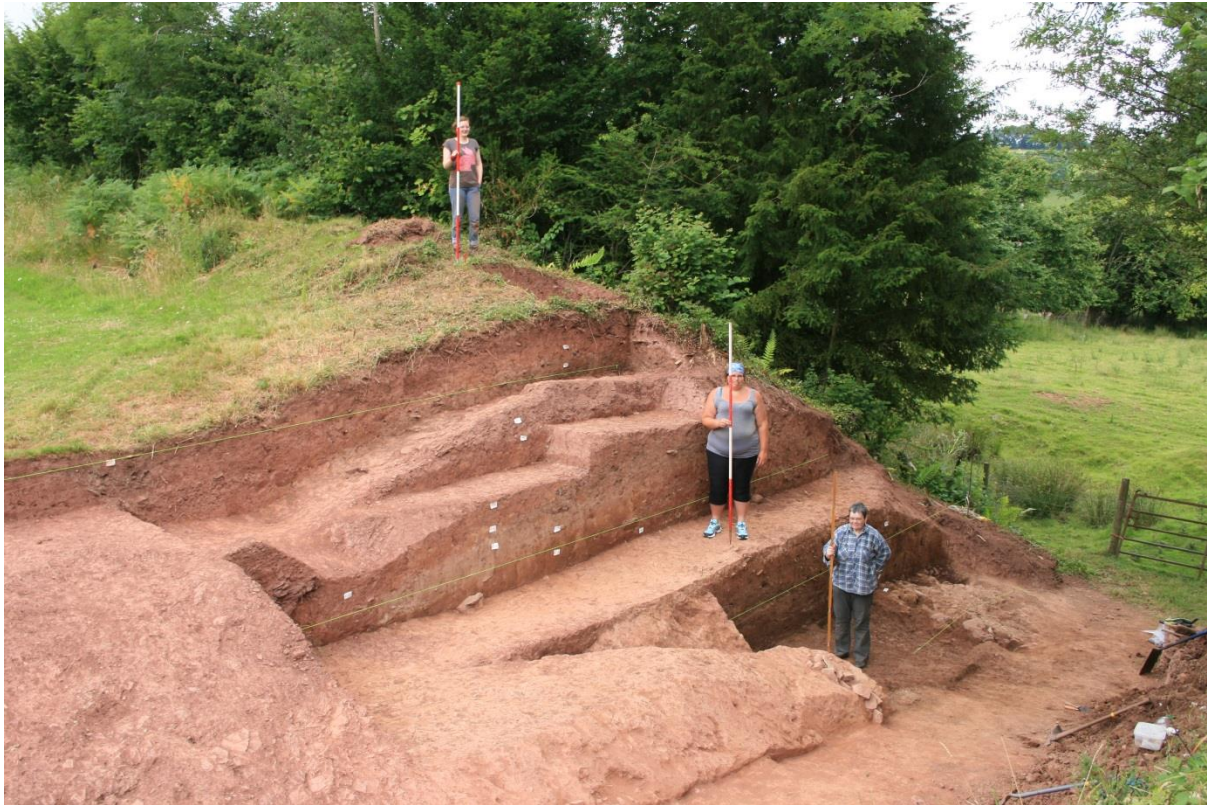
Plate 7: The completed rampart section

In conclusion, the excavation successfully provided a cross-section of the bulk of the eastern rampart and was able to demonstrate that a primary turf bank on the old ground surface was followed by the raising of a massive dump rampart. It will not be possible to demonstrate whether all the material for this was derived from the digging of the extramural ditch alone until a profile of the latter can be reconstructed. The dump rampart was later raised in height by a marginal amount. The front of the rampart was probably not retained in any way, but it is less certain how the rampart top (only a very small part of which was sampled) was defended, and it is possible that some material has been lost from its top through erosion or through more deliberate activity. It is however highly unlikely that the eastern rampart ever had masonry components, whether a front revetment or a curtain wall on top, and it appears to have lain outside the scope of the early 13<sup>th</sup>-century works represented by the motte

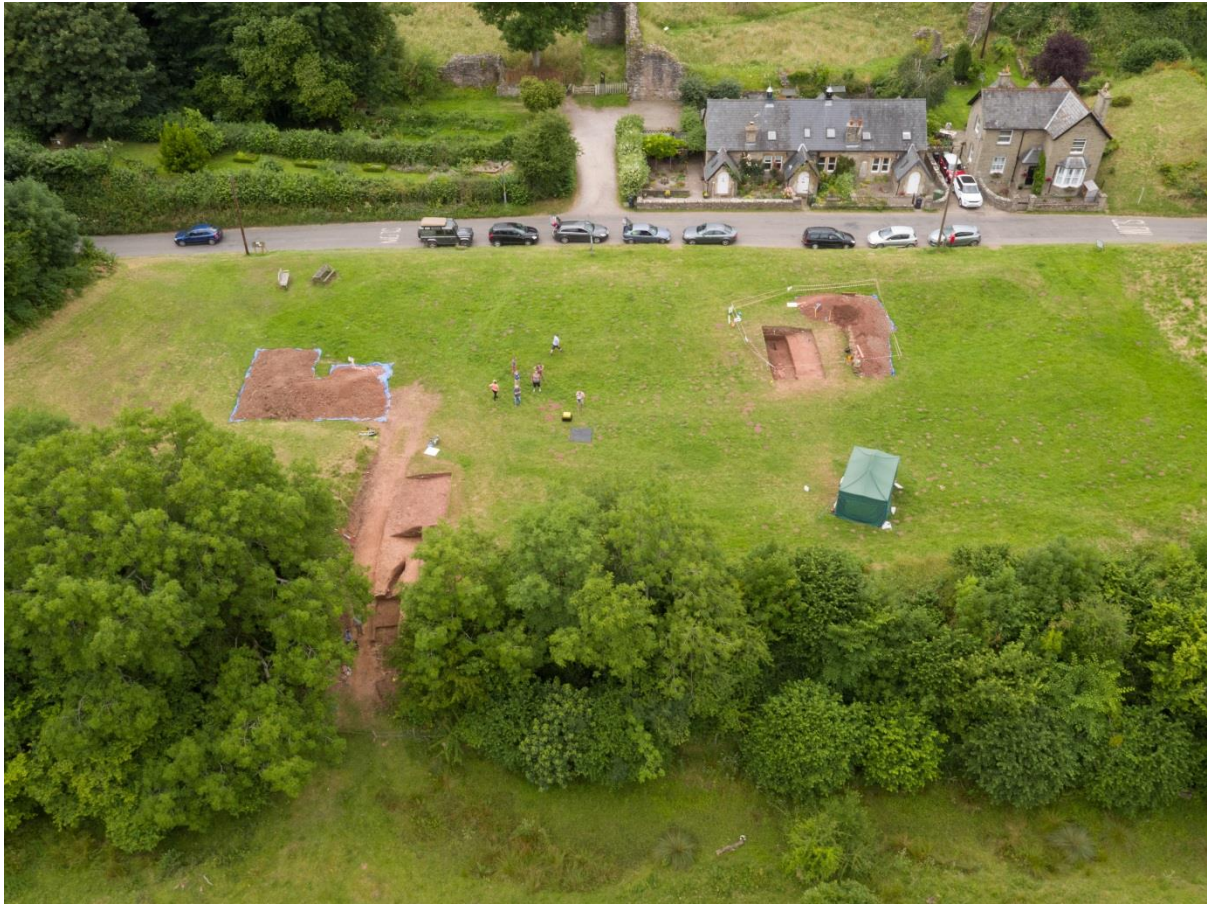
Plate 8: Aerial Photograph showing the two trenches in relation to the castle.

Trench 2 was located on the Green adjacent to the road, north of the castle, on ground sloping down towards the north-east. It was located over the corner of a rectangular earthwork with the intention of ascertaining whether the earthwork was modern spoil associated with the construction of the school during the late 19<sup>th</sup> century or whether it related to earlier activity on the site. The trench measured 6m (east-west) by 4m (north-south).

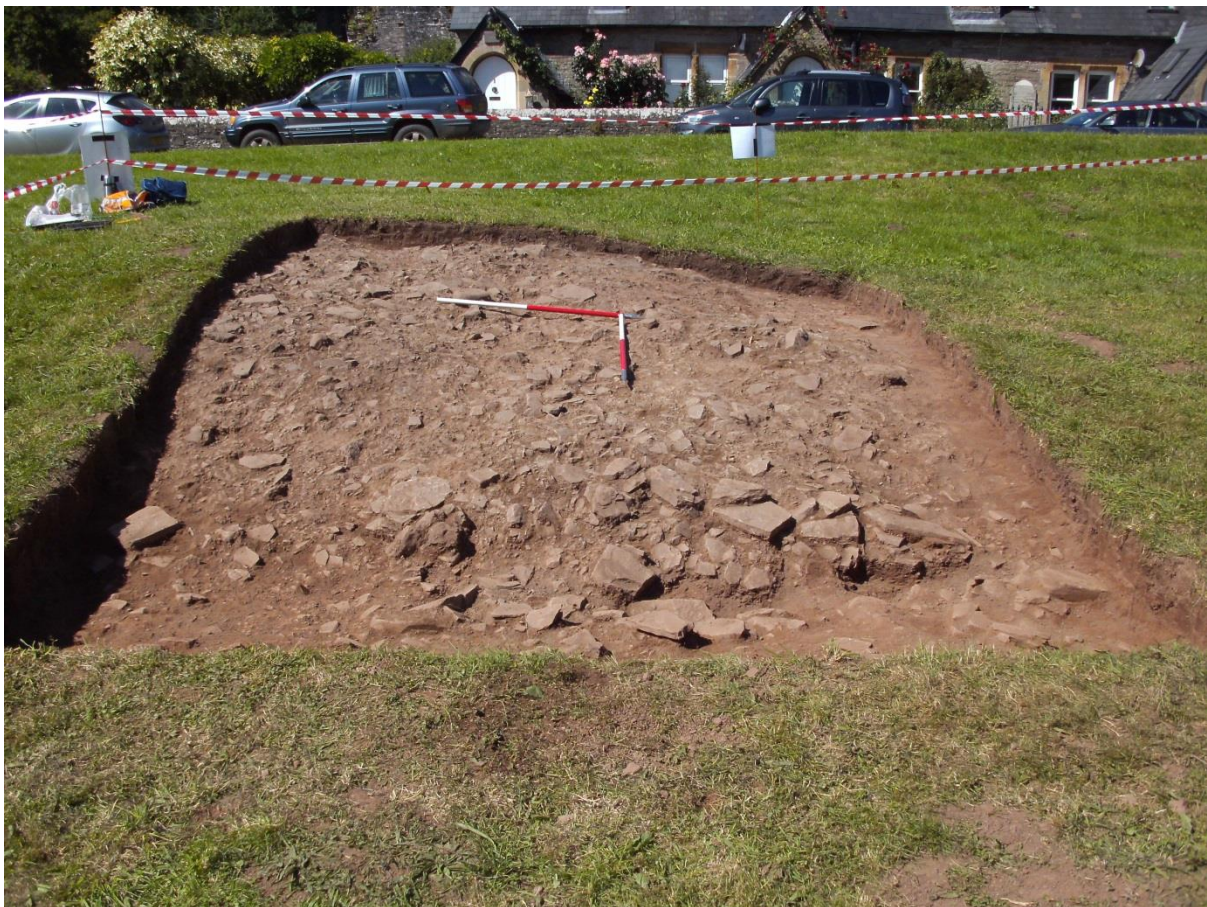
Plate 9: Trench 2 looking west showing the flat sandstone deposit (201)

Immediately beneath this deposit, there lay an extensive spread of flat angular sandstone fragments (201) that included pieces of stone roof tile, identified by the picked peg holes. It could be seen on the ground that this mound of stone stretched along the roadside for almost the entire length of the green. The deposit within the trench sloped down toward the north and east, where it noticeably thinned, partly exposing a linear feature, close to the eastern trench edge, that the stone was slumping or tipping into.

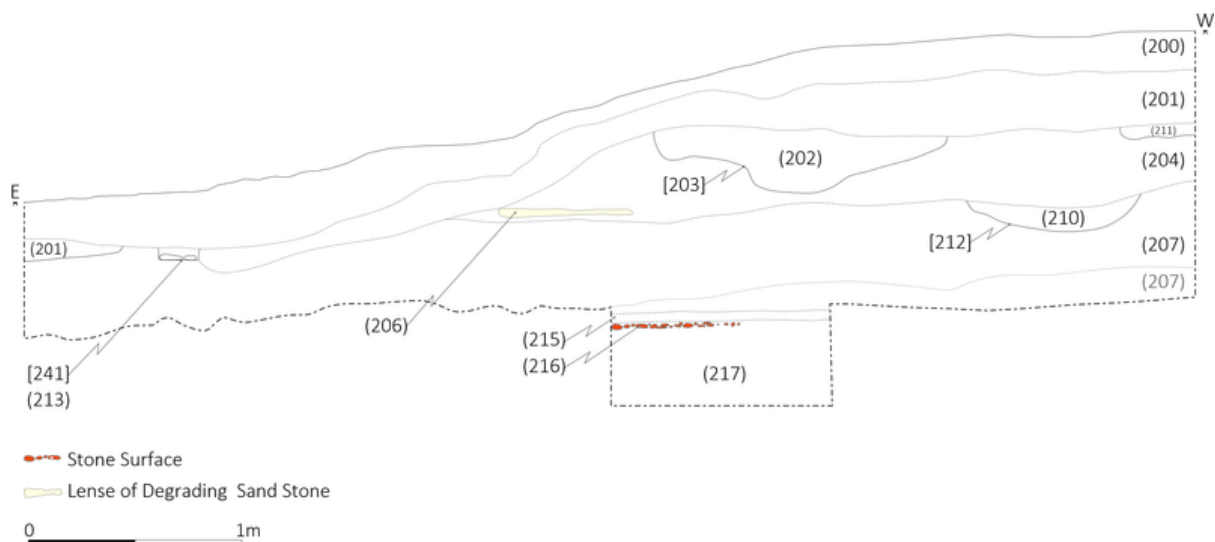
Figure 11: Southern section of Trench 2

Beneath this later were a series of stoney deposits, (204), (205) and (206). These appear to be dumps of stone waste and marl. No artefactual material was forthcoming from these deposits.

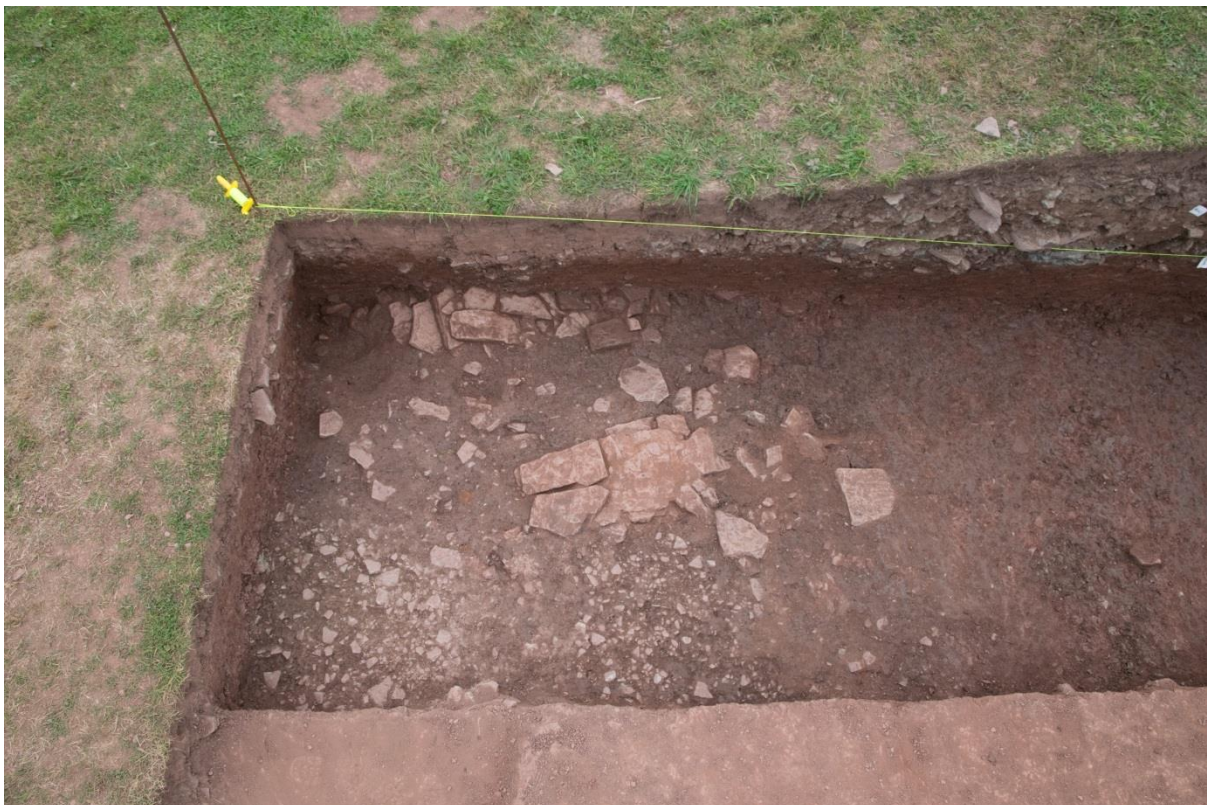
Plate 11: The gravel surface (216) and the flat larger stones within or showing through (217).

Within or perhaps showing through, surface (216) are several large, horizontally deposited angular stones (see Plate 11), located towards the south east corner of the trench and continuing under the southern section. Their grouping suggests a purposeful placement in some instances and these were left in-situ in order to be properly excavated during the 2017 season.

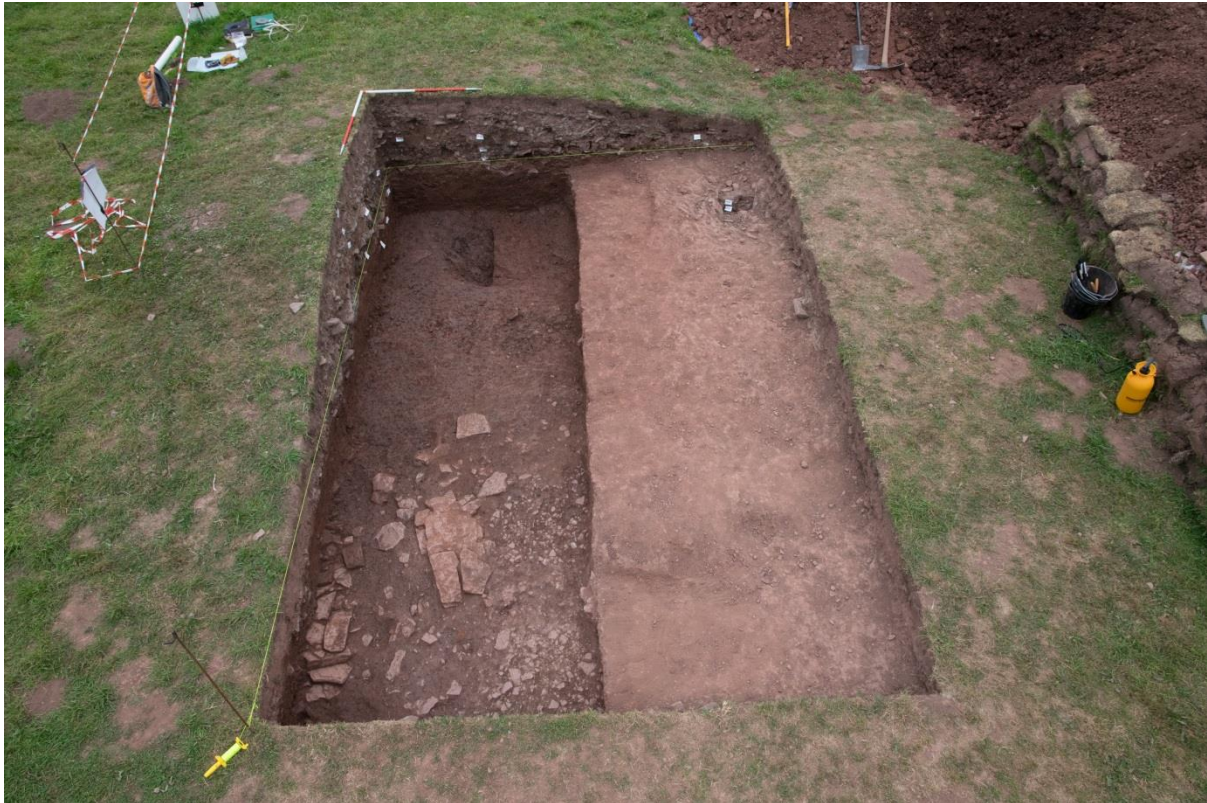
Plate 12: Trench 2 looking west showing the top of deposit (217) in the southern half of the trench and deposit (207) overlying it in the northern portion of the trench.

A small sondage was cut through the surface (216) approximately half way along the trench and hard against the southern section, in order to provide a sample of this material and to assess its depth and nature. The sondage was cut approximately 0.50m deep through (216) into a layer of greyish gritty gravel and clay below (217). This deposit was not bottomed and appears to comprise a soft clayey material containing charcoal and burned bone.

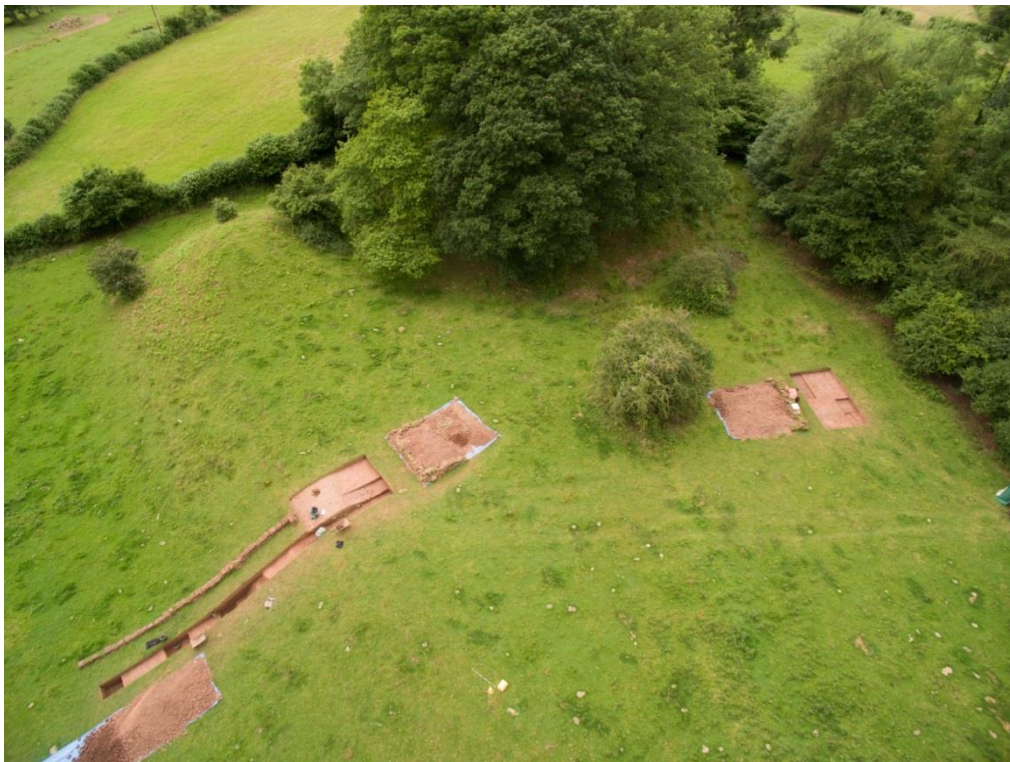
Plate 13: Aerial photograph showing trenches 2 and 3 in relation to the earthworks. Trench 1 is in the trees on top of the motte.

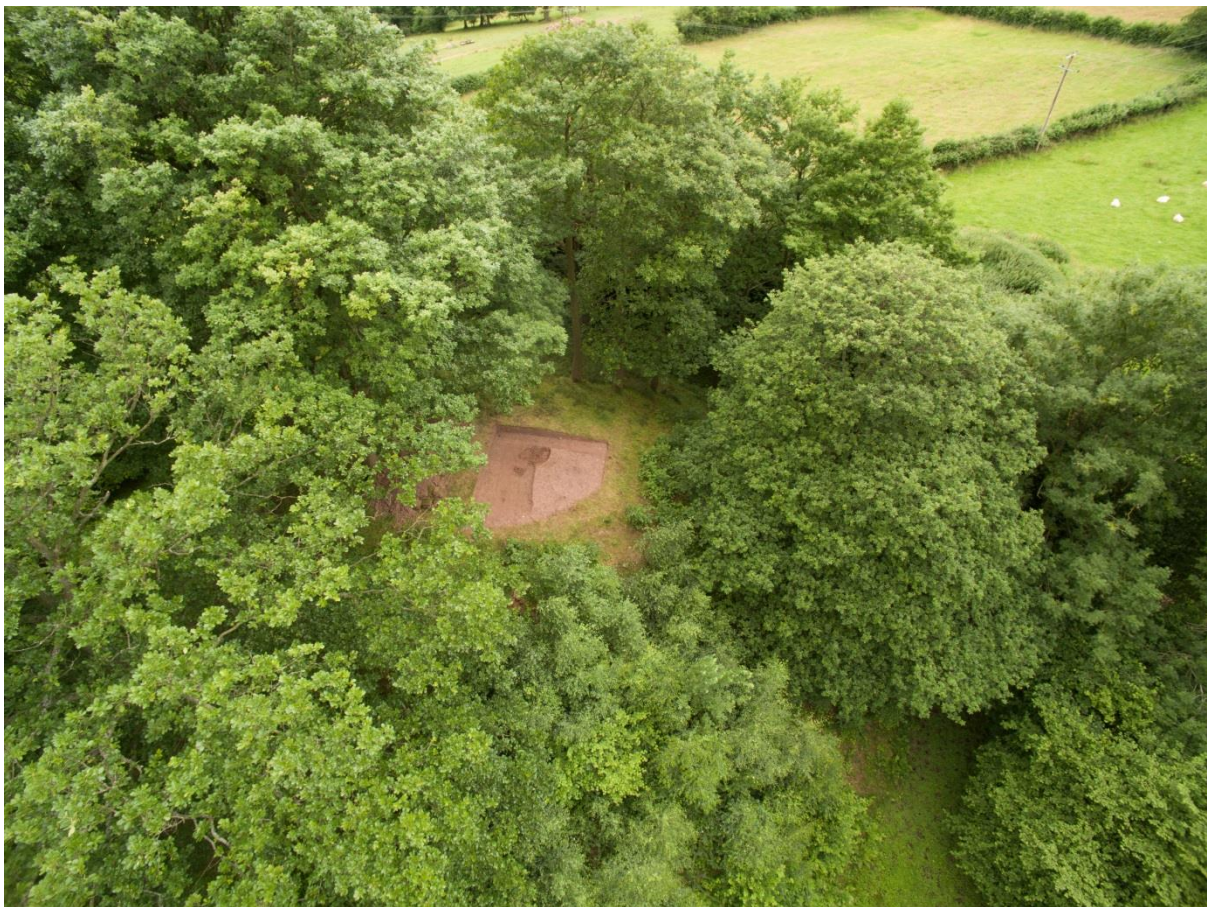
Plate 14: Trench 1 on top of the motte.

Trench 1 was located on the summit of the motte. It was positioned to examine the north-eastern quadrant of the summit and to take in an anomaly roughly in the centre of the motte identified during a geophysical survey undertaken prior to this project taking place. The southern and eastern sides of the trench each measured 6.00m. Its purpose was to reveal and record any structural features associated with a timber or masonry tower that might be expected to have existed here.

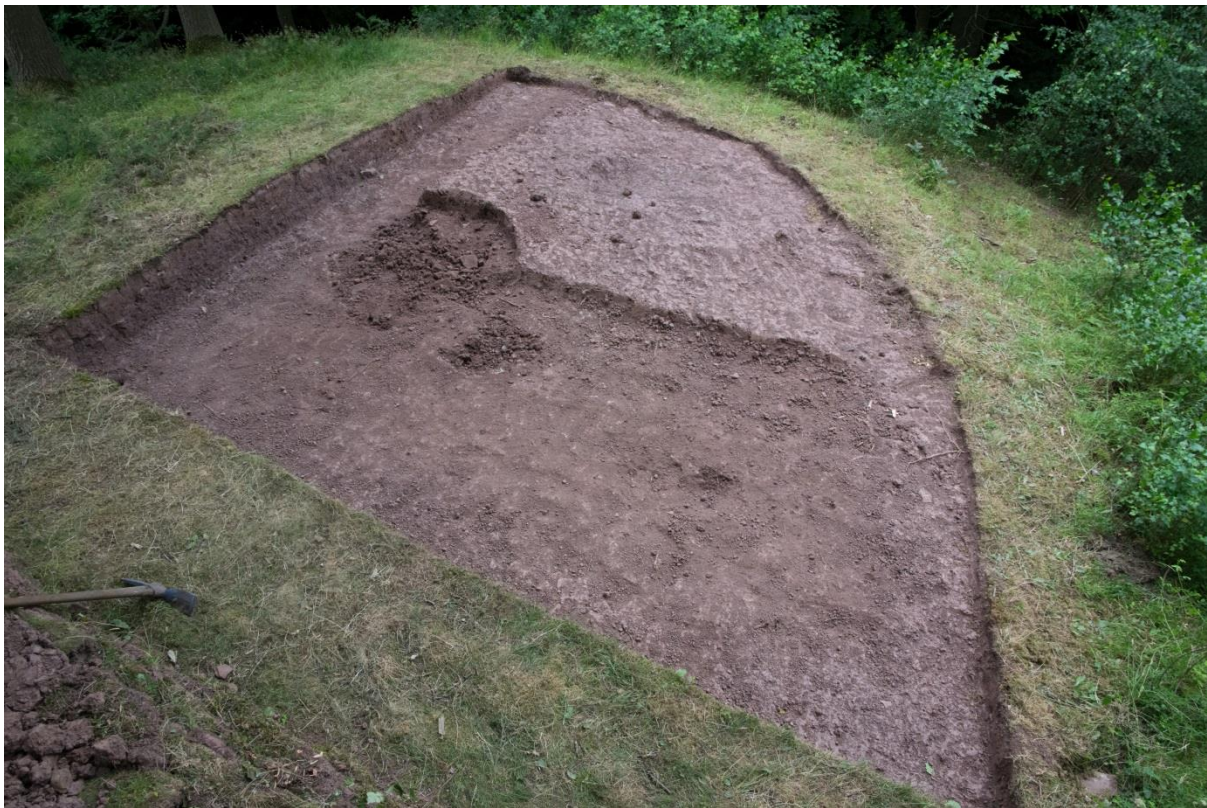
Plate 15: Detail of trench one as left at the end of the 2016 season prior to backfilling.

Two slots (0.70m x 5.00m) were excavated along the southern and western trench edges to a maximum depth of 0.40m. No features were identified within these or within the trench as a whole and although conditions were not ideal for identifying subtle features it was anticipated that any features associated with a tower would be fairly substantial. The clay body of the mound was however extremely dry, the summit is sheltered by the closed tree canopy and the weather during the excavation was for the most part warm and dry. It is intended to reopen the trench in 2017 and to remove a reasonable depth of the clay deposit to ensure that features have not been masked by surface disturbance. There were no finds from trench 1.

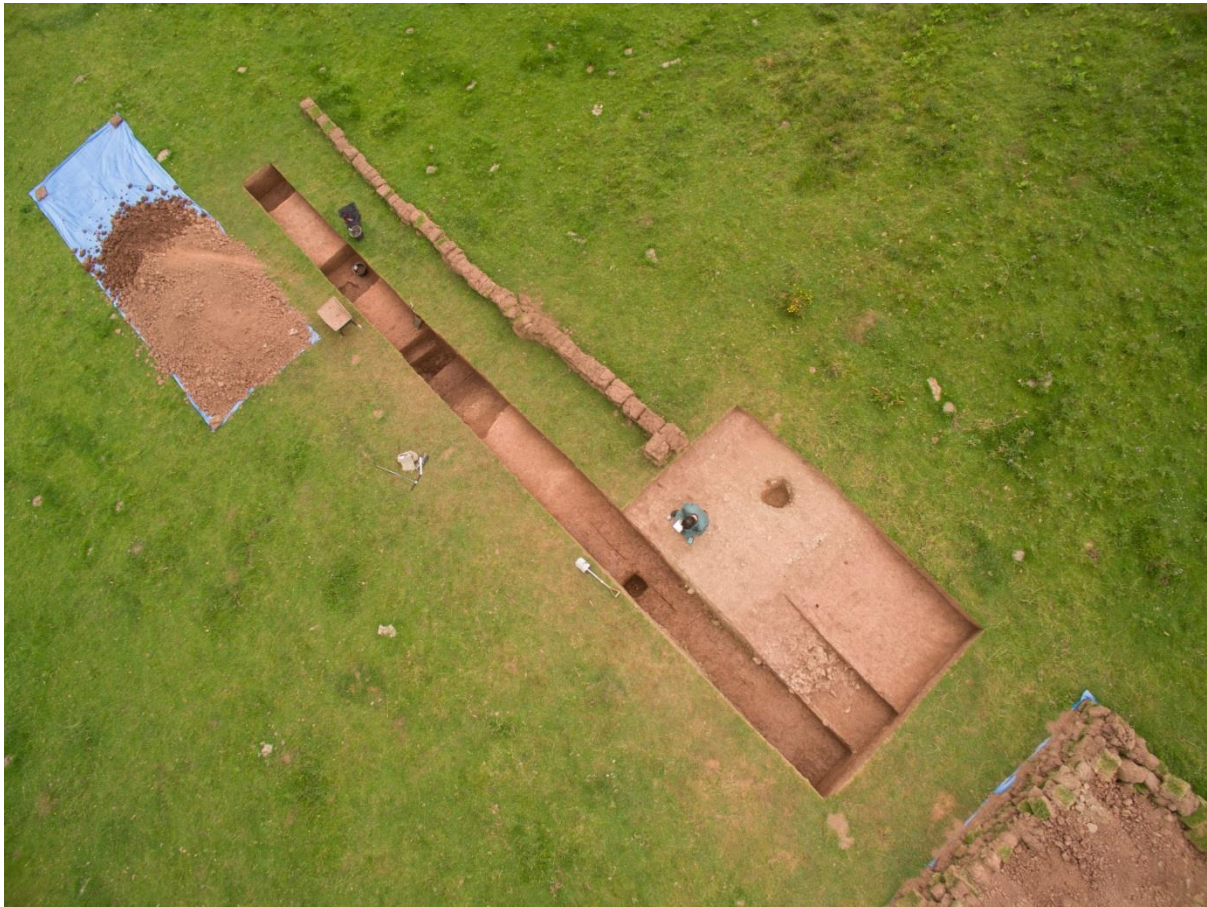
Plate 16: Vertical photograph of Trench 2.

Trench two was located across the eastern line of the bank defining the bailey. An area opened initially across the visible earthwork bank measured 4.00m north-east south-west by 6.00m north-west south-east. An extension 1.00m by 13.60m was excavated south-eastwards down the slope to try to identify any external ditches or other defensive features creating a south-west facing section 19.60m long.

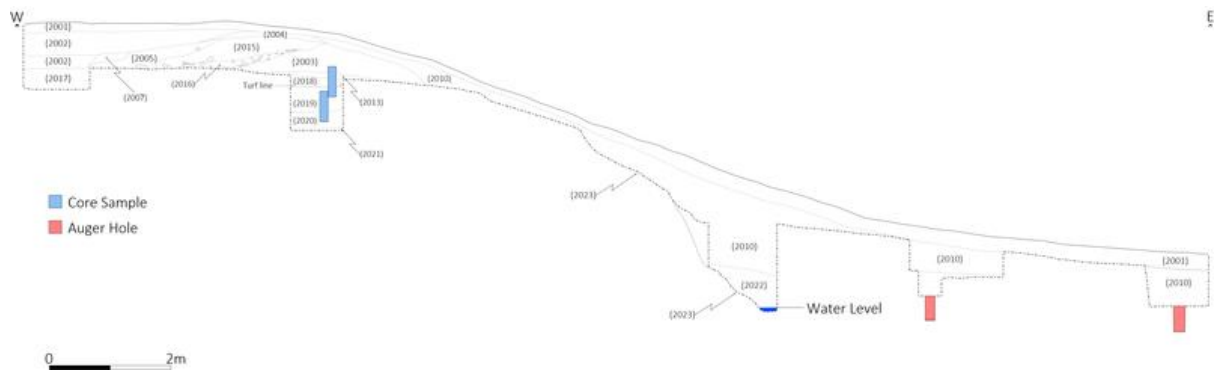
Figure 13: Eastern section of Trench 2.

The rampart consists of a series of dump deposits surviving to a maximum depth of 0.70m above a 0.97m deep buried soil with a clear relic turf line (see figure 13) The buried soil represents either an undisturbed brown-earth forest soil or a truncated forest soil with an upper horizon representing a cultivation soil. A column soil sample was taken of the buried soil to carry out micro morphological examination to establish which of these is the case and to enable pollen sampling to reconstruct the early environmental history of the site and area. A single struck flint was recovered from the junction of the buried soil and the rampart material. Two further flakes of flint debitage were recovered from within the buried soil.

The rampart material was found to have been quarried from a wide shallow external ditch and is essentially the reverse stratigraphy of the material as it was quarried. The lowest horizons (2013 and 2003) may have been an initial turf strip and foundation bank. The former (2013) was dark reddish brown silty loam, almost stone-free, identified as redeposited turf, above that 2003 was dark reddish brown silt clay, with medium sized weathered stones. Overlying the back of this material are two deposits of degrading green sandstone in a

matrix of red and red brown clay loam. Green sandstone bedrock was recorded in the ditch section to the east (see below) and this material is almost certainly derived from there. Two further deposits served as a capping to the stone deposits. Red purple clay loam (2005) forming the rear of the bank and a stony deposit (2004) forming a hard packed surface to the crest of the rampart. The latter was cut by a post-hole (Plate 17 & Figure 14) 1.00m maximum diameter and 0.80m deep with a post pipe between 0.50m and 0.55m diameter. It is possible that this represents a palisade fence along the top of the rampart.

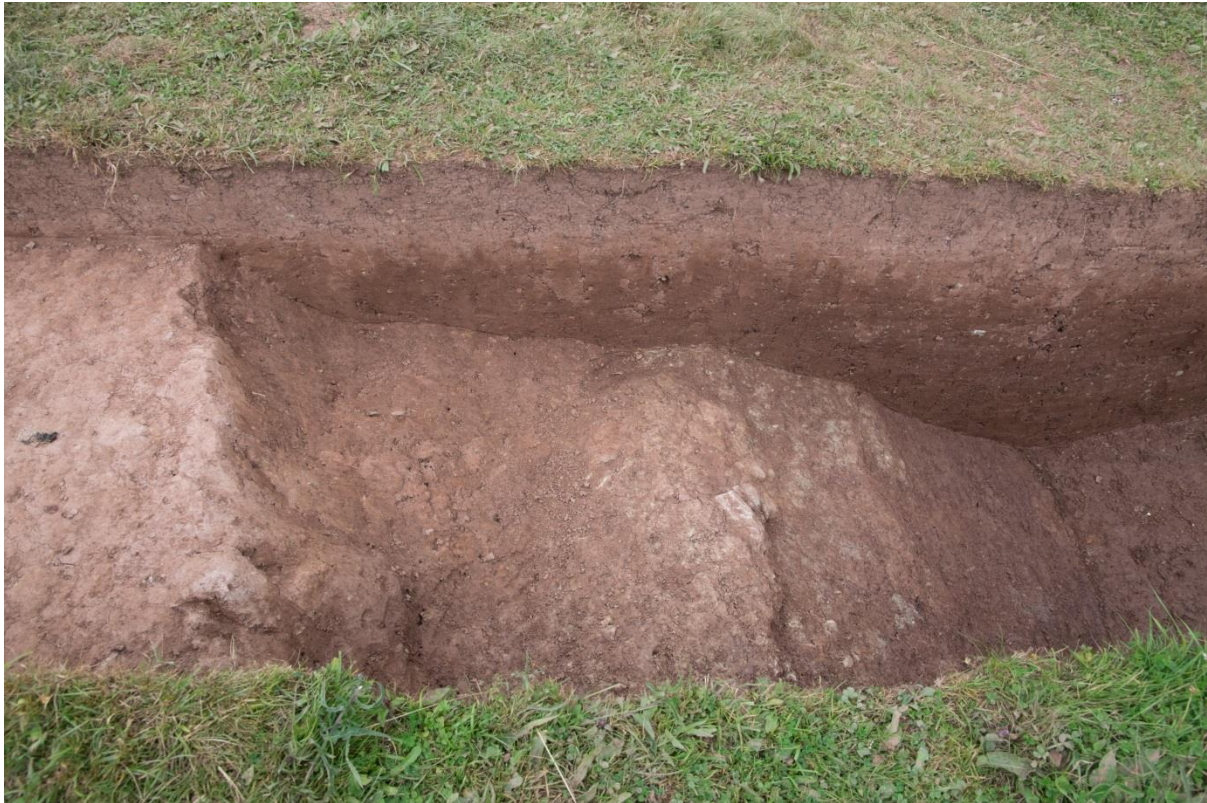
Plate 18: the outer face of the rampart cut into natural marl and green sandstone.

The defensive quality of the site had been enhanced by steepening the natural hillslope between the rampart and the ditch. The scarped slope essentially formed the elongated internal side of the ditch. The ditch itself was examined in one area. The western side was defined by distinctive green sandstone bedrock interspersed with red clay mixed with degrading green sandstone. Excavation was limited to 2.1m below current ground level (1.4m below the general trench level) so the depth of the ditch could not be established, however natural clay marl was recorded by auger at approximately the same absolute depth only 2.60m to the east suggesting that the base of the ditch might be up to, but probably not more than, 1.00m deeper. The ditch fills were fairly homogenous. The lowest (2022) was red brown clay with small flecks of silica and degrading yellow sandstone up to 3mm. The depth exposed in section was just over 0.60m. Above this and below the modern turf and topsoil was a 1.26m thick deposit of colluvial material, red brown clay loam with green flecks of degrading sandstone.

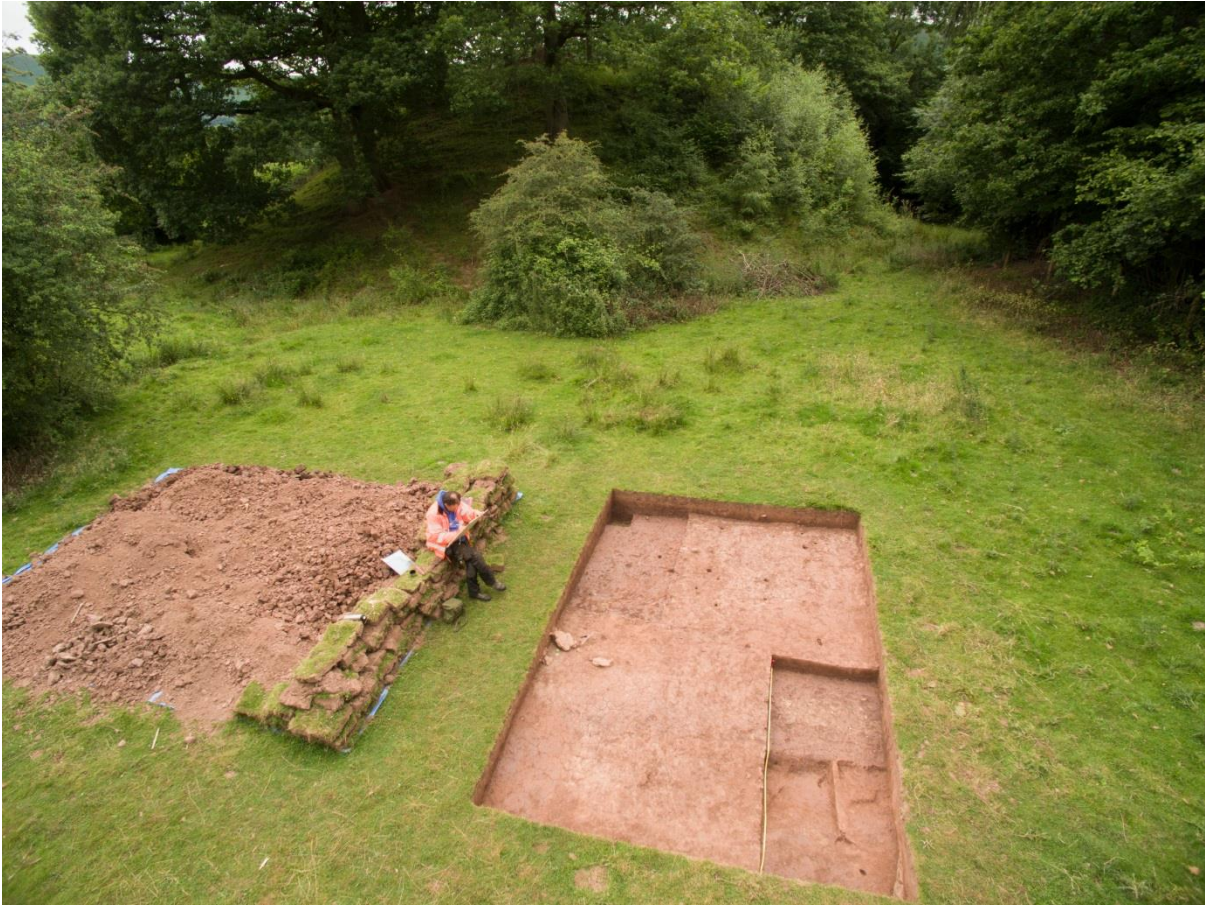
Plate 20: Trench 3 looking west.

Trench three was located within the bailey enclosure to the east of the motte and measured 6.00m east west by 4.00m north south. Modern turf, topsoil and subsoil (3001 and 3002) were removed to reveal a leached clay deposit over the entire area of the trench. The only features recorded within this were a number of holes and burrows. Most were clearly created by moles but it is possible that some may have been stake-holes.

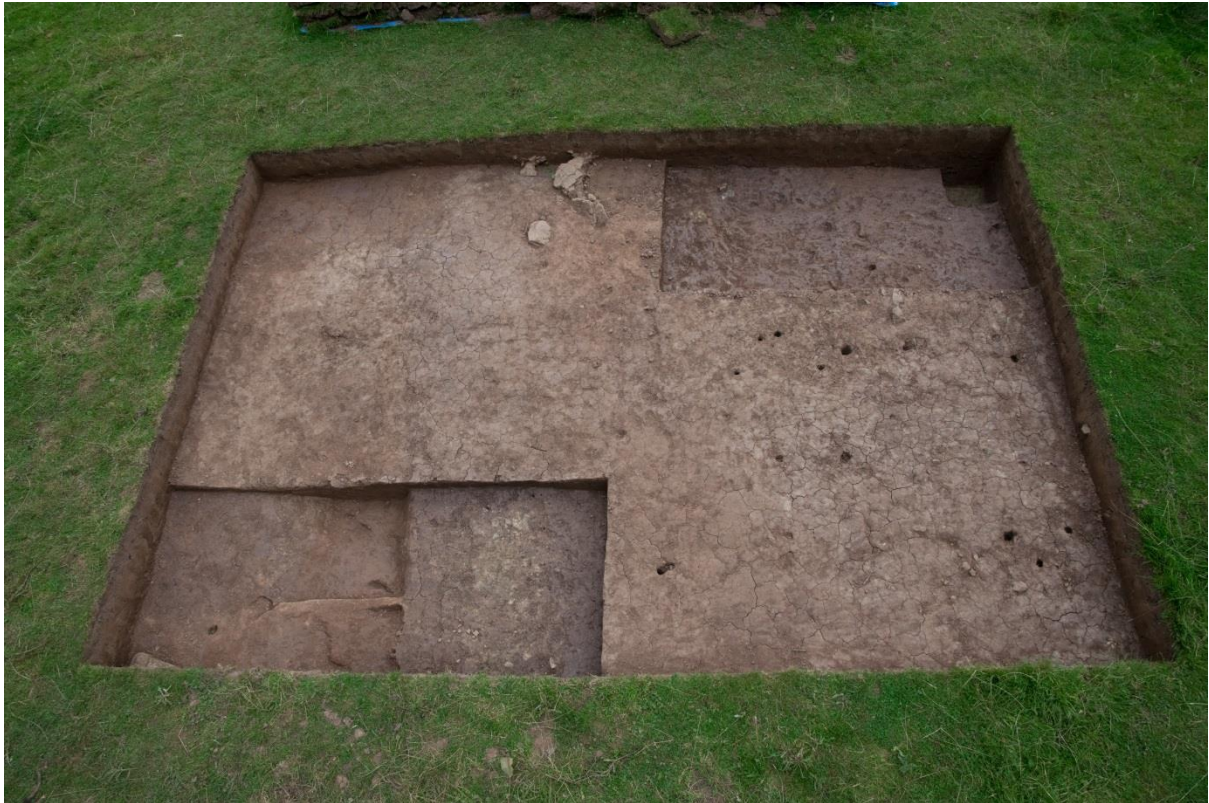
Plate 21: Trench 3 looking south showing some of the deeper mole activity and the natural banding.

Again the warm dry weather was not ideal for feature recognition but weathering and differential drying over a number of days revealed a series of wide bands running roughly north to south across the width of the trench (3003, 3004, 3007). Further examination of these showed them to be banding within the natural clay. A sondage cut in the south-west corner of the trench recorded degraded sandstone within distinct yellow/green clay at a depth of 0.60m below present ground level.

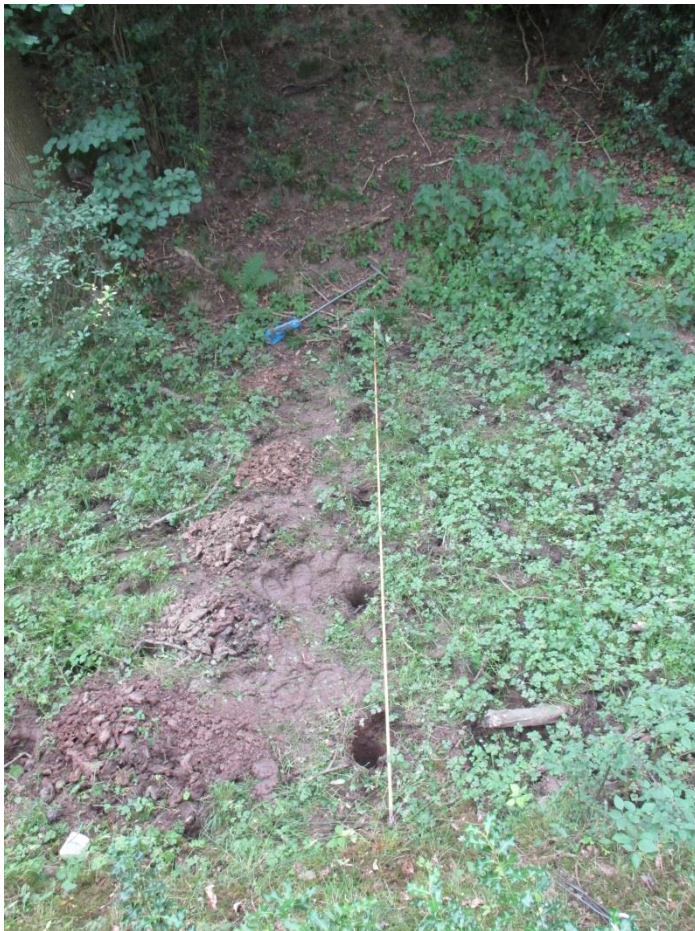
Plate 22: line of auger holes across the south-west portion of the moat.

Two of a planned series of three auger transects across the motte ditch were carried out in the 2016 season. These showed that the ditch to the north-west and south-west of the motte, although in reality cut from some meters above current ground level, contained very little fill material. The maximum depth of fill recorded was 0.85m. The profiles were fairly consistent with disturbed organic material and clay in the first 0.25m above stiff clay deposits with some organic material gradually becoming cleaner with depth. Lower deposits were clays with stone and sand before natural stony marl.
