Survey and Conservation work associated with a Cairn and Limekiln, Craswall, Herefordshire

**Herefordshire Archaeology Report No. 362
Event No. EHE 80202**

**NGR: SO 572 672
Event Number: EHE 80202**

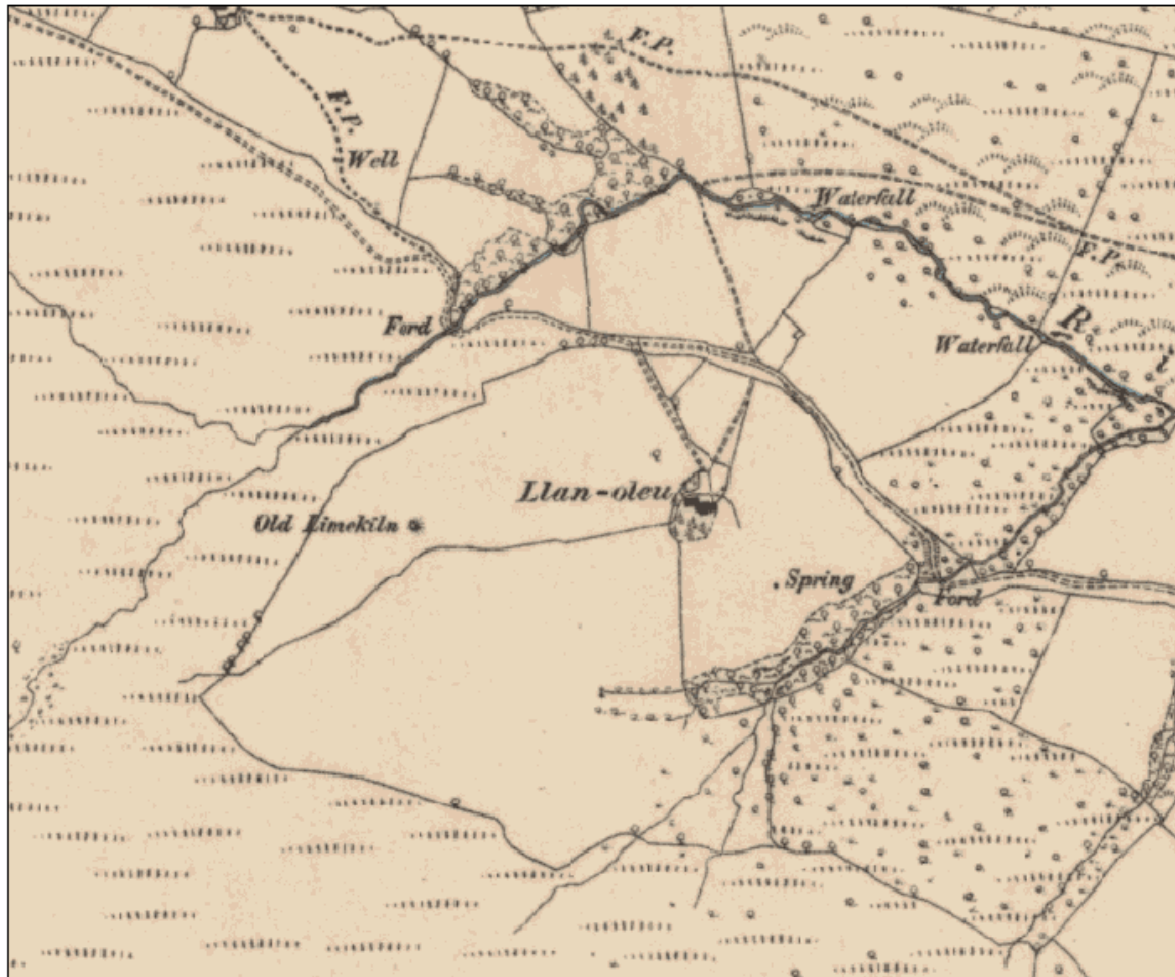
Figure 3: Extract from the 1st Edition Ordnance Survey Map 1886-7 showing the Old Limekiln.

The limekiln is shown as “old limekiln” on the 1886 1st Edition Ordnance Survey map, suggesting that it dates from the early 19th century or earlier. The kiln comprises a single entrance, top loading kiln. It is in poor condition, having completely collapsed and been substantially quarried, (probably for building stone). The lower courses of the northern and southern walls survive, these are approximately 4m apart and survive for a maximum of four courses in height. The kiln appears to have collapsed past the loading hole and this has left two vertical steps close to the crest of the earthwork associated with the kiln. The upper step is made of stone and appears to be the outer core of the kiln cone. The lower step is made up of vitrified stone and appears to be the internal face of the remains of the cone. The Void which was the cone and the entrance has been filled with stones, some from the kiln itself and others found whilst ploughing the field and tipped in (R.Richards, *pers com*). This has helped protect the surviving elements of the kiln. In recent years some of the stones which make up the top courses of “*in situ*” walling have become displaced by livestock.

The survey has clarified the description from the schedule designation and has made it clear that only one cairn is present on the scheduled site and that this has been cut into on its western side in order to construct a limekiln. Map regression analysis would suggest that the limekiln was constructed in the early 19th century or earlier – as it documented on the 1886 Ordnance Survey Map as being old/ disused.

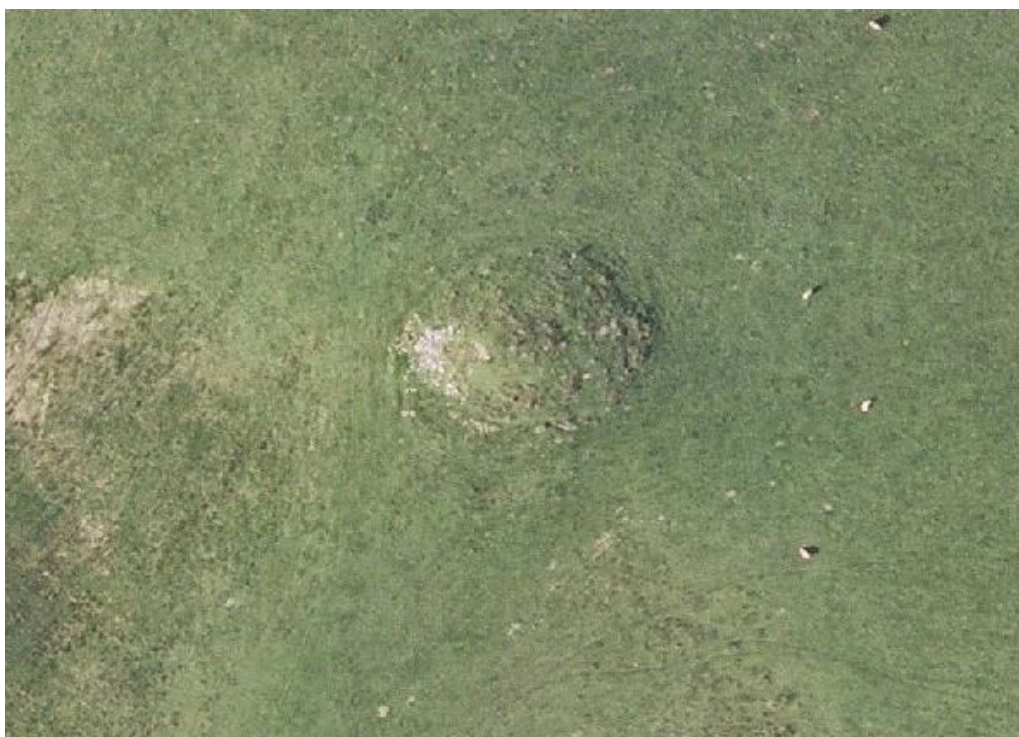
Figure 5: Detail of 2009 aerial photograph showing stone collapse of the limekiln on the western side.

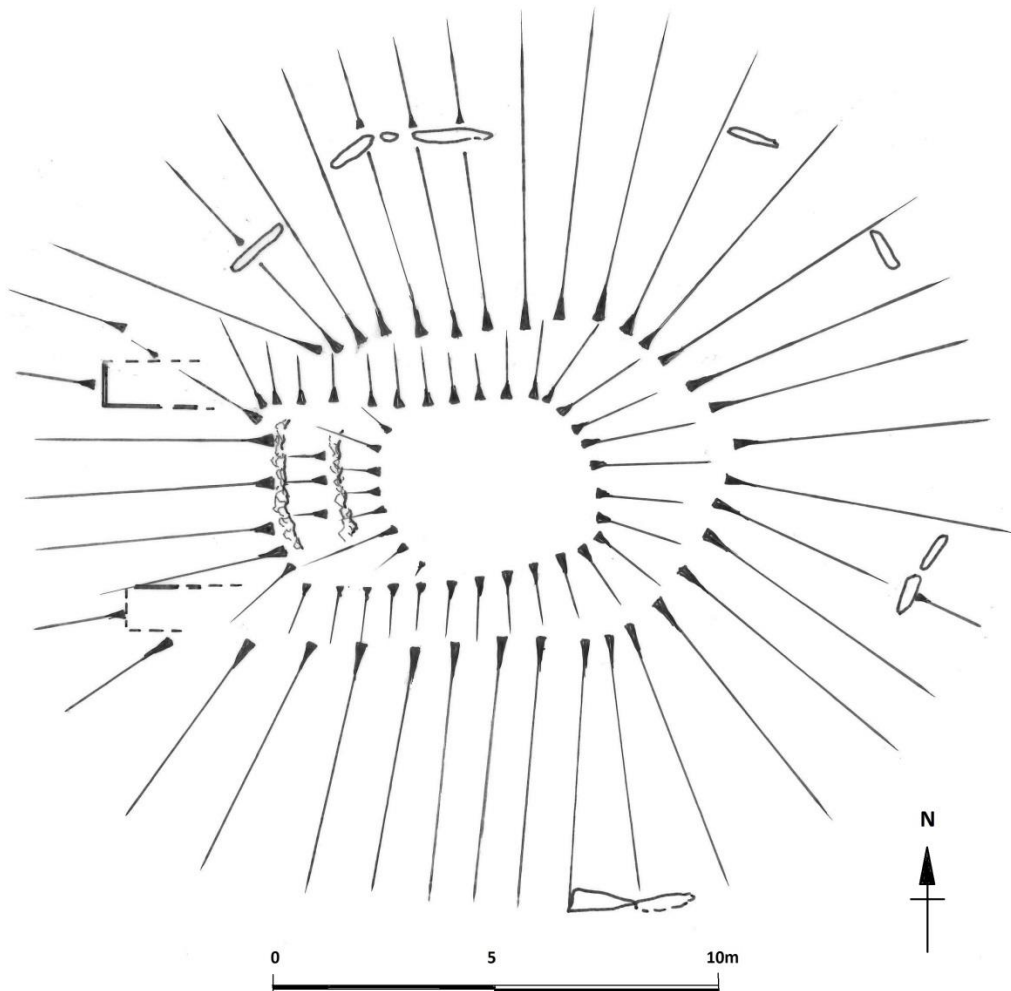
The survey has documented that the monument comprises a mound, approximately 24m long (east / west) and 18m (north south) reaching a maximum height of approximately 3.2m. The schedule description appears to be inaccurate in that there is only a single cairn (not two as previously thought) and the limekiln which has been cut into the western side of the cairn has formed the higher “peak”, giving the impression of two cairns.

Figure 6: Hachure plan of cairn and limekiln showing visible stone kerbing and remains of kiln walls.

The cairn appears to comprise the remains of a series of vertical stones sets, forming a kerb approximately 18m in diameter within which sits a roughly circular stone core, covered in a turf or earthen mound. This stands to a maximum height of 2.6m and is situated on the top of a natural knoll. It may be slightly elongated on its west-east axis compared to its north-south axis, but this is at present difficult to confirm due to the disturbance to the cairn caused by the insertion of the limekiln.

The schedule description describes a total of 16 kerb stones being visible, at the time of this survey only ten kerb stones were visible. This does not necessarily mean that the eight stones have been removed, more likely is that the turf and ant hills have grown over them.

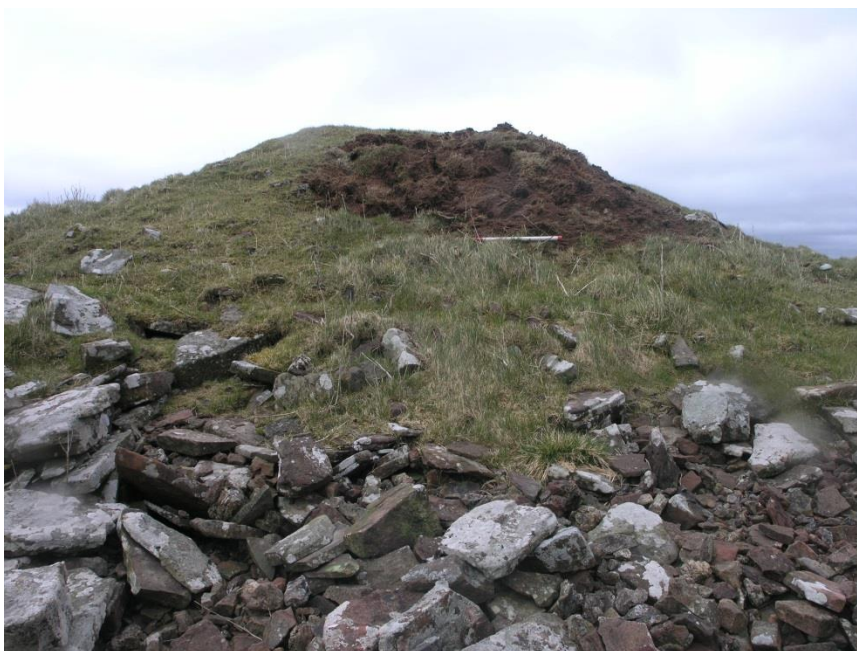
Plate 1: Scar after infill with topsoil and turf.

The landowner had collected clean topsoil and turf from nearby and this was spread over the upper scar caused by the collapse of the kiln cone. The lower area of rubble between the two wall stubs was left alone as it is likely that some of the material deposited on the upper scar will be washed down and create grass infill between the stones therefore achieving stability of this part of the monument whilst still rendering the kiln visible.

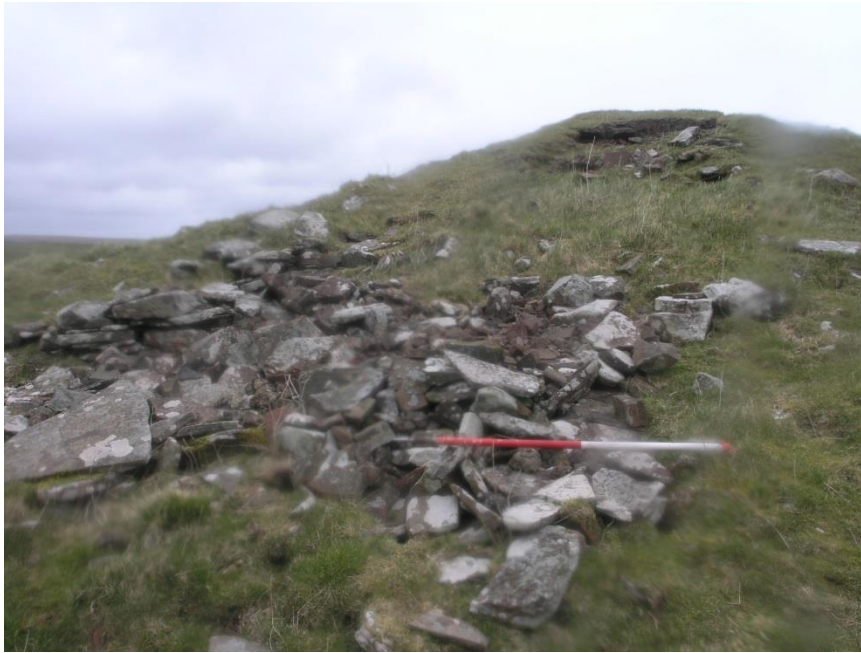
Plate 2: Showing the scar above the limekiln rubble.

1. The material deposited over the scaring is monitored for slumping and more material added if needed.
2. Additional material is gradually added over the limekiln collapse in order to cover and preserve the last remains of the side walls and not present an area of shelter for livestock.
3. The moles are controlled / eradicated – in order to prevent further intrusion into what appears to be an archaeologically significant deposit surrounding the cairn and at the southern end of the ridge to the south of the cairn.
4. The causeway and the low rise to the south of the cairn should be incorporated into the HER and taken into account during any future Farm Environmental Plans.
