The excavation of two Auxiliary Unit Operational Bases on Bromyard Downs, Herefordshire

**Herefordshire Archaeology Report No. 361
Event No. EHE 80201**

The excavation of two Auxiliary Unit Operational Bases on Bromyard
Downs, Herefordshire

NGR: SO 672 551
Event Number: EHE 80201

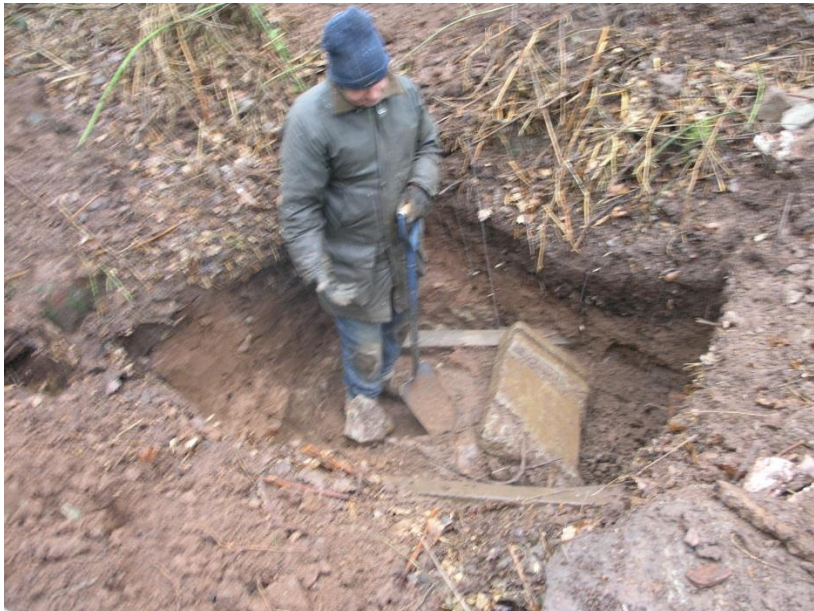
Plate 1:
Reinforced
concrete blocks
and other
remains under
excavation.

It quickly became apparent that the reports that this bunker had been blown up, in order to make it safe and stop children playing in it once and for all, were accurate.

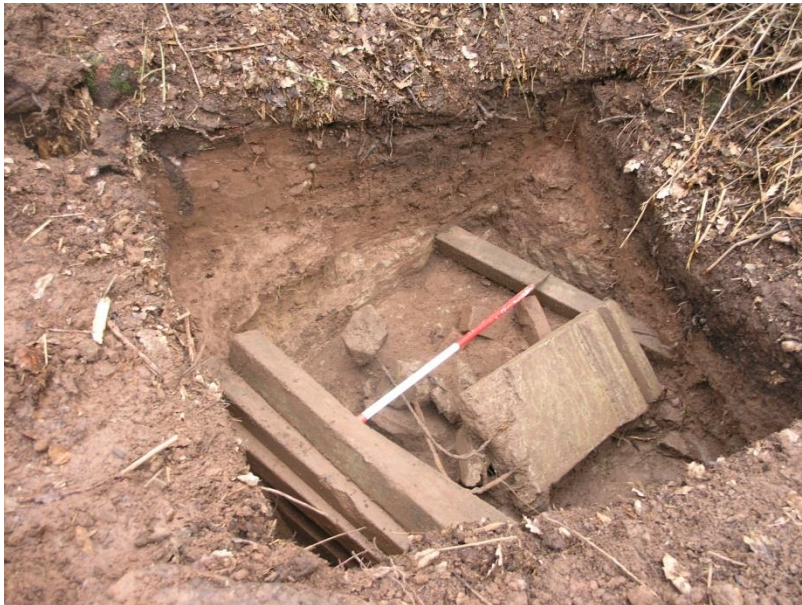
Plate 2: OB1 entrance shaft remains showing the concrete beams lining of the shaft which is cut into bedrock.

It would appear that in addition to blowing the OB up, the remains were then bulldozed in order to fill in the void and tidy up the site. This has resulted in a lowering of the ground surface. It is understood that in order to access OB1, there was a short, vertical shaft onto a bedrock “step” before a second drop into the bunker itself. It would appear that it was the base of the shaft that was encountered within this trench.

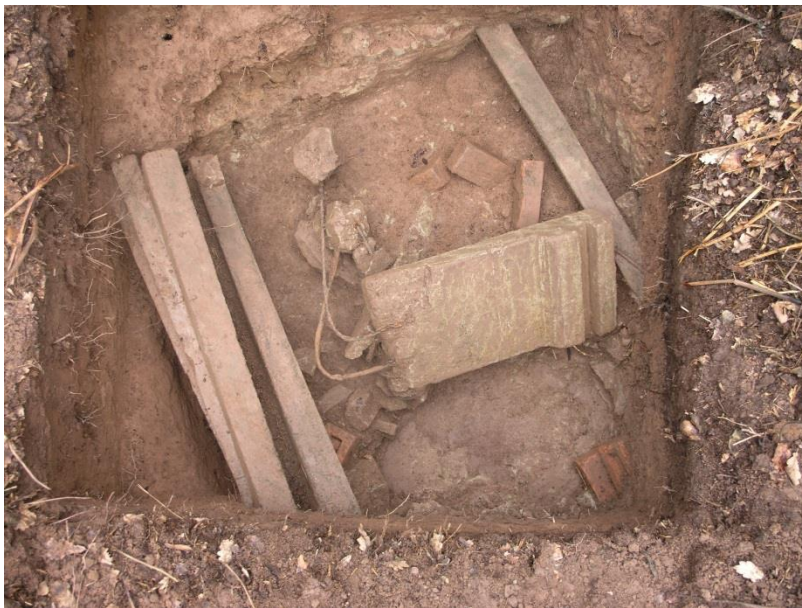
Plate 3: Vertical photograph showing the bedrock floor of the shaft under the concrete slab.

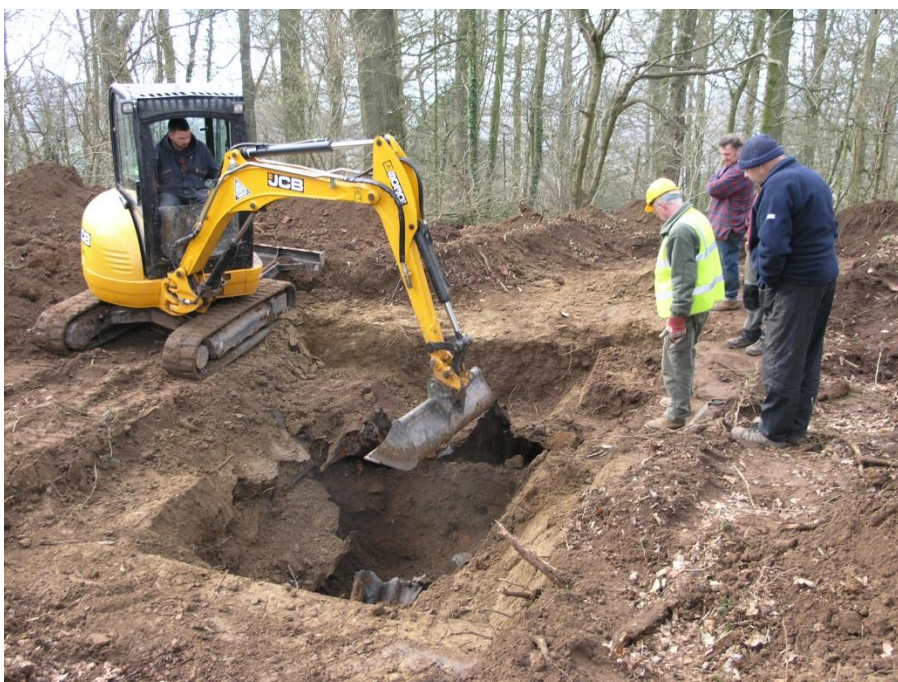
On February 29th 2016 a trench cut by mini-excavator east-west across the depression first identified quantities of apparent quarry waste (crushed limestone) under the topsoil either side of the depression with a more mixed fill within it containing occasional ceramic floor tiles and similar rubble. Further excavation then revealed the flat top of solid limestone bedrock on the west side of the depression, terminating at a straight north-south cut edge. This was investigated and pieces of corrugated iron soon came to light and effectively confirmed the initial identification of the site as that of the OB. Those sheets that appeared to be in situ were left in place and were resolved into a damaged and distorted curved roof with the topmost sheets torn off. The excavated area was then enlarged horizontally to provide a stepped profile so that the excavation could be safely taken down to the level of the OB floor. This was achieved with the mini-excavator, revealing the concrete floor surface. The backfill under the remaining roof slopes was later excavated by hand to provide an east-west sample section through the structure.

Plate 4:
Operational
Base 2 under
machine
excavation.

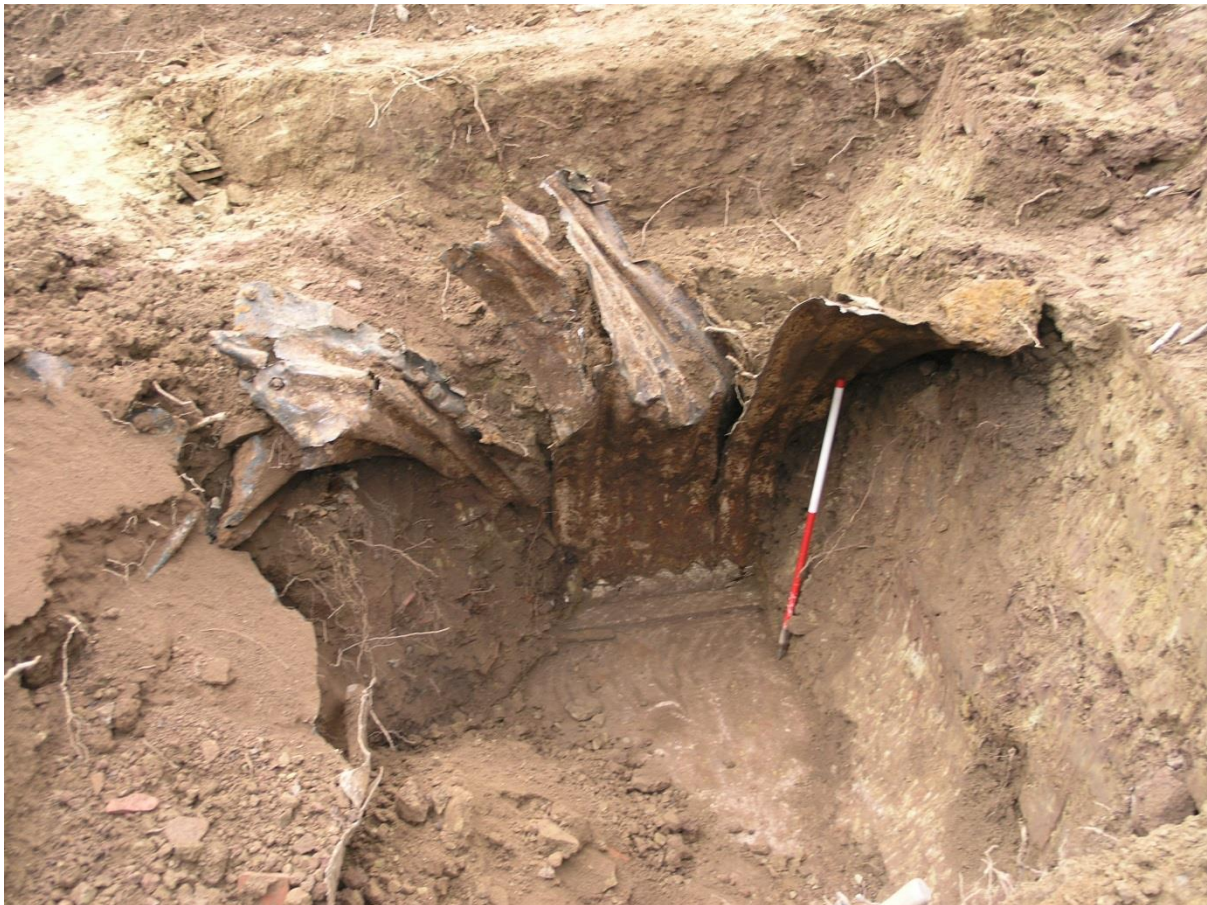
The OB was found to have been built in a vertically-sided north-south cutting, 3.62m (12 feet) wide, cut to a depth of around 2.5m (8 ft 6 ins) below the present ground level, up to at least 2.1m (7ft) into solid limestone bedrock. The surface of the limestone was higher on the west side of the OB than on the east side: the reason for this was not established. The footings of the OB were not explored below floor level but the sheets of the corrugated iron roof and sides were founded apparently outside the floor slab, possibly on some kind of drainage gullies to collect ground-water running down the outside of the roof and condensation running down the inside. The internal width of the OB at floor level was 2.95m (c.9ft 10ins). The floor was found to have a raised sill on each side just within each side wall and a cement fillet or skirt had been added along the base of the corrugated iron sheets, sloping at 45-degree angle, again, it seemed, to control condensation and prevent water running down the roof and onto the floor.

Plate 5: OB2 showing the remains of the corrugated wall and roof and the concrete floor.

The corrugated iron sheets rose vertically to c.20-30cms above the floor before curving inwards, suggesting that the building had a nearly semi-circular profile (rather than at first curving outwards to form the greater part of a circle). If this was indeed the case, its maximum internal floor-ceiling height can be reconstructed to have been about 1.74m (5ft 8ins) or slightly over, giving a depth of burial of the roof apex of about 0.66m (2ft 3ins) or slightly less – in approximate terms a six-foot high structure buried with two feet of cover over the roof. The corrugations were larger

than those found in modern corrugated iron sheeting and the sheets were of heavier gauge, they may be 'elephant shelter' sections of First World War vintage or design. The sheets were riveted together and their underside (inside) face was whitewashed.

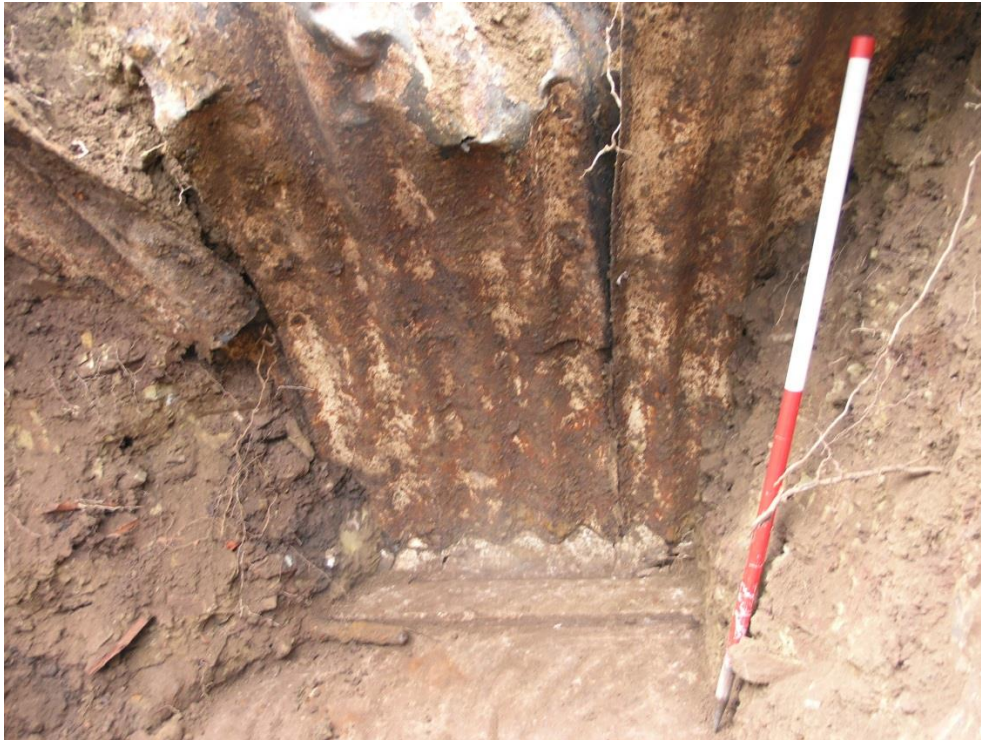
Plate 6: Detail of the wat that the concrete floor was attached to the corrugated iron superstructure, showing the cast "step" and the concrete fillet.

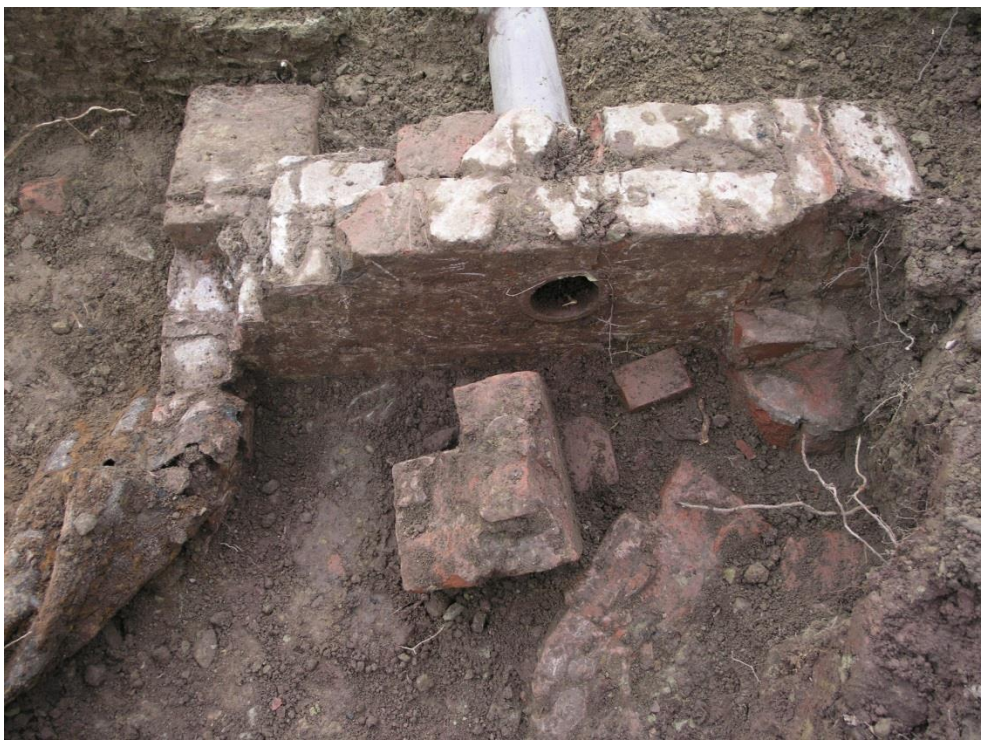
About 1.5m north of the full-depth excavation an H-shaped brickwork footing was found just within the western cut into the bedrock. The footing was 1.13m long (north-south), two bricks thick, with short (16cm) returns projecting into the OB cut and slightly longer returns (25cms) on the west side. From the centre of this footing a 4-inch-diameter drainpipe composed of brown glazed sections led gently upwards over a distance of 4.5m westwards and terminated with a 90-degree angled pipe section pointing upwards to the surface. This is interpreted as a ventilator or flue pipe formerly linked via a (missing) connector pipe through the roof of the OB presumably to, or over, the documented paraffin stove.

Plate 7: The remains of a brick flue and ventilator pipe used to take fumes from the paraffin stove out of the bunker.

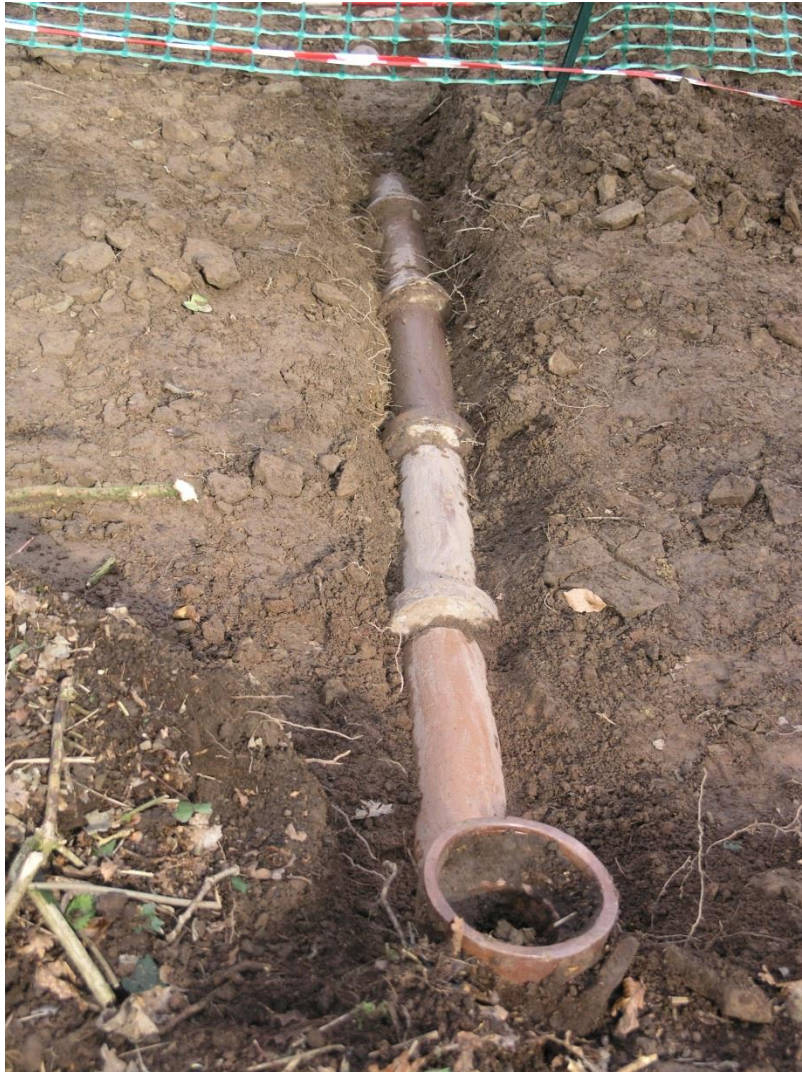
Plate 8: The ventilator pipe which runs from the brick built flue, out of the bunker for 4.5m before terminating in a vertical section.

The 4.5-metre offset from the OB is likely to have been designed to render it grenade-proof and mislead searchers as to the exact position of the OB. The corrugated iron of the OB roof was built into the brickwork of the east-side returns of the H-footing, demonstrating that it was an integral part of the OB construction. The brickwork would have been carried down to floor level and would have formed a small cooking or heater bay, though the oral account shows that, in practice, no cooking was actually undertaken in the OB.

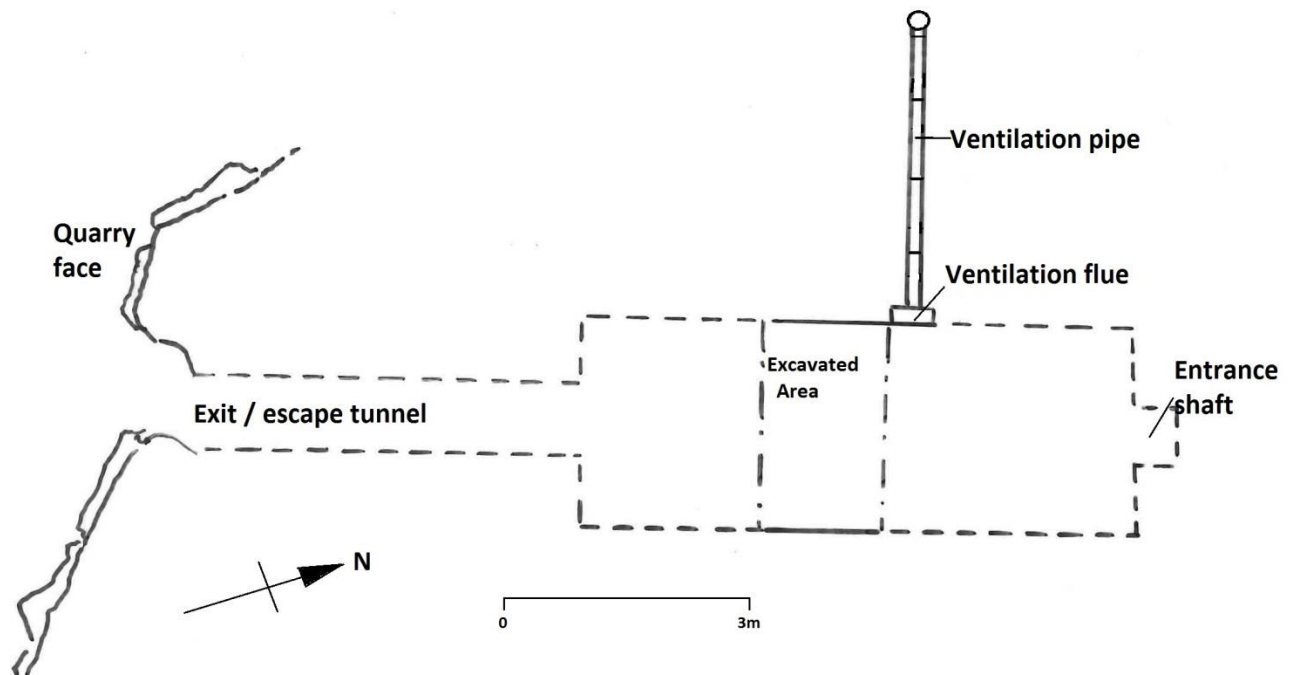
It is assumed that the vertical entrance shaft of the OB was at its north end, beyond the investigated area. No trace was seen of the documented 20-foot long escape tunnel which would have led from its south end to the quarry face, this too lying beyond the excavated area. Excavation along the adjacent section of the quarry face with the mini-excavator failed to find the entrance. At the south-east end of the face the bedrock and other natural strata were seen to have been cut away but the nature of the cut could not be determined as it was partly covered by a massive dump of scree-like quarry waste material, interpreted as part of the work by the Army to make the former OB safely inaccessible. However, dowsing on the surface suggested that the tunnel may have projected southwards from the OB along its axis.

As reported already, both Operational Bases are thought to have been destroyed by the Army for safety, probably at the end of the 1960s. While the concrete OB 1 to the north appears to have been blown up, the 'softer' corrugated iron and brick OB2 was rendered inaccessible by less violent means. The top sheets of the corrugated iron superstructure were torn off, possibly by a mechanical excavator. The interior was then filled with material tipped from the east, presumably from a lorry or trailer accessing the site from the track between the OBs and the reservoir. The material used for backfilling was, in order, a mixture of limestone rubble and mid-20th-century floor tiles (used and unused) and tile pieces; crushed limestone; red clay with limestone pieces; and further crushed limestone – which was identical to the local bedrock and appears to represent quarry waste from the immediate vicinity and/or material from the 1940-41 cut for the OB. The original backfill down the sides and over the roof of the OB could not be distinguished from the tipped material derived from the final infilling of the site. The backfill, together with the surviving wall/roof sheets was then compressed, distorting the OB's profile.

Figure 4: Suggested plan of OB2, based upon the excavated evidence, location of the quarry face in relation to the excavation and the description contained within Lowry & Wilks 2002.
