# **Watching brief of works associated with the mending of a water pipe, Victoria Street, Hereford.**

**Report prepared by  
Tim Hoverd**

**Herefordshire Archaeology Report No 360.  
Event EHE 80195  
Source SHE 23708**

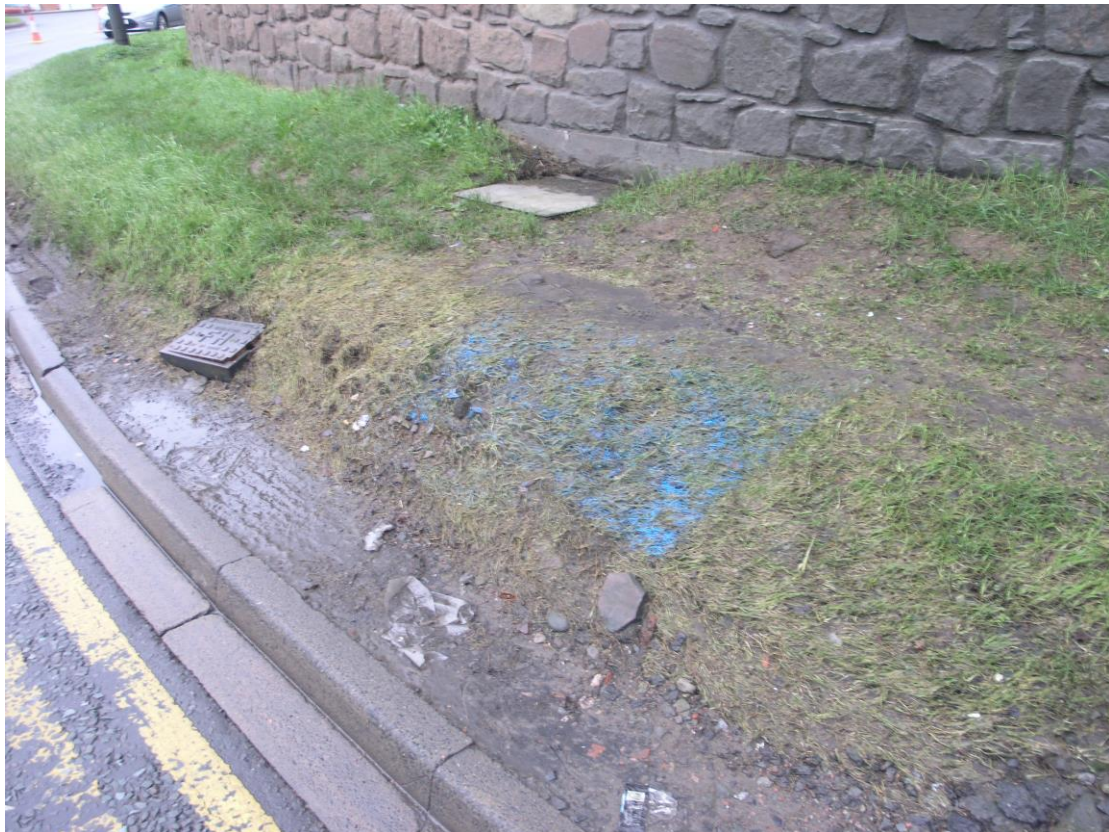
Plate 1: Location of pipe leak (blue marker paint) within the verge and in relation to other services.

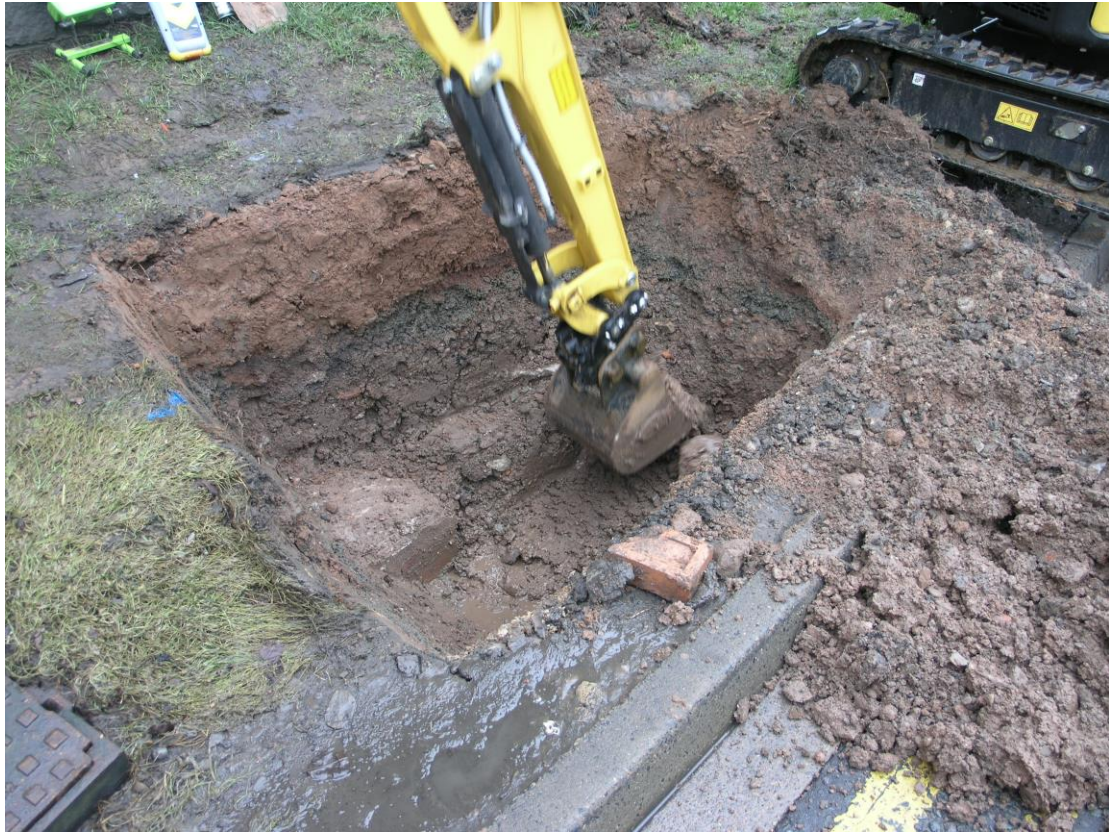
Site work was undertaken on the morning of Sunday 31<sup>st</sup> January. The works were carried out by machine excavation using a mini digger under close archaeological supervision. Immediately below the turf was a 0.35m thick layer of red sand and stone. This is directly associated with the construction of the wall during 1983-4. Immediately below this was a 0.25m thick layer of scalplings. Below this deposit was dark earth with brick and concrete fragments representing material associated with the construction of the ring-road. This deposit included a single, well cut, square, masonry block which would have originated from the medieval city wall. This was clearly out of context and overlay an offcut of steel reinforcing wire.

Plate 2: Trench during excavation clearly showing a top deposit of red sand associated with the construction of the wall.

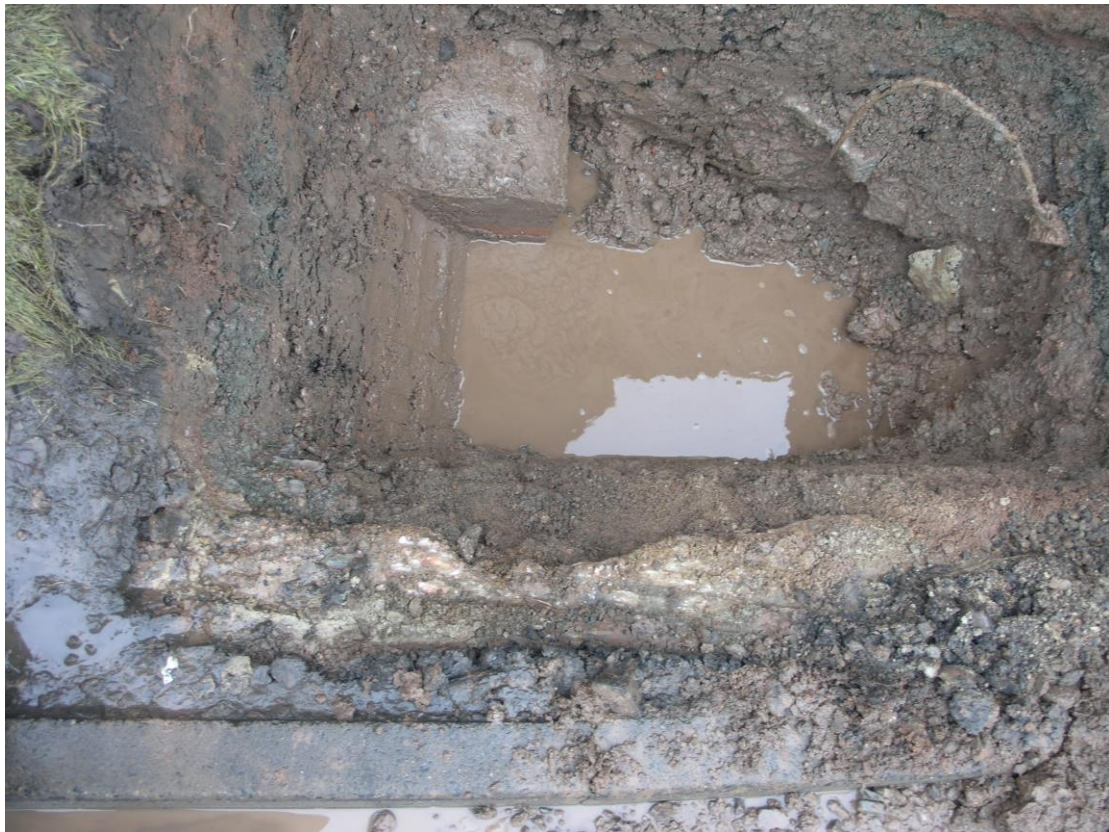
The north-eastern corner of the trench contained the edge of a brick built inspection chamber, (see plate 3). It would appear that the inspection chamber had compromised the integrity of the water pipe at this location and this had, over time, caused the leak. The material associated with the ring-road construction was not bottomed and the excavation terminated at a maximum depth of 1.25m. No archaeologically significant deposits were encountered. It is clear that a large number of services run through this location. This, together with the considerable disturbance caused by the construction of the ring-road, suggests that little of archaeological significance survives at this location at this depth. It is likely that some deeper deposits do survive here below the construction horizon of the ring-road.

Plate 3: Trench "in plan". The squared corner represents the south-western corner of an inspection chamber.

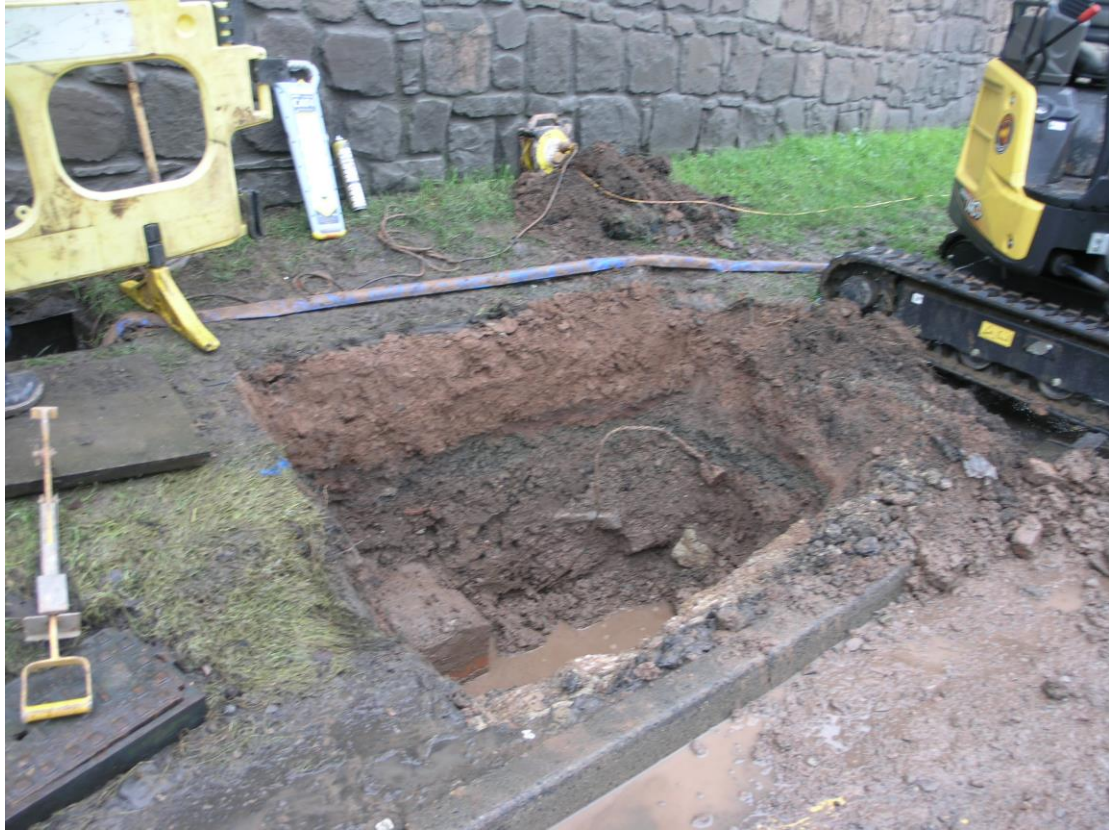
Plate 4: Trench at finished depth showing a well mixed, modern layer of disturbance containing concrete, walling stone, brick and off cuts of reinforcing wire.
