Watching brief of works associated with the replacement of a water pipe, East Street, Hereford.

**Herefordshire Archaeology Report No. 359
Event No. EHE80194
Source No. SHE23708**

An archaeological watching brief was undertaken during the excavation of three trenches needed to mole a replacement water pipe within the car park close to the East Street / Ethelbert Street Junction.

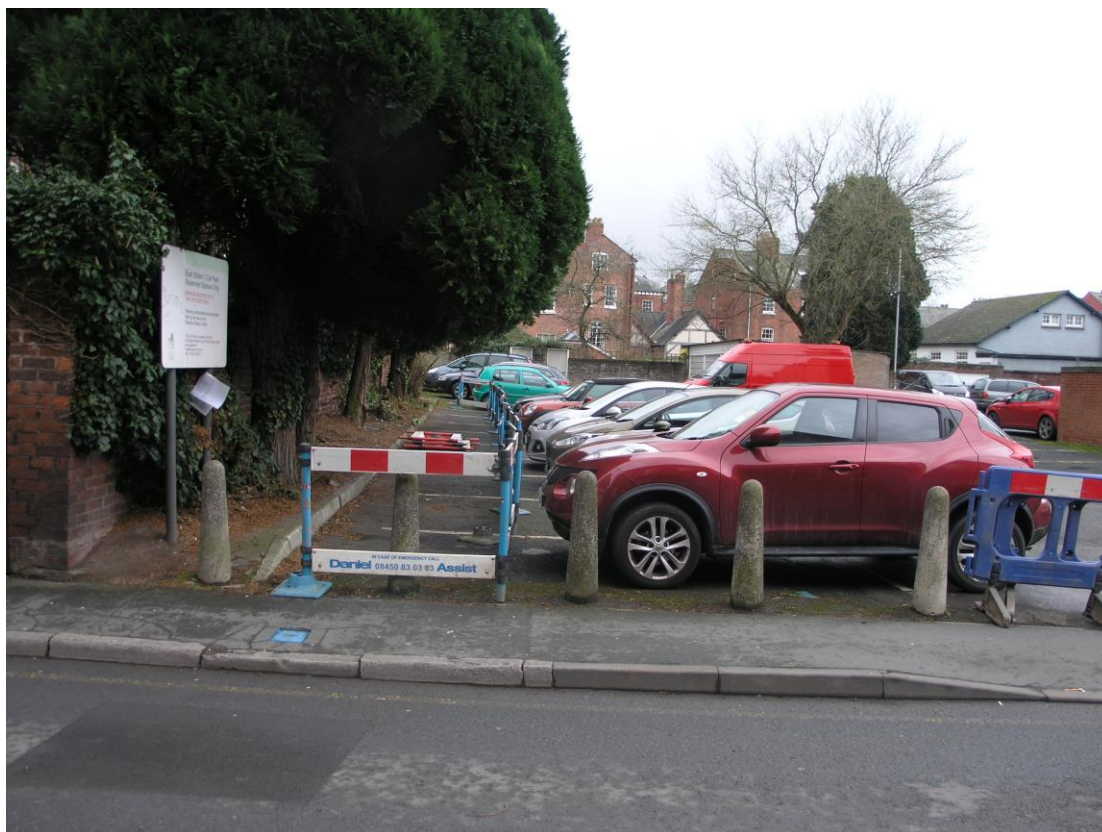
Plate 1: View southwards along line of works.

Site work began on Monday 25th January 2016 by Wye Water. The works comprised the excavation of three small trenches in order to mole a replacement water pipe along the eastern boundary of the site. The works were carried out by machine excavation using a mini digger and cleaned out by hand.

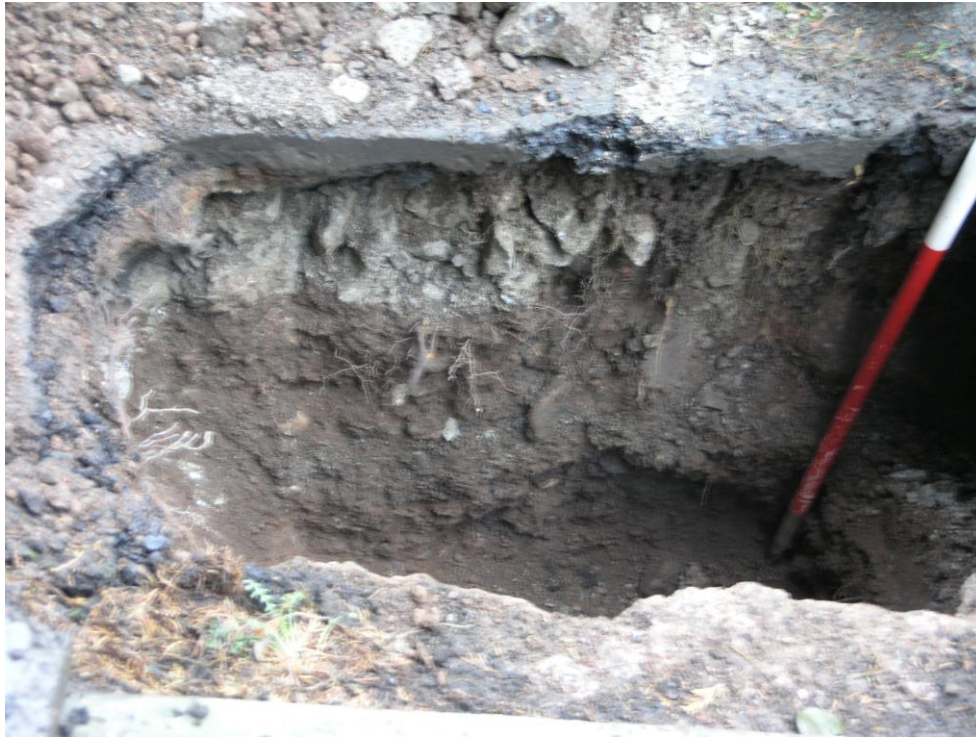
Plate 2: Trench 1 looking west

Trench 1, closest to the frontage with East Street, revealed the footings of a substantial wall which appears to have run along the East Street frontage. The wall comprised a number of well squared, grey sandstone blocks (see Figure 6) and had been neatly cut through in order to install the original water pipe. The wall, although robbed and damaged by the water pipe appeared to be approximately 0.5m wide and the footings continued through the base of the trench. It is presumed that this is the boundary wall present on the 1775 map, its construction date is not known. The wall footing was cut into a layer of very well compacted, clean gravel, the old water pipe had also been laid immediately on top of this gravel deposit. It is thought that the gravel represents the top of the surviving deposits which were used to construct the pre-conquest rampart. The excavation did not go into this layer.

The recording of the stone wall which ran along the East Street frontage is of interest as it suggests that (being of well-cut and squared stone rather than rough stone or brick), this feature may be older and more substantial than may otherwise be thought.

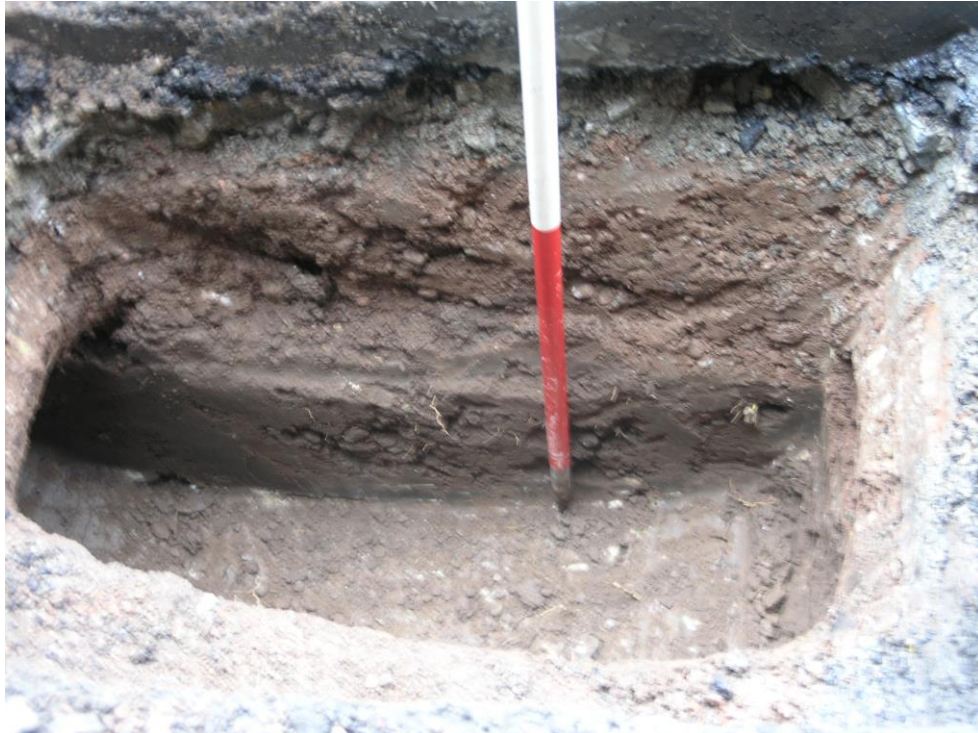
Plate 3: Trench 2 looking west.

Trench 2 was located approximately 13.5m to the south of Trench 1. This was excavated to a total depth of 0.9m and was filled to and beyond its base with a well-

mixed, clay loam, garden soil. Nothing of archaeological significance was noted except that the presence of the thick soil layer confirms the early map evidence of this part of the site being laid to garden for at least 250 years.

The recording of a considerable depth of well mixed garden type soil within Trench 2 has confirmed that the plots to the rear Castle Street / Ethelbert Street had not been intensively infilled during the post-medieval period.

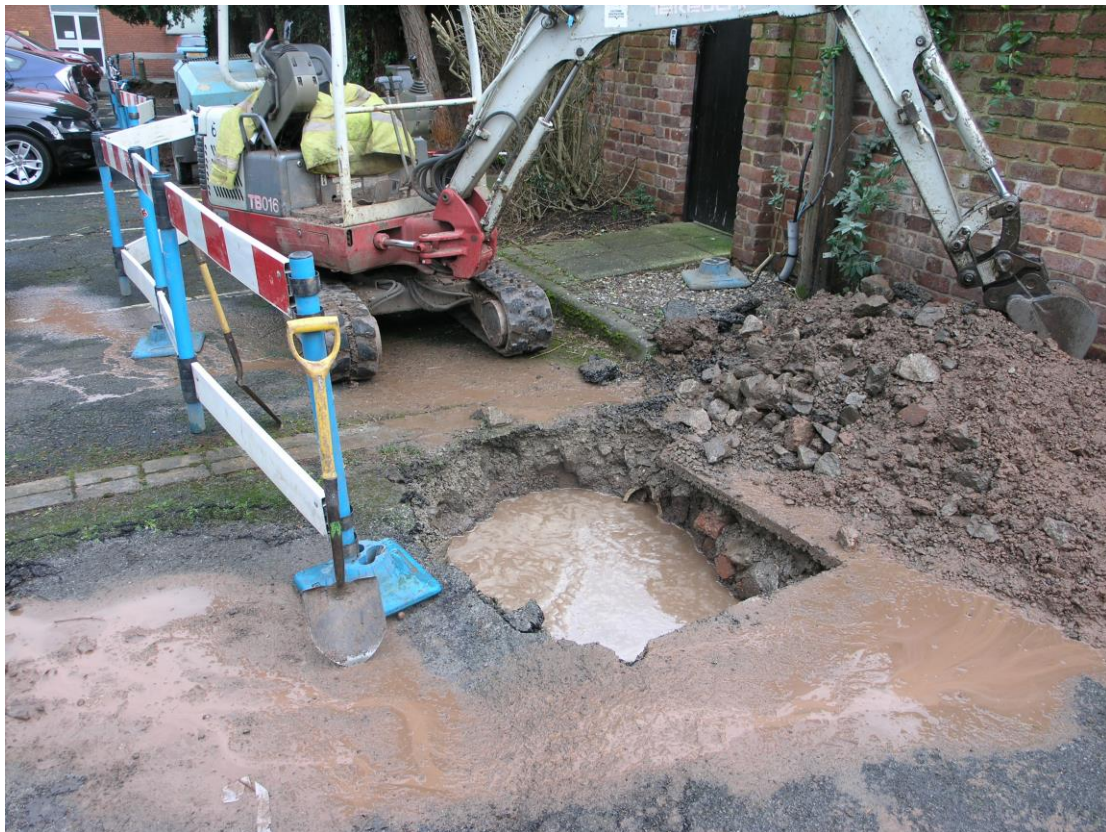
Plate 4: Trench 3 looking north.

Trench 3 was excavated approximately 12m to the south of Trench 2. Immediately after the removal of the tarmac surface, it was apparent that the water leak had had a considerable effect on the underlying deposits. The area immediately to the west of the trench had clearly been undermined by the scouring effect of the water under pressure and this had resulted in sinkage within the tarmac. The western side of the trench collapsed as the water rushed in and whilst the underlying stratigraphy could not be recorded in situ, it was apparent that it comprised of large quantities of brick rubble and comprised modern "made ground".
