A watching brief during the excavation of an Electricity Cable trench at Eastnor Park, Herefordshire.

October 2015

**Herefordshire Archaeology Report No. 355
Event No. EHE 80169**

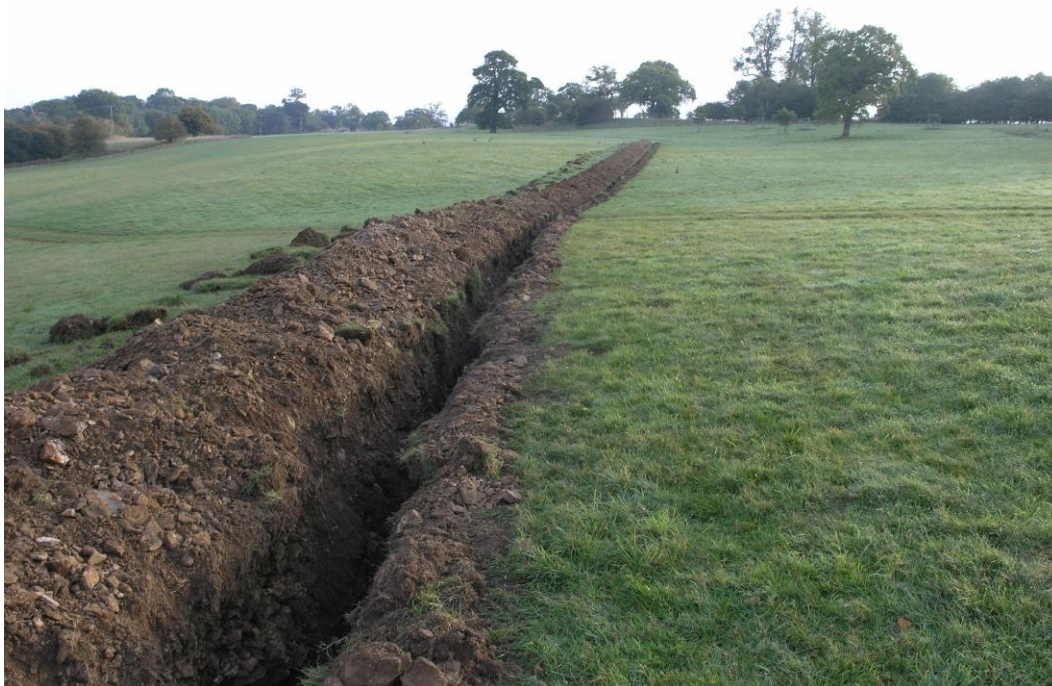
The watching brief comprised a series of five site visits between 28th September and 1st October. The trench was machine cut, measuring 0.35m wide, 1.3m deep and 570m in length. The line of the trench left the track at the base of slope (NGR SO 73537 37783) and ran in a north easterly direction across the slope to NGR SO 73683 37876 at which point it turned to the north-north-east, just below the ridge top to terminate immediately to the west of Park Lodge at NGR SO 73861 38198.

Plate 1. Cable trench looking from the track, upslope to the north-east..

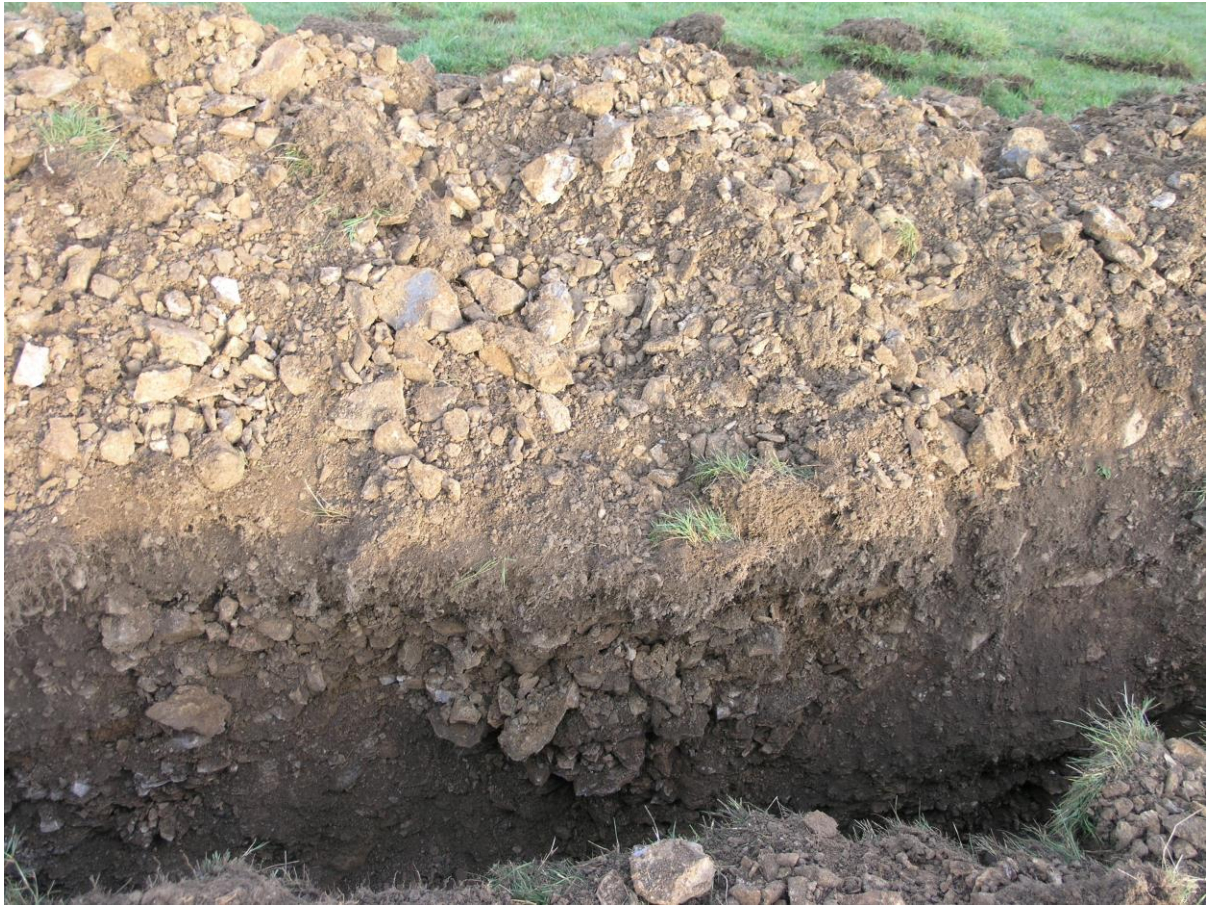
During the process of excavation, it rapidly became apparent that the topsoil comprised a thin, well drained, mid-brown, loam which continued to a maximum depth of 0.25m. This lay directly over a stony and slightly clayey subsoil, the depth of which varied between 0.4m and 1.1m below the present ground surface. This directly overlay a nodular limestone bedrock.

Plate 2: Trench section showing depth of bedrock.

Whilst the trenching observed during the watching brief did not intercept any cut archaeological features, such as ditches, pits or boundary features, it has provided some information concerning the profile of the underlying geology. The fluctuation of the depth of bedrock together with the variation in thickness of the subsoil (between 0.4m and 1.1m) would imply that a substantial degree of “smoothing” of the topography has occurred and that the hill slope was at one time more “stepped” than its current appearance may suggest. This would have made it ideal for its use as arable and/or pasture for the earliest farming communities in Herefordshire during the Neolithic and early Bronze Age. The build-up of subsoil, particularly over the steeper slopes may, in part, be due to this and later (medieval) ploughing which has caused eroded material ploughed from the ridge top to be transported downslope.
