**A Conservation Management Plan for Rotherwas House
Scheduled Area, Rotherwas, Herefordshire.**

**A BASIC MANAGEMENT PLAN
TO ASSIST IN GUIDING THE MANAGEMENT
OF THE MONUMENT**

**Scheduled Monument No. 1014880
NGR: SO 5355 3839
Event Number: EHE80167
Herefordshire Archaeology Report No. 354**

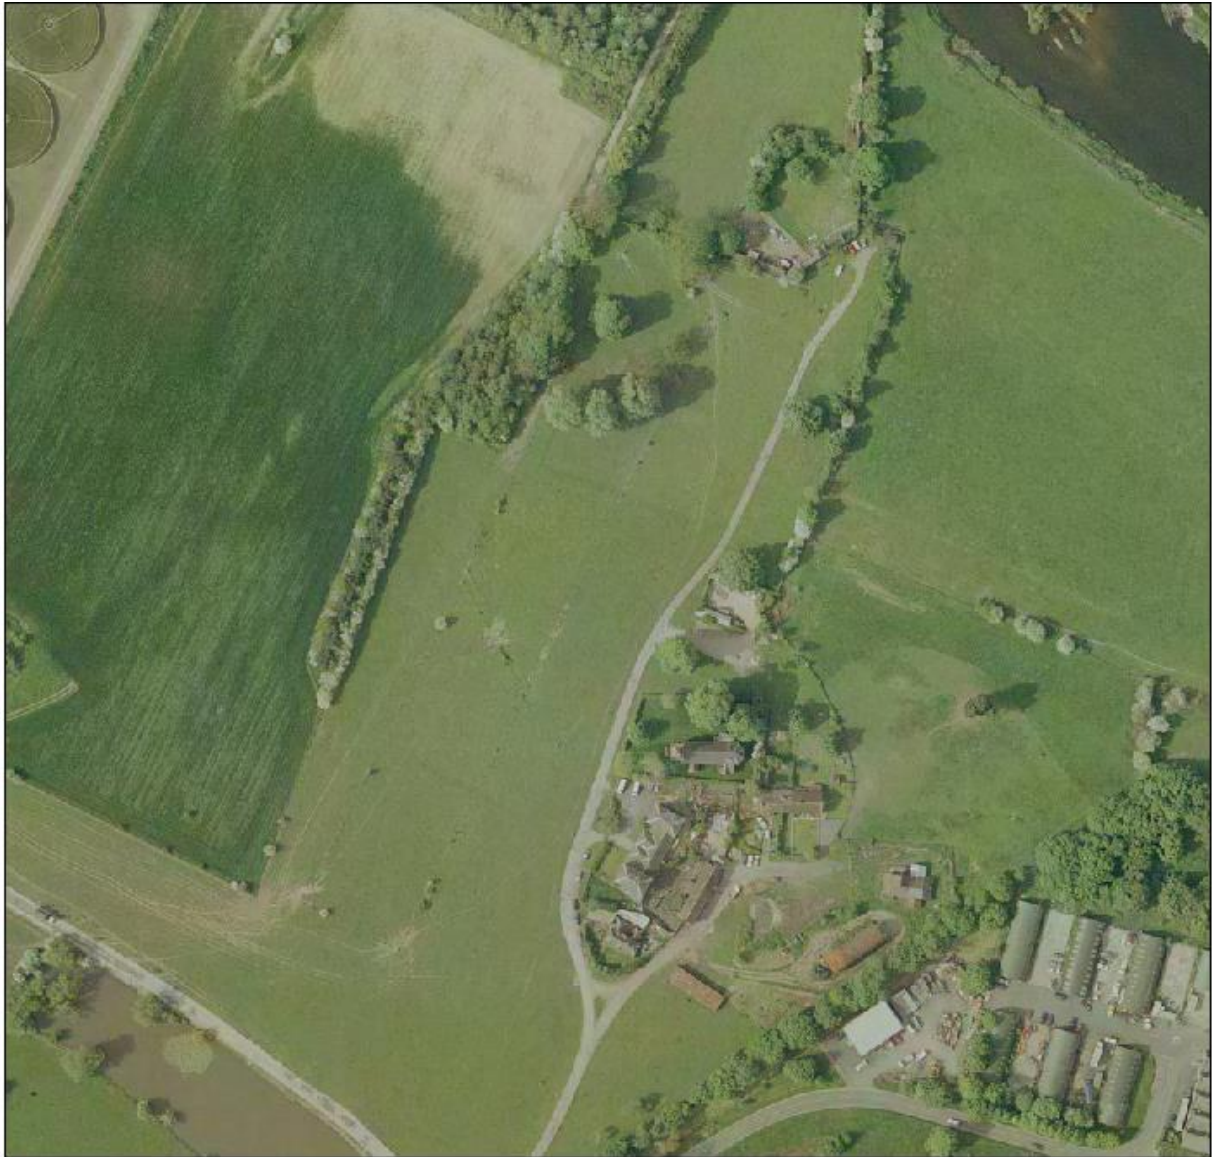
Since being designated as a Scheduled Ancient Monument the entire area has been managed as permanent pasture, the principle , open area being grazed and / or cut for hay whilst the smaller parcels around Rotherwas Chapel and other buildings being mowed at regular intervals. Up until approximately 2007-8 there was no physical boundary on the southern side of the scheduled area, the site apparently still being open parkland (figure 4).

Figure 4: Aerial Photograph of 2000 showing retained parkland and lack of southern boundary to site. © Crown copyright. All rights reserved 100024168.

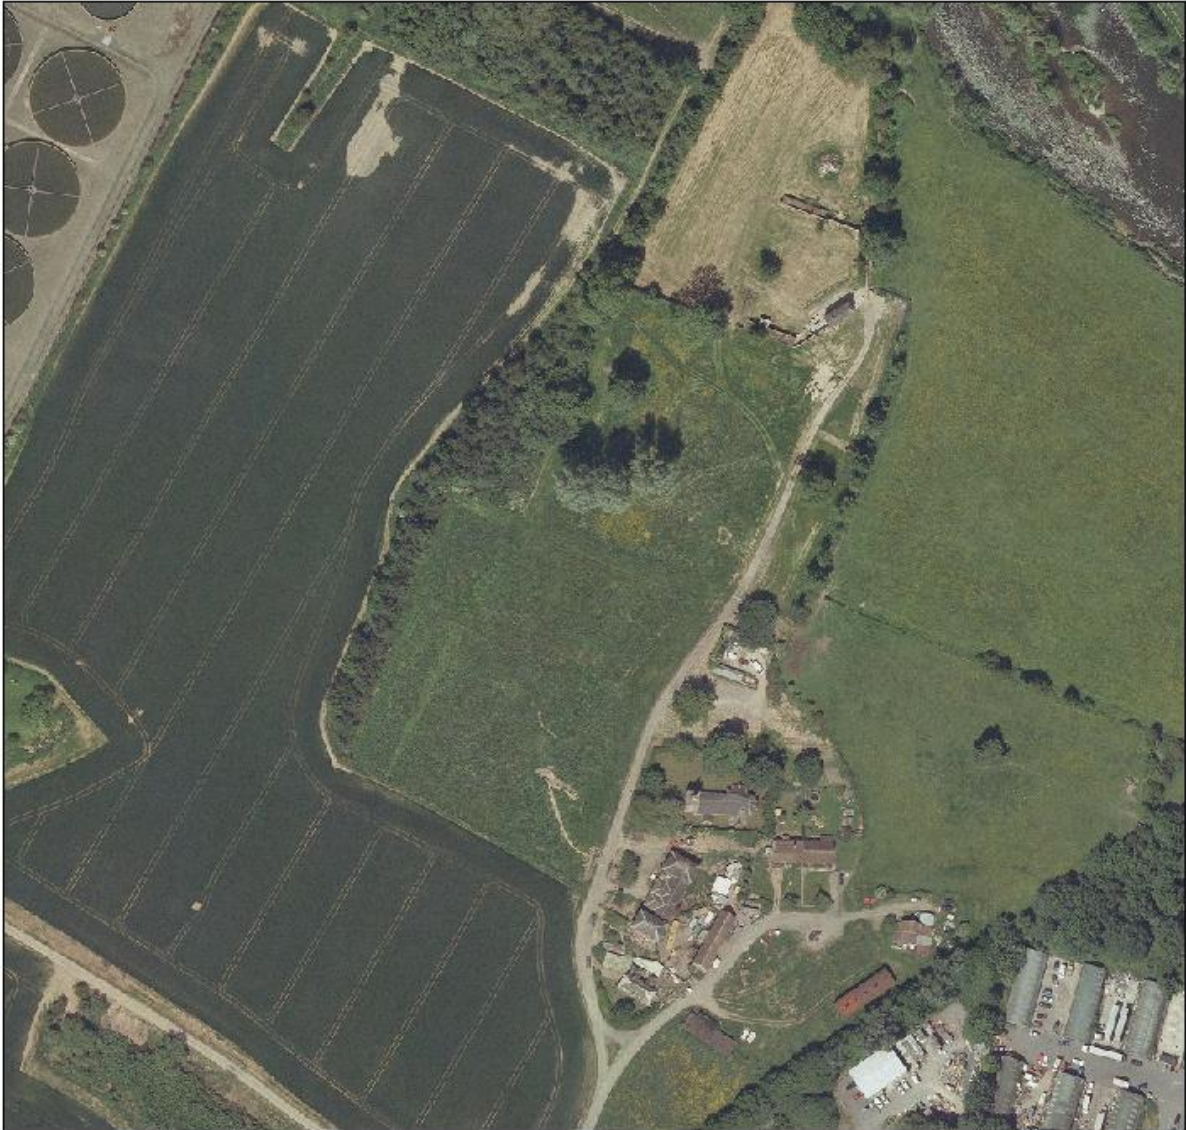
This had changed radically by 2009 (figure 5), by which time a straight fence and hedge had been inserted running from the southern end of the shelter belt in a south easterly direction to the access road. This did not follow the line of the scheduled boundary and effectively cut

off part of the southern, curved, boundary of the scheduled area leaving it in, what in 2009 was a cultivated field. The 2009 aerial photograph also clearly shows the scar associated with the renewal of a water main within the scheduled area. It is understood that the holding, including the scheduled area is currently farmed under an Entry Level Stewardship Scheme.

Figure 5: Aerial Photograph of 2009 showing new, straight southern boundary, parkland under cultivation and scar for a replacement water main. © Crown copyright. All rights reserved 100024168.

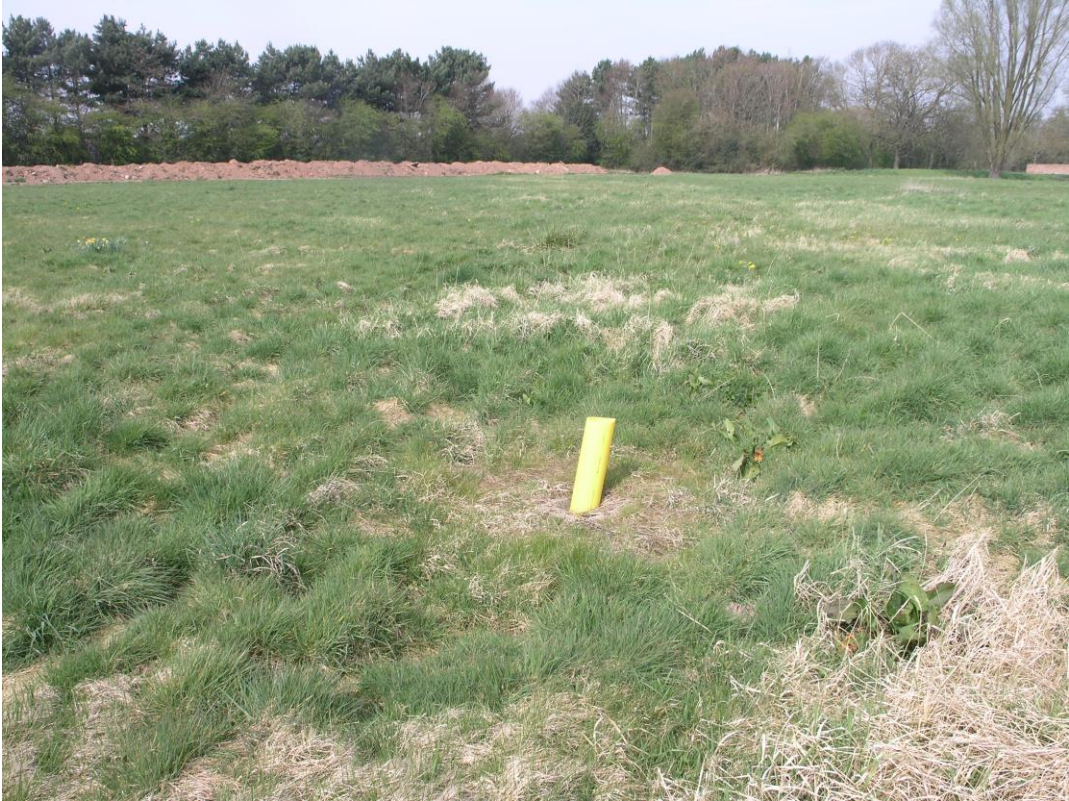
2. The water main terminal close to the south-eastern corner of the scheduled area (Plates 2 & 3). This appears to be contained within a concrete block “box” and has a length of yellow plastic pipe protruding from it, presumably as a marker in order for it to be avoided when mowing.
3. The area of the scheduled monument which has been included within the 2008 / 9 area of cultivation. This represents a small (approximately 8m at its widest point) area of the southern curved boundary to the scheduled area and has been regularly cultivated since 2008, (Plate 4). This includes the insertion of a hedge and post and wire fence line.

Plate 2: Location of 2009 water main terminal within scheduled area.

1. Commission a survey of the two poplar trees in order to ascertain their integrity.
2. Cap or seal water main terminal in order to make it less prominent within the scheduled area.
3. Remove modern hedge and associated post and wire fencing and move the boundary 10m to the south in order that the whole of the scheduled area is under a single and more appropriate, management regime.

The circumstances regarding the water main renewal are, at present unclear. If the renewal involved the removal of the original pipe and the insertion of a new pipe within the original cut this would have had little effect upon the buried archaeology. This however has not been demonstrated.

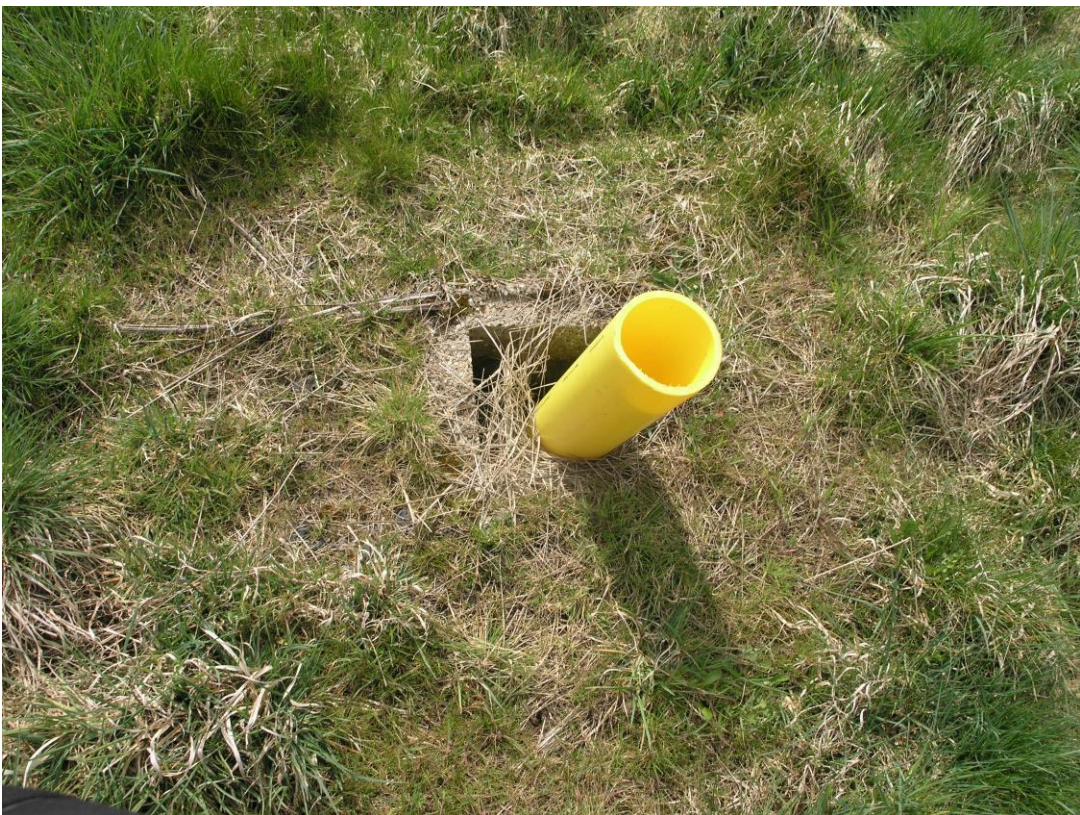
Plate 2: Detail of housing for 2009 water main within scheduled area.

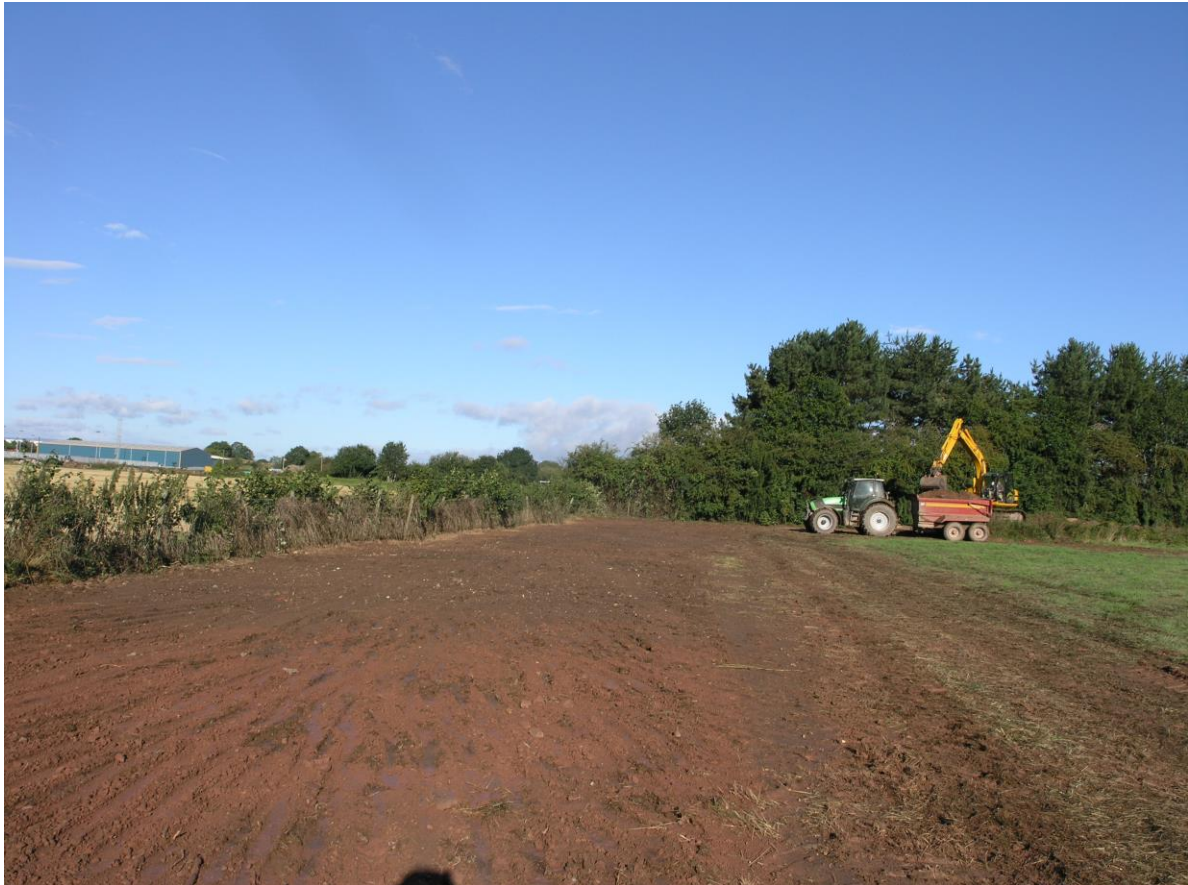
Plate 4: “new” hedge and post and wire boundary (left side of picture) cutting across the southern boundary of the scheduled area.

The removal of the southern boundary hedge and fence line is desirable in order to bring the scheduled area under a single type of management which is more appropriate to the site. Again, the circumstances surrounding the planting of the hedge (approximately 7 years ago), together with the erection of the post and wire fence, are unclear.
