Watching Brief for de-silting works at Lower Brockhampton Manor House, Lower Brockhampton Estate, Bromyard.

**Herefordshire Archaeology Report No. 349
Event No. EHE 80123**

**Watching Brief for de-silting works at Lower
Brockhampton Manor House, Lower Brockhampton
Estate, Bromyard.**

**Monument No: 4894
NGR: SO 6874 5590
Event Number: EHE 80123**

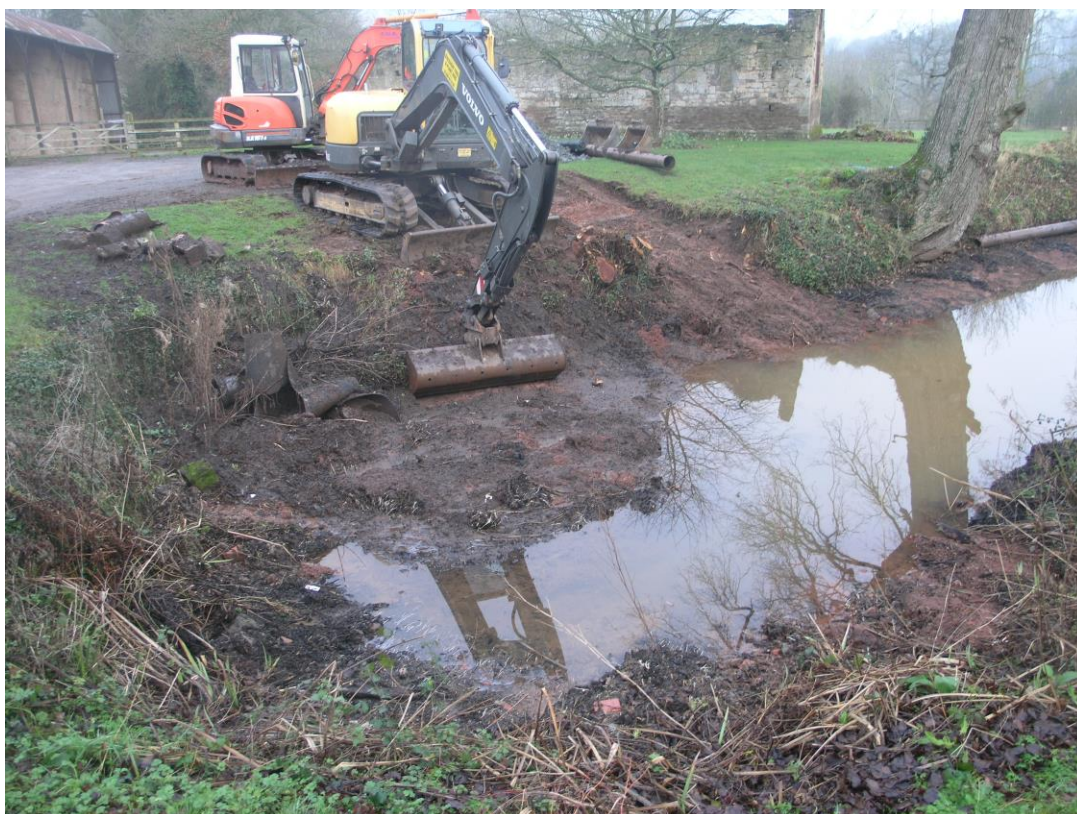
Access into the moat was created by cutting a 2.5m wide ramp (plate 1), into the moat close to the south-western terminal. Within the cut for the ramp were two stones running parallel to the moat edge. These appear to be aligned with the stone built wall, recorded in 2012, which encloses the western terminal of the moat. Investigations suggested that both stones were laid onto the top of the clay subsoil at a depth of 0.35m below the present ground surface. No evidence of mortar or any other bonding material was recorded and no additional stonework was encountered beneath them. It is possible that these represented the base footing for a dry stone wall, however if this were the case it has been heavily robbed and damaged by tree roots. The stones were clearly not associated with the well-built and mortar bonded wall recorded in 2012 and must have therefore belonged to a far less substantial structure.

Plate 1: Access ramp cut into western bank of moat close to south-western terminal.

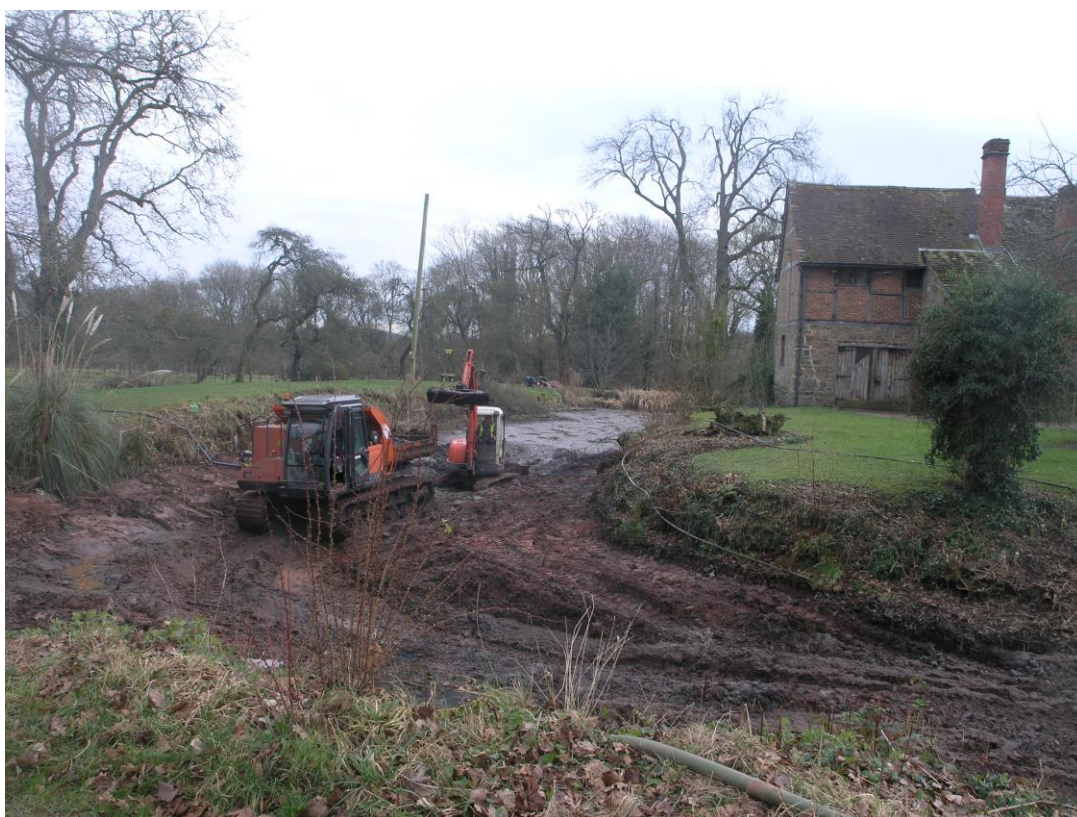
Plate 2: General view of drained moat long east.
Description of the moat

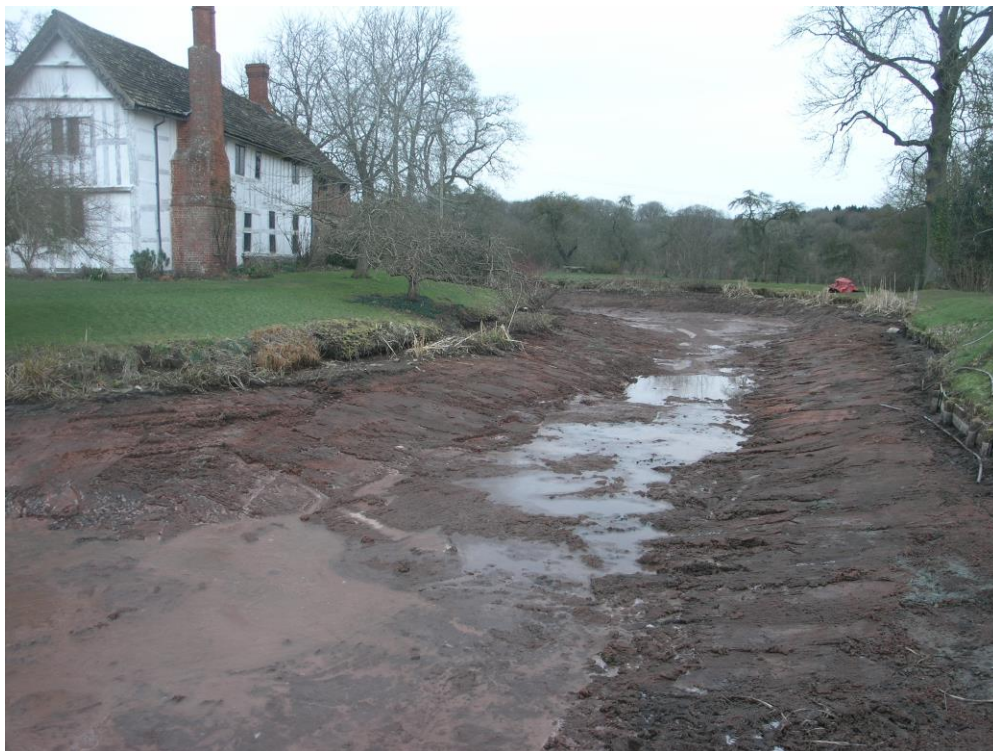
The de-silting progressed from the south-eastern end of the moat in an easterly direction. It rapidly became clear that the moat profile was not uniform. The initial clean of the moat began to confirm the moat as being wide but shallow, similar in profile to other, no defensive moats (such as the moat at Ford Abbey Farm, Puddleston). However, the 2012 Assessment Report had recorded a “drop off” within the eastern arm of the moat suggesting that this represented either the original moat edge on the eastern side or that the moat profile was narrower and deeper originally. It appears that the recorded drop off represented the cut for a channel which runs along the centre of the entire moat. (plates 3 to 6 and figure 2). The channel is approximately 3.5m wide and 0.8m deep, cut into the clay / marl subsoil and is roughly central to the course of the moat.

Plate 3: Moat after de-silting looking west showing central channel.

The channel widens to approximately 5m within the eastern arm of the moat before narrowing to under 3m as it approaches the gatehouse. The side of the channel are cut to an angle of approximately 40 degrees, compared to the 15 to 20 degrees angle of the shallower moat cut.

The silt from within the channel was directly comparable with that from the sides of the moat and this, together with the shape and dimensions of the channel, particularly the fact that it widens and narrows as the moat widens and narrows, may suggest that this was excavated during the 1980's de-silting in an attempt to deepen the moat and increase the volume of water within it.

The channel running along the centre of the moat may well be of modern date. Its uniform profile and flat base is suggestive of machine cutting as is the fact that it widens and narrows with the present shape of the moat.

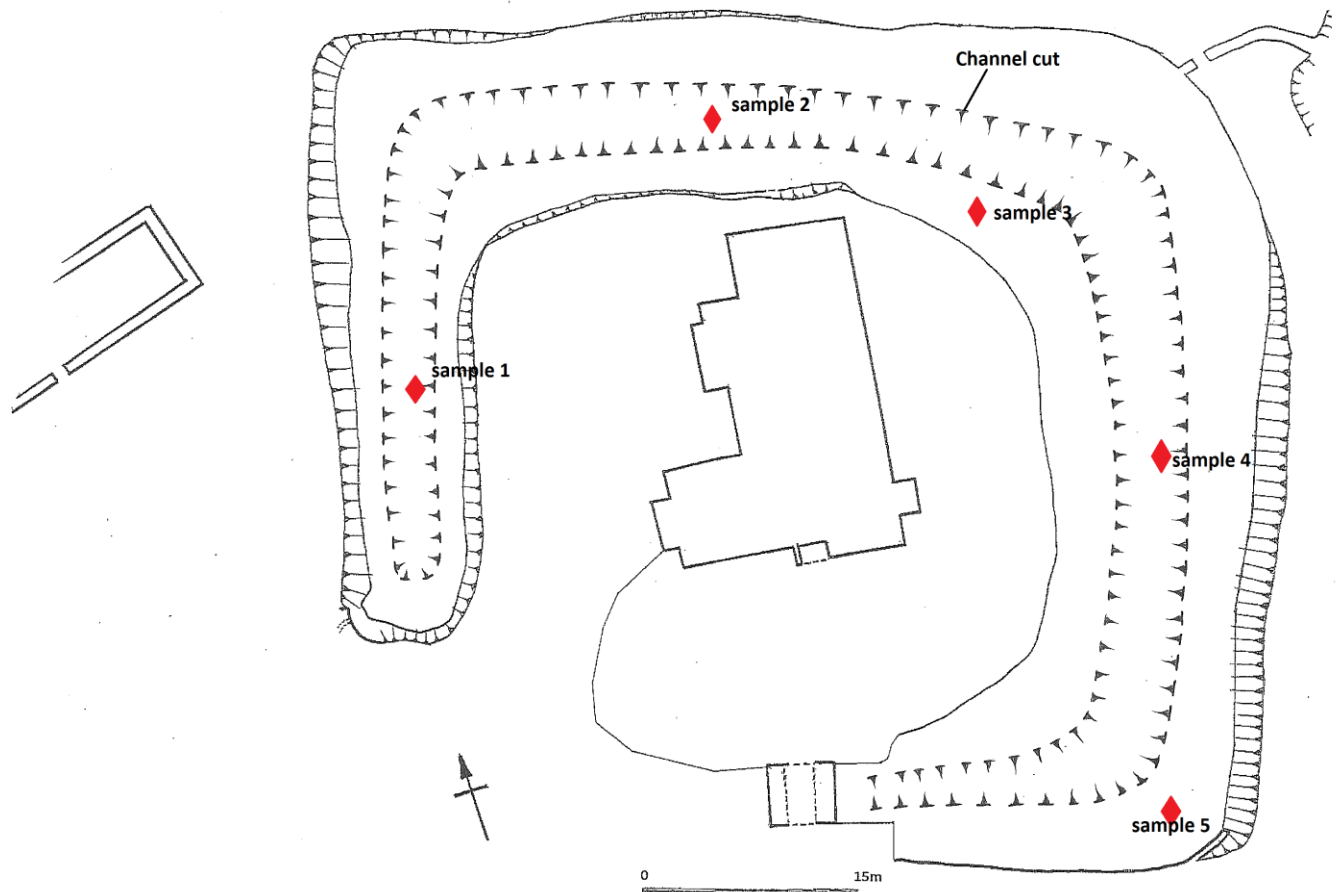
Figure 2: Plan showing extent of channel cut and locations of environmental samples

The samples were taken from five different locations within the moat, (see figure 2). Sample 1 was taken from the top of the silt within the western arm of the moat. Sample 2 was taken from the base of the channel roughly midway along the northern portion of the moat. Sample 3 was taken close to the inner bank at the north-eastern corner of the moat. Sample 4 was taken from within the channel roughly midway along the eastern arm of the moat. Sample 5 was taken from the eastern side of the moat close to its south-eastern corner.

There was little variation in the material from the sieved and cleaned samples. Much of each sample comprised a very fine organic (vegetable) deposit consistent with having been passed through the digestive system of waterfowl. The larger environmental fragments (apparent within all five samples), were identified as the leaf, stem and seeds of the Greater Reed mace, (*Typhaceae*), leaf and stalk fragments of Waterlily, (*Nymphaeae*) and Flag Iris, (*Iris pseudacorus*), small fragments of Canadian pondweed (*Elodea canadensis*) and Rigid Hornwort, (*Ceratophyllum demersum*), leaf and bark of Oak, (*Quercus*), Ash, (*Fraxinus*) and Damson, (*prunus*). Samples 1 and 2 contained small quantities of ash / charcoal. Sample 2 contained the lower jaw of a mouse / vole whilst a scale from a common carp was recovered from sample 5. Artefactual evidence comprised 3 modern wire nails (rusted together) from sample 2 and an 18th century clay pipe bowl from sample 3. The pipe bowl was badly abraded and obviously not stratified.

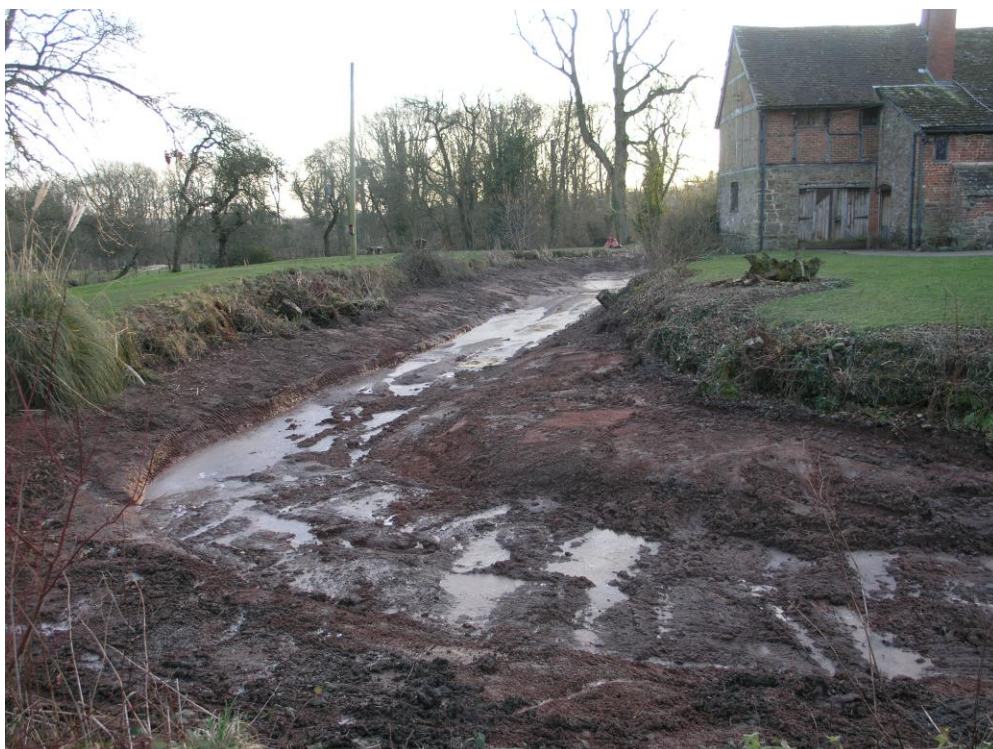
Plate 4: Moat after de-silting looking north-east.

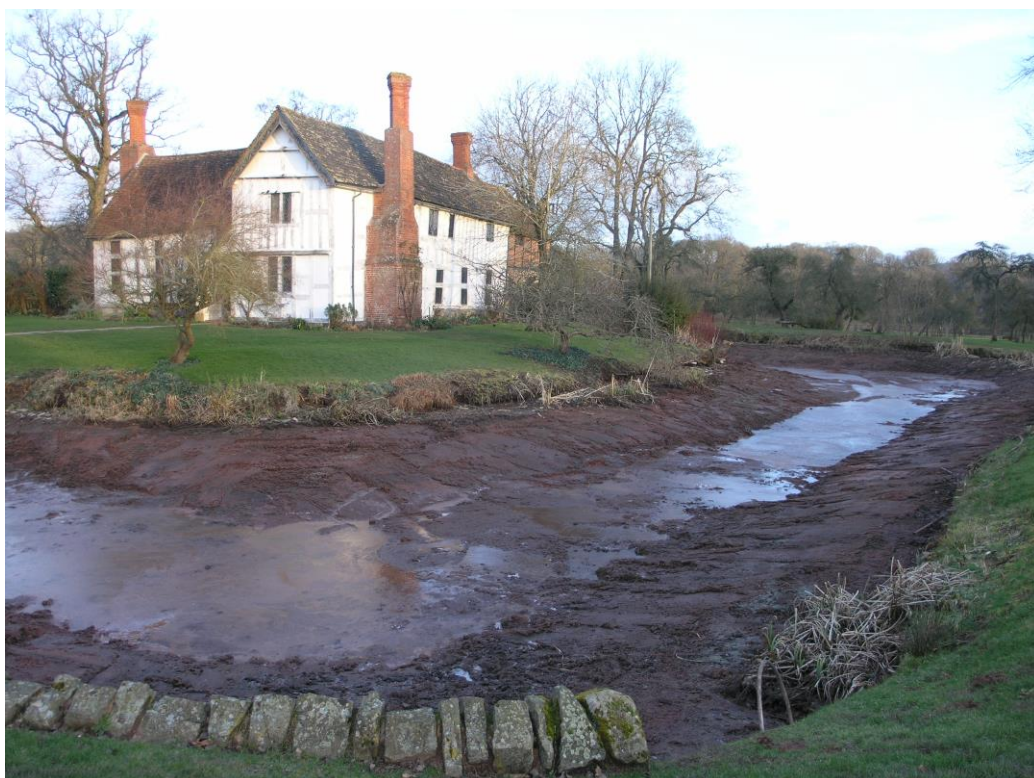
Plate 5: Moat after de-silting looking north-west.

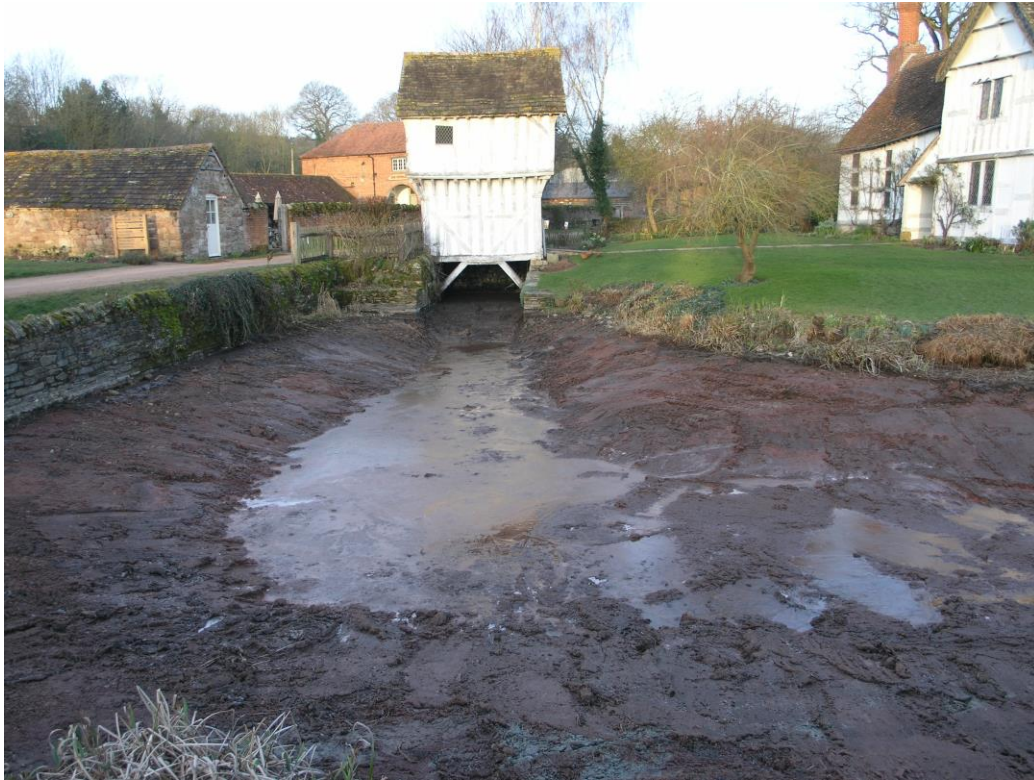
Plate 6: Moat after de-silting looking west.

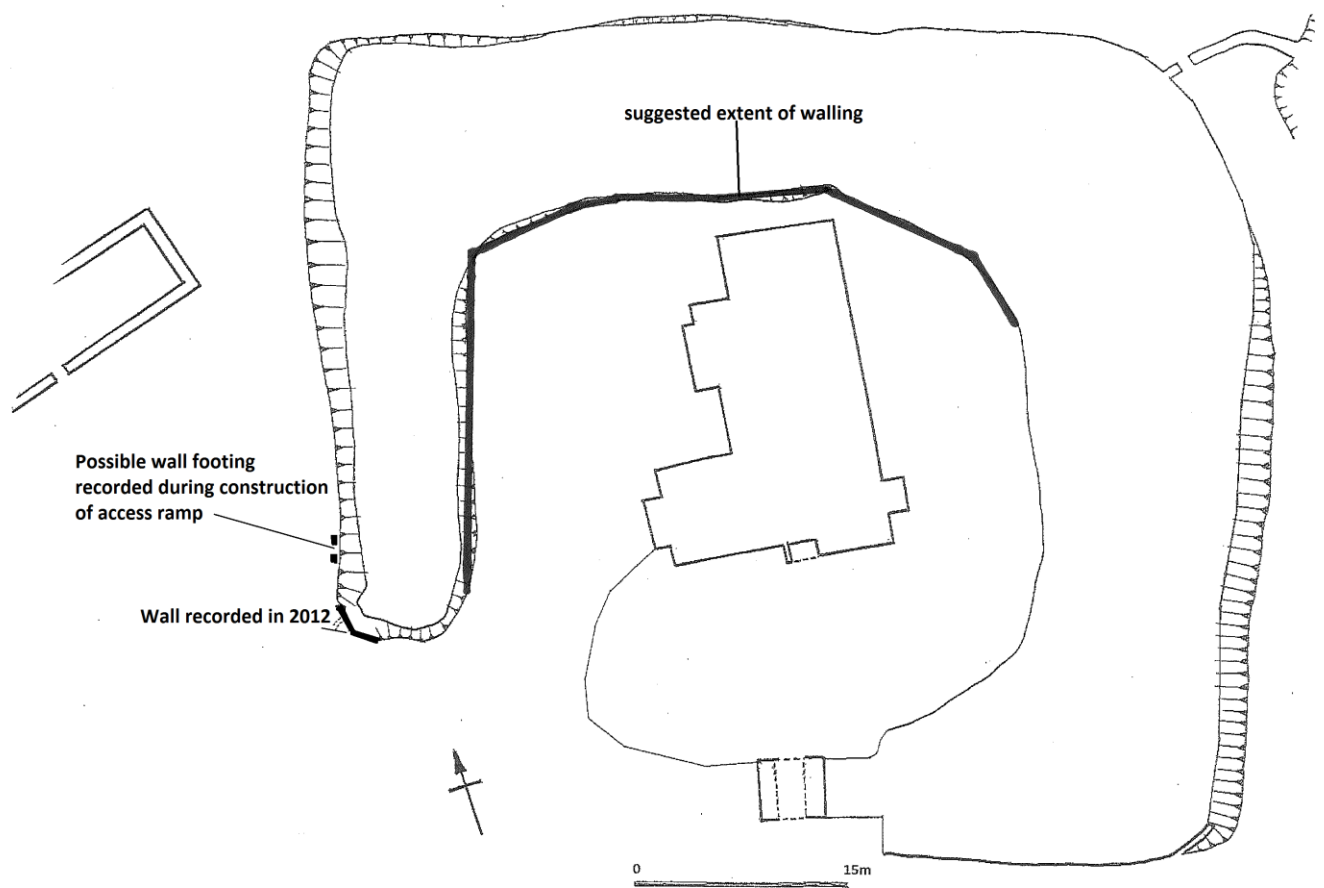
In addition to the possible wall line recorded during the cutting of the access ramp, the remainder of the internal and external edges (banks) of the moat were inspected for evidence of walling and / or revetting. The 2012 assessment report suggested that a stone wall had existed along the inner bank of the northern part of the moat. This has been confirmed during the de-silting works and it is now strongly suggested that a stone wall ran from the north-east corner of the inner bank of the moat right along the northern inner bank and continued round to the south western terminal (Figure 3), possibly linking up with the section of walling recorded during the 2012 Assessment. Whilst there is not the quantity of stone which would be expected to indicate a collapsed wall over this distance, enough "occasional" fragments both within the bank and at the base of the bank to indicate its extent with some confidence.

Figure 3: Plan showing the suggested extent of stone wall around inner bank of the moat, the light wall footings recorded within the cut for the temporary access ramp and the extent of walling recorded during the 2012 assessment.

The watching brief has provided some useful information which goes some way to confirming the extent of walling / revetting around the internal bank of the moat and has suggested that a less structural wall once ran along the top of the outer bank of the western arm of the moat. It is suggested that the walling which must have collapsed into the moat from the northern and western internal banks was either removed for use elsewhere or removed during the earlier instances of moat cleaning / de-silting.
