# **Evaluation Excavation in advance of a pipe trench, Croft Castle, The Croft Estate. Herefordshire**

**Herefordshire Archaeology Report No. 338**

**NGR: SO 449 655  
EHE 80015**

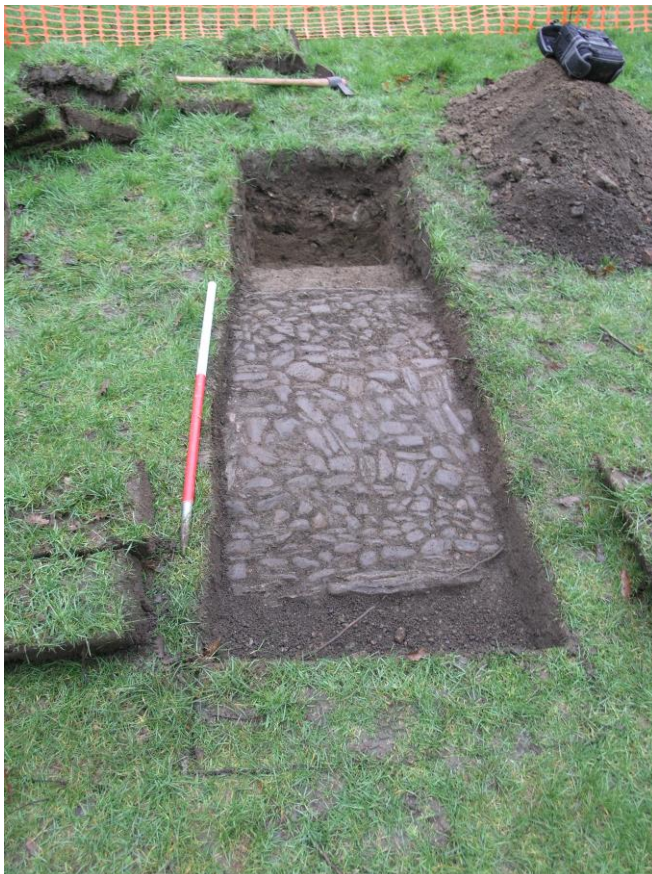
Plate 1: Trench 1, looking west, showing the cobbled path overlying the 19<sup>th</sup> century pipe trench.

After discussions with the National Trust's Project Manager it was agreed that the width of the 19<sup>th</sup>-century pipe trench should be revealed in order to confirm that the new heat pipe run could be accommodated within it. A 3m long by 0.75m wide trench was laid out perpendicular to the line of the service trench. Upon the removal of the turf a 1.4m wide, cobbled path was apparent, (Plate 1). This comprised a well laid stone set path with vertical stone kerbing which appeared to run directly between the doorway into the walled / kitchen garden and the cobbled path which leads through the shrubbery to the east front of Croft Castle.

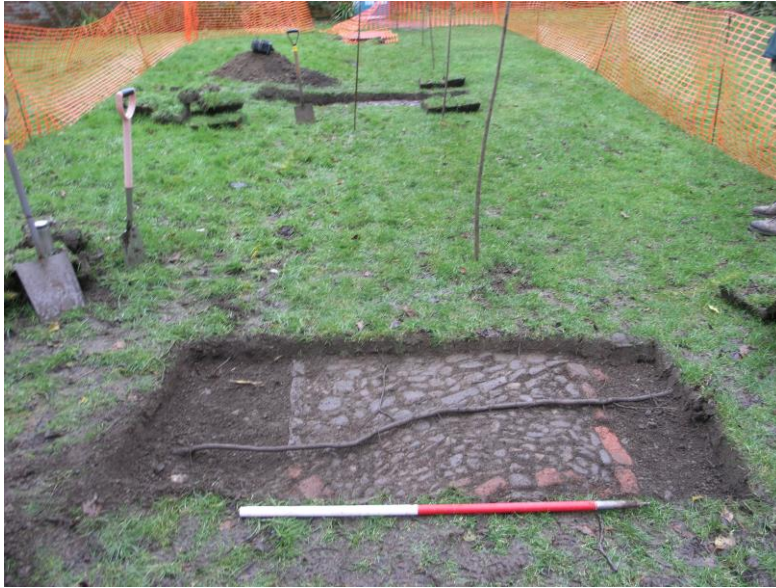
Plate 2: Trench 2 showing the cobbled path overlying the 19<sup>th</sup> century pipe trench. Note the brick within it's construction.

To confirm the presence / survival of the rest of the course of the path a second trench was excavated approximately 8m to the south of trench 1. The location of the second trench was chosen to coincide with the point at which a service drain, (identified by the service scan) runs through or under the likely route of the path. Trench 2 also contained the cobbled path, (Plate 2). In part the stone kerbing had been replaced by brick and brick fragment formed part of the metalled surface of the path. The use of brick coincided with the line of the service drain which runs diagonally on a north-east / south-west axis and suggests that the path was disturbed during the laying of the drain and then re-built using a mixture of bricks, original cobbles and brick fragments.

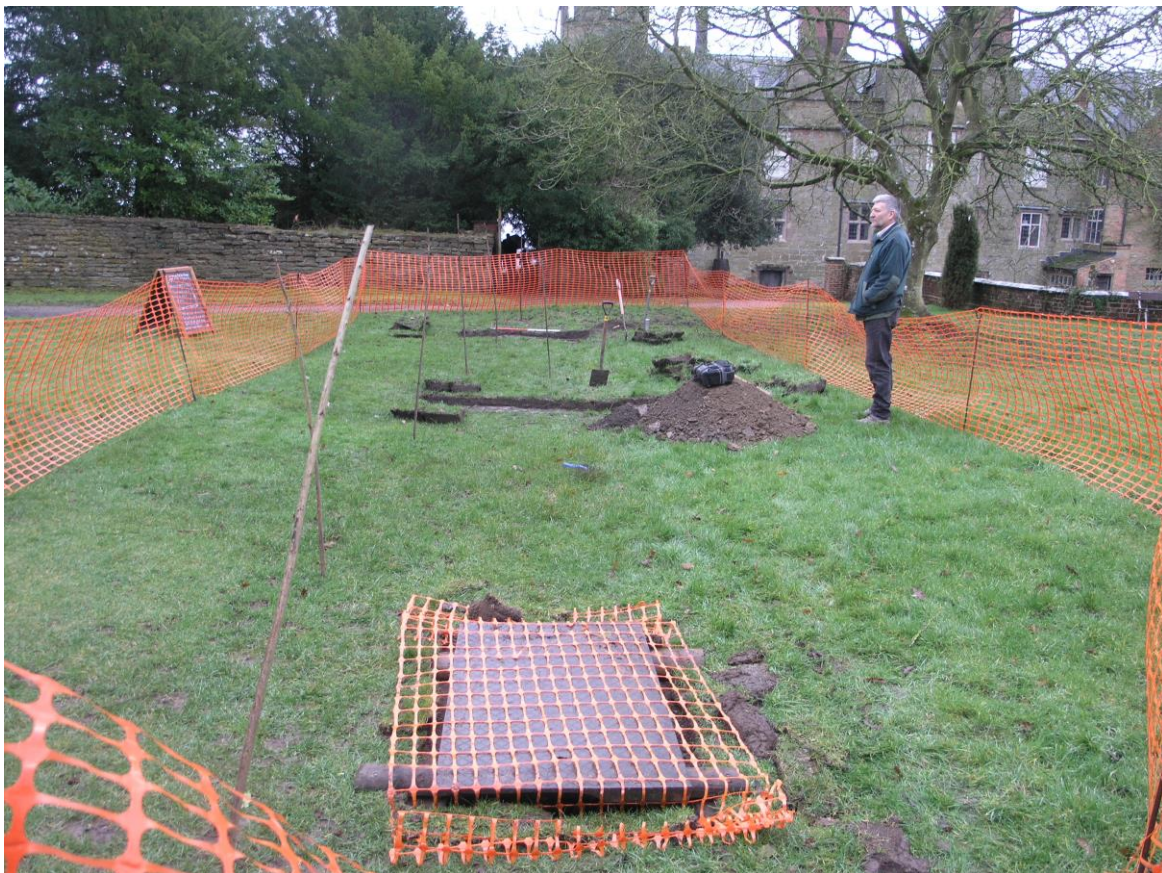
Plate 3: Line of trench / path looking south showing the drain inspection lid in the foreground.

It is understood that the National Trust had planned to construct / re-instate a pathway on the line of the existing cobbled path. It was therefore decided to re-route the new pipe trench so that it ran along one side or other of the existing cobbled path. Test pits were excavated either side of each exposed section of path in order to sample and record the underlying stratigraphy.

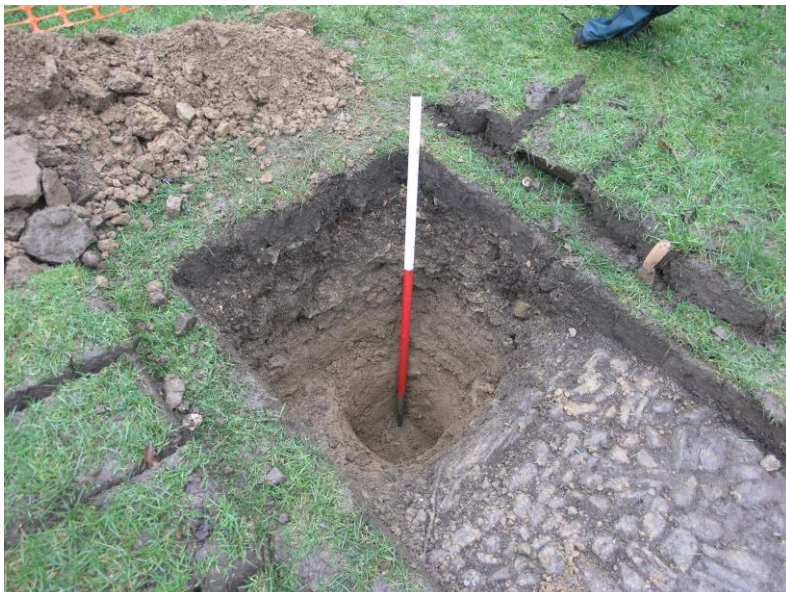
Plate 4: Eastern end of trench 1 showing sondage through re-deposited natural.

The sondage within the eastern end of Trench 1, (Plate 4), was excavated to a depth of 1.0m and appears to comprise a very well compacted but re-deposited mix of natural clay and bedrock, containing occasional charcoal fragments. It is suggested that this represents the fill of the 19<sup>th</sup>-century service trench.

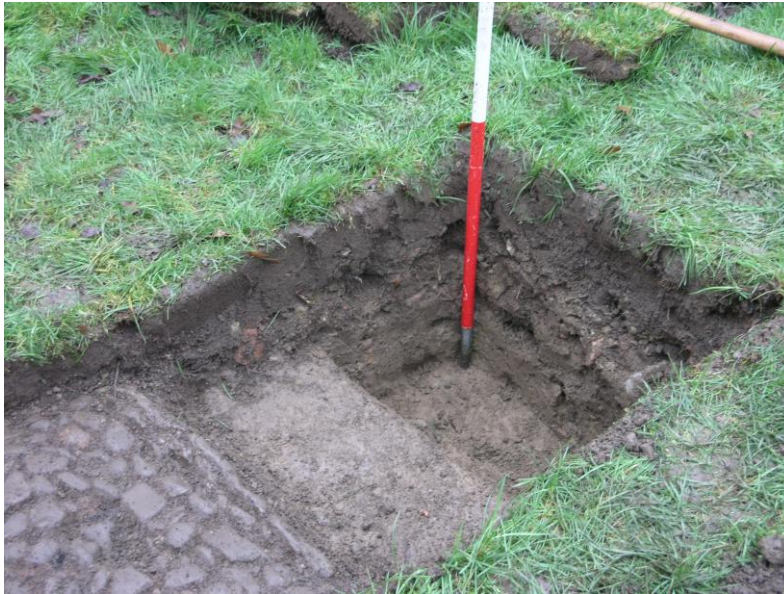
Plate 5: West end of Trench 1 showing sondage into natural subsoil.

Four sondages were excavated. The sondages at the western ends of Trench 1 and Trench 2, (Plate 5 and Plate 7), contained a 0.25m thick layer of dark, loamy earth containing ash and small stones. It is suggested that this represents a deposit associated with a flower bed. This directly overlay a clay sub-soil which became more compact and stoney with depth.

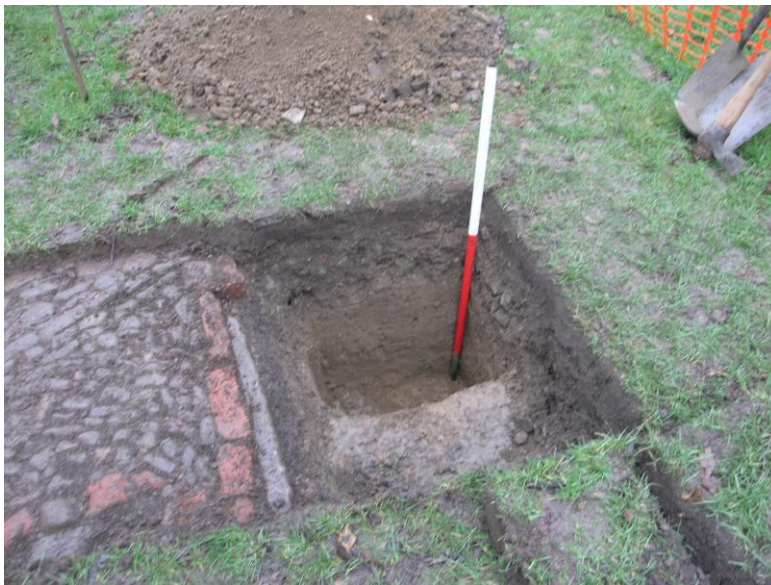
Plate 6: Eastern sondage within Trench 2, showing re-deposited natural within service trench.

The sondage within the eastern end of Trench 2, cut through a similar, re-deposited natural, (Plate 6). This was the compacted fill of the pipe trench which runs on a north-east / south-west axis from Stable Cottage.

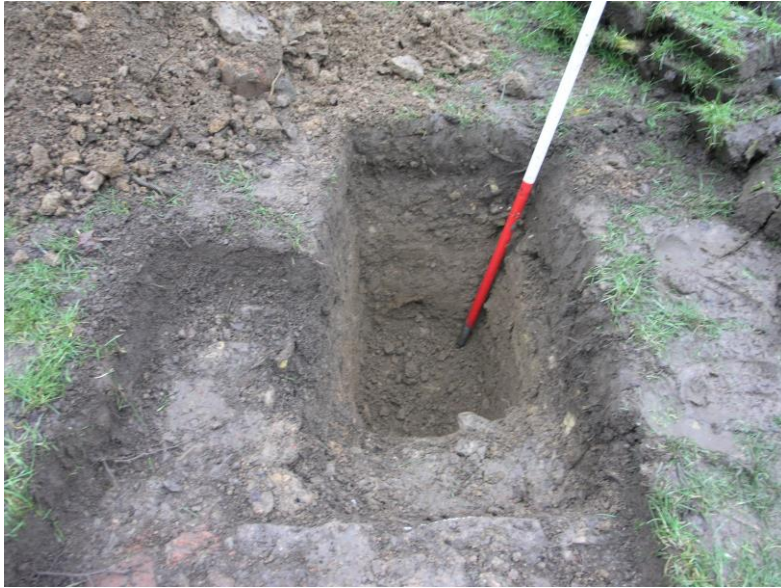
Plate 7: The western end of Trench 2, showing sondage into natural subsoil.
