An Archaeological Watching Brief at Lower Brockhampton Manor House, Bromyard, Herefordshire

Herefordshire Archaeology Report No. 321

**NGR: SO 6874 5590
EHE 2066**

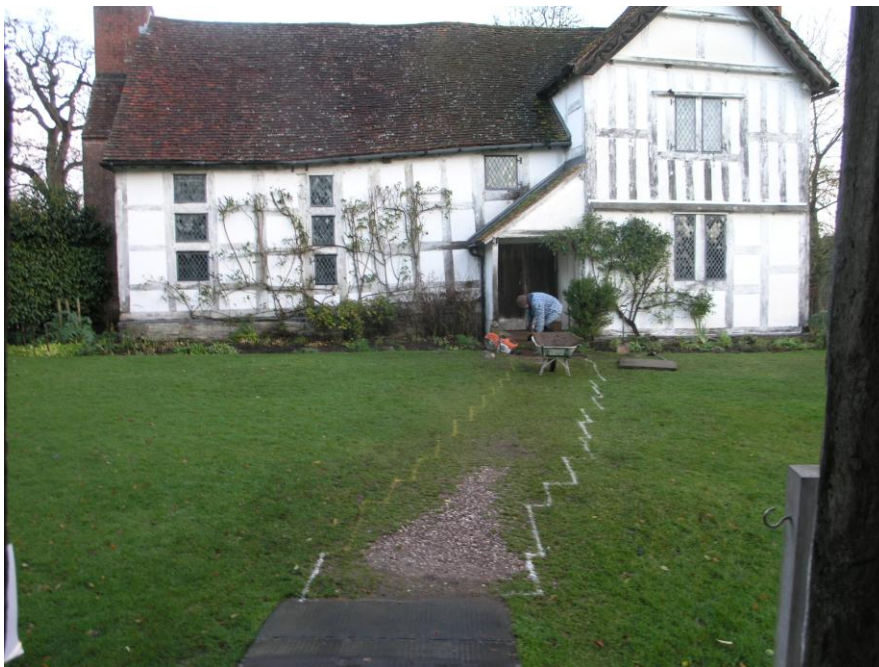
Plate 1: Layout of paving pattern.

The edges of the paving for the path were laid out and cut using a petrol disk cutter in order to cut through the plastic re-enforcing net within the turf. (Plates 1 & 2). The turf was then cut into sections using the disc cutter before being removed from site. Once the turf was stripped a further 0.10m of material was removed in order to provide sufficient depth to bed the flagstones. A gap of approximately 0.1m was left between each stone and turf was placed within these gaps.

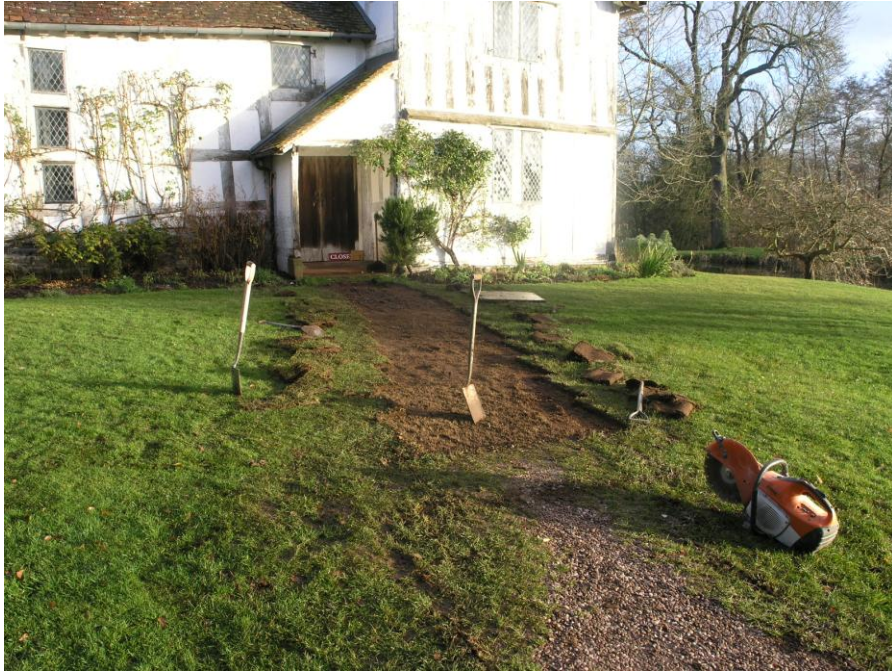
Plate 2: The path under excavation

The excavation was carried out by hand to a maximum depth of 0.15m below the top of the turf. The excavated material comprised a 0.02m layer of pea gravel immediately below the turf which overlay a 0.05m thick layer of well mixed, loamy soil. Immediately below this was a layer of brick and stone rubble. This layer was not completely excavated – only the larger fragments of rubble being removed to provide a flat surface onto which to bed the flagstones.

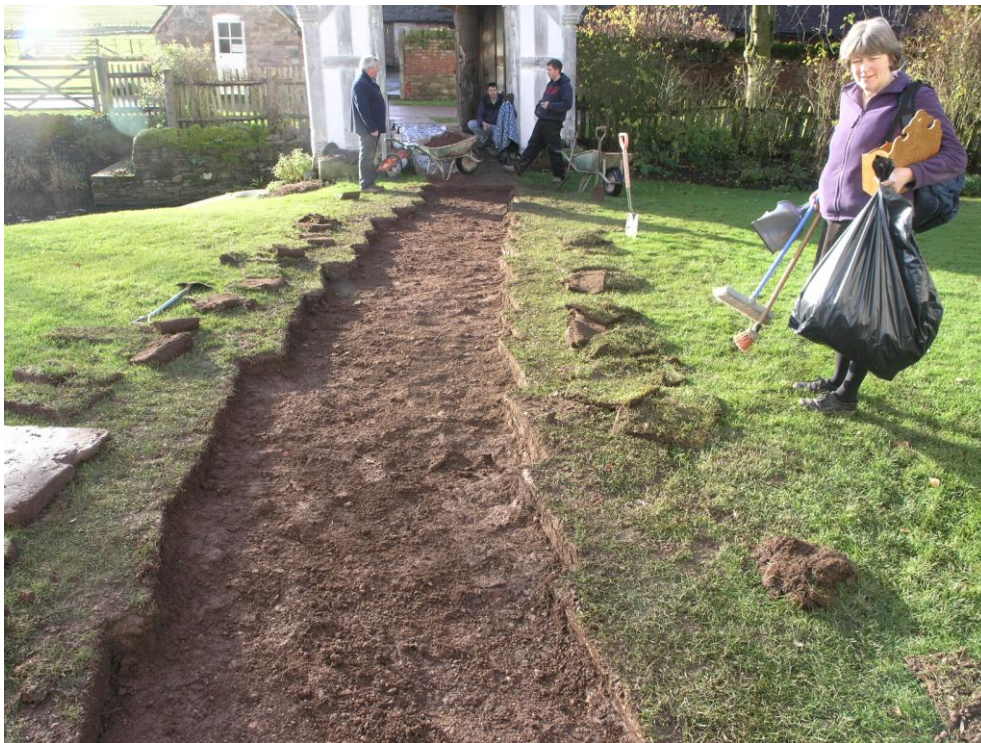
Plate 3: The excavation completed prior to the laying of mortar and flagstones.

The excavations for the path did not reach sufficient depth to impinge upon deposits / features of archaeological significance. The building rubble layer has been identified (Hoverd & Williams 2011) as rubble associated with the 1952 renovation of the manor house. The 2011 suggested that this rubble layer had purposefully been deposited to provide a well drained base for the pea gravel path. This was confirmed by the excavation for the new path which showed that the rubble deposit continued along the entire length of the excavated strip for the new path.
