Hereford city defences a conservation management plan

Part two: Gazetteer

Herefordshire Archaeology Report 292

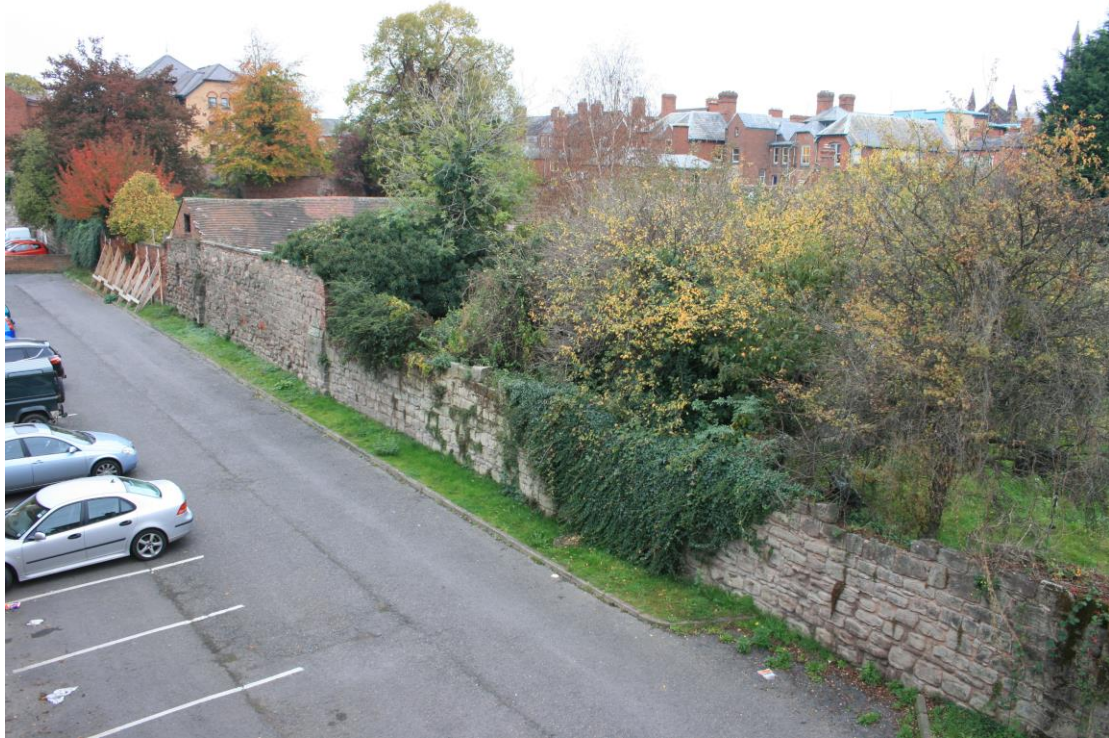
General view of the south end of section 1

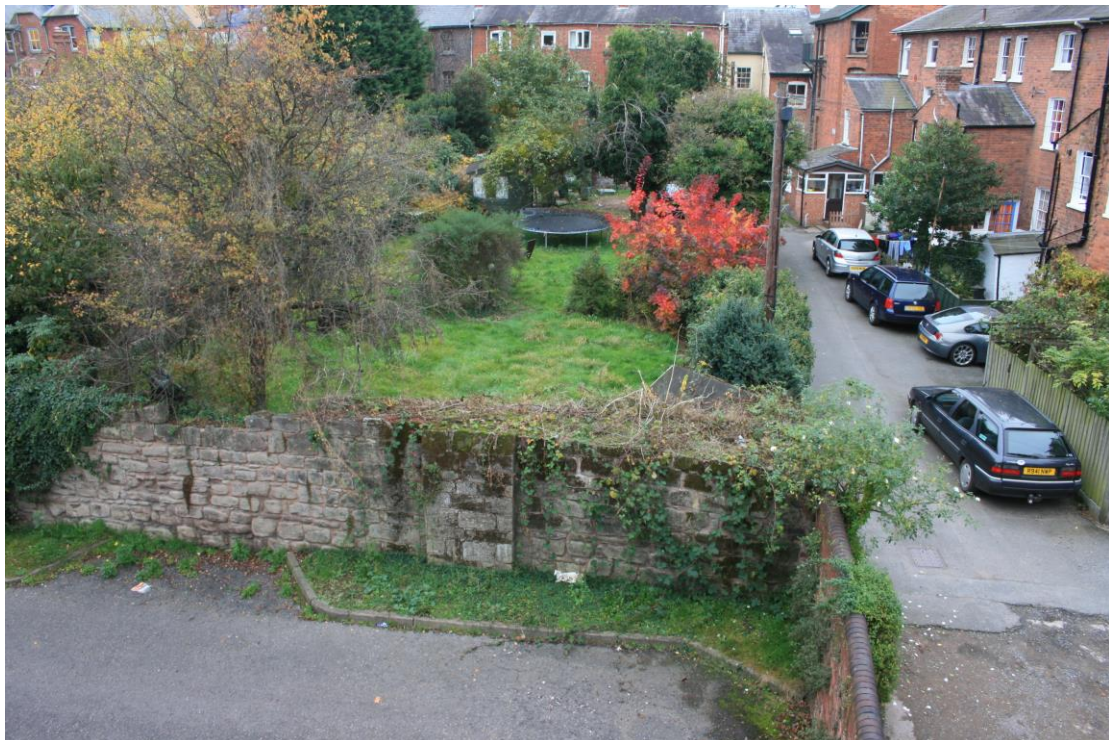
The southern termination of the free-standing buttressed stretch of section 1 behind Wye Terrace

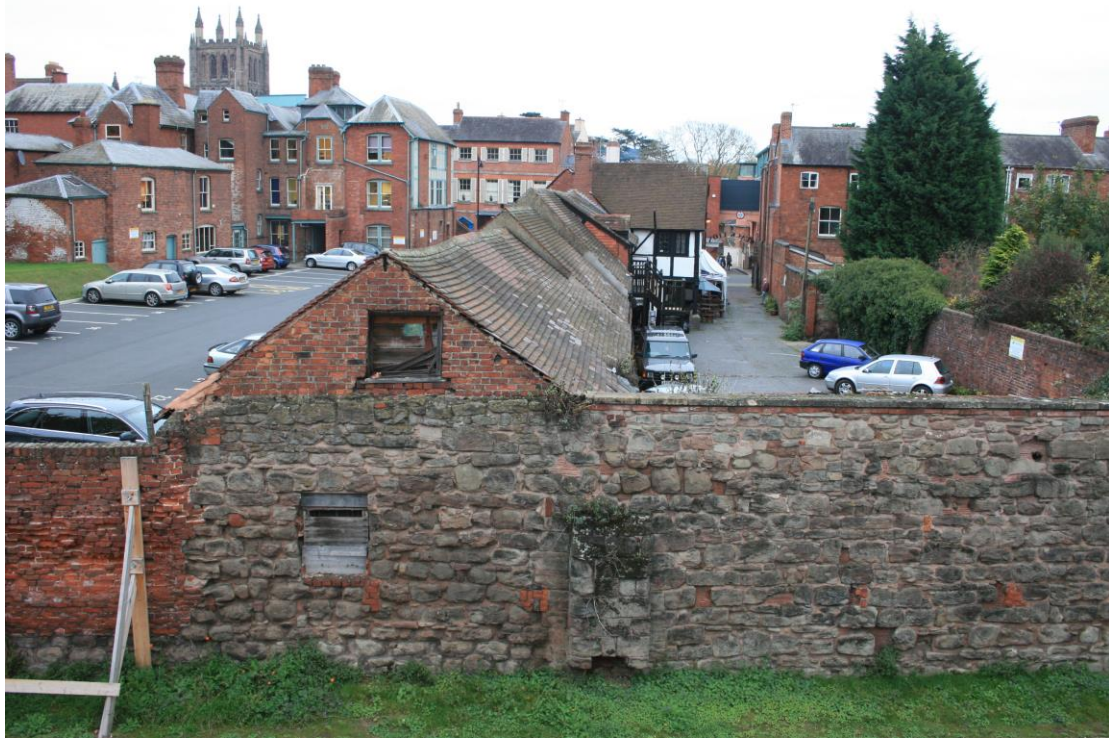
The section 1 wall at the rear of the Black Lion pub on Bridge Street

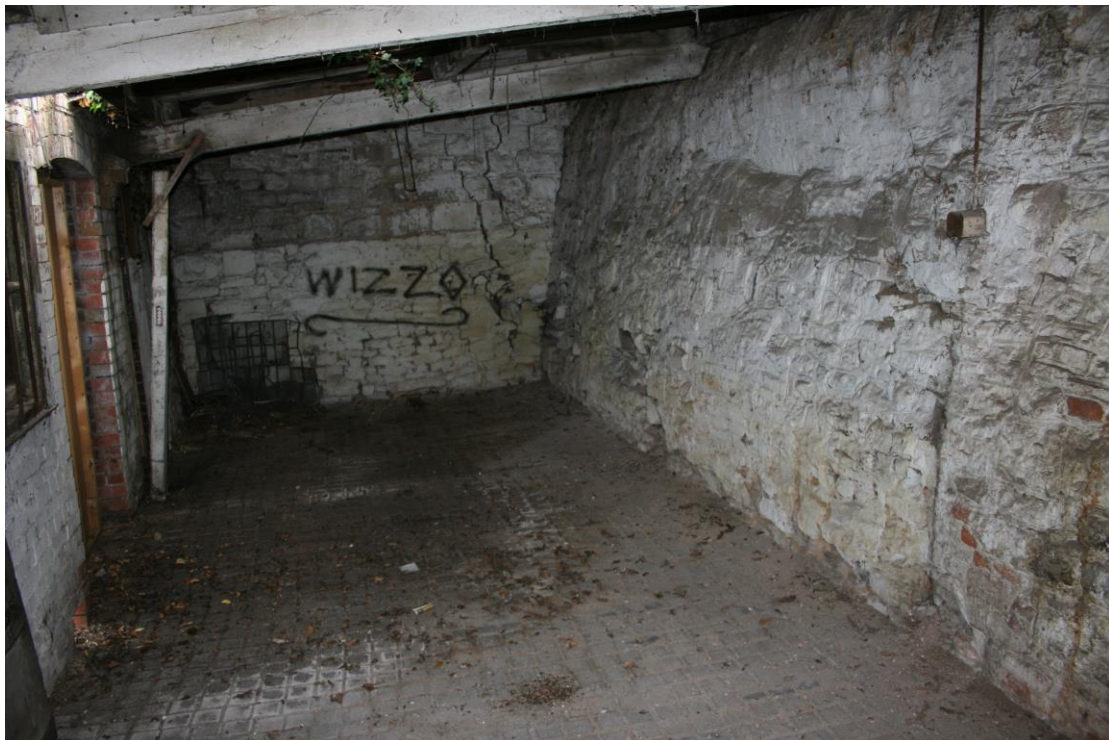
Interior (east) face of the wall in the Black Lion outbuildings

The interior face of the wall within the Black Lion's outbuildings, built along the wall, is currently neglected within the empty outbuildings, parts of which are in poor condition. The owners should be encouraged to make more of the city wall as a historic feature of the property

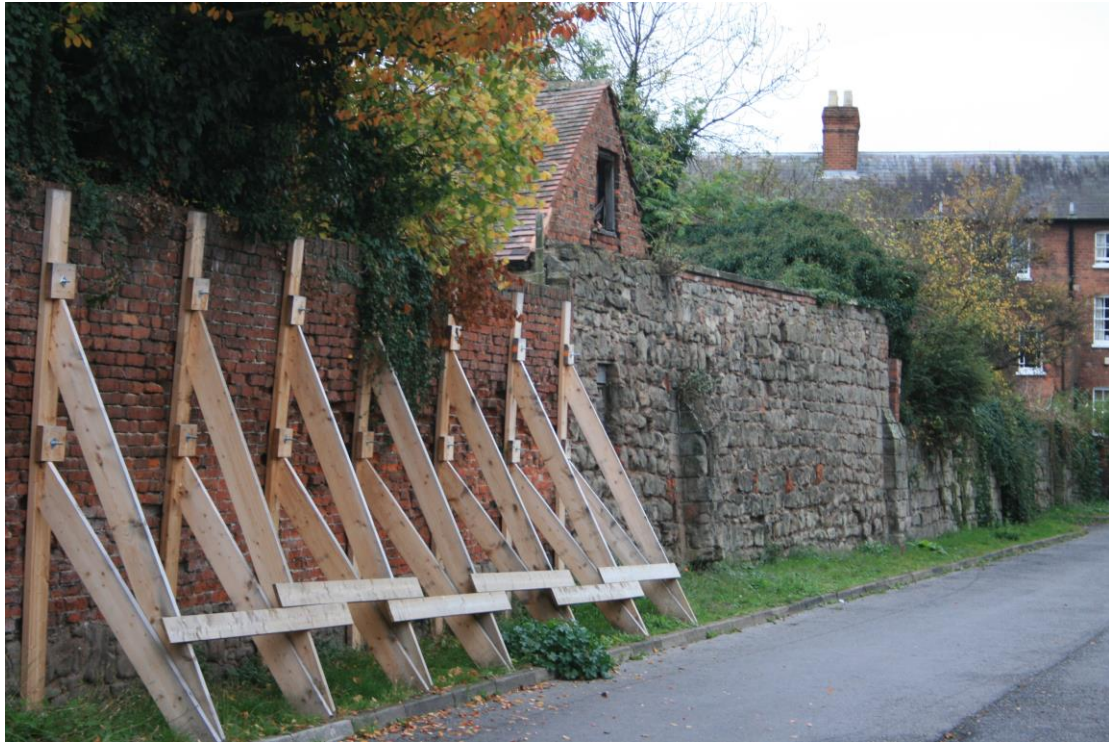
A substantial section of superincumbent, badly eroded brickwork on the wall line between the bastion and the Black Lion has developed a substantial outward lean and is being held up by temporary and unsightly timber shores to prevent its collapse: this is now (September 2011) about to be taken down under archaeological supervision and rebuilt. Further north, adjacent to the bastion, there are substantial mats of ivy on the wall top potentially masking loose masonry. Although not presenting such an immediate hazard, mature trees growing just within the wall in this area will, in the long term, cause root damage to the monument. Ivy and tree growth will also shortly (September 2011) be addressed.

The failed brickwork stretch of wall immediately north of the Black Lion plot, prior to repairs

- Repairs to the failing brickwork, and control of ivy and tree growth is about to be addressed on this section (late 2011)
- Although this part of the wall receives a fair amount of attention from visitors, particularly those using the car park at its foot, there is presently no interpretation on site, nor guidance to seek out this section in any wider-ranging visitor literature. Carefully designed sympathetic on-site interpretation is needed, together with referencing within city-centre visitor guides.

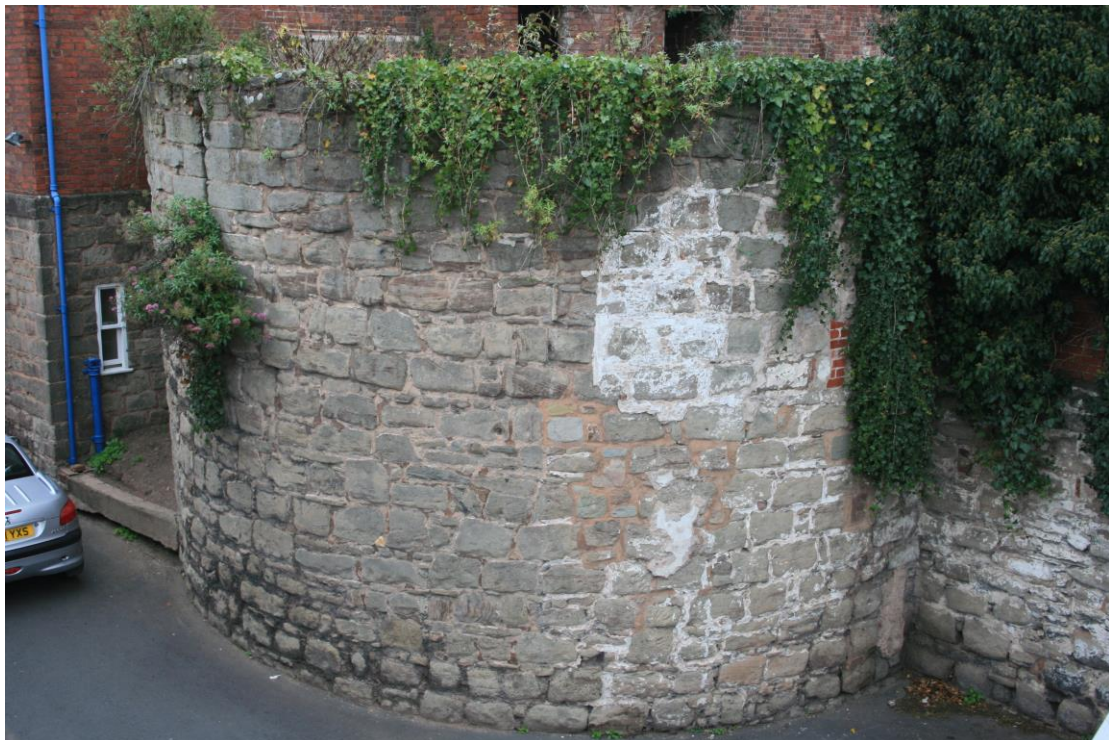
The bastion B2 is mostly in sound condition though at least one substantial crack has become apparent in the NW-facing upper courses. Undergrowth within the bastion interior and inside the wall has recently been removed. The wall in this section is elsewhere generally in a relatively good state of repair with only limited vegetation growth in some joints in the wall face and a mat of ivy overhanging the southern section of the wall.

Bastion 2, adjoining the south side of the Greyfriars Surgery.

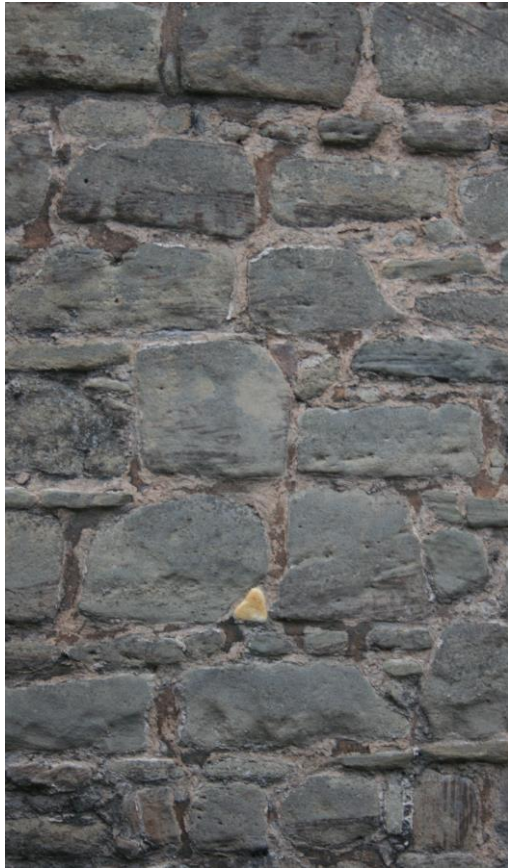
Detail of the suggested 'primary' build character masonry, seen in section 1 and elsewhere, consisting of large square blocks with short, intermittent levelling-up courses

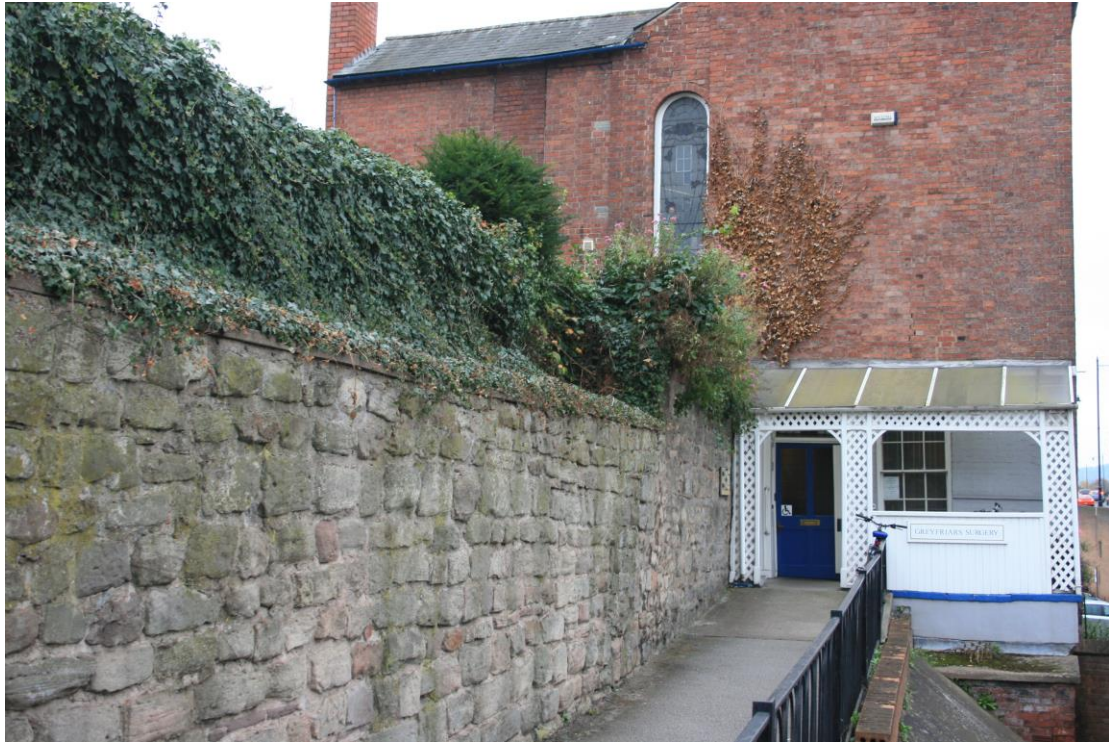
The surviving length of wall is in relatively sound condition. The lack of any interpretation (other than a small plaque on the wall on the opposite side of St Nicholas Street) is an issue that should be addressed.

Section 2: the wall on the approach to the Greyfriars Surgery

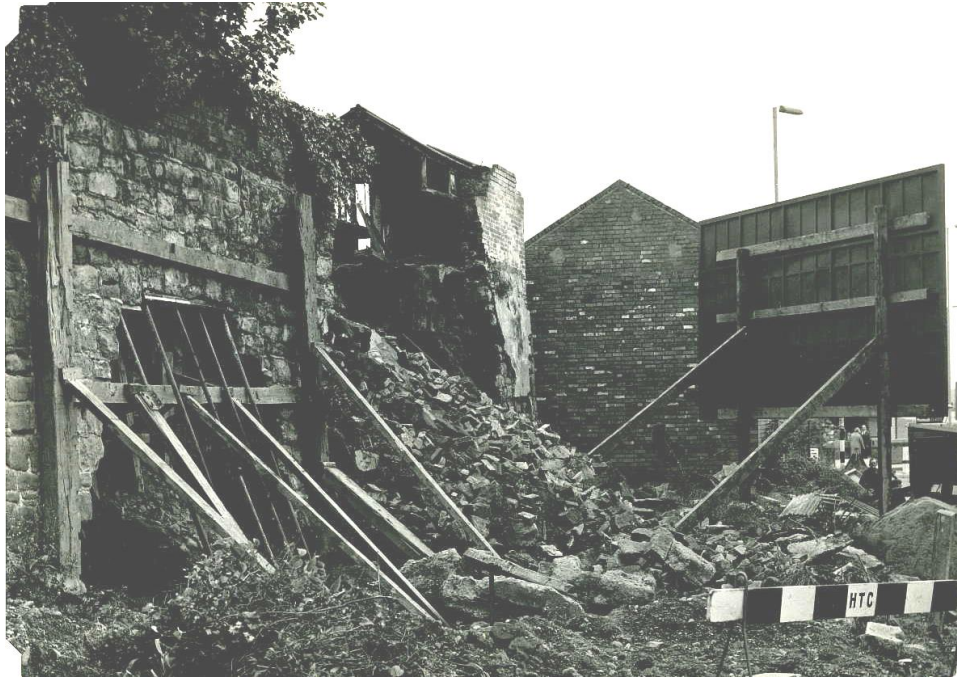
The south end of section 3 looking south. Photograph of September 1968 showing collapses immediately north of the electricity sub-station (Hereford City Council contract photographs file)

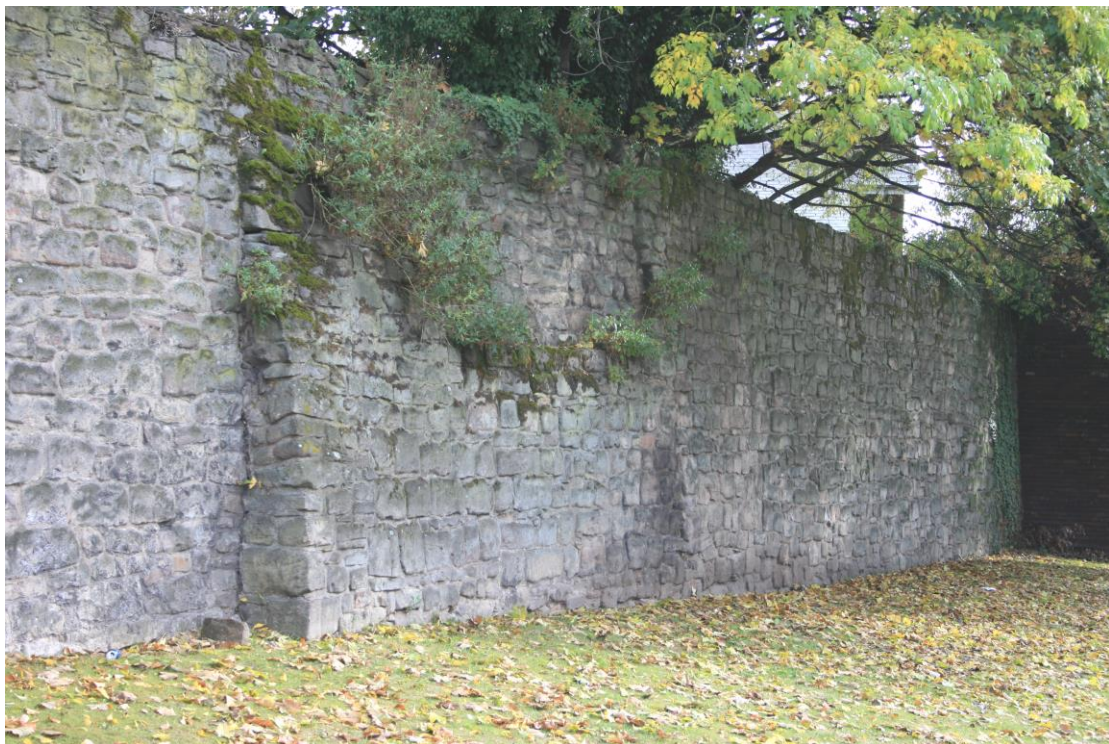
The same view in 2009. The Civil War cannonball found embedded in the rampart material behind was built into the masonry c. 3 metres above ground level just short of the electricity sub-station (right)

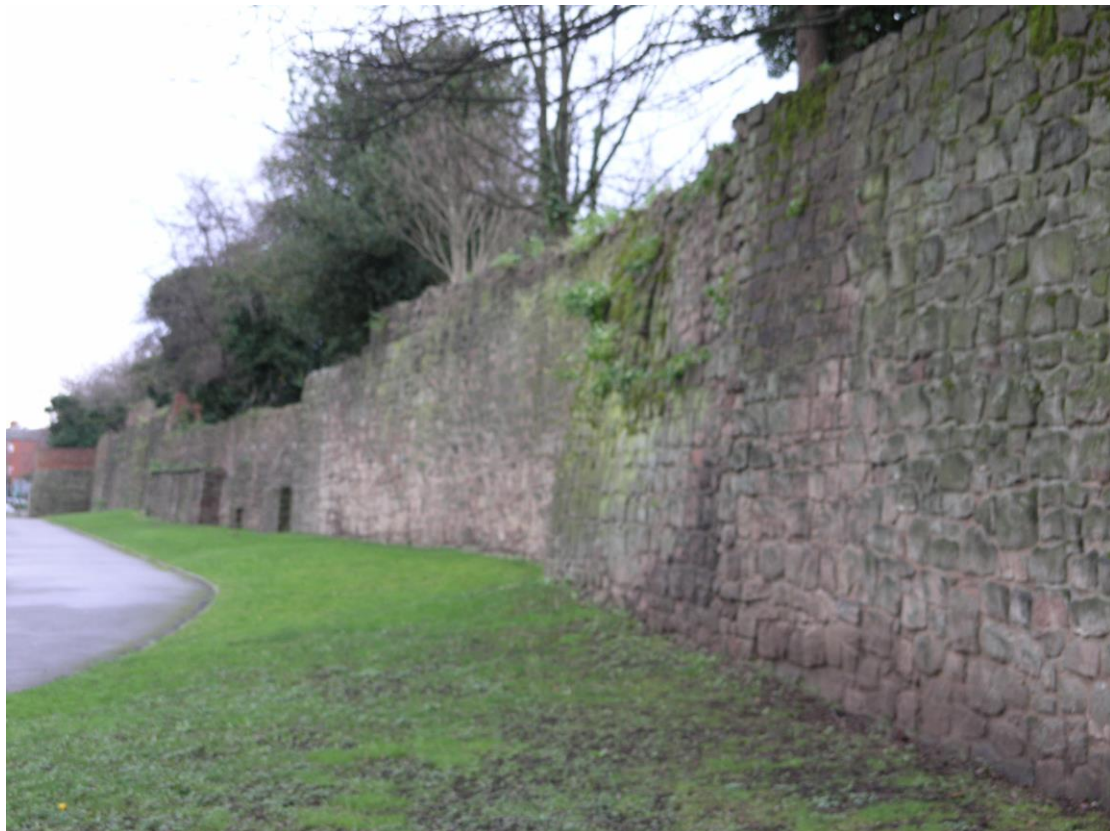
The outer face of the wall was comprehensively restored and re-pointed, and some sections completely rebuilt, in 1968-9. The pointing here is generally in good condition with occasional vegetation growth on the wall face, though mats of ivy hang down from the wall top in some places, particularly at the north end adjacent to bastion B4. Some cracking is apparent, generally at junctions between rebuilds and there are signs of outward movement in the masonry of the bastion. Where the inner face of the wall is visible above ground- or rampart level this is in some areas in poorer condition and the concrete capping of the wall (and offsets) at the south end is parting company from the fabric beneath.

The same view in 2008. Apart from the absence of the brickwork features seen above, the extent of the 1968-9 reconstruction work is not obvious

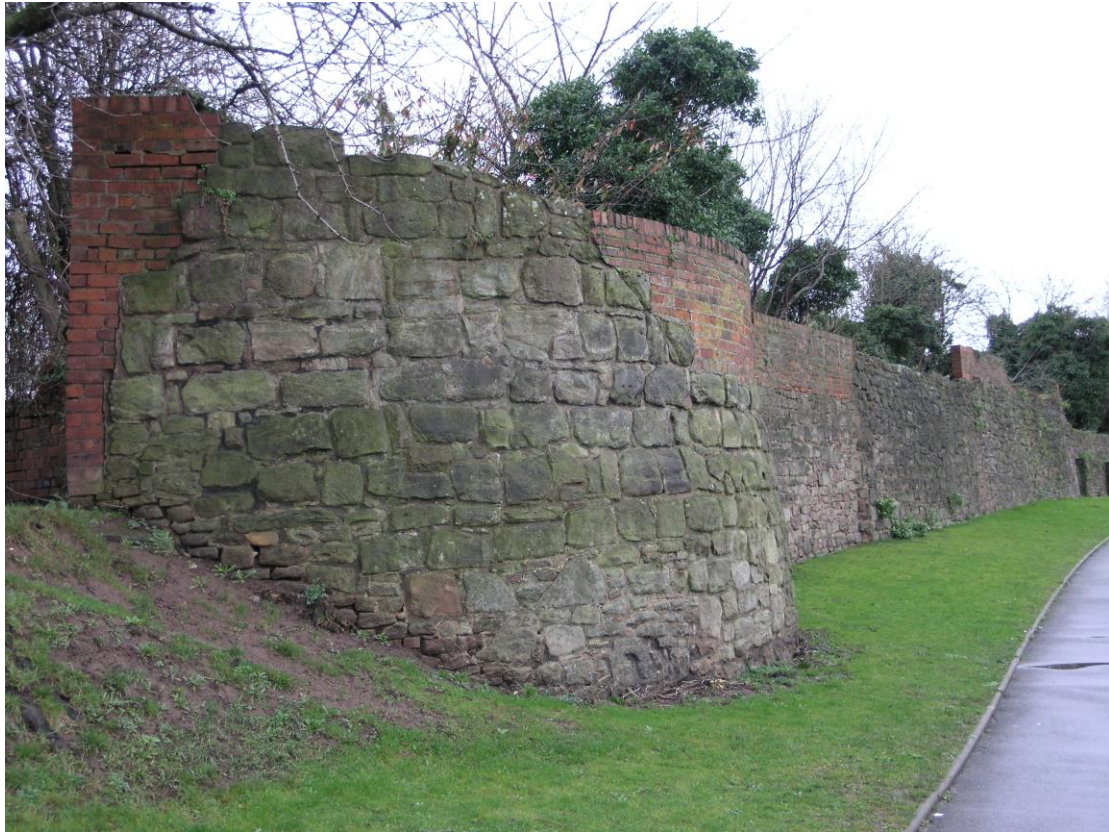
General view of section 3 looking south from Bastion 4

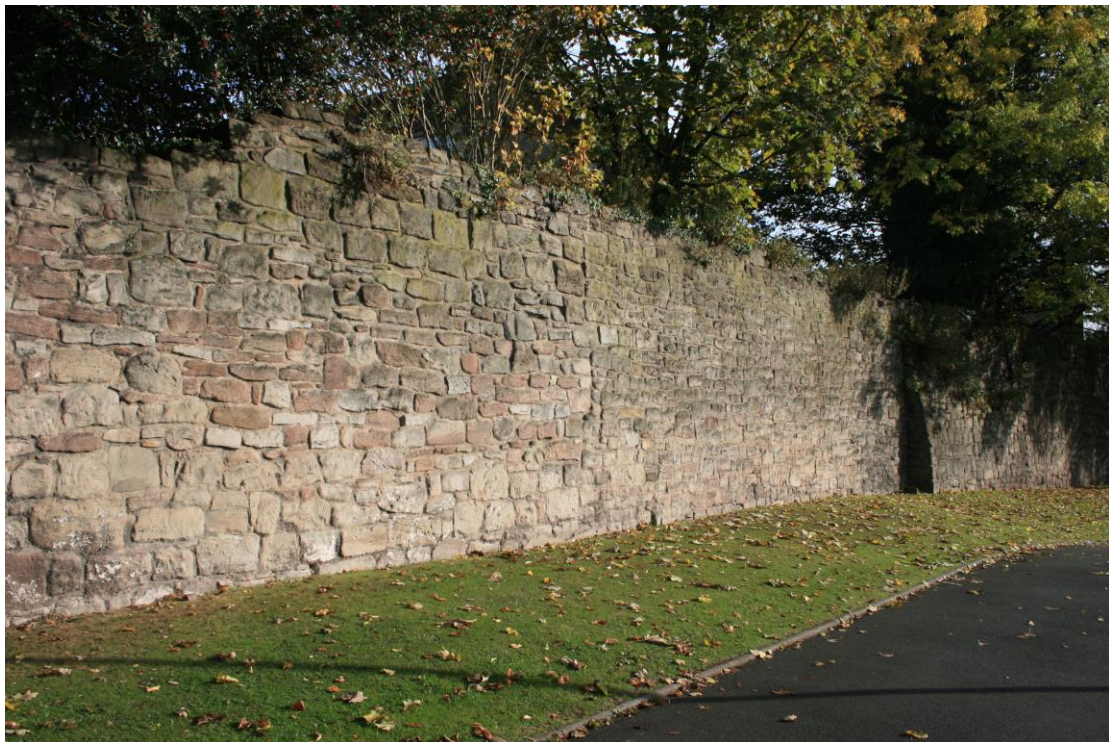
Different builds in the masonry of section 3 on the exterior face of the Berrington Street Job Centre stretch

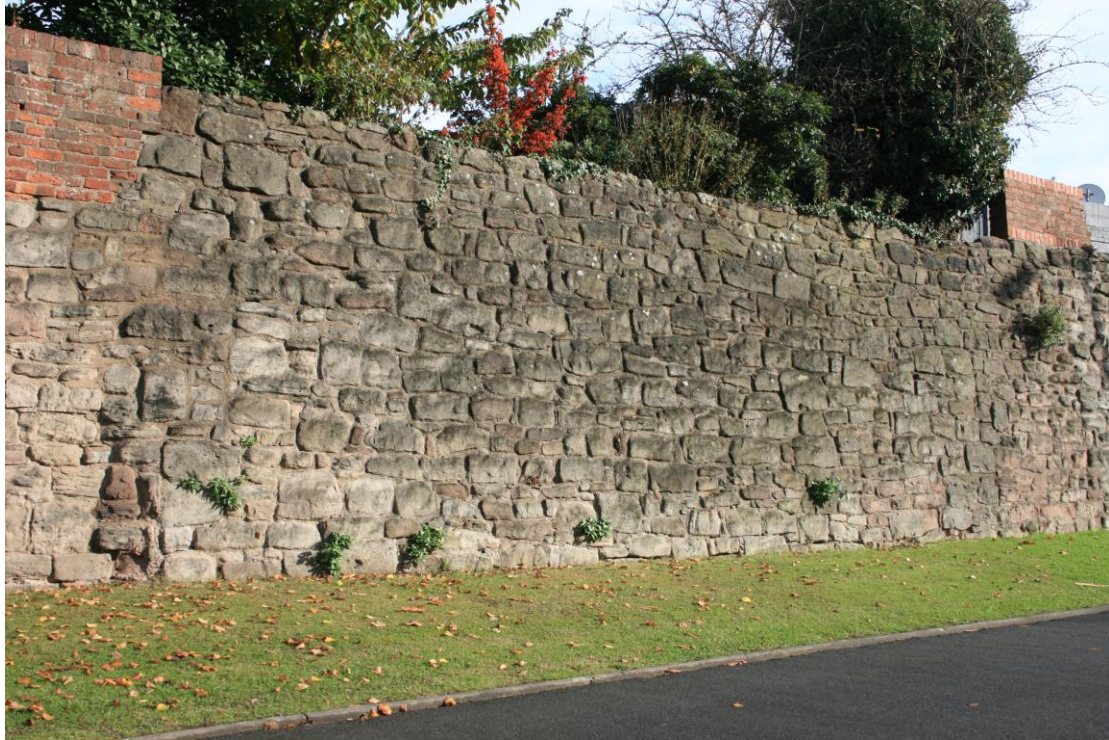
Outer face masonry of section 3 opposite the Blue Rooms plot

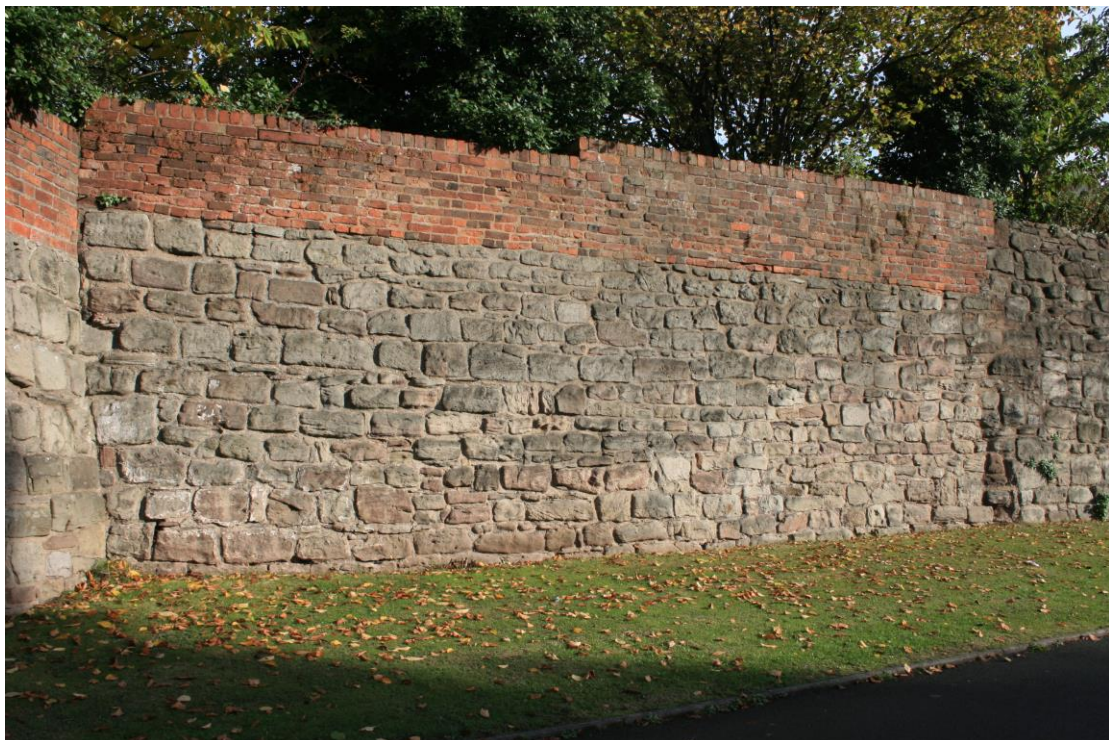
Outer face masonry of section 3 immediately south of Bastion 4

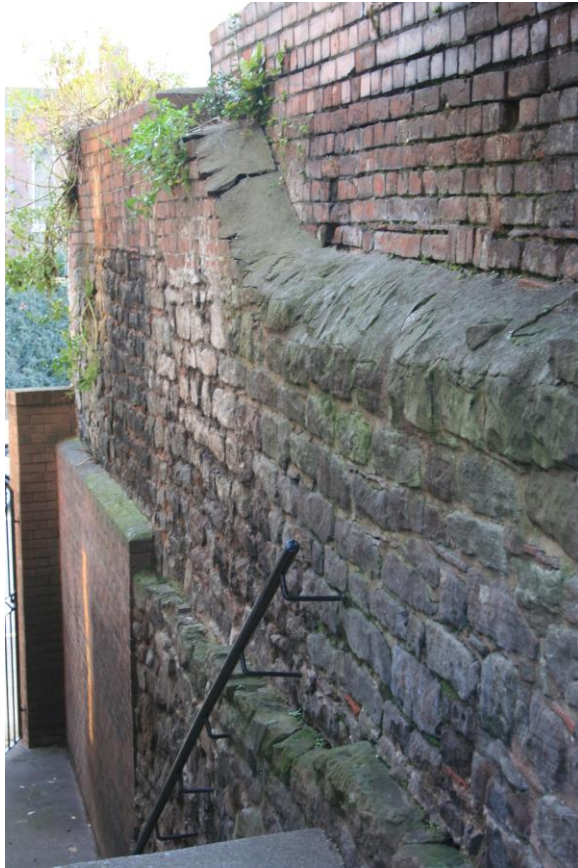
Interior face masonry of section 3, south end, with the descent from rampart-top level down to St Nicholas Street

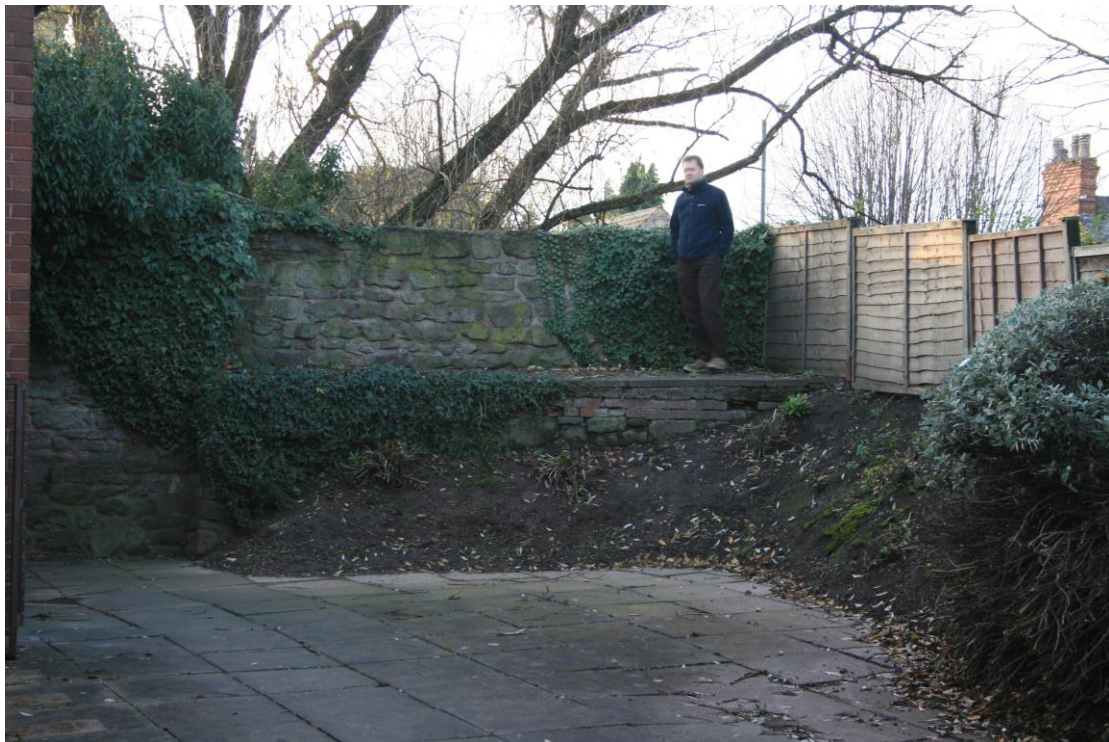
Interior at rampart level behind offices/houses on St Nicholas Street. This is the area of the collapsed section north of the sub-station, seen above in 1968

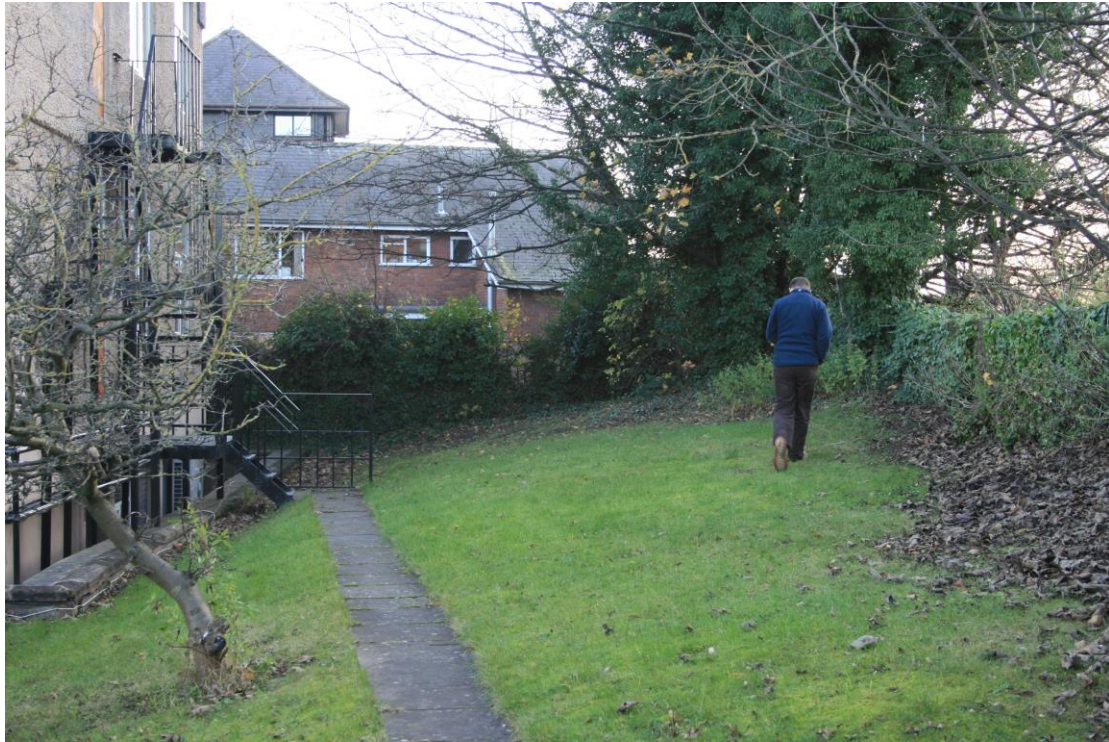
Rampart-top/parapet level on the Berrington Street Job Centre site, looking south

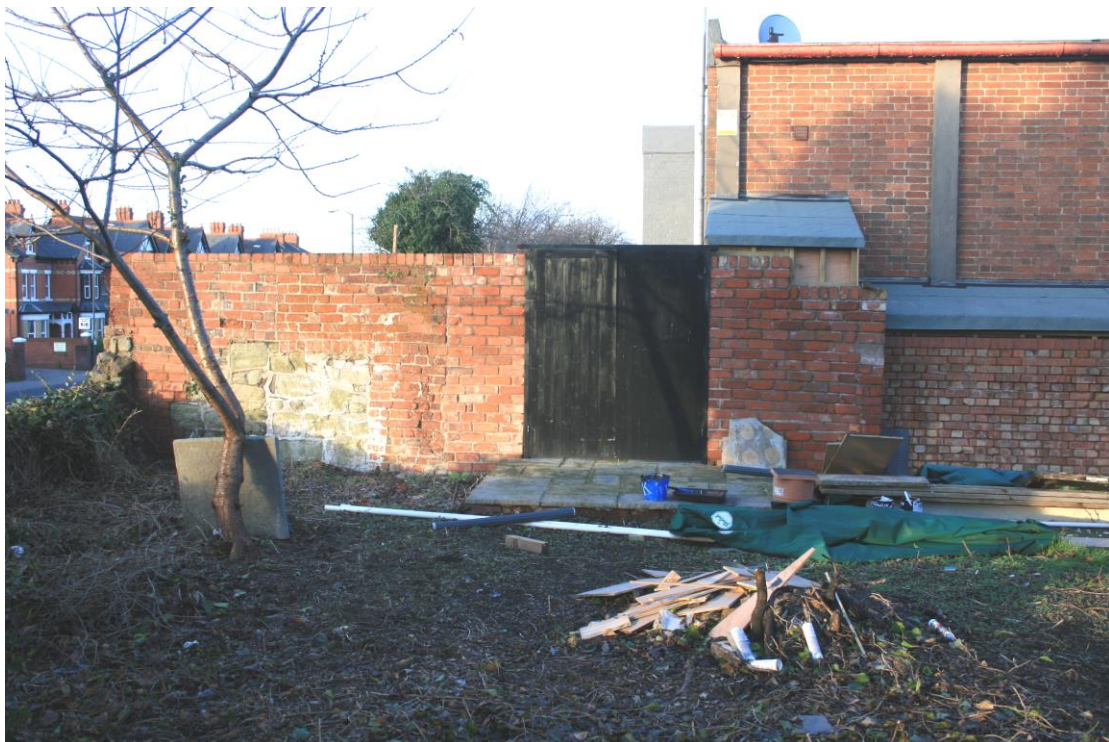
Rampart-top/parapet level at the north end of the Job Centre plot, looking north towards the boundary of the Blue Rooms plot

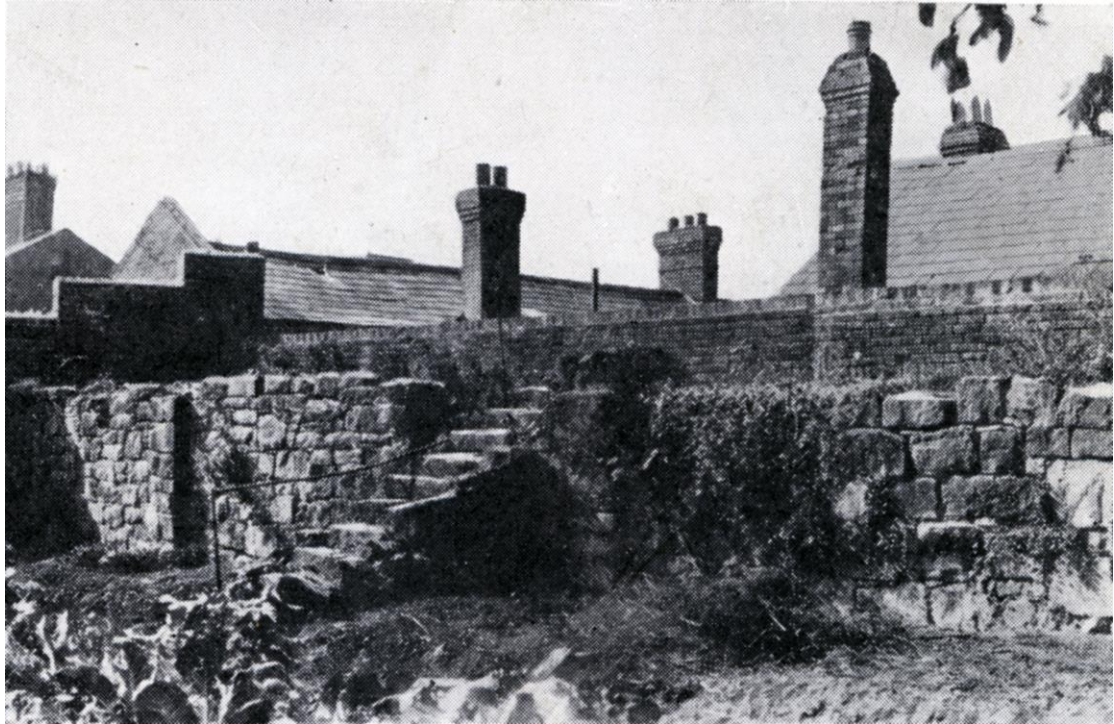
View of c.1900 probably showing buttressed interior face of the wall on the Blue Rooms nightclub plot (south of Job Centre) (courtesy Derek Foxtan)

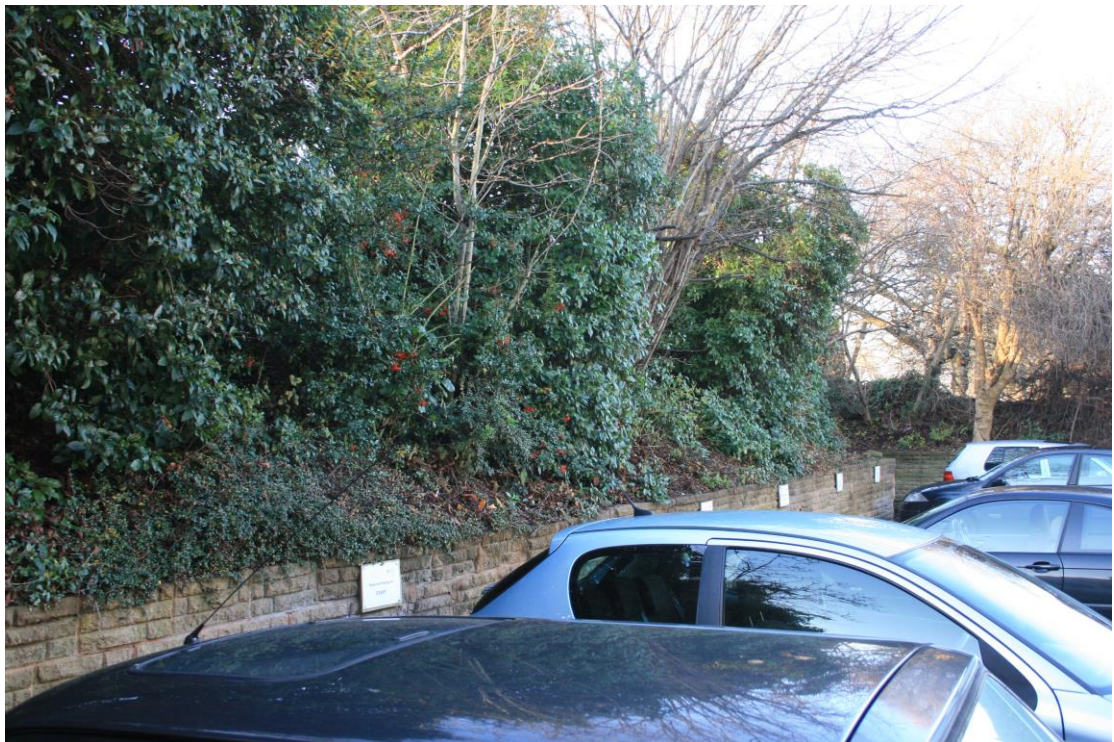
Interior face of the rampart on the Kemble Housing Association plot, looking north towards Bastion 4. The wall parapet is concealed by the dense undergrowth

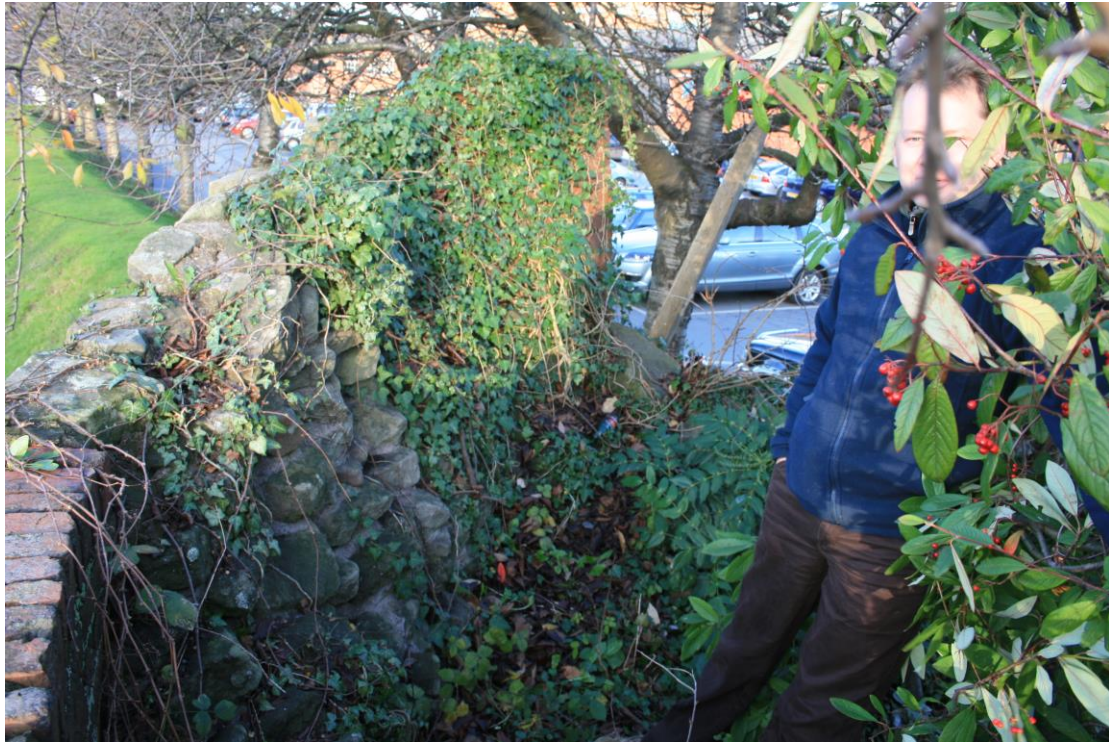
Bastion 4 interior, looking north at rampart-top level. The figure in the foreground is parting the undergrowth to allow a clearer view

- Consideration should be given to the restoration of bastion B4. The immediate imperative would be to rectify the present poor condition of the monument in terms of the parapet masonry/brickwork, the brickwork of the property boundary that runs into the bastion and forms the party wall between the public car-park and the Kemble Housing Association property, and the overgrown interior. A less urgent but arguably equally significant imperative would be to develop the bastion as a feature that is interpreted for visitors, certainly by means of signage in the public car-park but also possibly by means of a lightweight platform in the interior approached via access steps from the public car park .

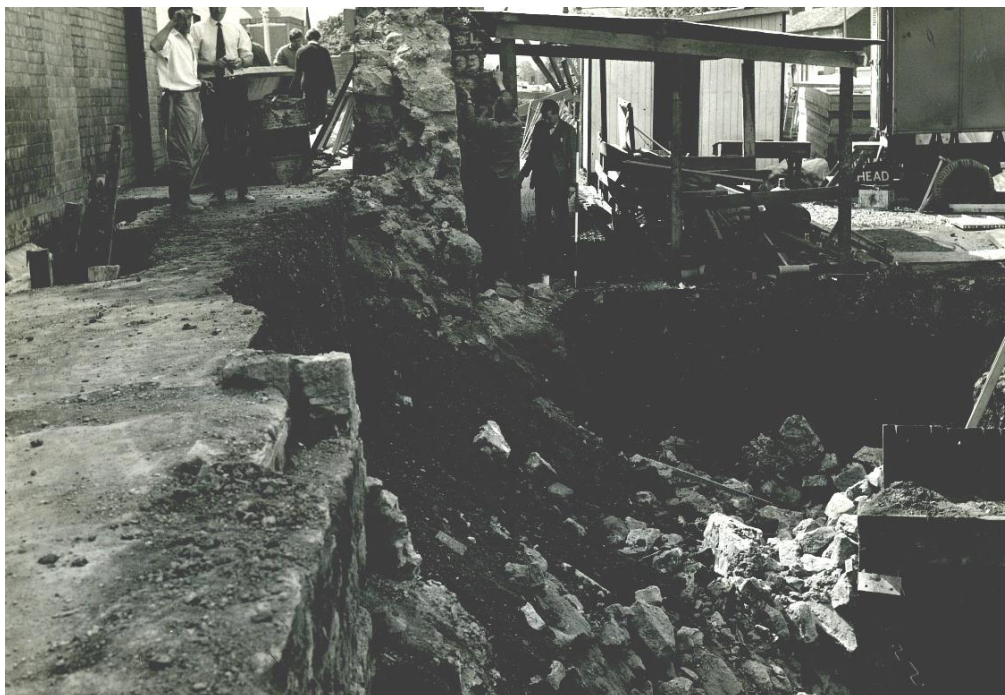
The north end of the Gunners Lane wall in 1968 following the collapse of masonry into the underpass excavations alongside (Contract photographs file, Hereford City Council)

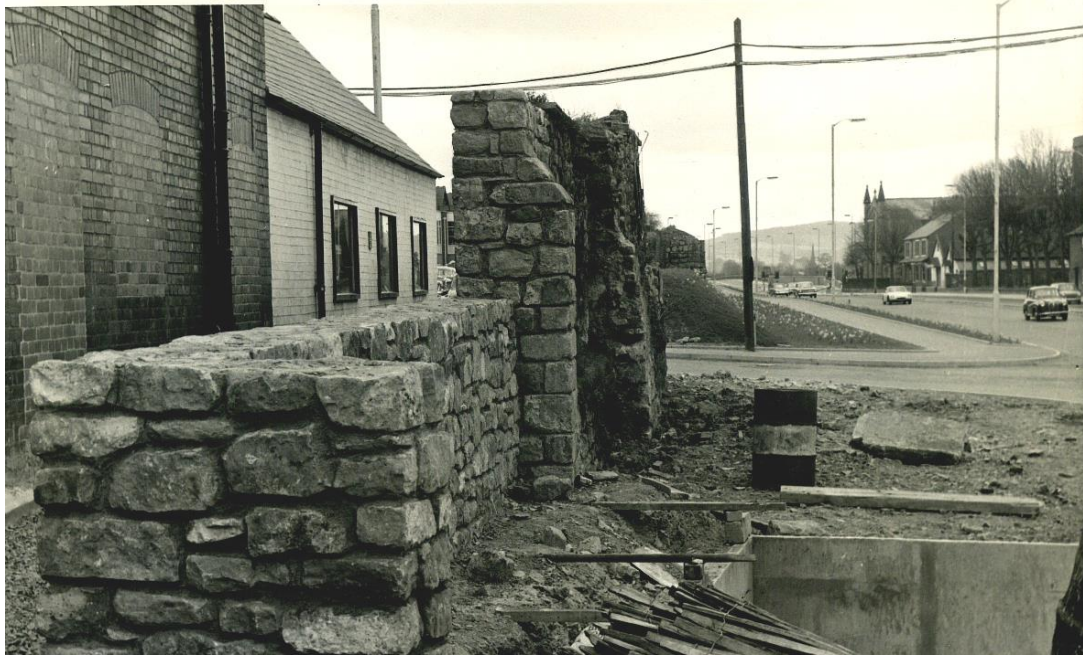
The north end of the Gunners Lane wall in April 1969 after reconstruction. Other photographs show the stones of the buttress (mid-foreground) numbered for dismantling (Contract photographs file, Hereford City Council)

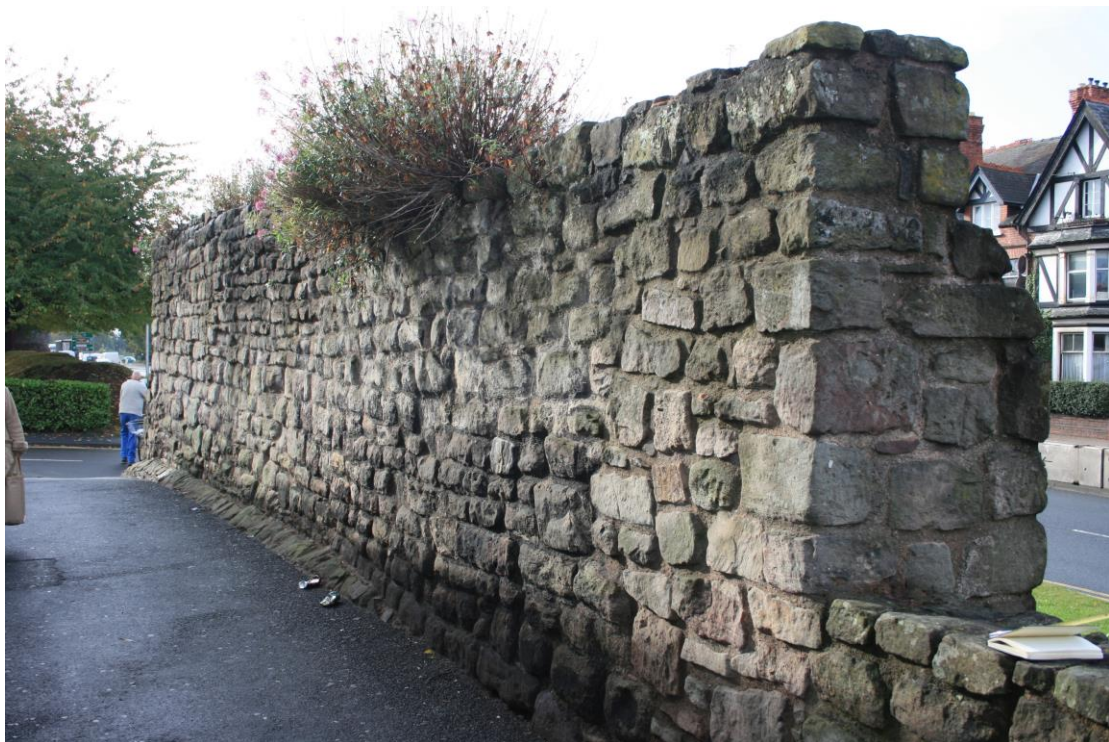
Interior face of the Gunners Lane wall, looking south

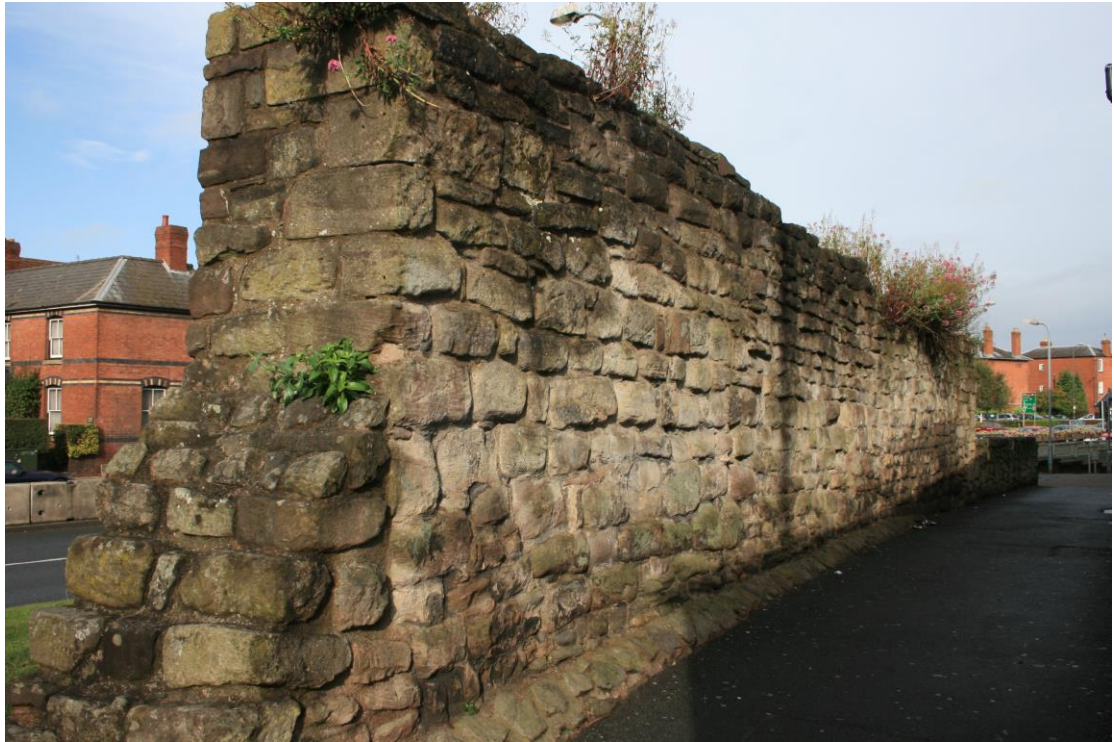
The interior face of the Gunners lane wall, looking north
