Hereford city defences a conservation management plan

Part two: Gazetteer

Herefordshire Archaeology Report 292

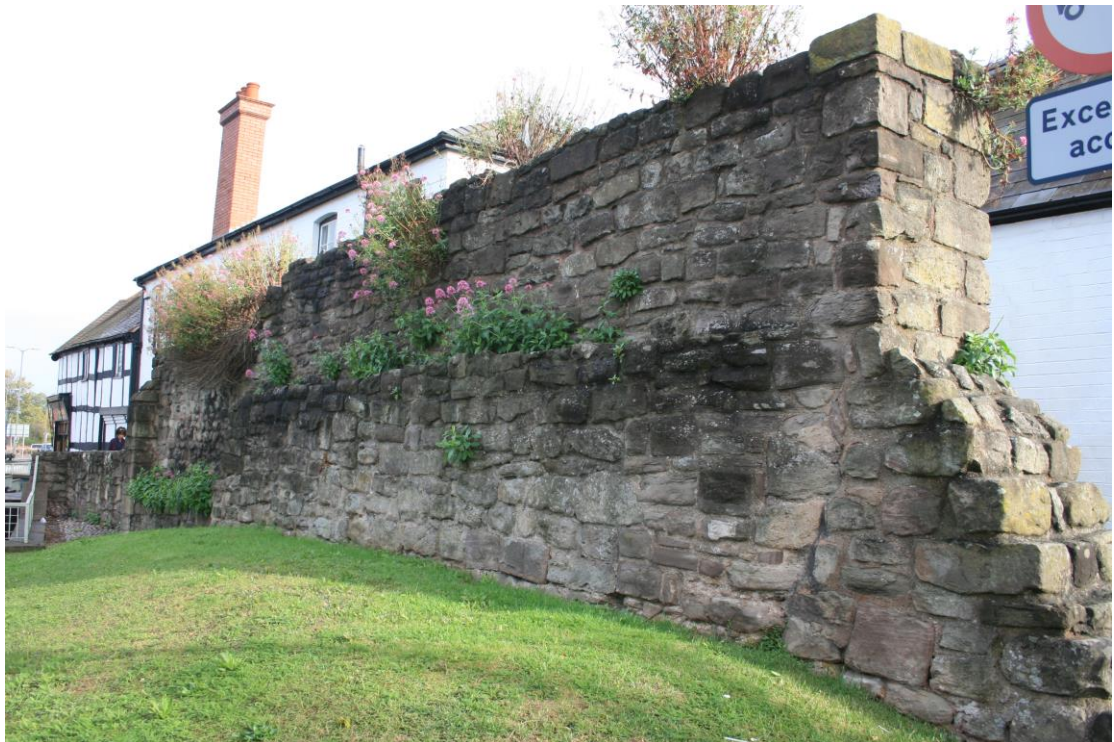
The exterior face is more complex, with at least four builds evident apart from recent repairs. At the south end, a section of random rubble 1.45m high projects c.240mm forward from the face above, which is largely composed of flattish blocks of sandstone; at the north end a similar projecting lower section is composed of large blocks of stone, contrasting with the small rubble in the top section of the wall. The wall terminates at the north end with a rebuilt vertical end bonded in with an external buttress; photographs taken in 1969 clearly show the stones of the buttress numbered for re-erection (Inner Relief Road archive file).

The exterior face of the Gunners Lane wall, looking north

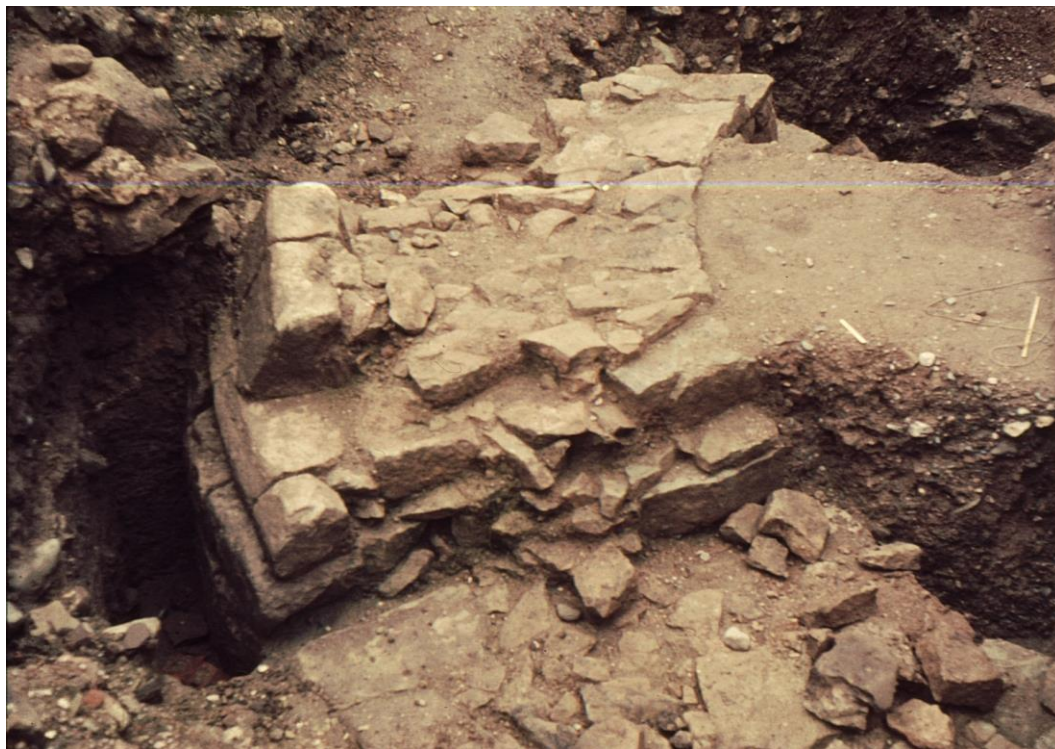
Photograph of the remains of bastion 6 under excavation in 1968; note chamfered plinth courses (for a comparison see section 16 illustrations). Photo: Ron Shoemith

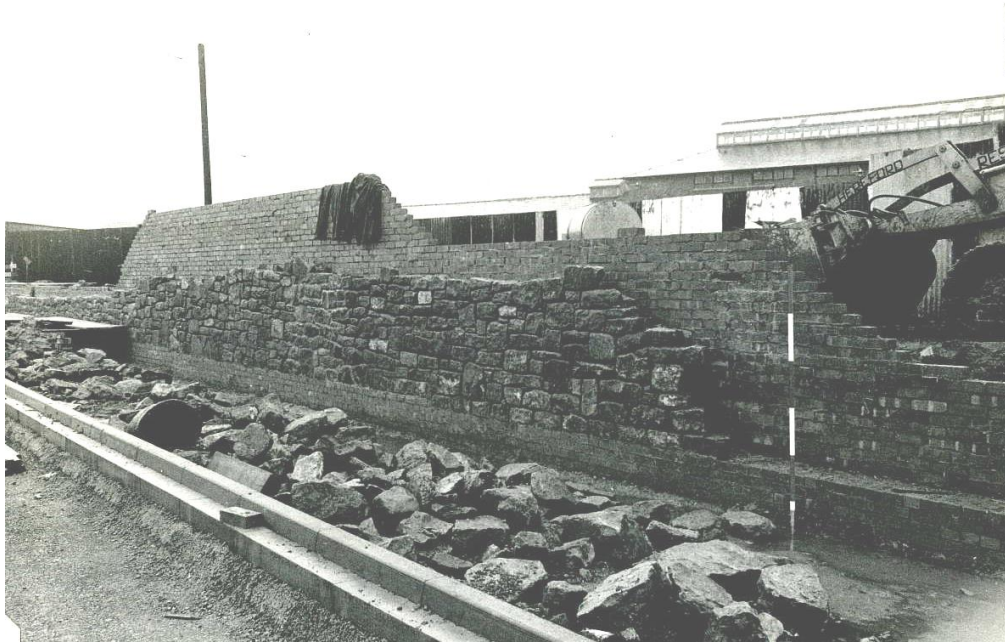
The first replacement wall under construction in October 1968, looking north-east across the site of the 1968 Brewery site excavation trench

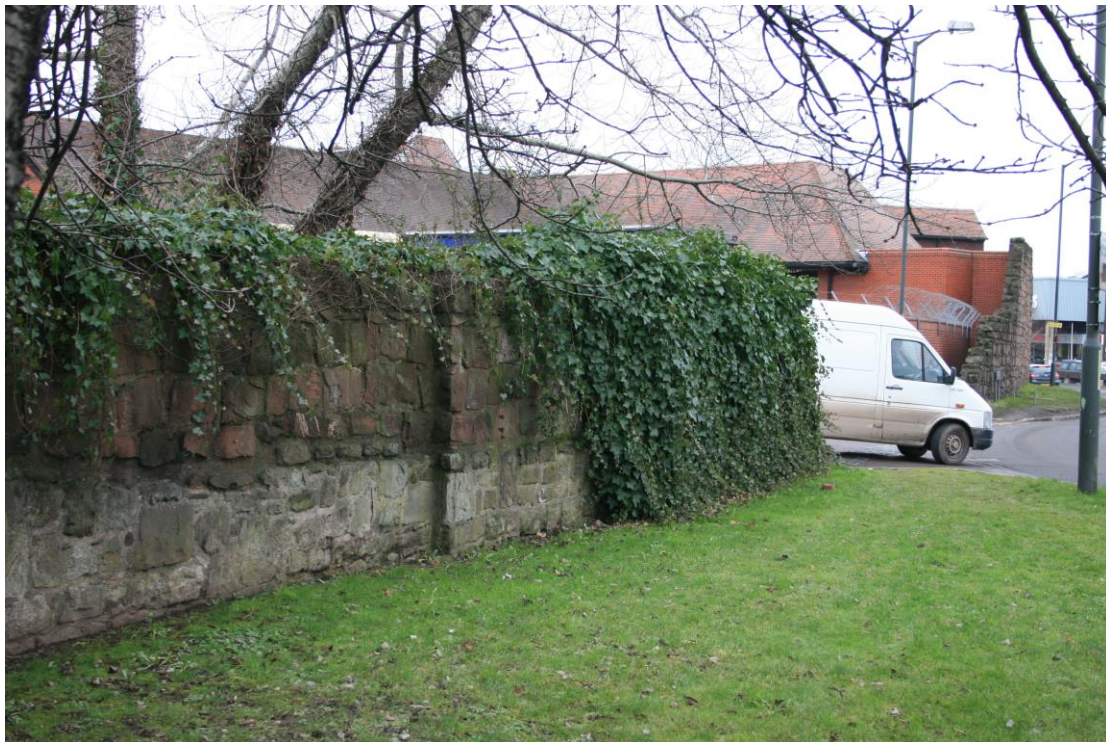
Looking west towards the north-east end of the section 7 (c.1983) wall beyond the Tesco vehicle exit. The section 8 wall in the foreground consists of base courses surviving from the 1968 wall raised by the addition of the distinctive red c.1983 Tesco-Shoesmith masonry

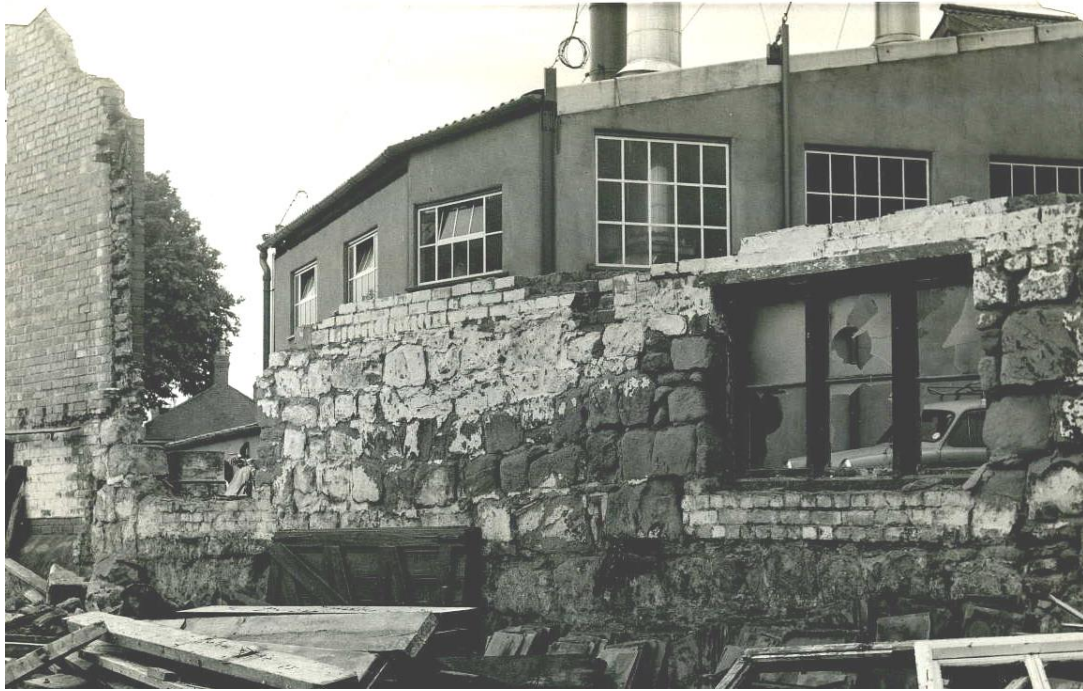
A stretch of the Wall Street wall, with the characteristics of primary city wall masonry, newly exposed by the demolition of buildings on the south side of New Market Street in August 1968 (City Council contract photographs file).

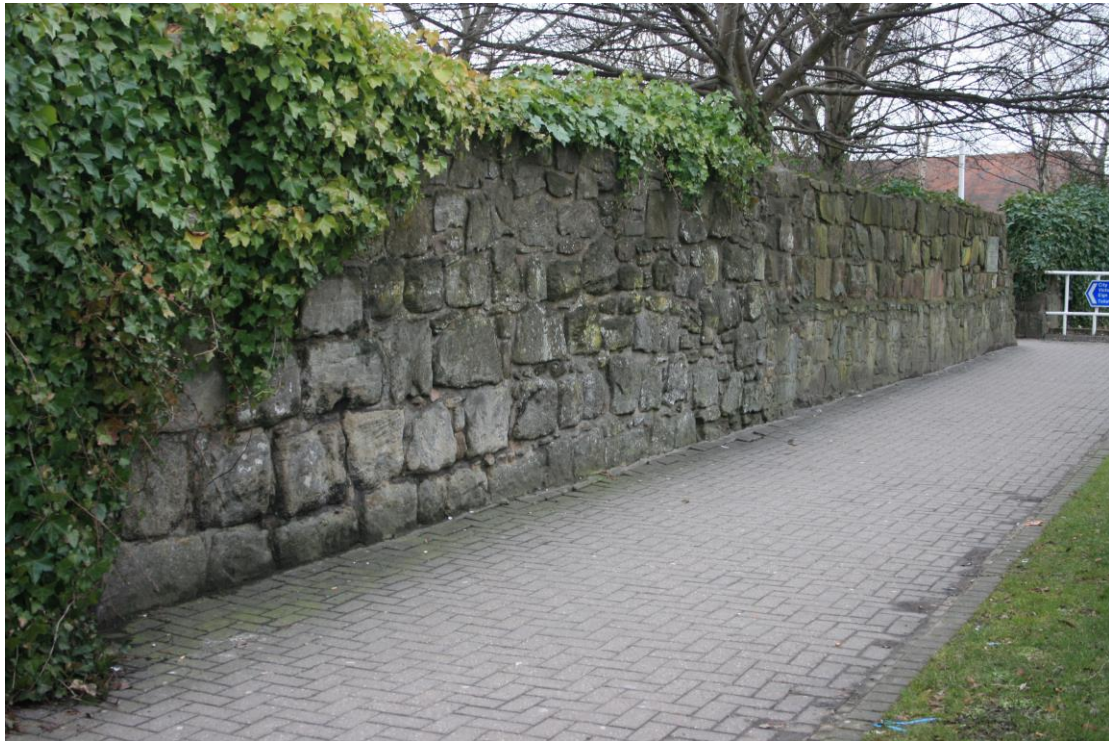
City wall masonry of probable 'primary' character (foreground), possibly as photographed above, to the east of the pedestrian entrance to the Tesco car park

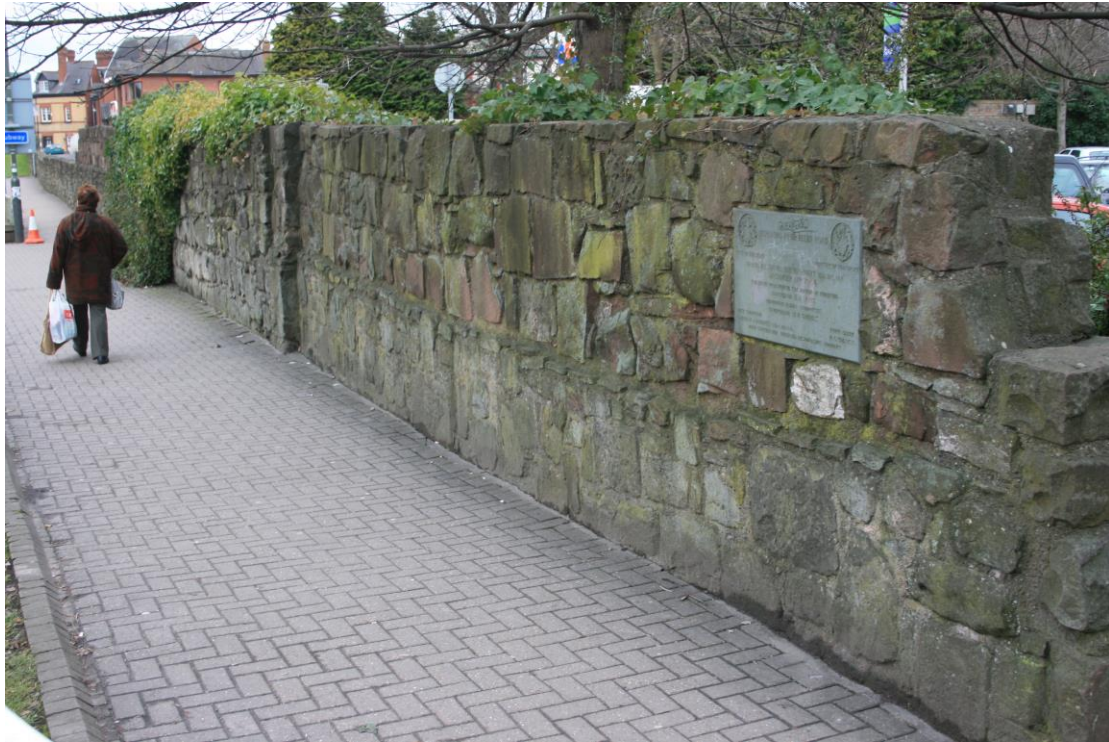
General view of the Wall Street section, looking east. The plaque in the foreground commemorates the opening of the Inner Relief Road in 1969 but is embedded in masonry of the c.1983 build. The lowest courses may be remains of the 1968 wall

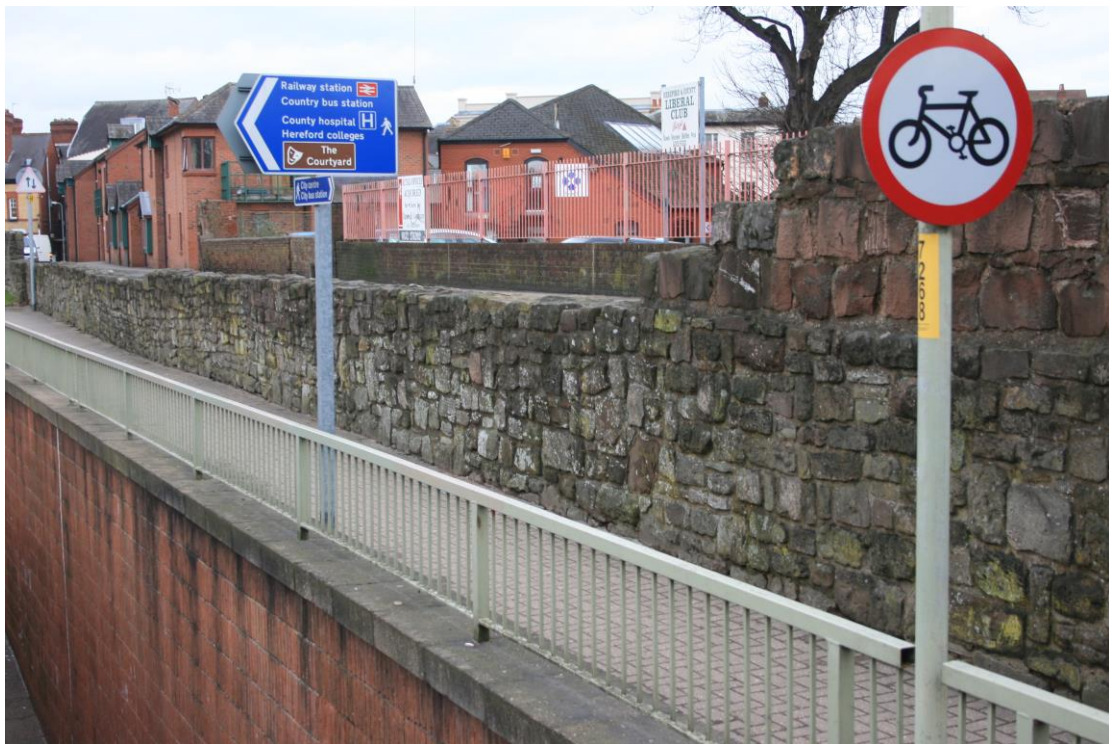
The Wall Street section, reduced in height alongside the pedestrian underpass. The eastern termination of the 1983 reproduction masonry is visible

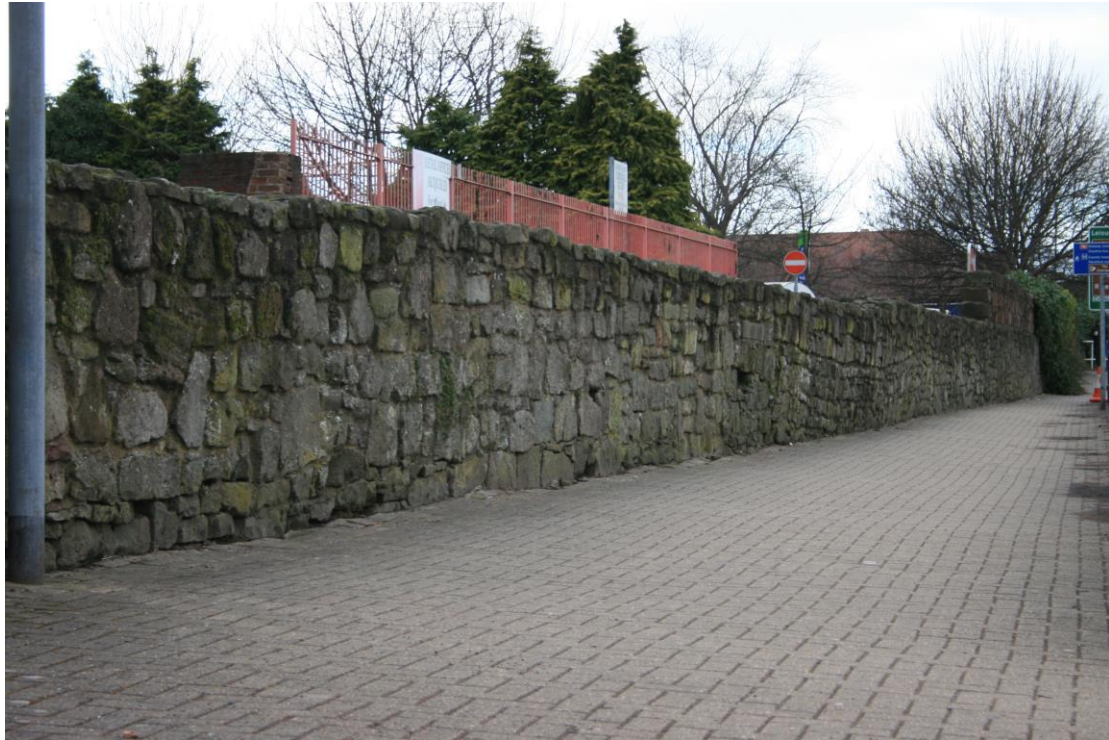
The Wall Street wall looking west alongside the New Market Street pedestrian underpass. The date of this masonry is unknown but is likely to represent a long history of ad hoc repairs in the post-medieval period with an uncertain degree of rebuilding c.1968; the blocks in the foreground may represent re-set primary facing masonry

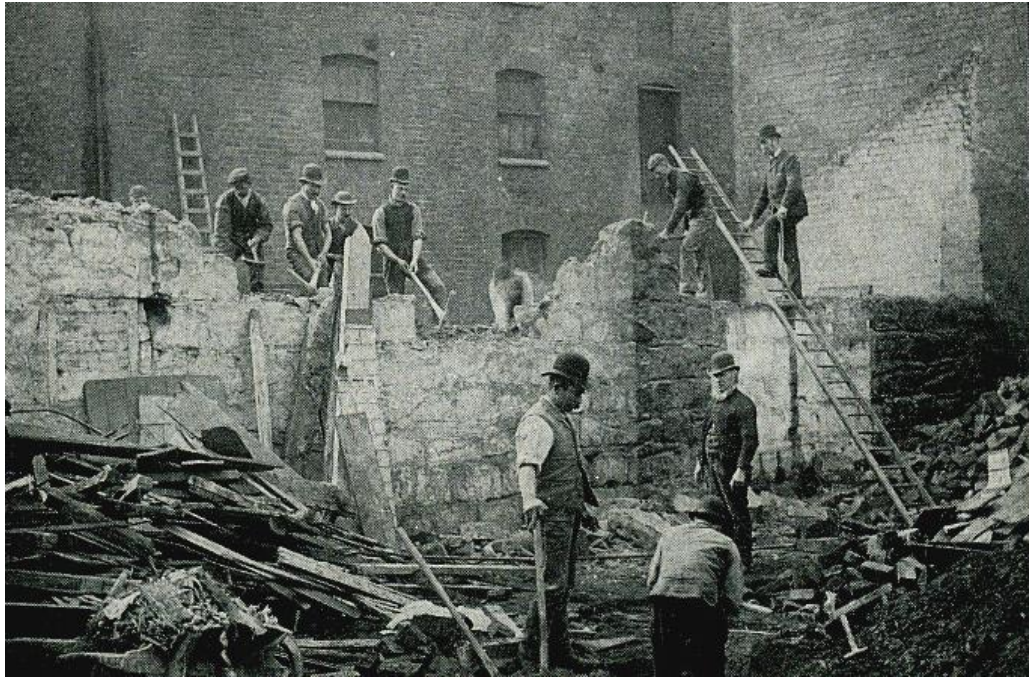
Alfred Watkins' photographs of the demolition of the city wall on the Old Wellington Inn site (now JDs) c.1900 immediately west of Widemarsh Street. The masonry was of 'primary build' type with large square blocks and small levelling-up courses. The photograph below shows a doorway found in the wall, probably late medieval

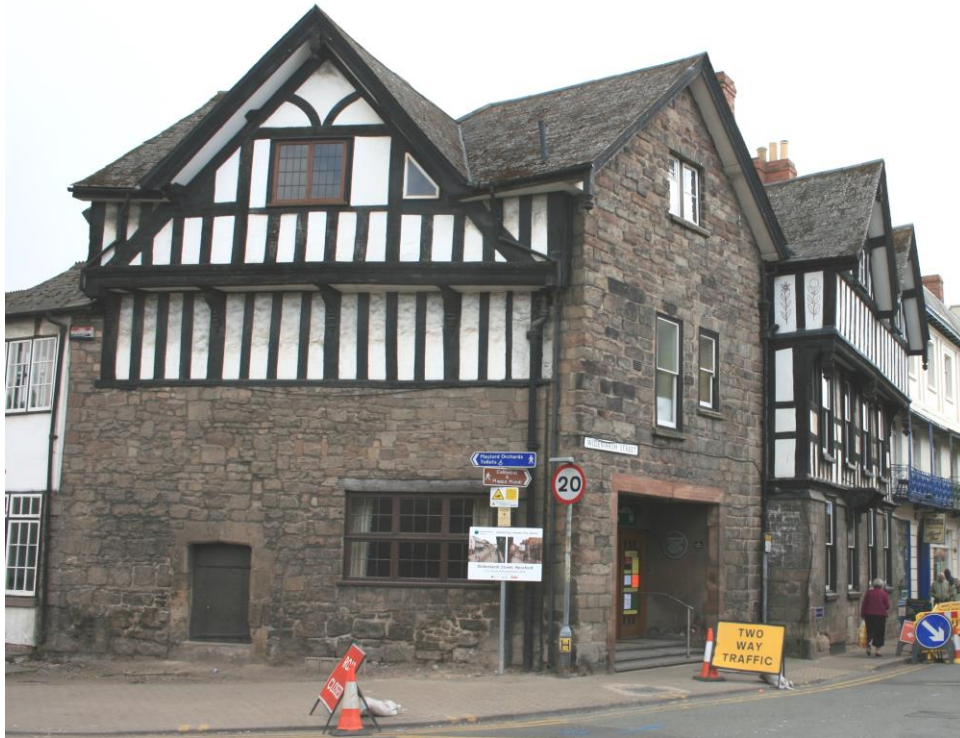
The Farmers' Club, Widemarsh Street. The lower part of the north elevation (foreground, below window-sill level) contains stonework of characteristic city wall type. The stone gable (right) would have been built to replace the end wall of the medieval Widemarsh Gate on its demolition in 1799

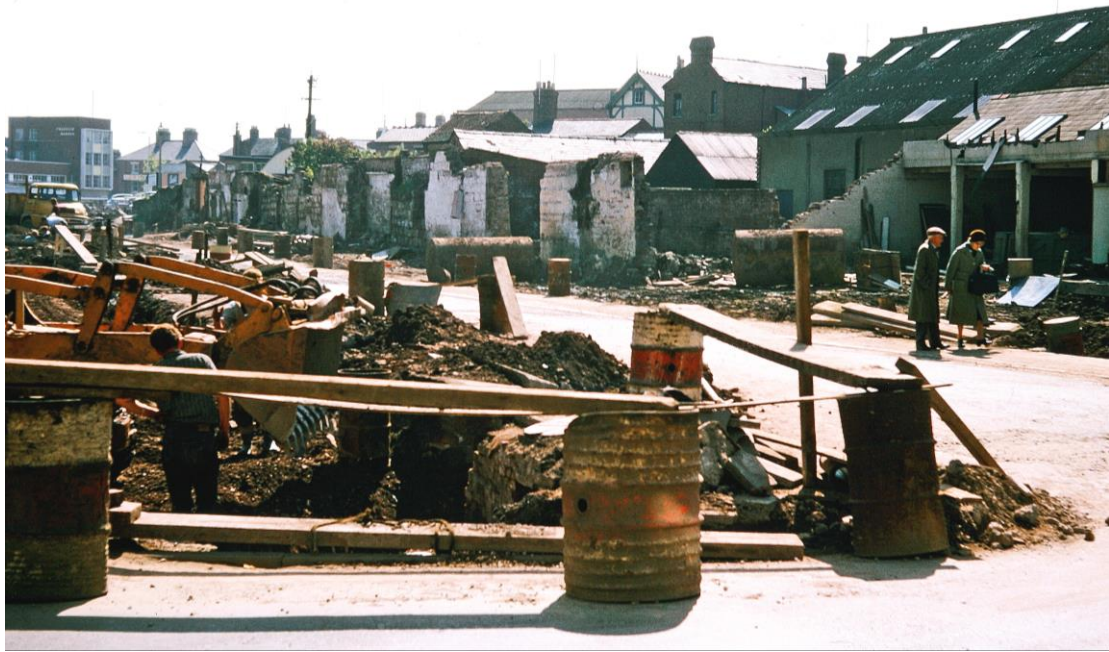
Blueschool Street in the 1960s, looking east, after the demolition of buildings on its south side revealed substantial sections of the city wall (Derek Foxtan)

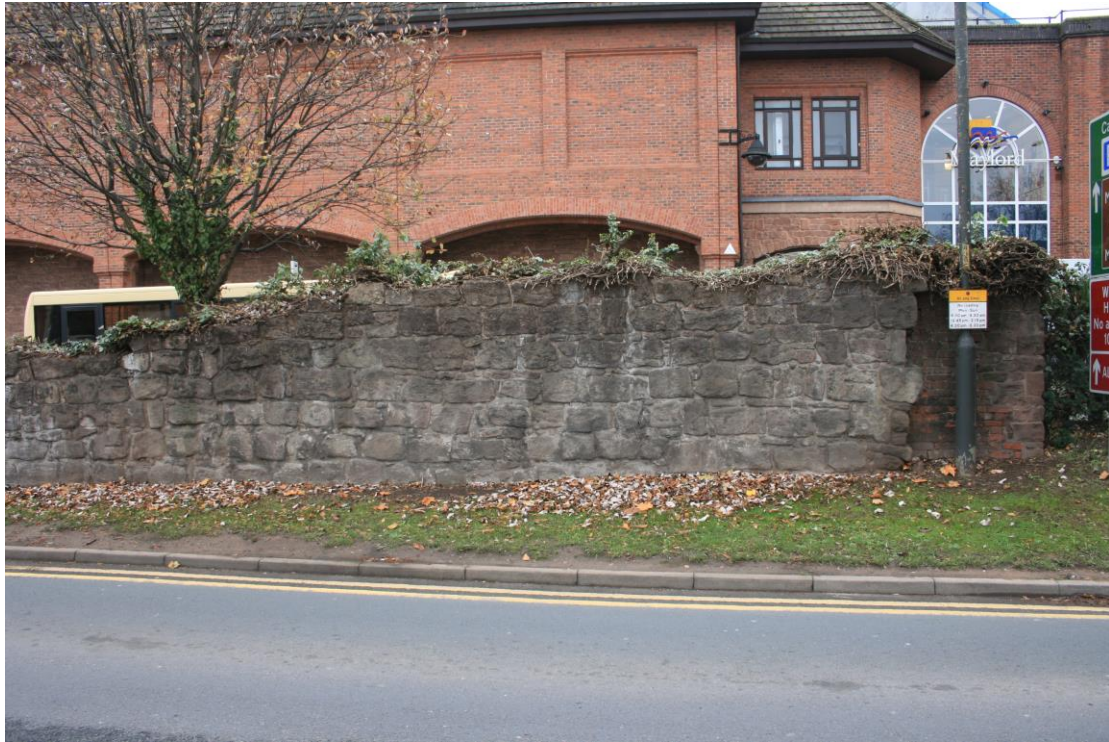
The western end of the Maylord Orchards wall, exterior face

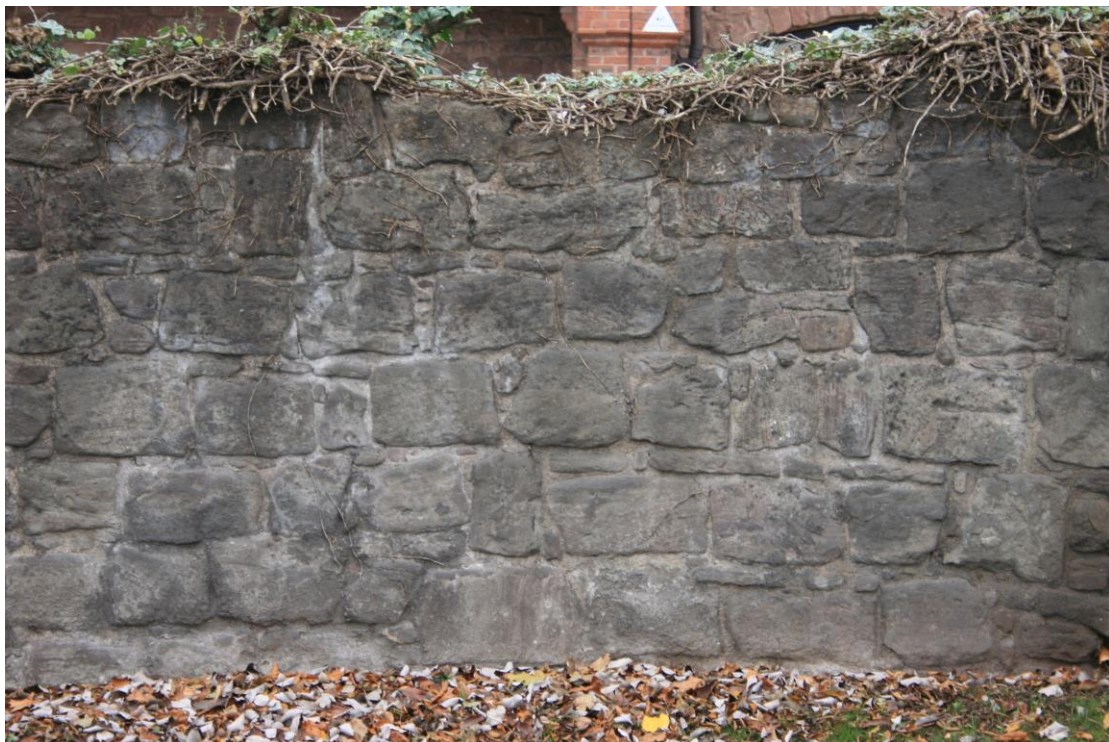
Detail of the probably primary medieval outer-face masonry

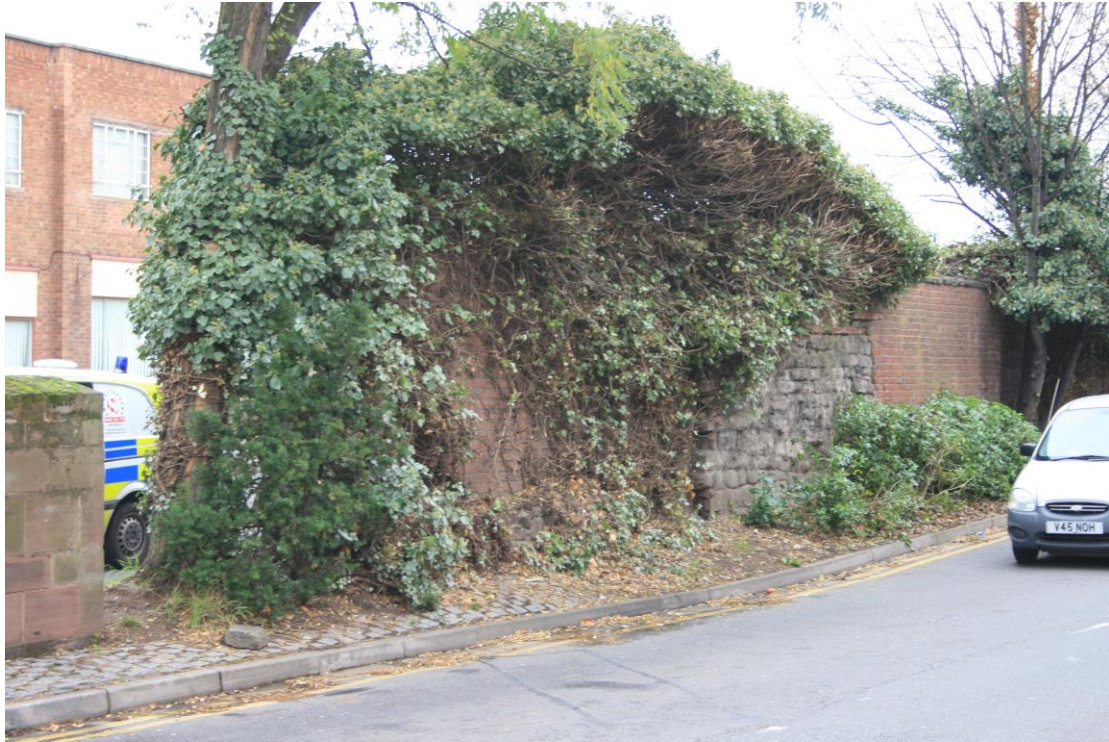
The inner face of the Maylord Orchards wall, looking east from the west end (2009). The problem of ivy, tree growth and the proximity of traffic to the wall face is apparent

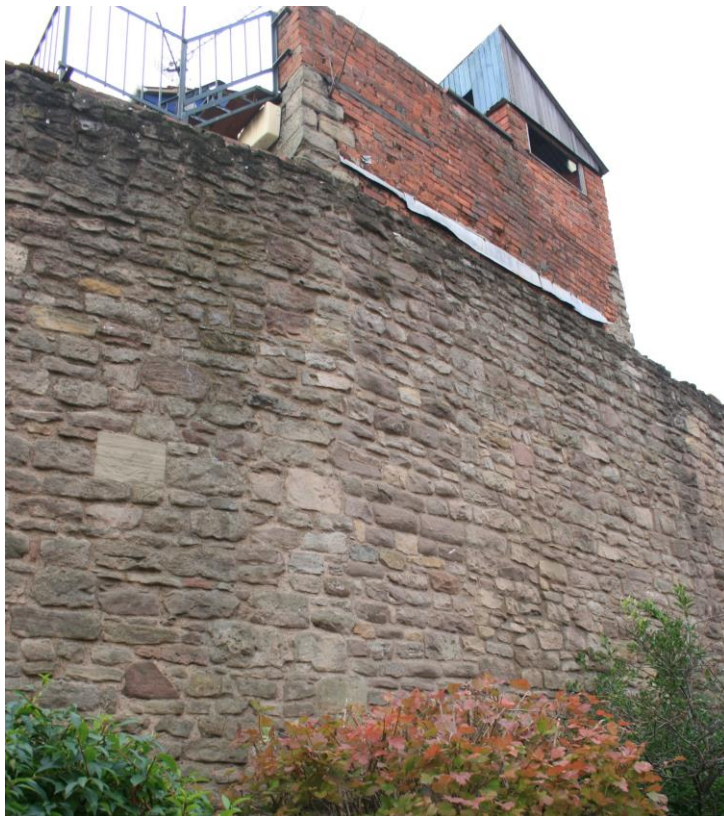
The Bastion Mews wall (exterior)

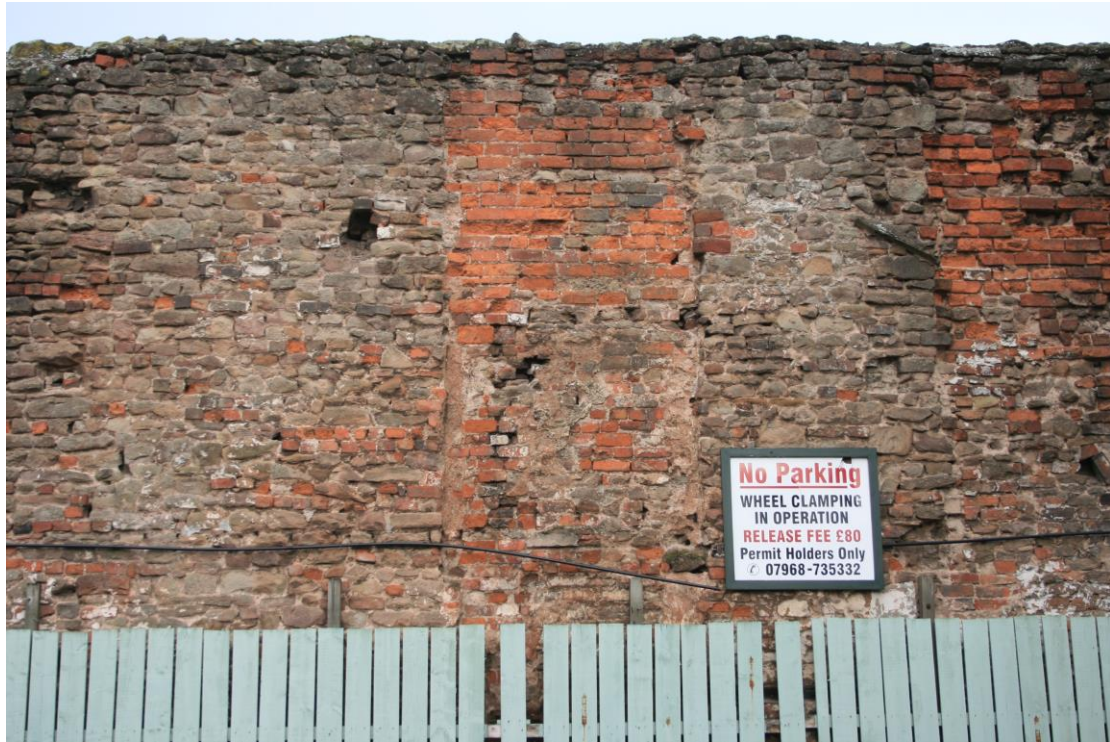
The Bastion Mews wall: internal face

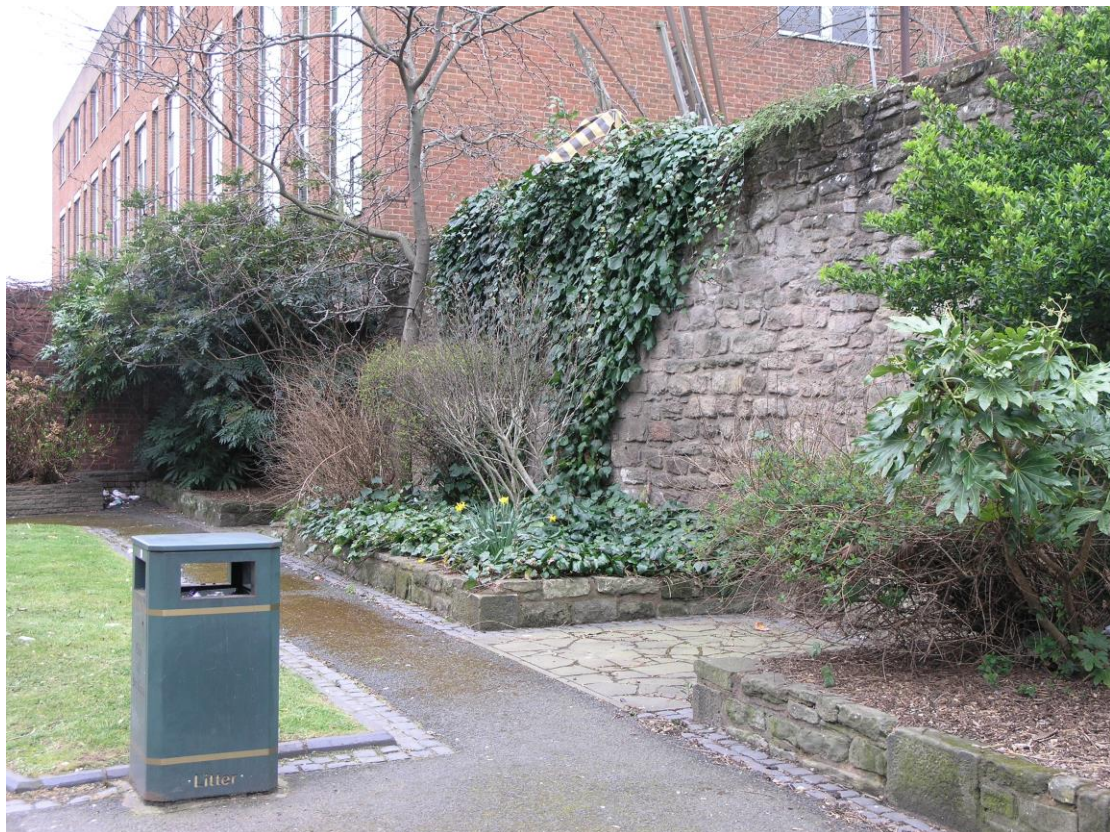
The Bastion Mews wall, east end, looking east towards the Police Station. The present (2011) electricity sub-station (overgrown wall, left) interrupts the view of the wall and disguises its continuity from Bastion Mews eastwards

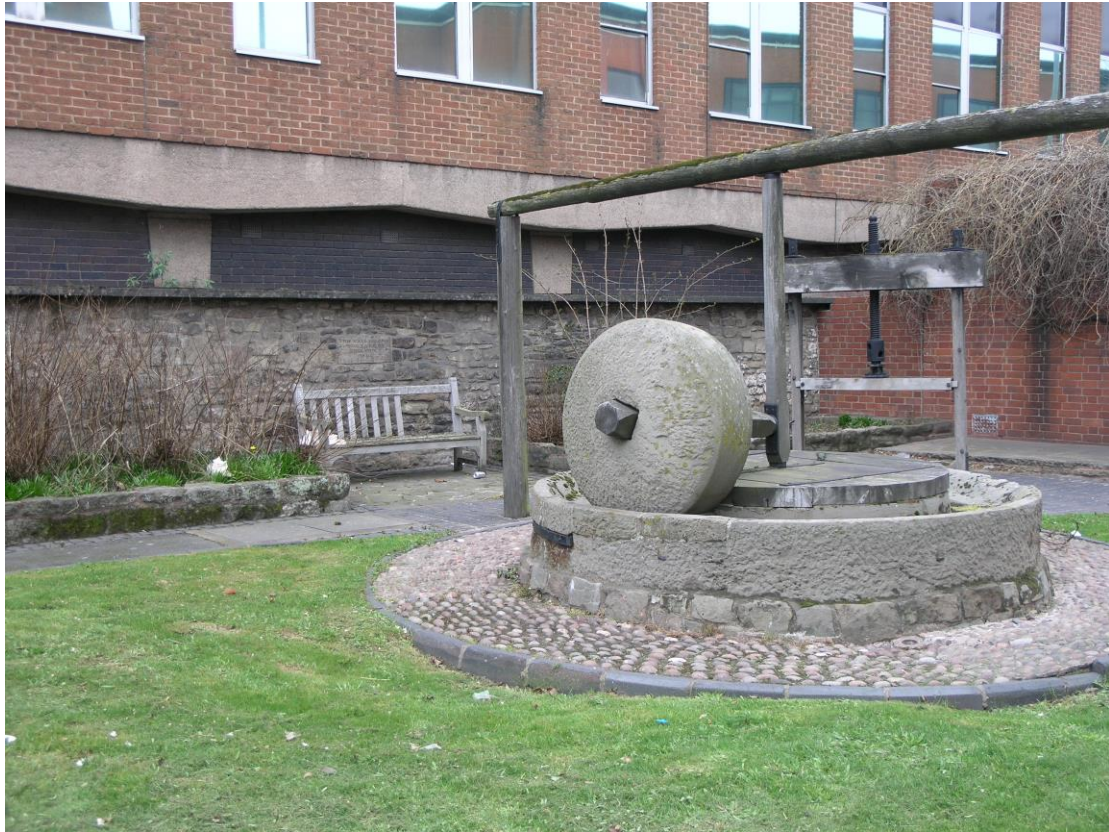
The Bath Street Police Station and the wall incorporated in its front elevation. The wall to the right is the electricity sub-station

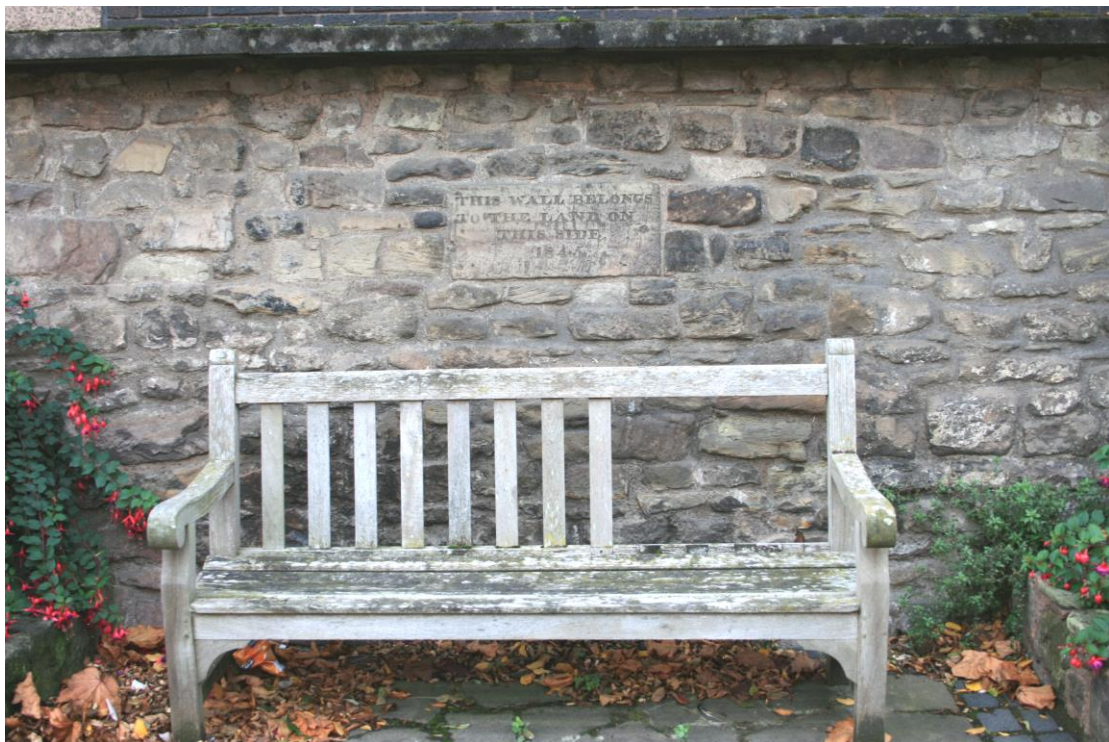
The (rebuilt) wall in front of the Bath Street Police Station. The plaque reads 'This wall belongs to the land on this side [ie the former ditch] 1845'

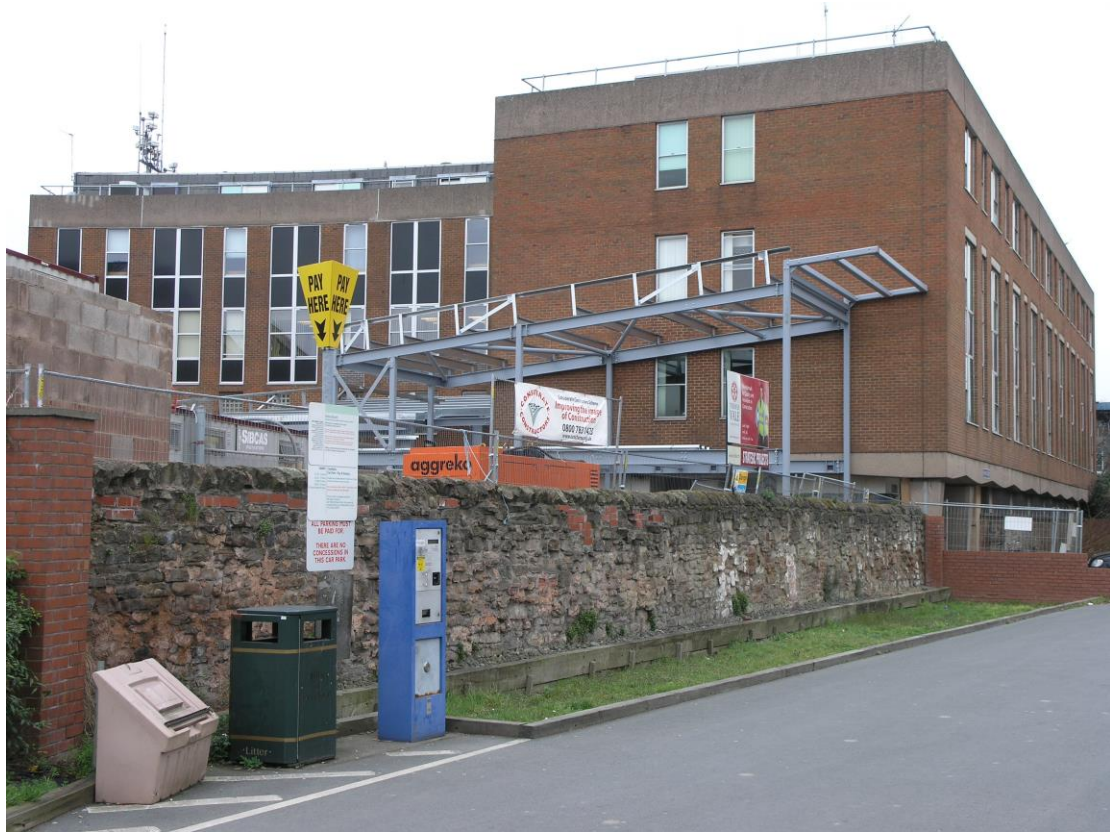
The wall and its setting to the east of the Bath Street Police Station

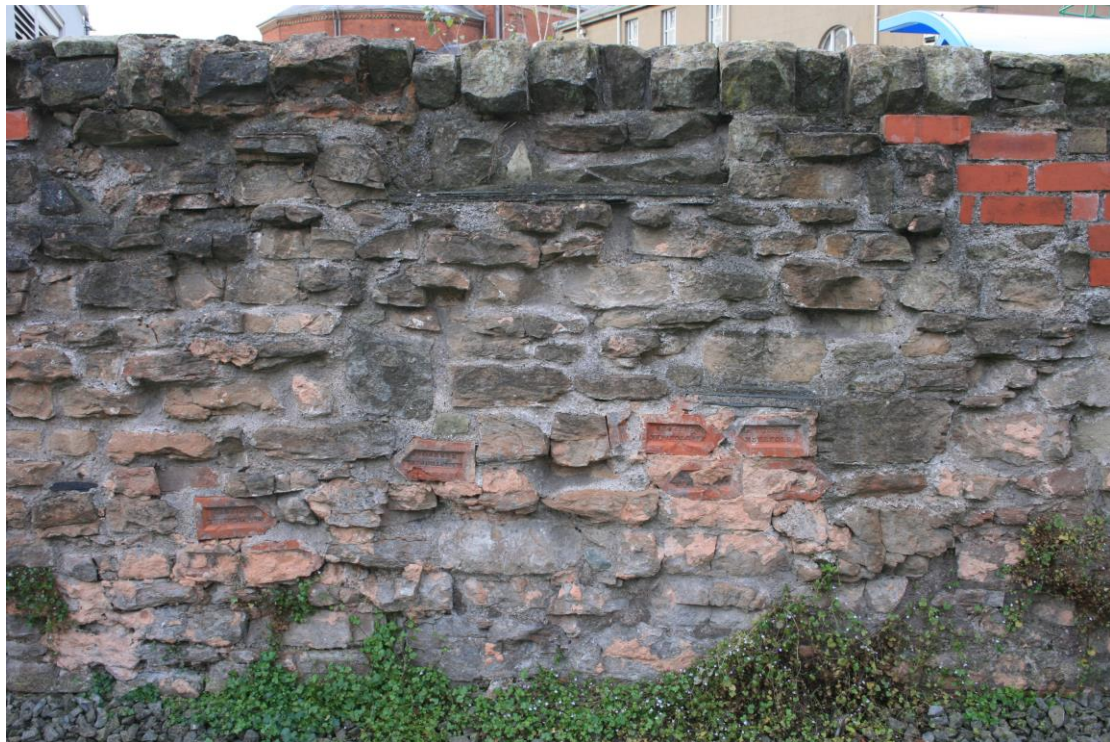
Detail of the rebuilt wall section making extensive use of 19th-century brick at the rear of the car-park east of the Bath Street Police Station

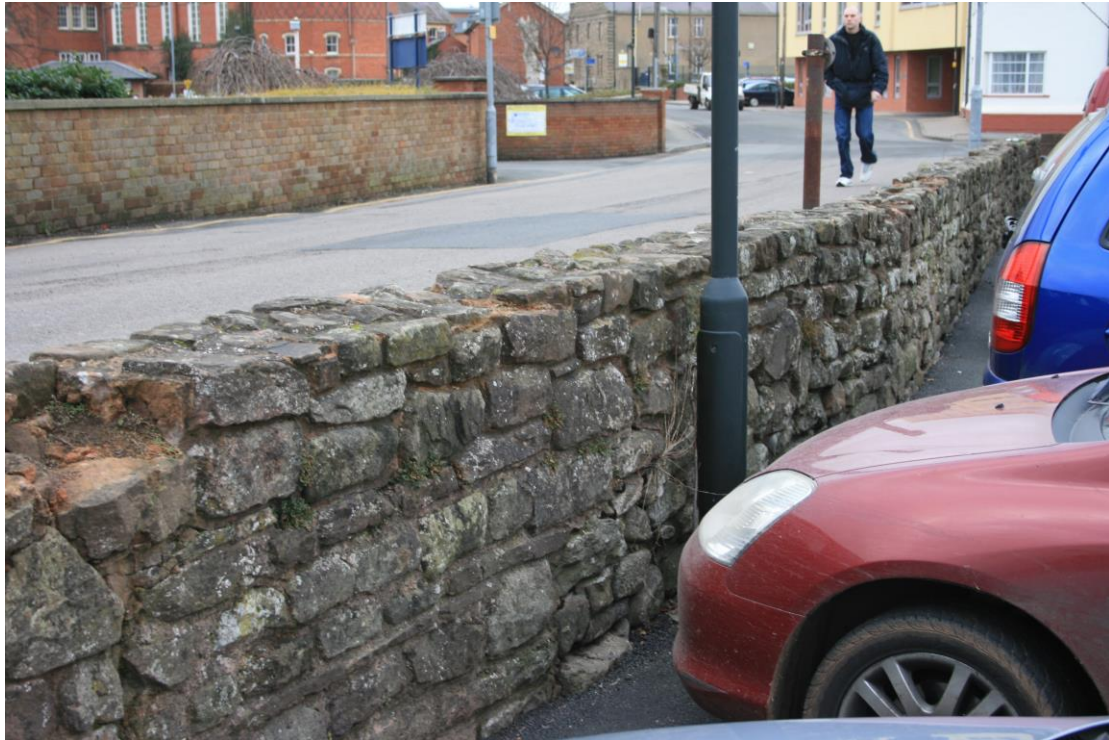
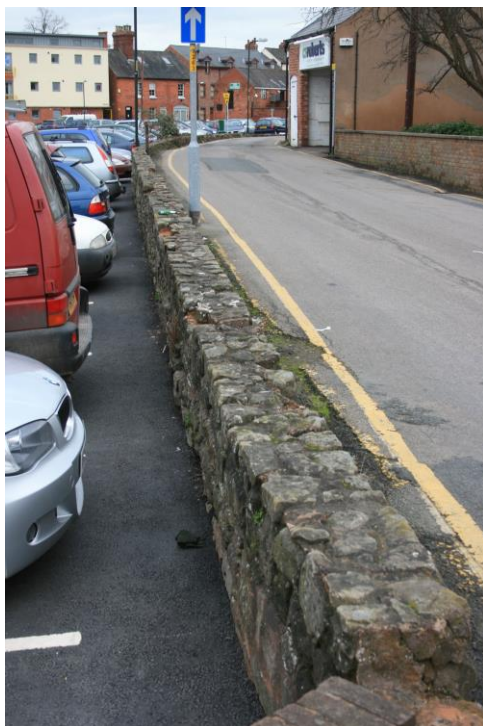
The Gaol Street/Bath Street car park wall, looking west (above), east (below). The wall beyond the lamp-post (above) is entirely modern; in front of the lamp-post the more regularly coursed masonry picks up the line of the medieval city wall. Gaol Street behind is at a higher (rampart-top) level than the car park (in the ditch)

The wall here is in fair condition: there is some ivy growth on the exposed face and a need for re-pointing in some areas. The principal issue here is a lack of interpretation: there is no clue that this low retaining wall is part of the city wall circuit, leaving it more vulnerable than it would be were its significance to be more easily apparent.

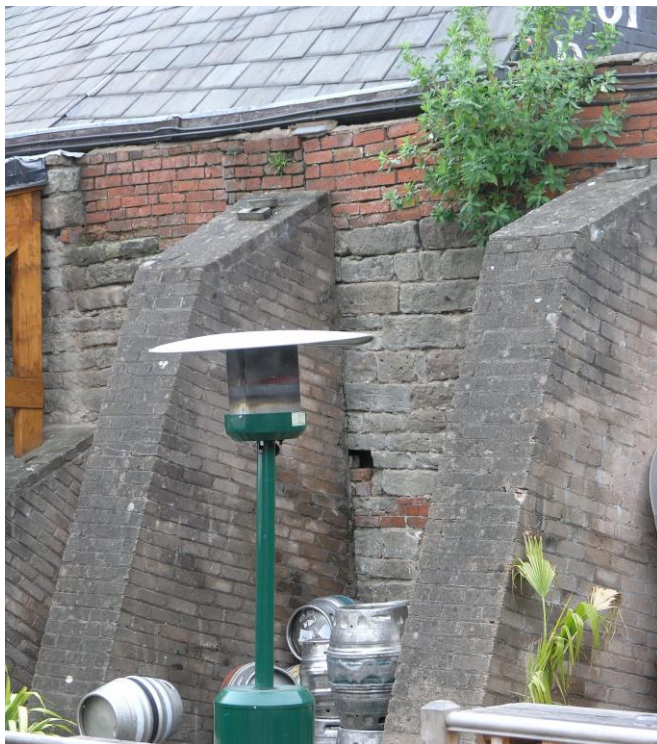
The city wall (outer face) in the yard at the rear of the Barrels pub on St Owen Street (2008). The modern buttressing hides much of the unique masonry of this section

The exposed sections of city wall either side of St Owen's Street are in generally sound condition and are maintained as they form components of party walls between adjacent properties. The substantial outward lean (about 300mm out of plumb in a wall of c.3m height) of the wall in the Barrels yard appears to have been stabilised by the buttresses, though these are most unattractive and are substantial enough to obscure much of the monument. More sympathetic and less obtrusive buttressing would improve the monument and its immediate setting.

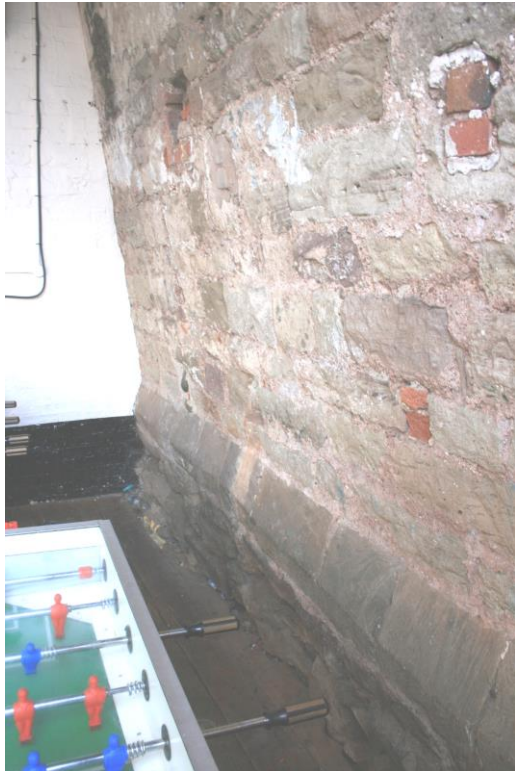
Detail of the wall in the Barrels, showing the extreme outward lean and the chamfered ashlar plinth with foundation courses below

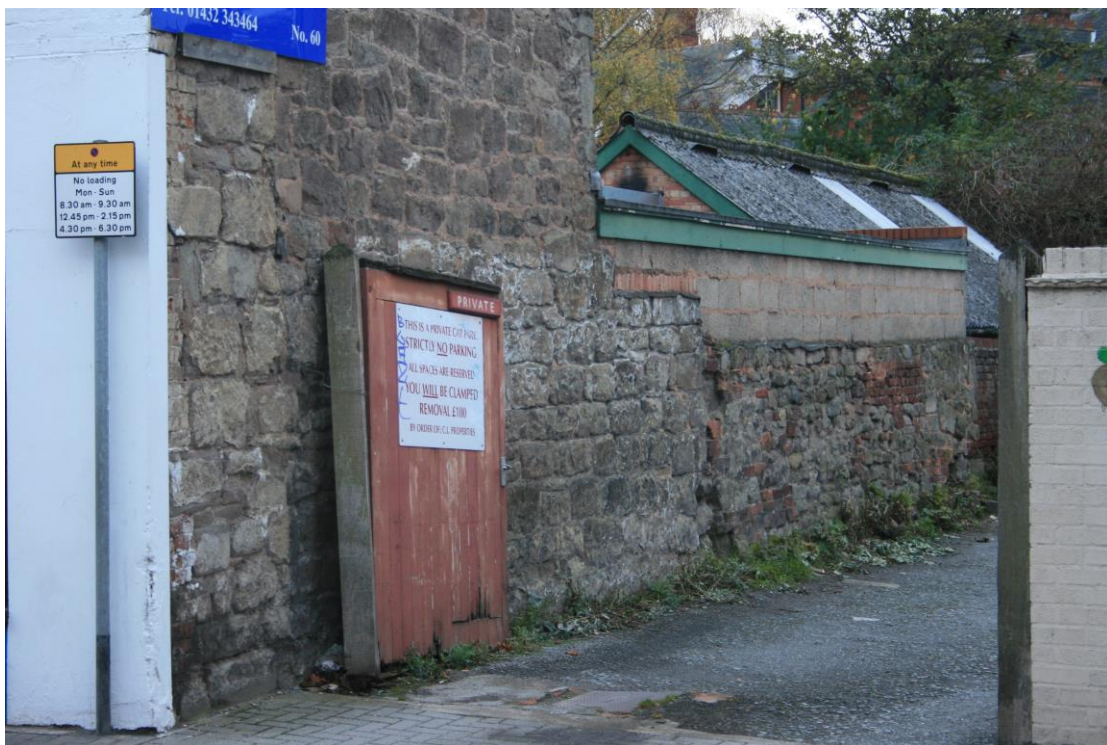
The city wall (inner face) on the south side of St Owen Street. There are clear differences between the ? primary masonry at ground-floor level, the upper floor of the frontage building, and the garden wall to the rear on the city wall line

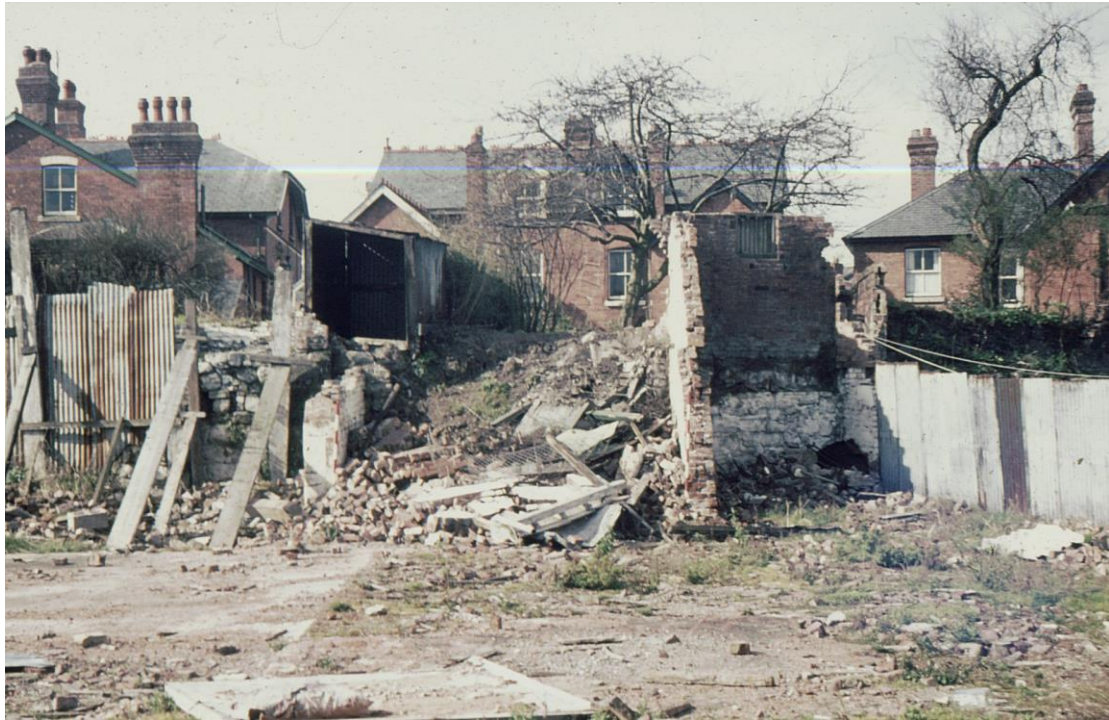
The city wall between Cantilupe Street and Mill Street prior to the excavation of 1972 (photo: Ron Shoemith)
