Hereford city defences a conservation management plan

Part two: Gazetteer

Herefordshire Archaeology Report 292

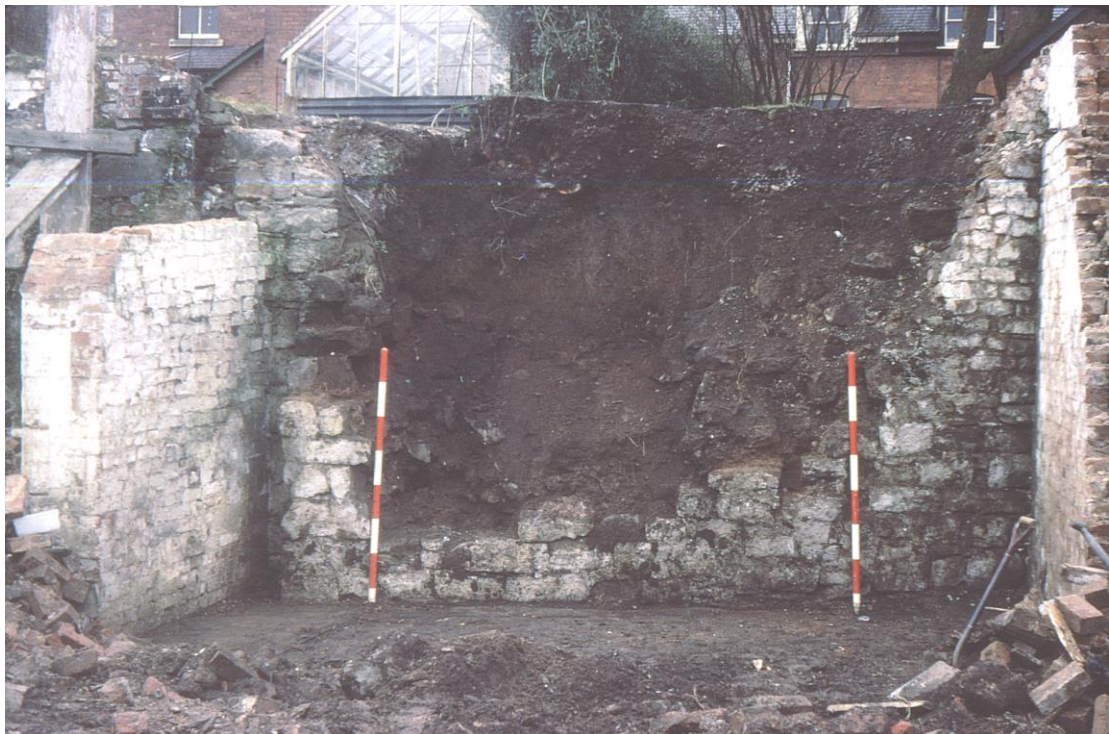
Photograph of the Mill Street – Cantilupe Street wall after removal of collapsed debris, immediately prior to excavation in 1972. (Photograph: Ron Shoemith)

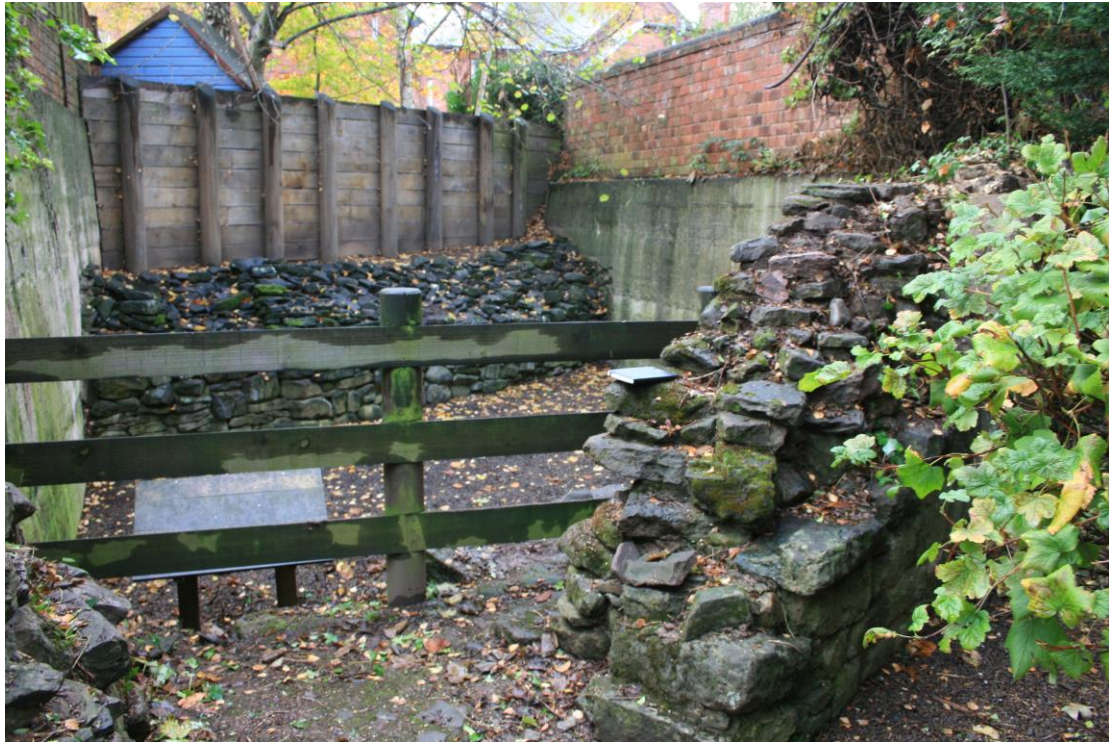
The preserved Cantilupe Street excavation site. The city wall is in the foreground; the 10th-century (stage 3) pre-Conquest wall is in the background below the reconstructed stage 2 palisade

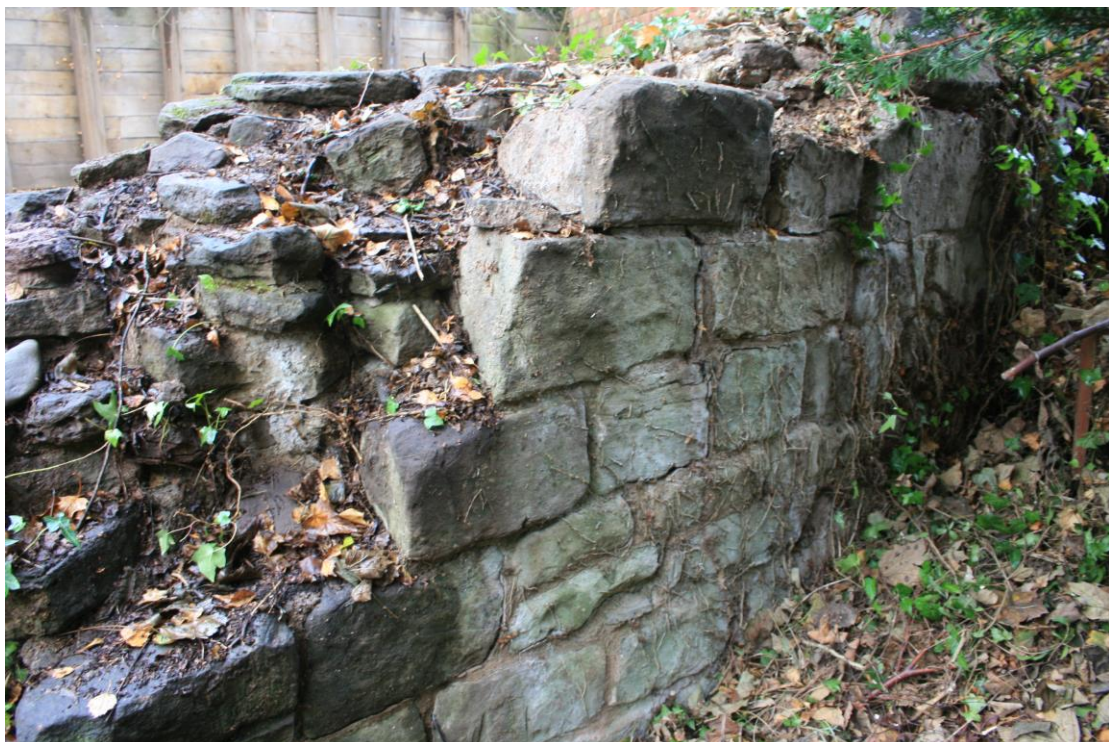
The city wall to the north of the entrance to the Cantilupe Street excavation. Excavation showed the face in this area to have been substantially rebuilt, possibly in the Civil War

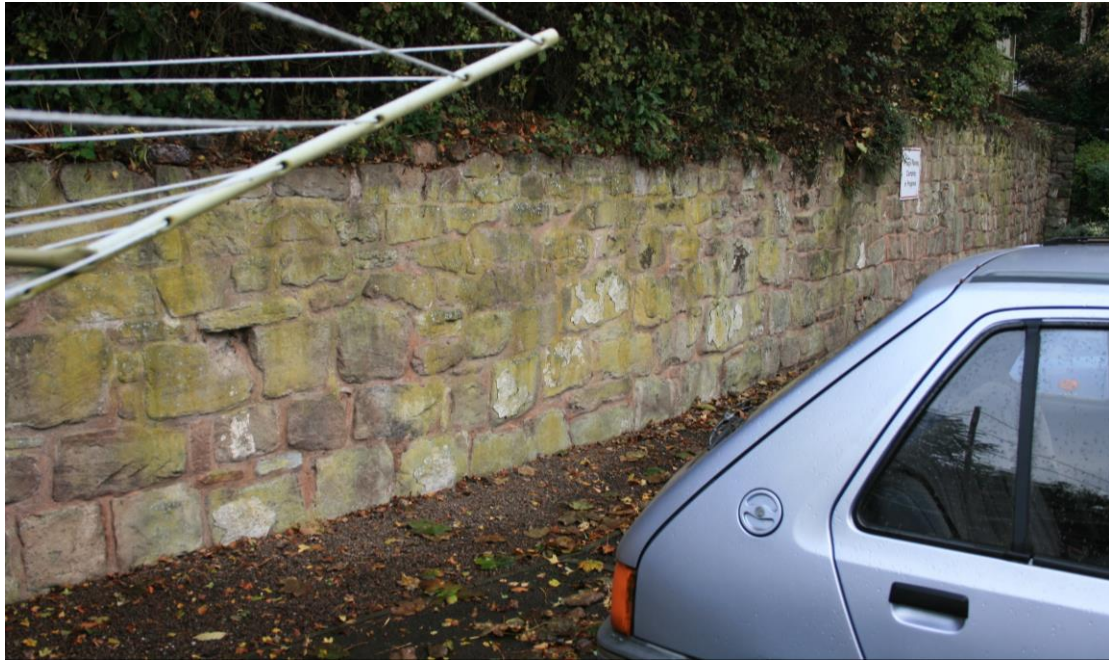
The wall, retaining the higher ground of the pre-Conquest ramparts, to the south of the Cantilupe Street excavation site

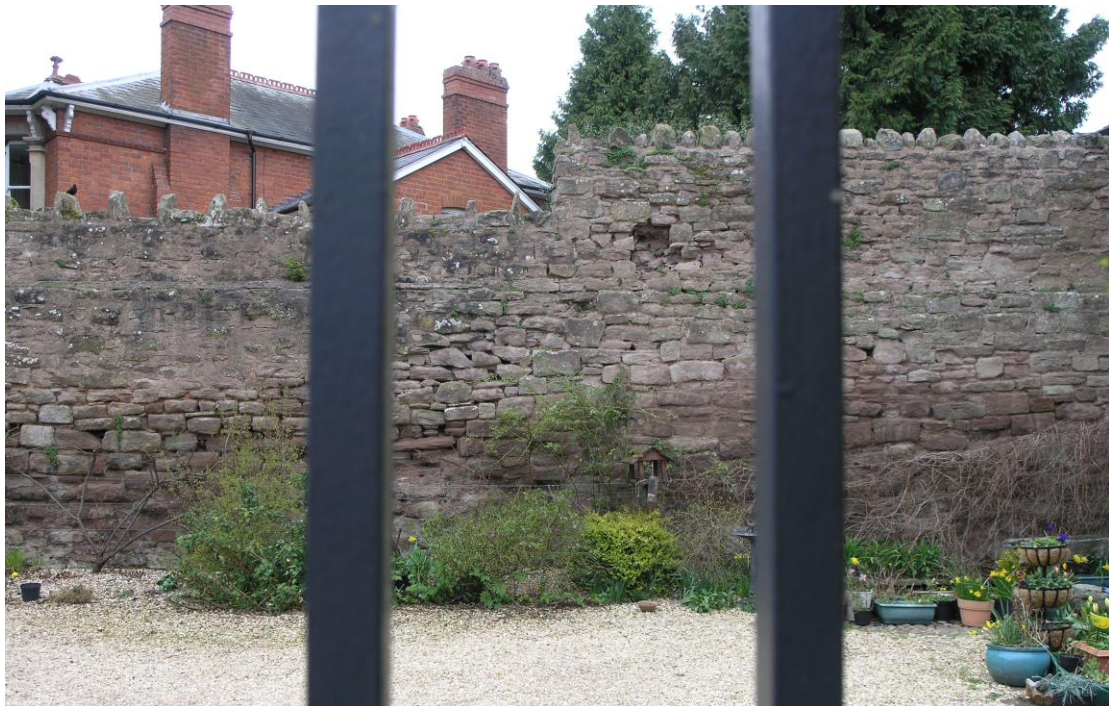
The wall in the garden of 14 Mill Street. The offset ledge marks the transition from the retaining wall to the garden wall on top. The condition of the wall in terms of missing and eroded stones, voids and lack of pointing is evident

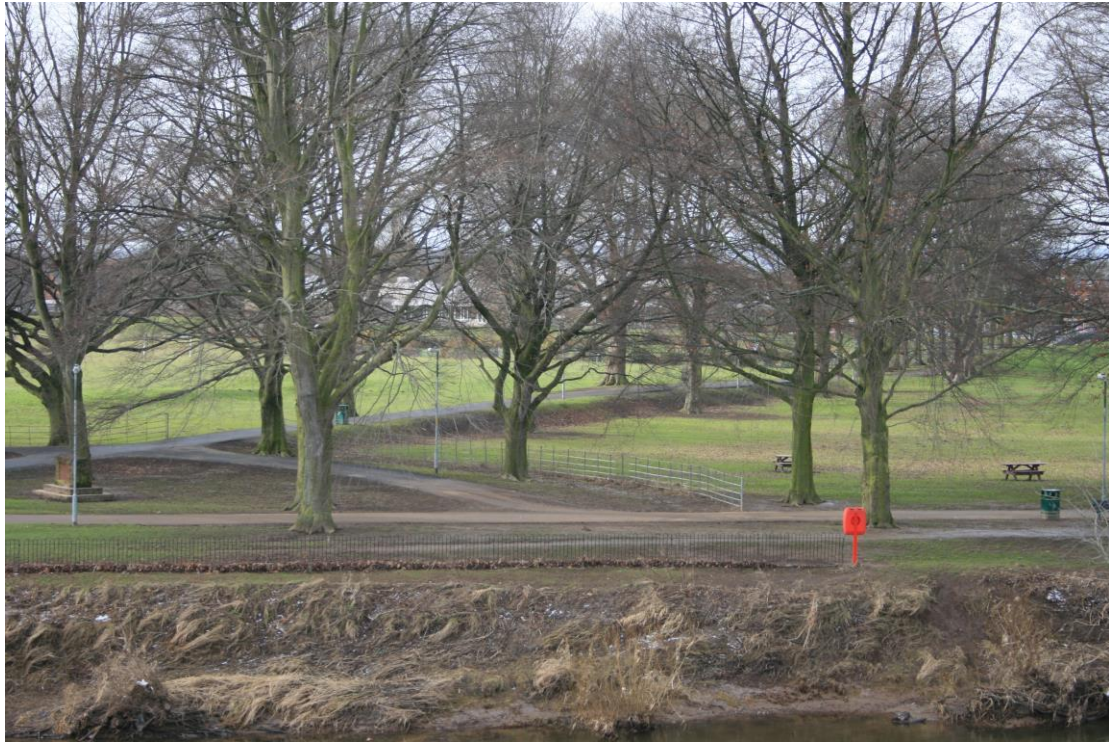
The Bishop's Meadow Row Ditch: general view from the castle, looking south-west across the river

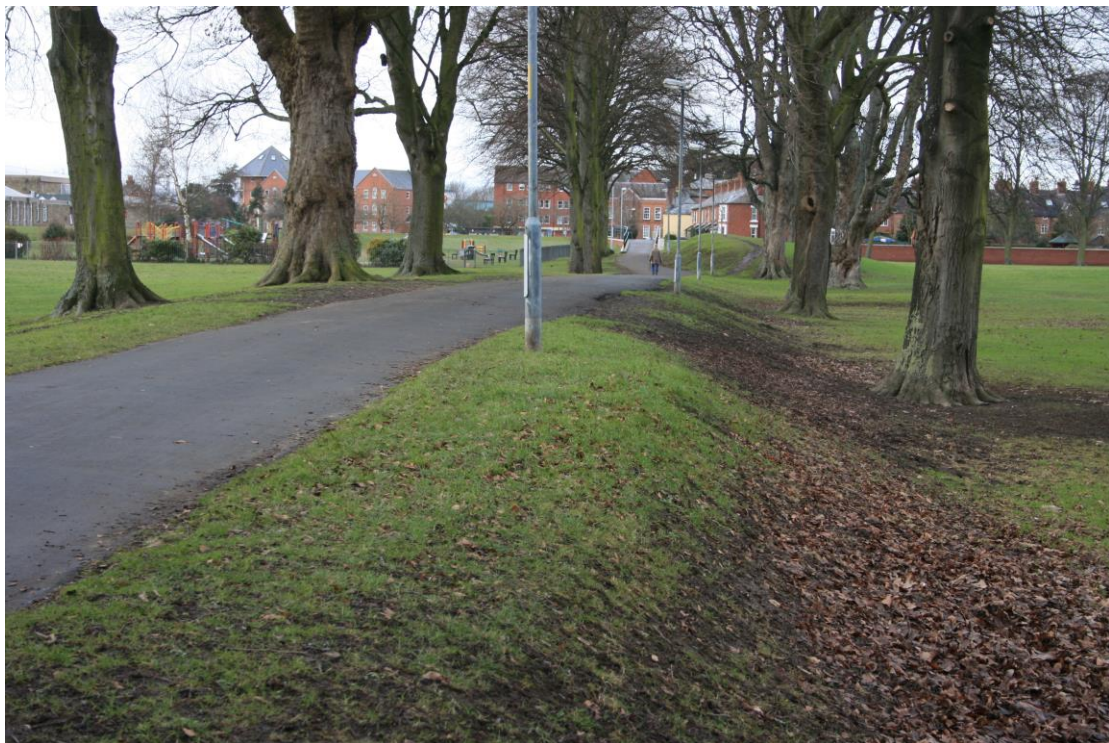
The Bishop's Meadow Row Ditch: eastern section, looking west

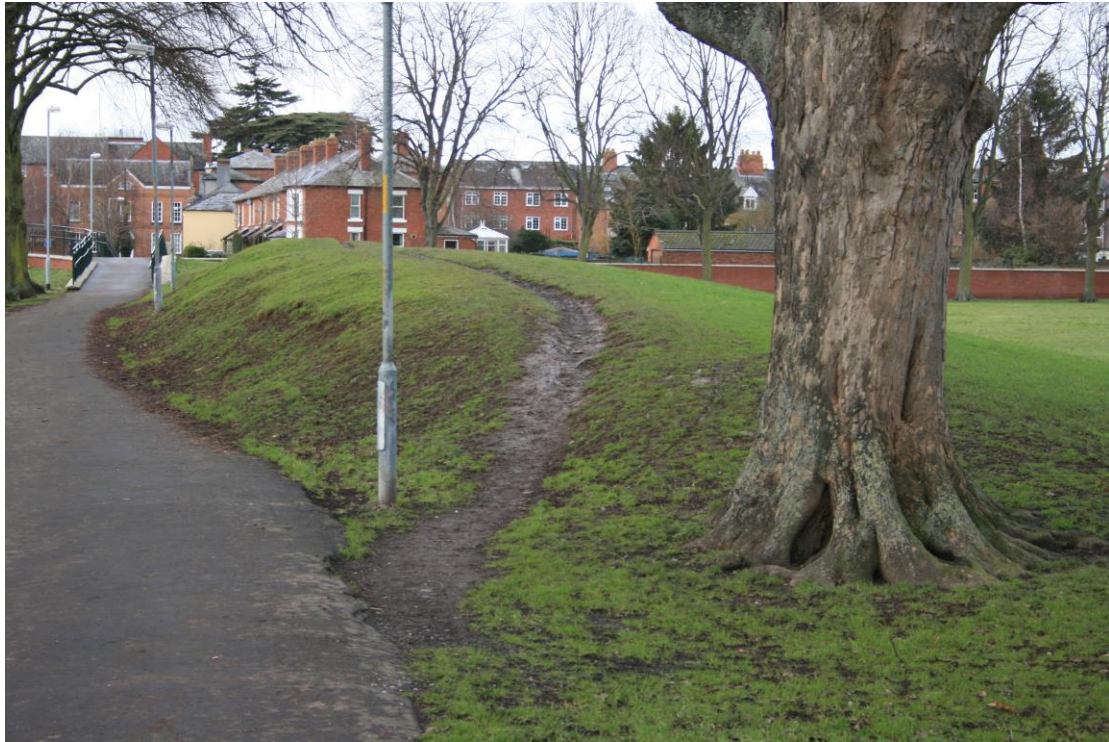
The Bishop's Meadow Row Ditch: western section, looking west

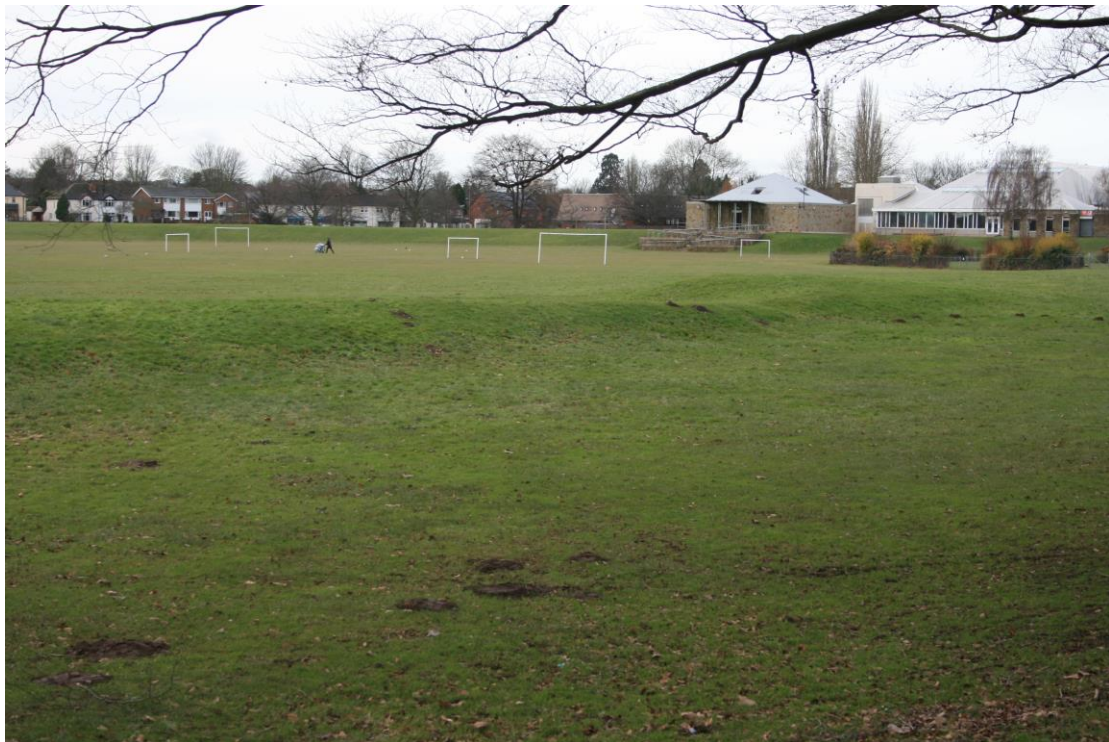
Possible Civil War battery earthwork to the south of the eastern section of the Bishop's Meadow Row Ditch

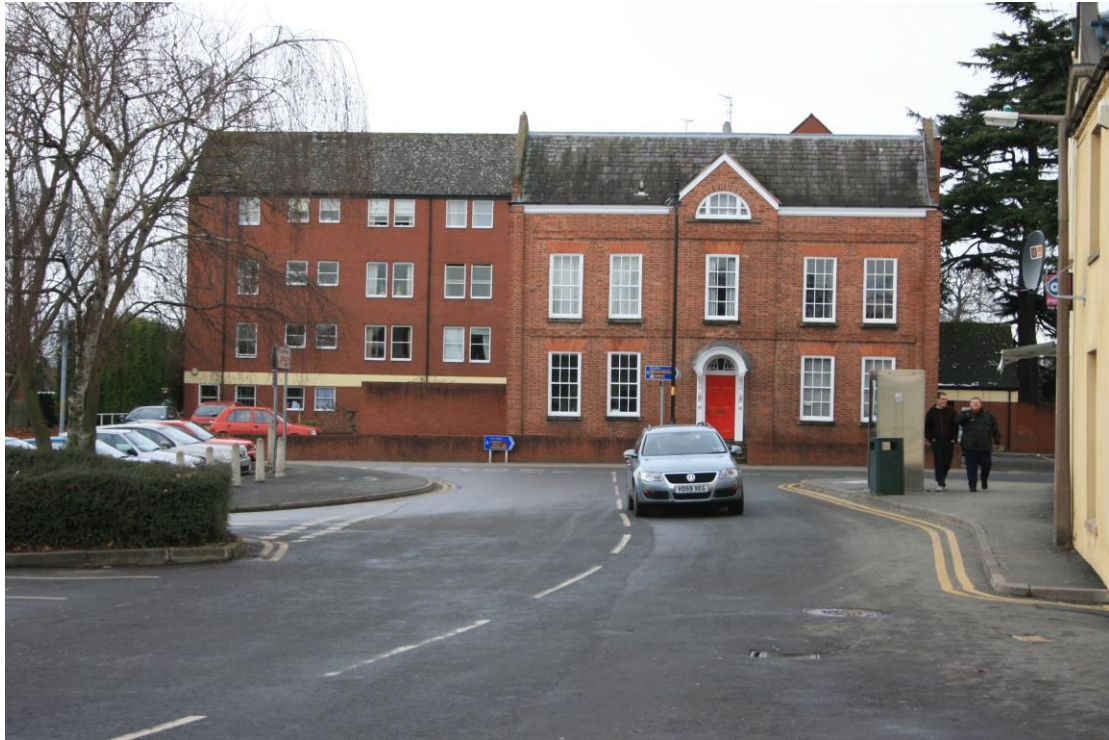
The line of the Bishop's Meadow Row Ditch heading west under Drybridge House. The rampart lies under the 18thC house; the ditch was investigated below the extension to the left (south). Levels dropping from right to left (foreground)

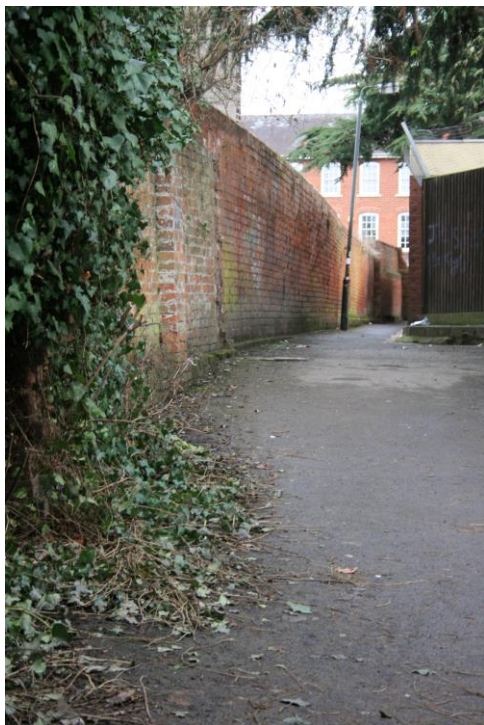
Levels dropping into the infilled ditch of the Bishop's Meadow Row Ditch to the north of Drybridge House at the rear of the St Martin's Street plots

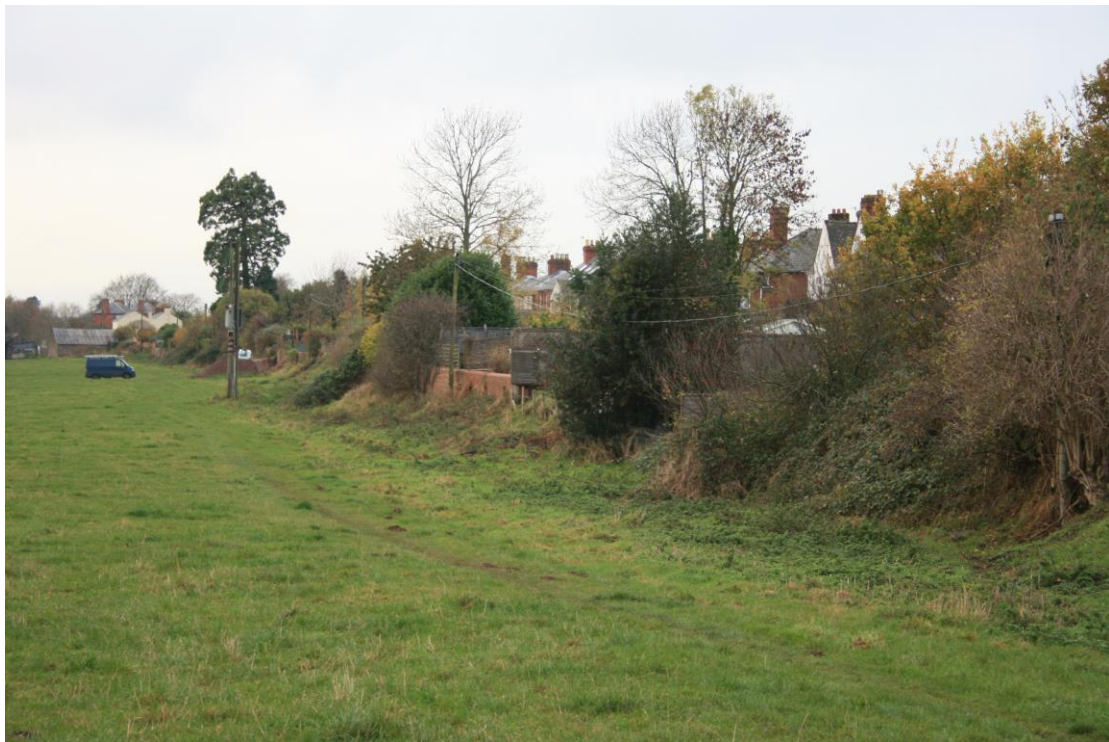
The Bartonsham Row Ditch, looking west from towards the east end of the monument

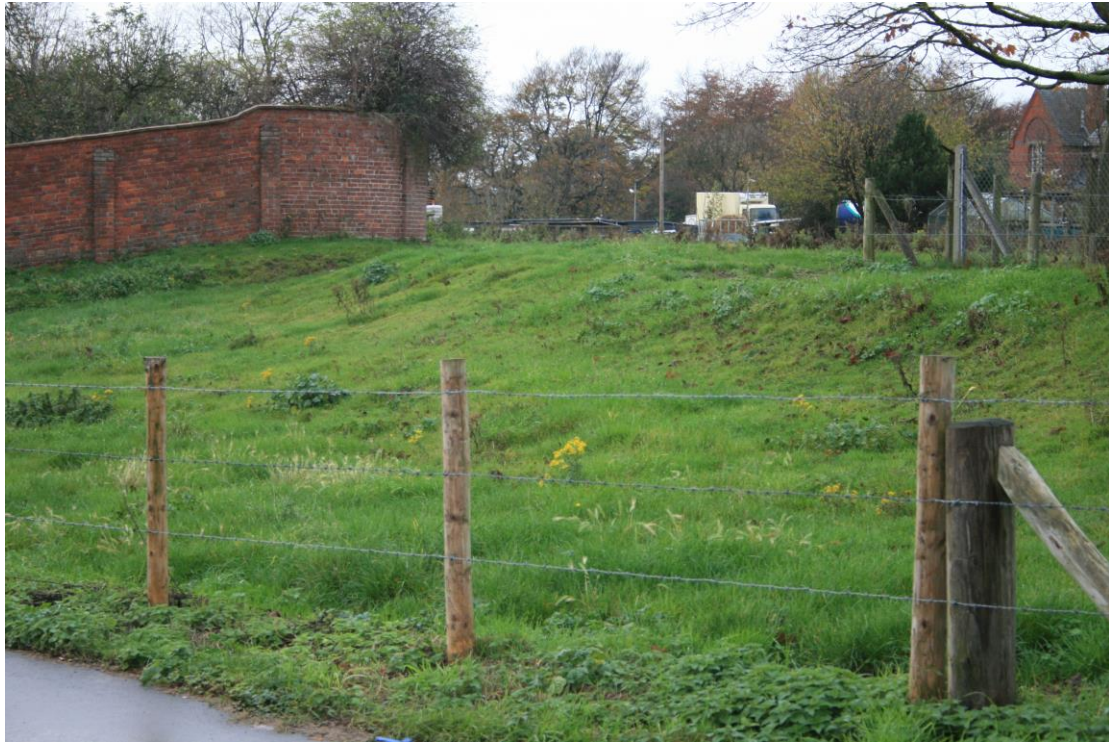
The Bartonsham Row Ditch: the rampart, west of Bartonsham Farm

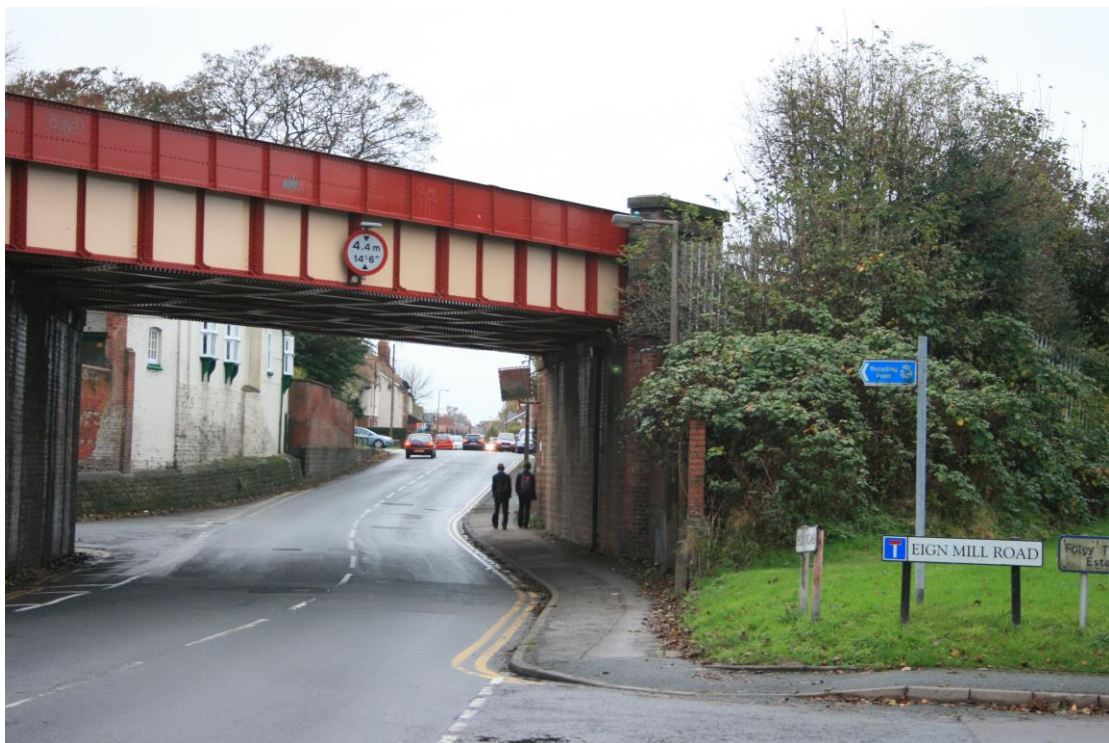
The probable line of the Bartonsham Row Ditch crossing Eign Road, reinforcing the rise in ground level up from the Wye/Eign Brook floodplain
