Eaton Camp, Ruckhall, Eaton Bishop CP New Steps Watching Brief

**Herefordshire Archaeology Report No. 297
EHE 1919**

NGR: SO 45380 39330
EHE 1919

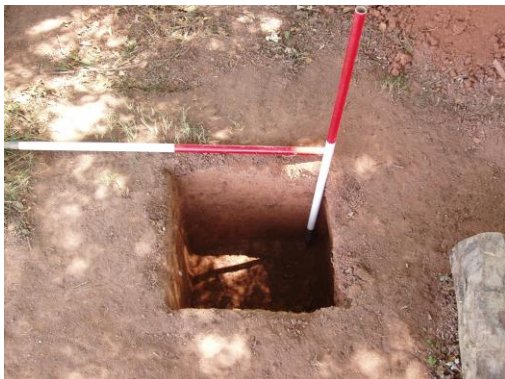
Trench 1 lay to the west of Trench 2 and was excavated with the intention to facilitate a 'locking' gate post. The trench measured 0.50m x 0.50m and excavated to a depth of 0.60m.

Figure 4: Trench 1 at the end of excavation, view to the south. © Herefordshire Archaeology

The topsoil, context/unit 001 consisted of a light brown semi loam/leaf mould of friable compaction. The deposit measured c.0.14m thick.

The topsoil overlay a deposit of plough soil context/unit 002, the horizon measured c.0.27m thick. The deposit consisted of moderately compact, dark brown clay with occasional cobble/gravel inclusions and charcoal flecking. Underlying this deposit was an earlier horizon interpreted as plough soil, context/unit 003. The deposit was not fully excavated and was investigated to depth of c.0.20m. The horizon was red brown clay with gravel/cobble inclusions and occasional charcoal flecking.

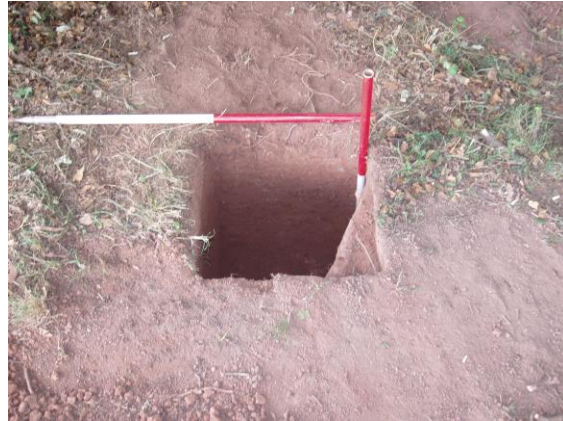
Trench 2 lay to the east of Trench 1 and was excavated with the intention to facilitate a 'swing' gate post. The trench measured 0.50m x 0.50m and excavated to a depth of c.90m.

Figure 6: Trench 2 at the end of excavation, view to the south. © Herefordshire Archaeology

The topsoil, context/unit 001 consisted of a light brown semi loam/leaf mould of friable compaction. The deposit measured c.0.16m thick.

The topsoil overlay a deposit of plough soil context/unit 002, the horizon measured c.0.20m thick. The deposit consisted of moderately compact, dark brown clay with occasional cobble/gravel inclusions and charcoal flecking. Underlying this deposit was an earlier horizon interpreted as plough soil, context/unit 003. The deposit was measured c.0.32m thick. The horizon was red brown clay with gravel/cobble inclusions and occasional charcoal flecking.

The underlying deposit, context/unit 004 was identified as representing the natural subsoil. The horizon consisted of very compact orange red clay with degraded sandstone inclusions; unlike the overlying deposits no charcoal flecking was apparent. The deposit measured c.0.20m thick although it was not fully excavated.
