**St Katherine's Car Park  
Archaeological Evaluation.  
Ledbury  
An Archaeological Investigation**  
NGR: SO 707 376

**Herefordshire Archaeology Report No.263**

**St Katherine's Car Park An  
Archaeological Evaluation.  
Ledbury  
Herefordshire:  
An Archaeological Investigation**

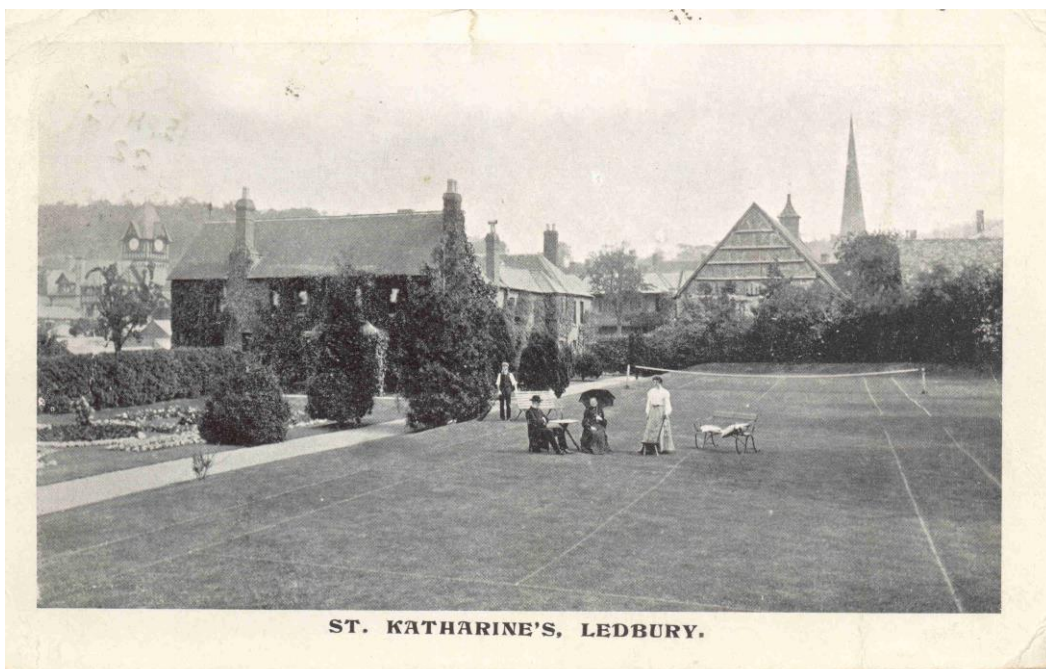
Figure 4: Postcard of 1905 showing the site under lawned tennis court and (with the exception of a bank at the eastern end) the whole area on one level.

figure 3) and a softer terraced garden laid out with fir trees on its eastern edge. It appears that this phase of garden had been dramatically levelled by 1905, (see figure 4), and laid to lawned tennis courts. It was probably during these works that the brick cistern and associated drains etc. were inserted.

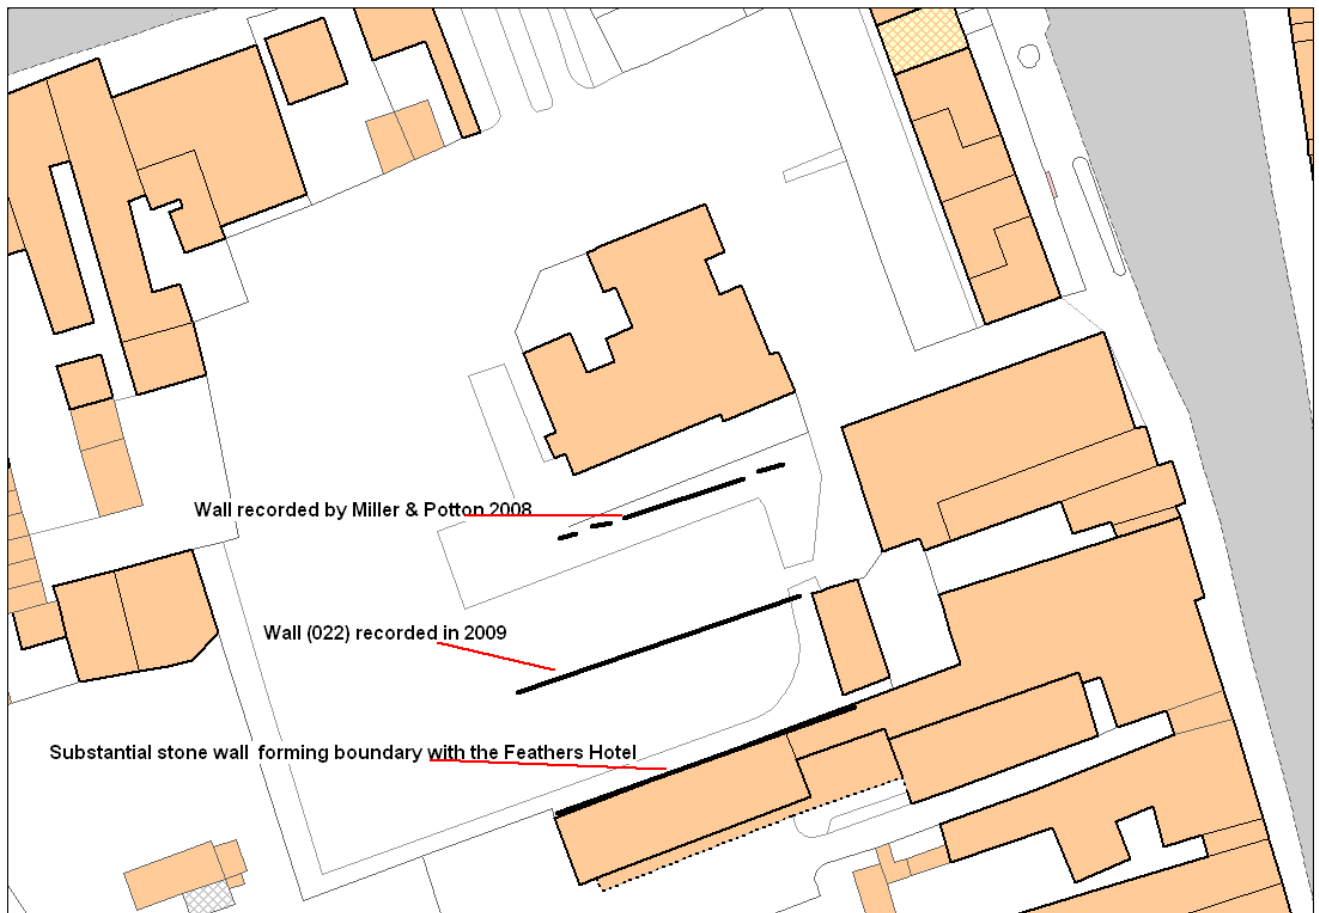
**Figure 6: Location of stone built walls showing consistent alignment and regular spacing.**

The presence of the medieval boundary wall (022), which ran on an east / west alignment through the centre of the site, raises a number of questions regarding the size, shape and location of the medieval hospital precinct. If the wall recorded during this excavation is one of a series of walls which include the length of wall recorded in the 2008 excavation and the surviving wall which forms the northern boundary of the Feathers Hotel, this could imply that these were burgage plot boundaries (see figure 6).
