**England's Past for Everyone,
Test Pit Excavations
Ledbury,
Herefordshire:
A Community Archaeological
Investigation**

Herefordshire Archaeology Report No 260

England's Past for Everyone, Medieval Ledbury: Community Archaeology Test Pit Survey.

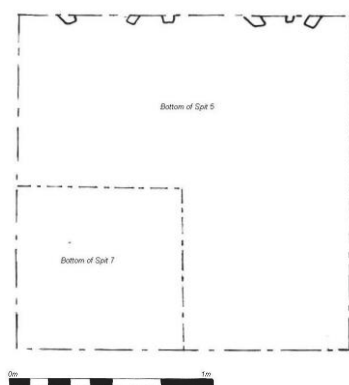
Figure 4: Trench plan of test pit 1 (scale 1:20) indicating location of sondage and protruding brick foundations associated with the Victorian track way. © Herefordshire Archaeology

At a depth of c.0.3m (Spit 3) within the east-facing section of the trench the buried remains of a Victorian footpath were uncovered aligned north south. The footpath was constructed using a brick/rubble foundation on top of which a layer of gravel was placed. The overall feature measured c.0.2m thick.

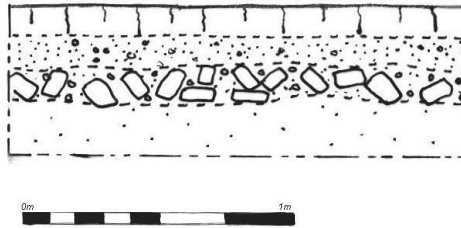
Figure 5: West section (scale 1:20) of test pit 1 showing a cross-section through the Victorian track way. © Herefordshire Archaeology

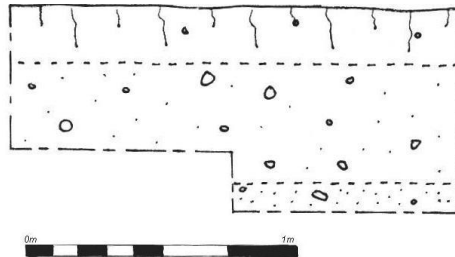
Figure 6: East section (scale 1:20) of test pit 1 showing the full depth of the sondage. All of the horizons recorded are attributed to post-medieval land movements. © Herefordshire Archaeology

Underlying the topsoil was a compact mixed clay matrix with inclusions of brick, tile and plaster to a depth of 0.7m. Artefacts from within these horizons included iron nails, glass, clay pipe, ceramics and disarticulated bone. The mixed clay deposit is likely to represent post-medieval land disturbance linked to the construction of the current Abbot's Lodge.

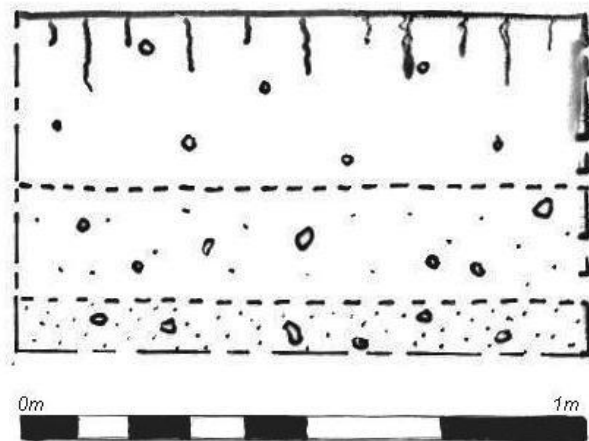
Figure 7: East section of test pit 1 (scale 1:20), the post-medieval horizons linked to landscaping are indicated. © Herefordshire Archaeology

The topsoil was excavated in three spits (001-003) that consisted of a black-grey friable loam. At a depth of c.0.3m the topsoil gave way to a horizon of light red-brown clay and sand matrix with inclusions of brick, tile and plaster. The horizon has been related to post-medieval disturbance and landscaping. Finds of blue and white pot, glass, clay pipe and oyster shells were made. Spit 005 was similar in character.

Within Spit 006 the horizon colour had changed to red-brown clay rubble, again linked to post-medieval earth movements. Finds from within the horizon consisted of brick, tile, bone, glazed ceramic, clay pipe, glass and shell.

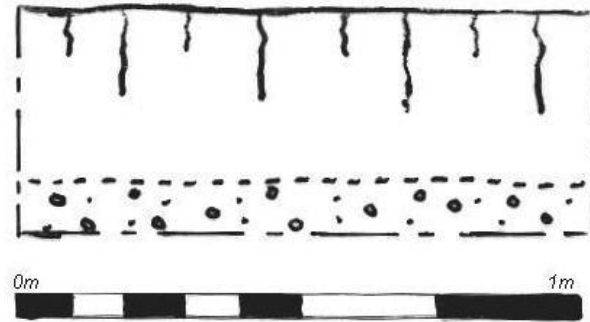
Figure 8: East section of test pit 1 indicating the depth of garden soil before reaching the post-medieval landscaping deposits. © Herefordshire Archaeology

The topsoil (Spit 1, 2 & 3) consisted of a brown/black friable clay and silt mix with inclusions of roots, charcoal and gravel/pebbles. Underlying this (Spit 4) was a horizon of orange-brown compact clay with gravel and charcoal inclusions attributed to post-medieval landscaping due to the finding of clay pipe, pottery and iron.

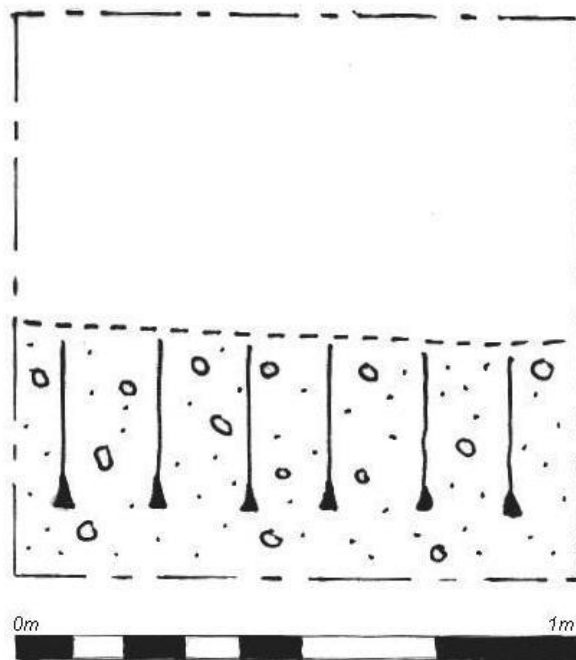
Figure 9: Plan of test pit 2 showing the course of a Georgian/Victorian path within the southern half of the trench. © Herefordshire Archaeology

The topsoil (Spits 1 & 2) consisted of a brown/black friable clay and silt mix with inclusions of charcoal and root. The underlying spits (3 & 4) had similar characteristics in that they were yellow/grey-brown clay with inclusions of charcoal, occasional stone and roots. Post-medieval finds of brick, tile, glass and iron slag. Cutting Spit 3 and Spit 4 within the south of the trench aligned east west was the remains of a Victorian/Georgian track constructed of gravel laid upon a brick rubble foundation. The gravel surface of the track had a camber that dipped down within the centre of the trench to the north. The discovery of iron slag and charcoal complement the documentary evidence for there being a Smithy on the site during the late 17th early 18th centuries.

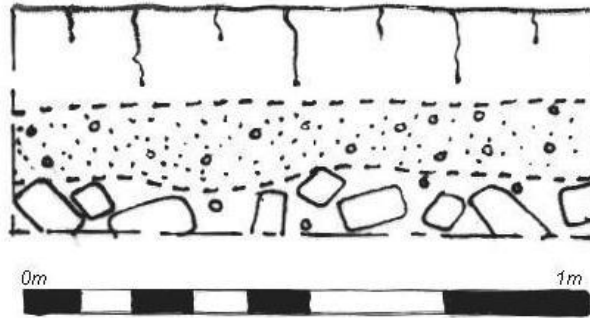
Figure 10: South section of test pit 2 showing a cross-section through the Georgian/Victorian path. © Herefordshire Archaeology

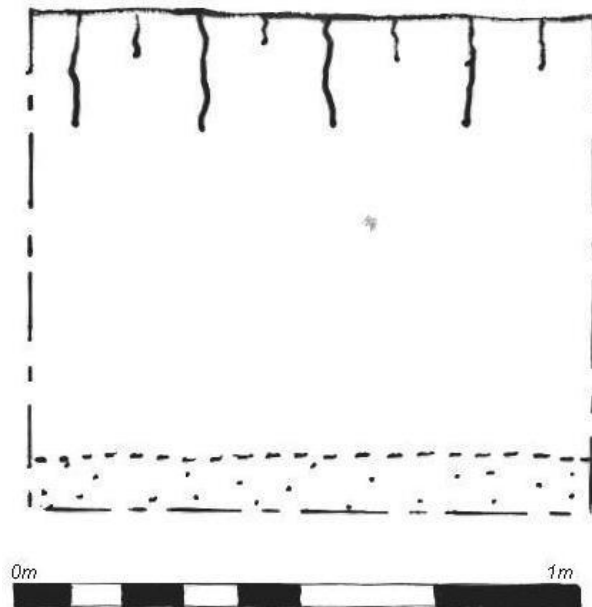
Figure 11: West section of test pit 1 indicating the depth of the modern groundwork's before encountering post-medieval activity. © Herefordshire Archaeology

A topsoil of 0.9m was encountered during the excavation and can be attributed to modern landscape due to the finding of plastic bags and tin cans! The horizon consisted of a dark brown friable compost type soil with a mixture of modern and post-medieval pottery and glass shards.

Within Spit 9 a horizon of red-brown mixed clay and sand was encountered and was excavated to a depth of 1.0m. The horizon of Spit 9 is very similar in character to the post-medieval horizons found elsewhere within Ledbury. No finds were uncovered within this horizon.

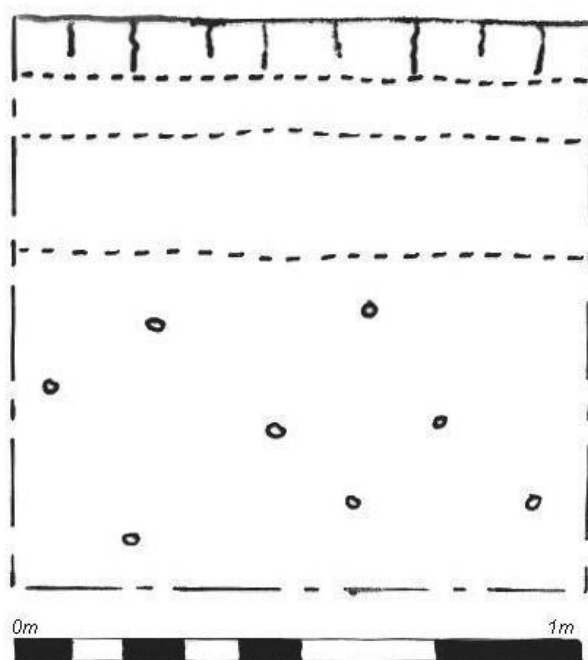
Figure 12: South section of test pit 1 indicating the thick layer of re-deposited natural with degraded sandstone inclusions. © Herefordshire Archaeology

Excavation of Spit 5 to 10 uncovered a layer of compact re-deposited red clay with inclusions of degraded sandstone. Within Spit 7 the clay was sealing a north-south aligned lead pipe that once connected the outhouse to the south with the cottage. Post-medieval finds of tile and pottery were retrieved from spits 5 and 6 but none underlying these.
