Church of the Holy Trinity, Preston Wynne Herefordshire, A Desk Based Assessment

**Herefordshire Archaeology Report No. 371
Event No. EHE80327**

This report (EHE 80194) provides an account of a Desk Based Assessment, detailed digital survey and geophysical survey of the Church of the Holy Trinity and its associated Church Yard.

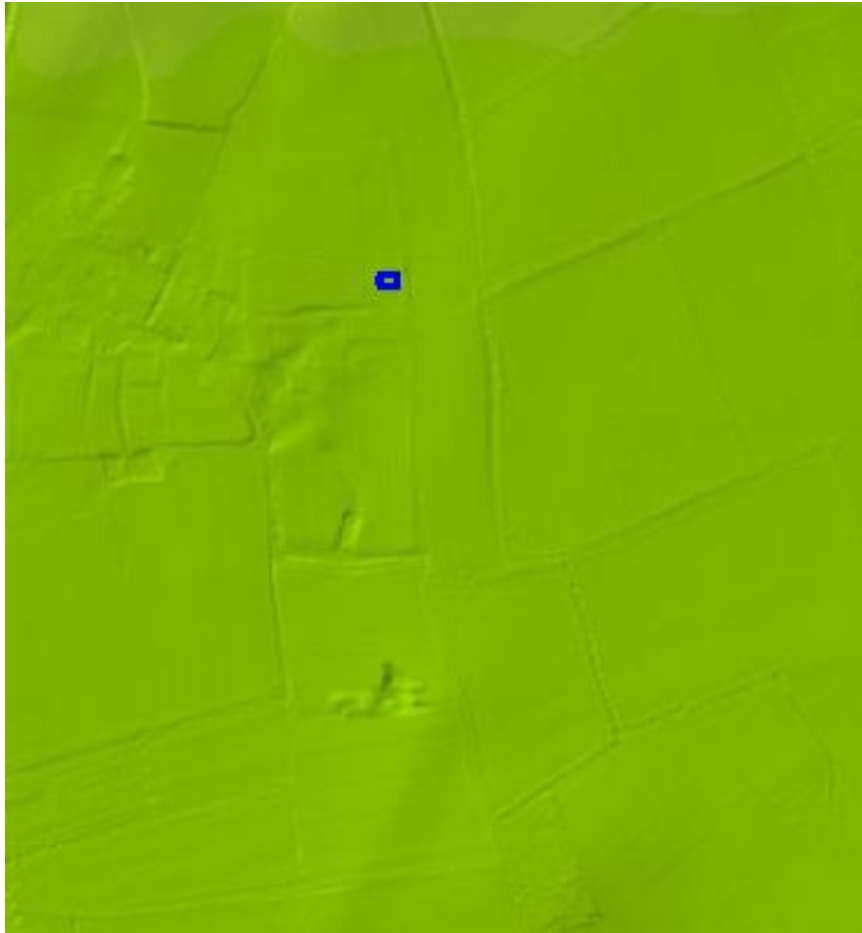
Figure 5: 2m LiDAR data, the church is outlined in blue. © Crown copyright and database rights (2013) Ordnance Survey (100024168)

The available LiDAR data (Figure 5) is unfortunately the 2m data and therefore only shows the largest of surface features. Even this however begins to show the complexity of earthworks to the south and south west of the church.

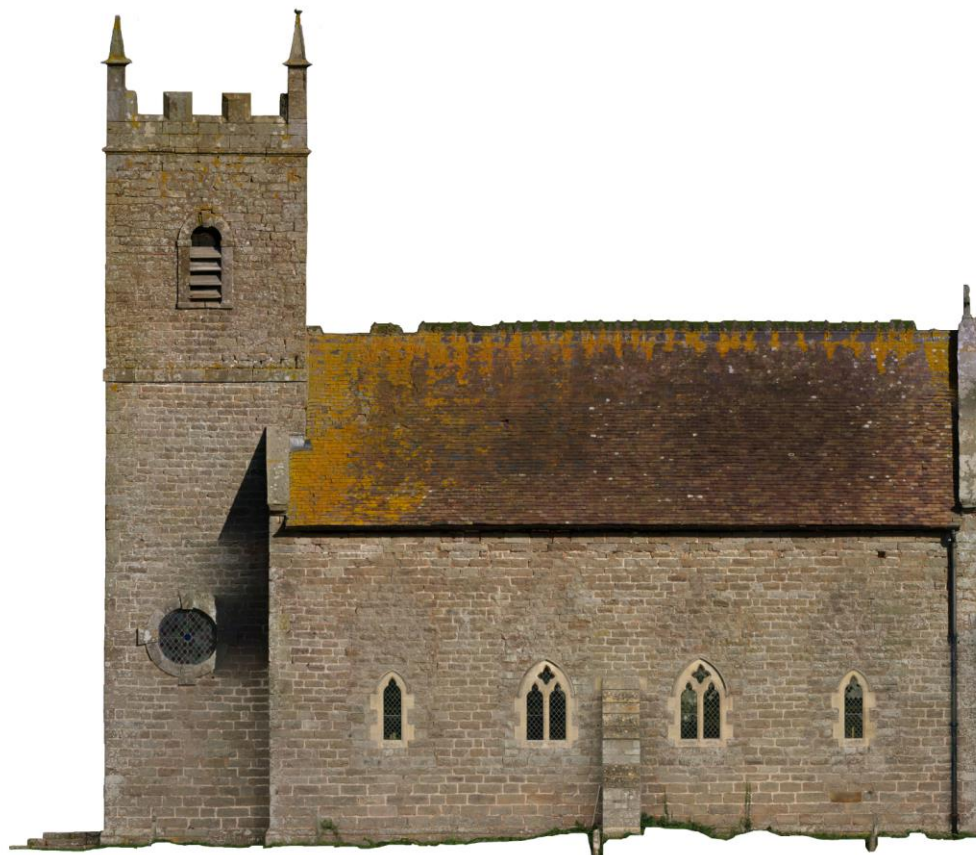
Church of the Holy Trinity, Preston Wynne, South elevation

The survey data and images provide significant detail concerning the coursing, insertion of windows, condition of masonry and pointing and the condition of the main roof and tower roof. The scarring on the southern elevation in particular shows the size of the original windows.

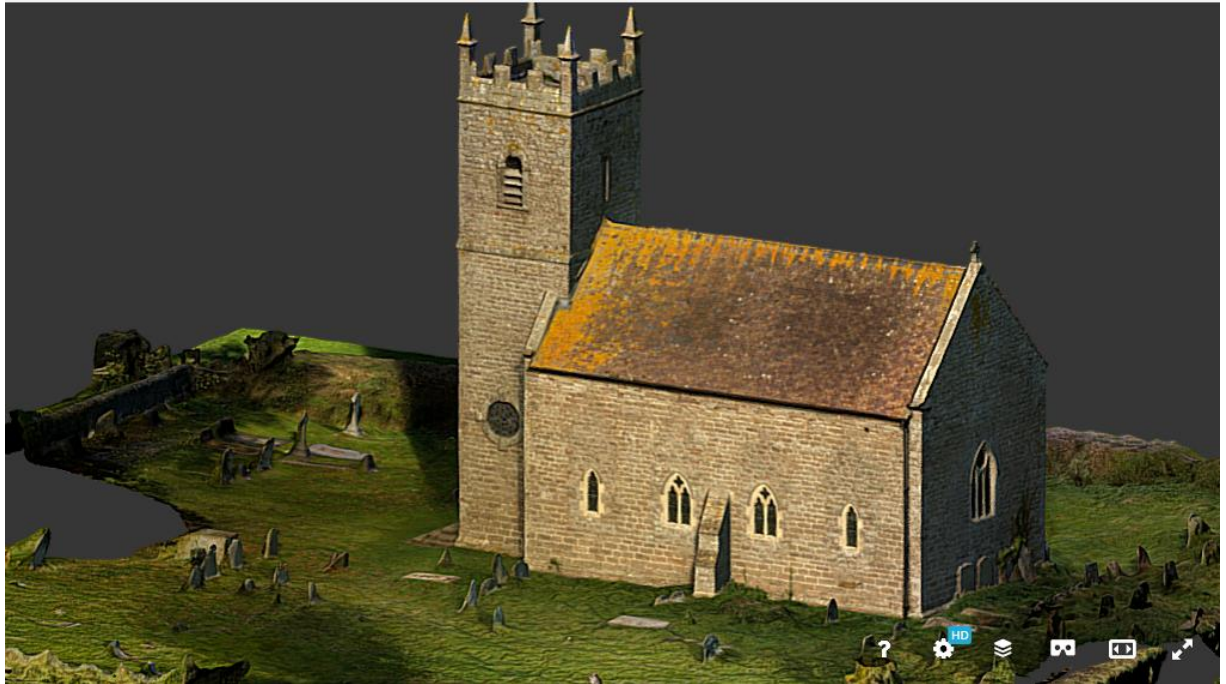
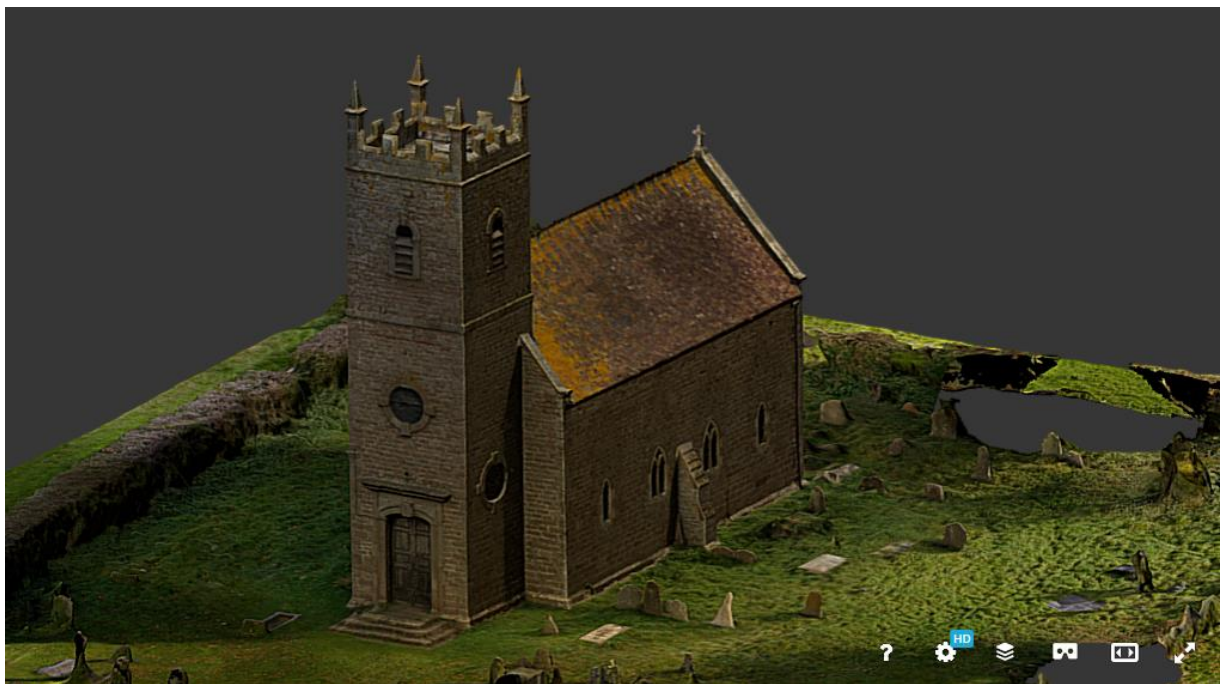
3 dimensional images (screenshots) of the modelled data.

The detailed survey has provided much useful information regarding the fabric of the building, the state of the roof, and has even shown that the tower hatch is not sitting correctly! The data from this survey should prove very useful during future works to the church.

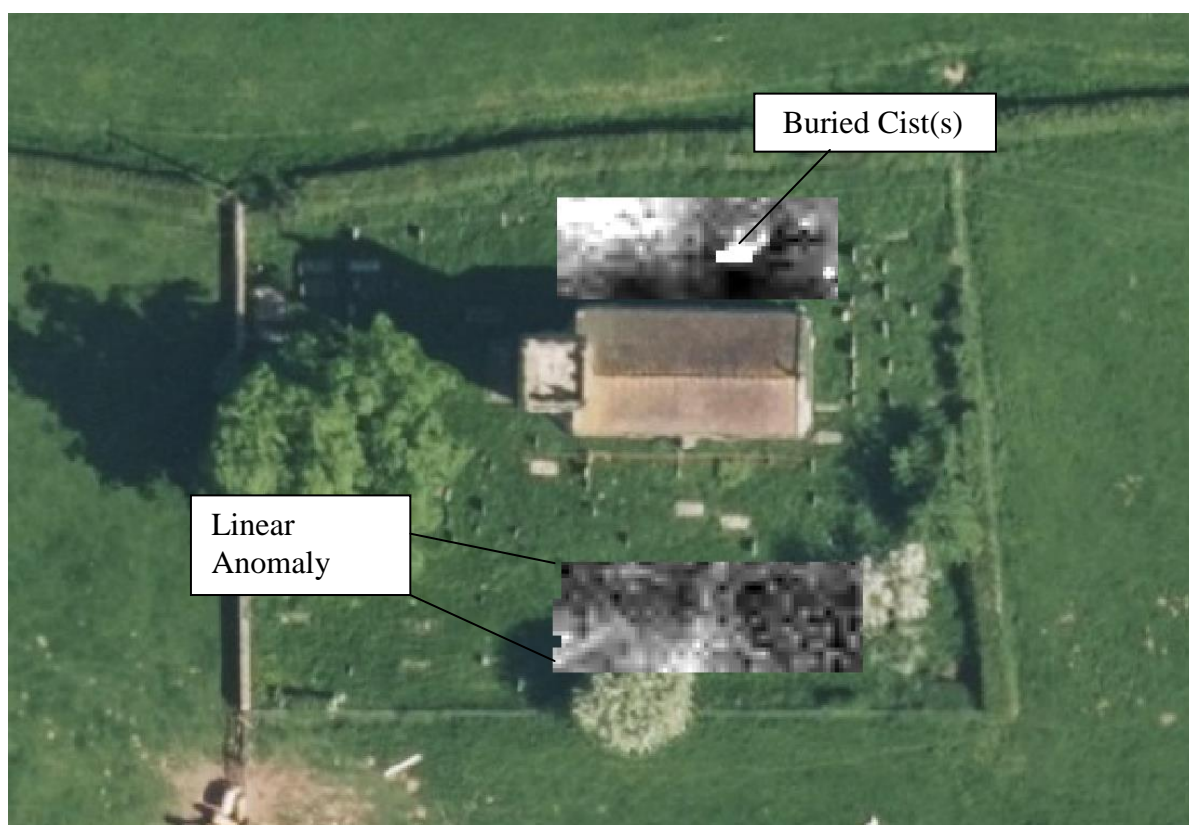
Figure 6: Resistivity Plots.

A Geophysical Survey was undertaken of the “quieter” areas of the church yard, in order to ascertain whether buried monuments were present within the northern and southern portions of the church yard. At the time of writing this report the data has only been partially looked at but despite this, Figure 6 clearly shows a large anomaly showing as a white area on the northern side of the church. The size, shape and alignment would suggest that this is either a single but large buried cist or perhaps a number of smaller cists within a family plot. There does not appear to be any other burials associated with monuments to the north of the church, however unmarked interments cannot be ruled out.

The area to the south of the church shows more disturbance – much of this may be due to rabbit burrowing, which is prevalent within this part of the church yard. However, there does appear to be a clear, hard, linear anomaly forming a 90 degree corner close to the western end of the plot. This feature is not aligned with the church or the lines of graves and appears to represent either wall lines or possibly drainage runs.

In terms of the proposed construction of the toilet and kitchen and the provision of rainwater harvesting, the western half of the plot to the north of the church appears to be the least problematical in terms of headstones, kerbed plots and chest tombs / cists.

The geophysical survey has provided at least an indication of the least problematical area for the siting of the new building and rain water tank and has also recorded potentially interesting features to the south of the church.
