### **Programme of Archaeological Observation, Investigation and Recording at Snodhill Castle, Herefordshire.**

**January 2017**

**Herefordshire Archaeology Report No. HAR 367**

**NGR SO 3223 4038  
EHE 2081**

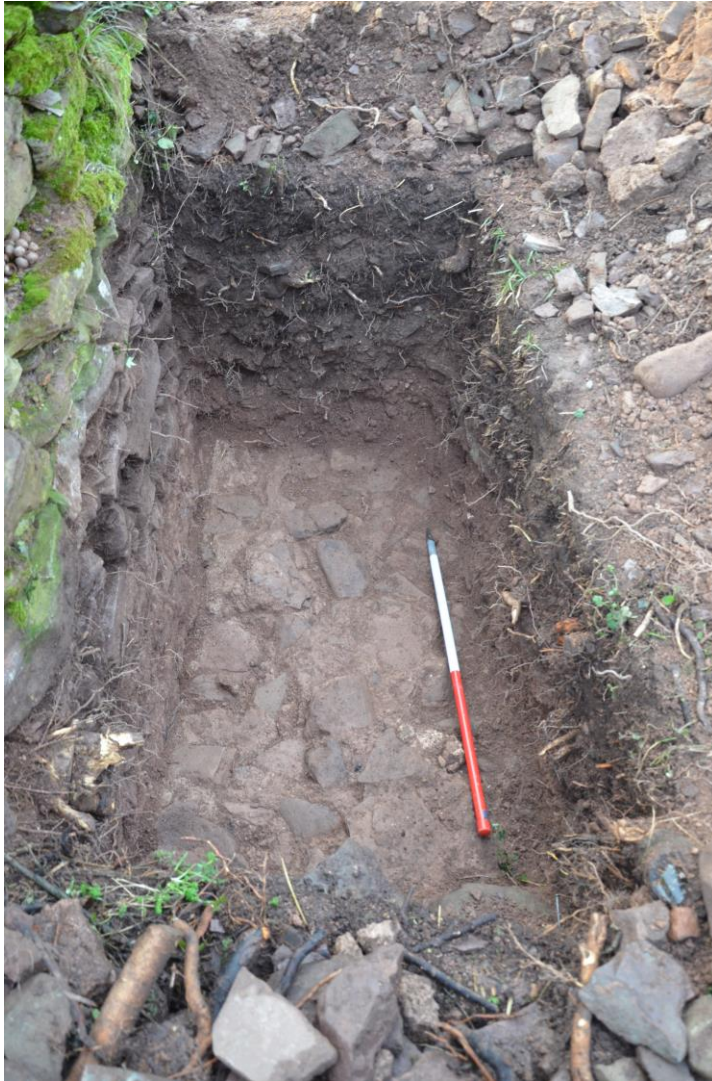
Plate 1: TP1 showing the mortared rubble "floor".

This was located immediately adjacent to a standing fragment of internal bastion wall and was 2m long and 1m wide. This was excavated to a maximum depth of 0.8m in order to reveal a rough, lime mortar, bonded surface. It revealed that the internal face of the wall at this location appeared to be of a single phase, using coursed but relatively rough and small stone, and continued through the base of the trench.

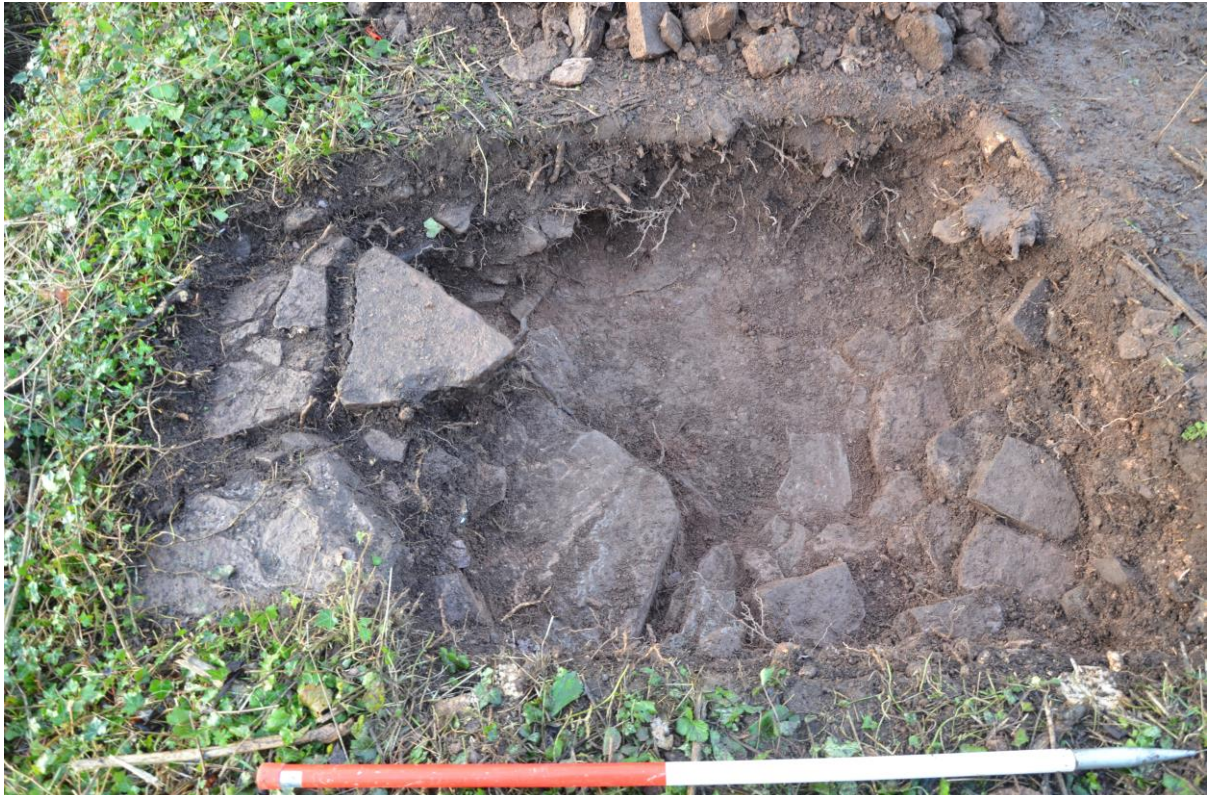
Plate 2: TP02 after initial topsoil strip showing the remains of the wall top and window reveal.

Immediately below the topsoil it was evident that the wall top survived and that the trench was positioned over the western reveal for a window (plate 1). This was excavated to a maximum depth of 0.7m in order to reveal the base of the window and the wall face beneath. The window jamb / reveal, is plain chamfered and terminates with a pyramidal chamfer stop at its base, (plate 3).

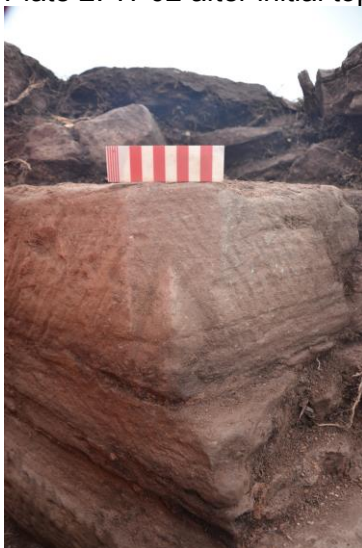
Plate 3: TP02  
Window reveal  
showing pyramidal  
chamfer stop.

plain chamfer on its eastern jamb with a pyramidal chamfer stop at its base. The western jamb has been cut back and the angle of the reveal altered as part of the Phase 3 works.

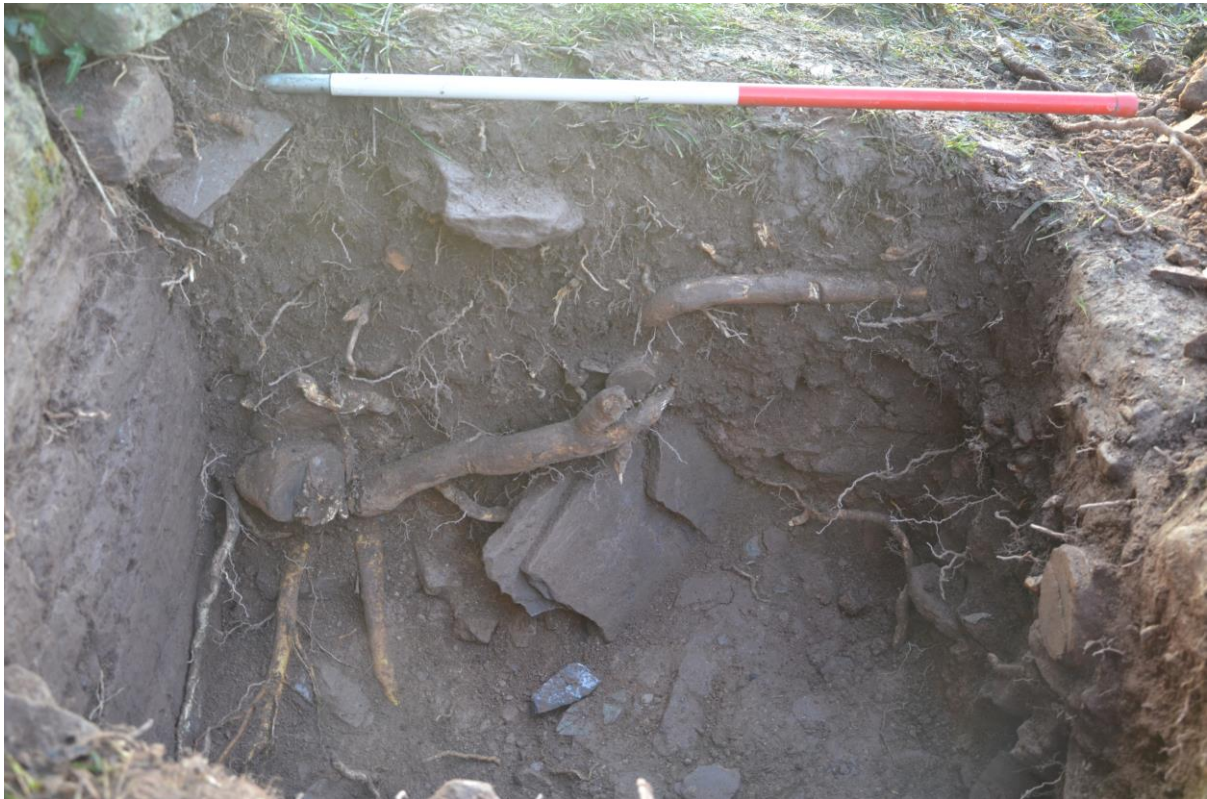
Plate 4: TP3 showing the rubble collapse within the southern section.

This was located against the internal face of the bastion wall close to its junction with the south flanking wall and was 1m square. It was excavated to a maximum depth of 0.75m

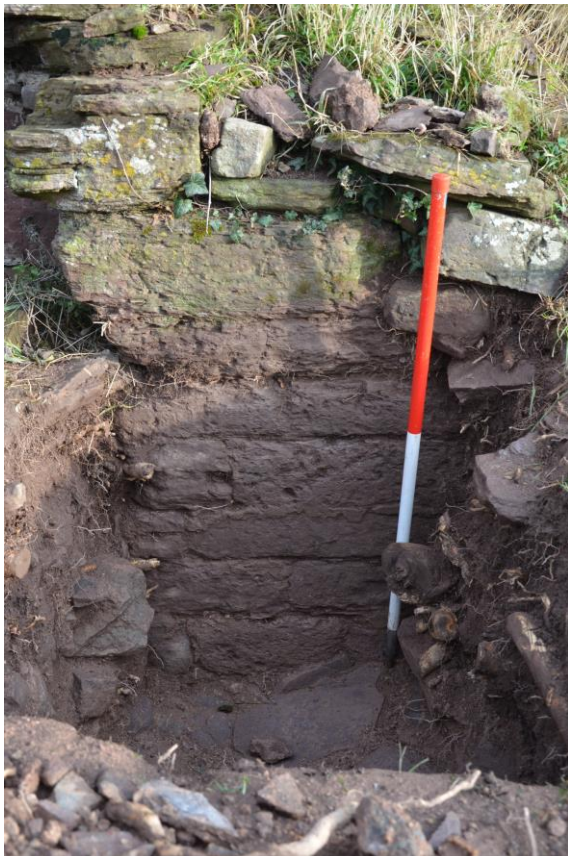
Plate 5: TP3 showing the well coursed and squared internal wall face.

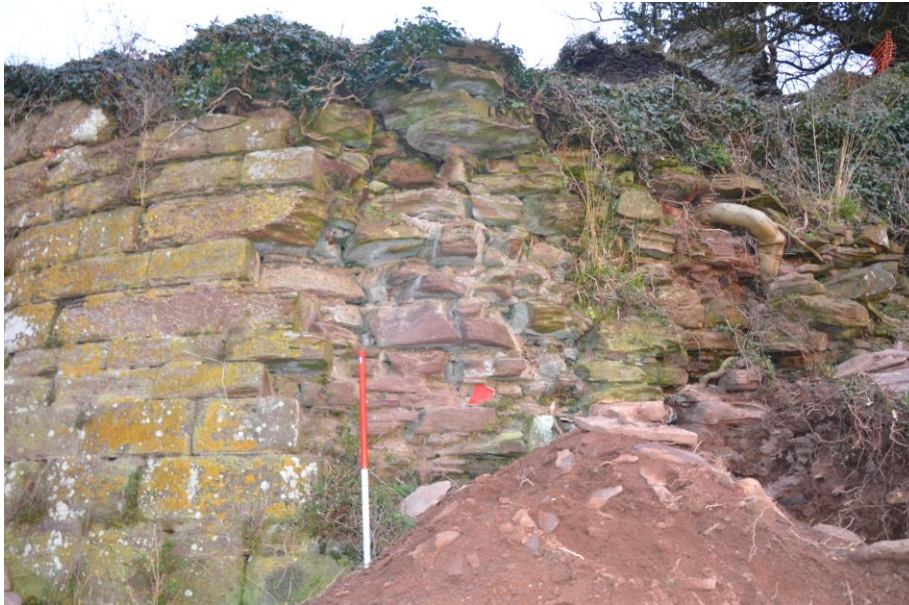
Plate 6: location of TP4 in relation to the external wall of the bastion.

This was located against the core work where the external face has collapsed and was 1m wide (north / south) and 2m in length. The excavation at this location was intended to expose the buried face and to reveal the type of foundation. It became apparent that, at this location, the external facing stones appear to be completely absent. The excavation was continued in order to follow the loose core-work so that the cut for the foundation could be observed. At a depth of 1.4m natural clay / marl was encountered onto which the core-work was sitting.

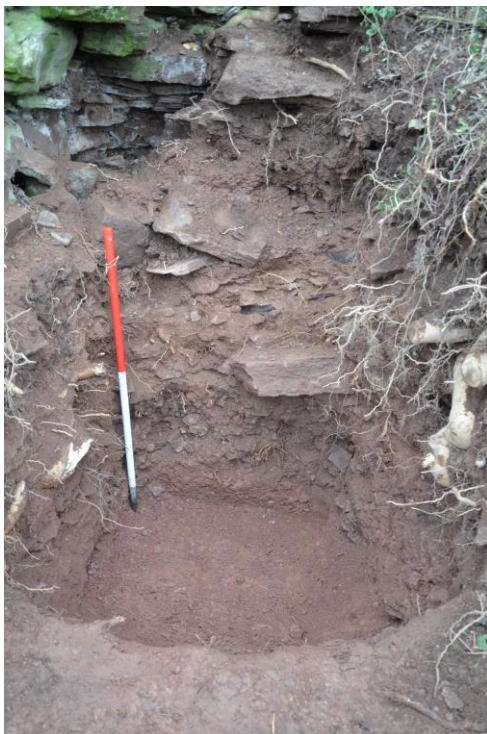
Plate 7: TP4 showing the extent of core work and the top of natural.

It would appear that the bastion has no “dug” footing or foundation but is built directly off the natural clay. It is suggested that the natural slope of the hill was terraced into and the bastion wall built onto the terrace.

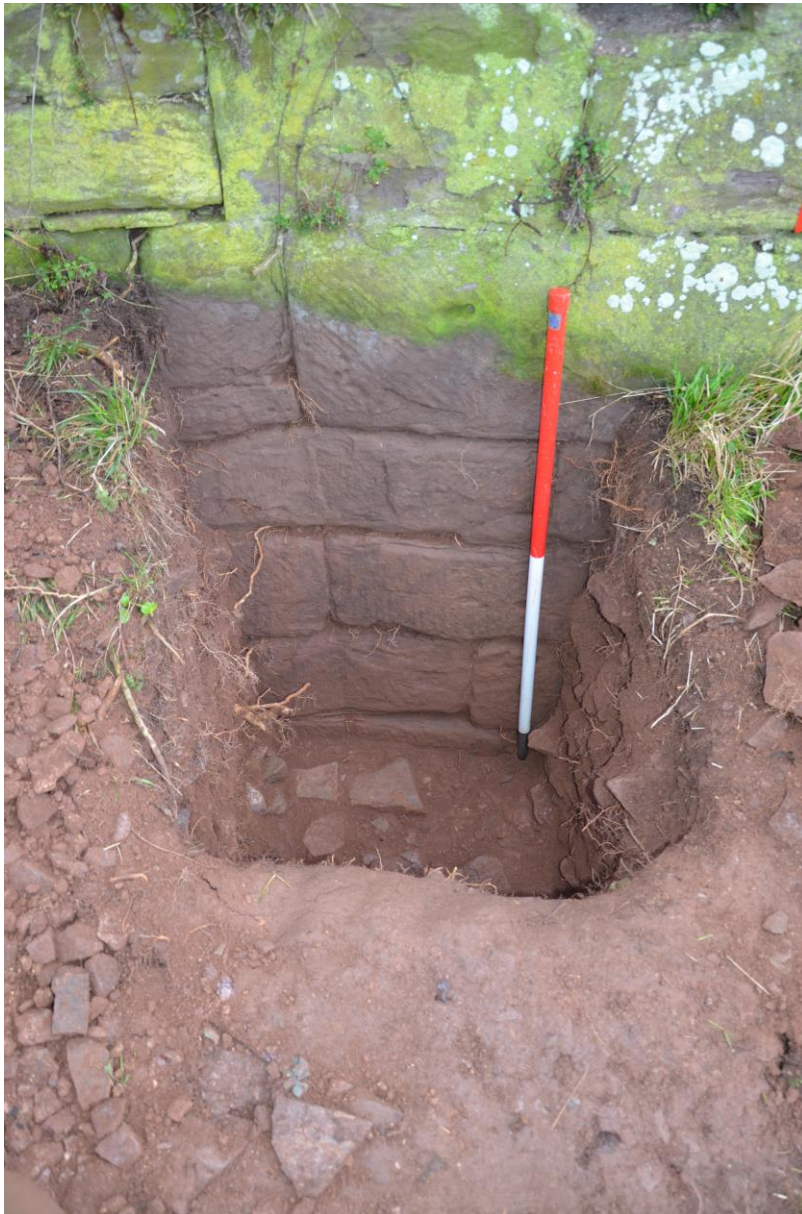
Plate 8: TP5 showing the high quality, well coursed, squared and tooled external wall facing.

This was located against the external face of the bastion at the point where the wall began to curve outwards to form the bastion and was 1m square. It was excavated to a maximum depth of 0.95m and followed the external wall face in order to establish whether the change in angle continued and to attempt to find the foundation course. Due to space and health and safety constraints the excavation was terminated at a depth of 0.95 without establishing the foundation depth.

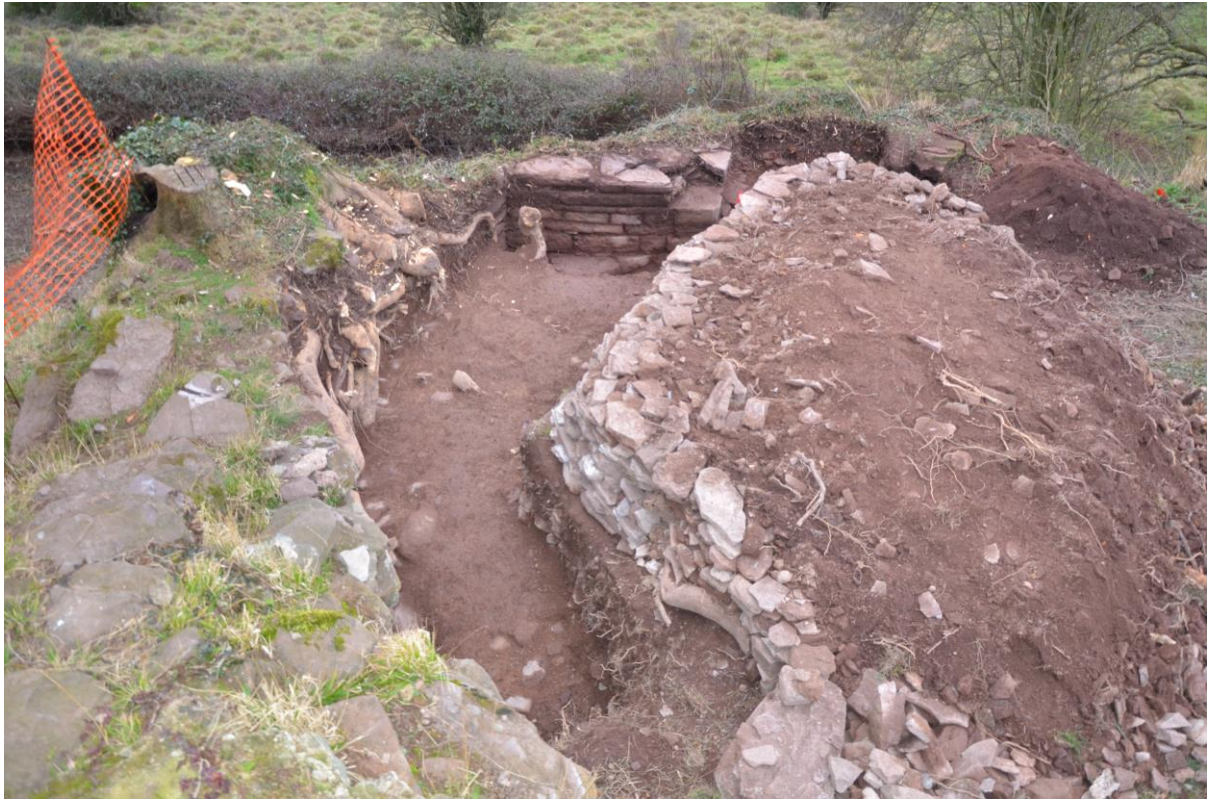
Plate 9: General view of excavation looking south.

At the progress meeting that was held on site of Friday 16<sup>th</sup> December, it was decided that due to the preservation on the internal wall face and the depth of rubble above any internal floor surfaces, TP2 should be excavated to join up with TP3. It was also agreed that TP2 should be enlarged further to the west in order to locate the western window jamb / reveal. TP3 was also extended to the north in order to investigate a recess in the wall thought to represent some form of cupboard.

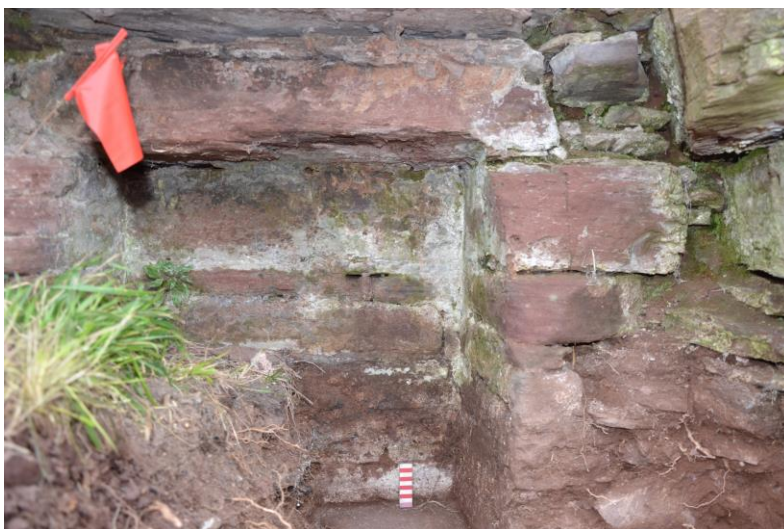
Plate 10: The partial excavation of the recess / cupboard.

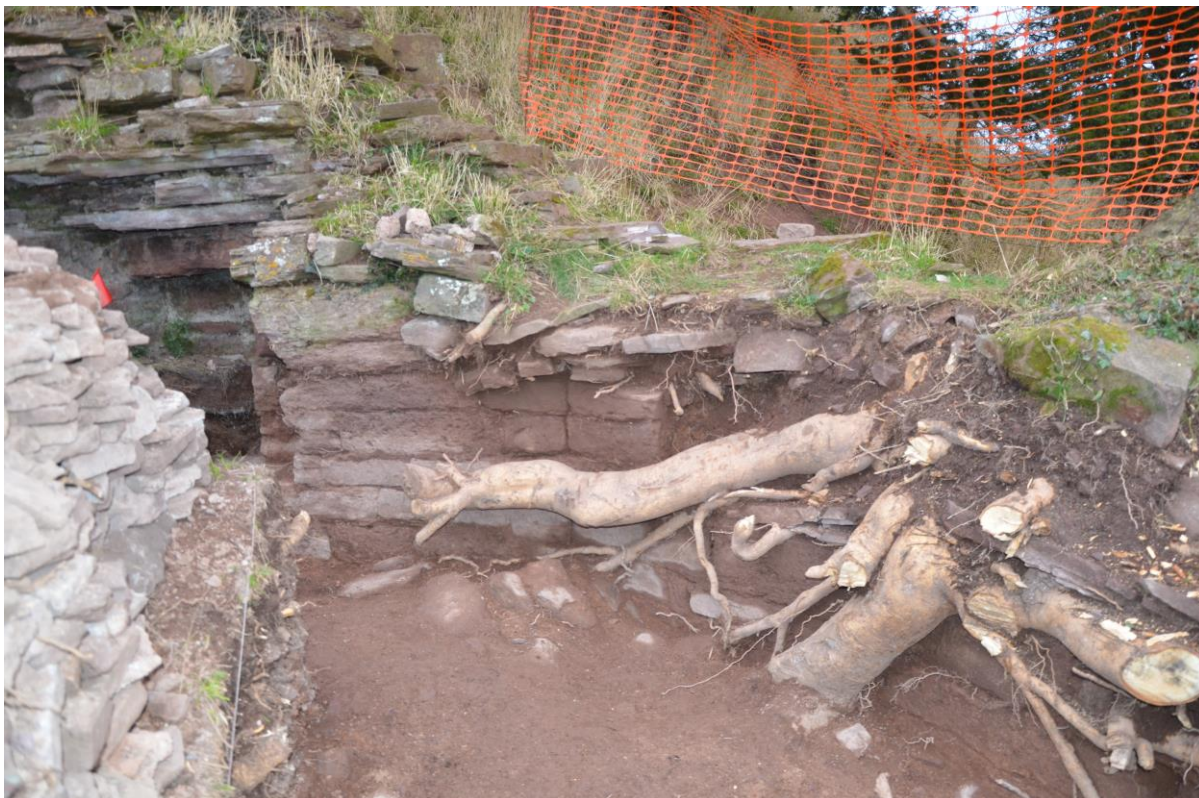
Plate 11: internal wall face looking east showing the blocked eastern window.

Only the northern jamb of the east facing window is apparent and is seen as a straight construction break filled by Phase 3 blocking before being obscured by tree roots.

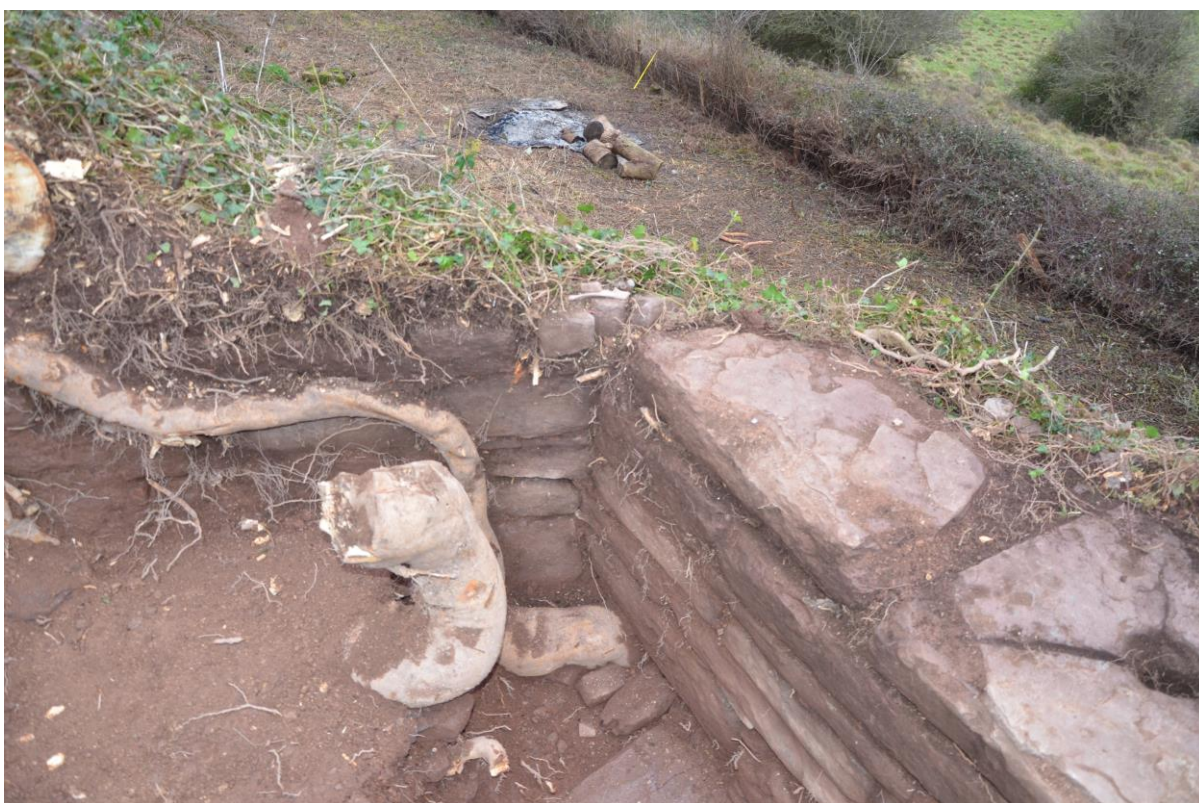
Plate 12: Detail of the change in angle between the east face and southern face.

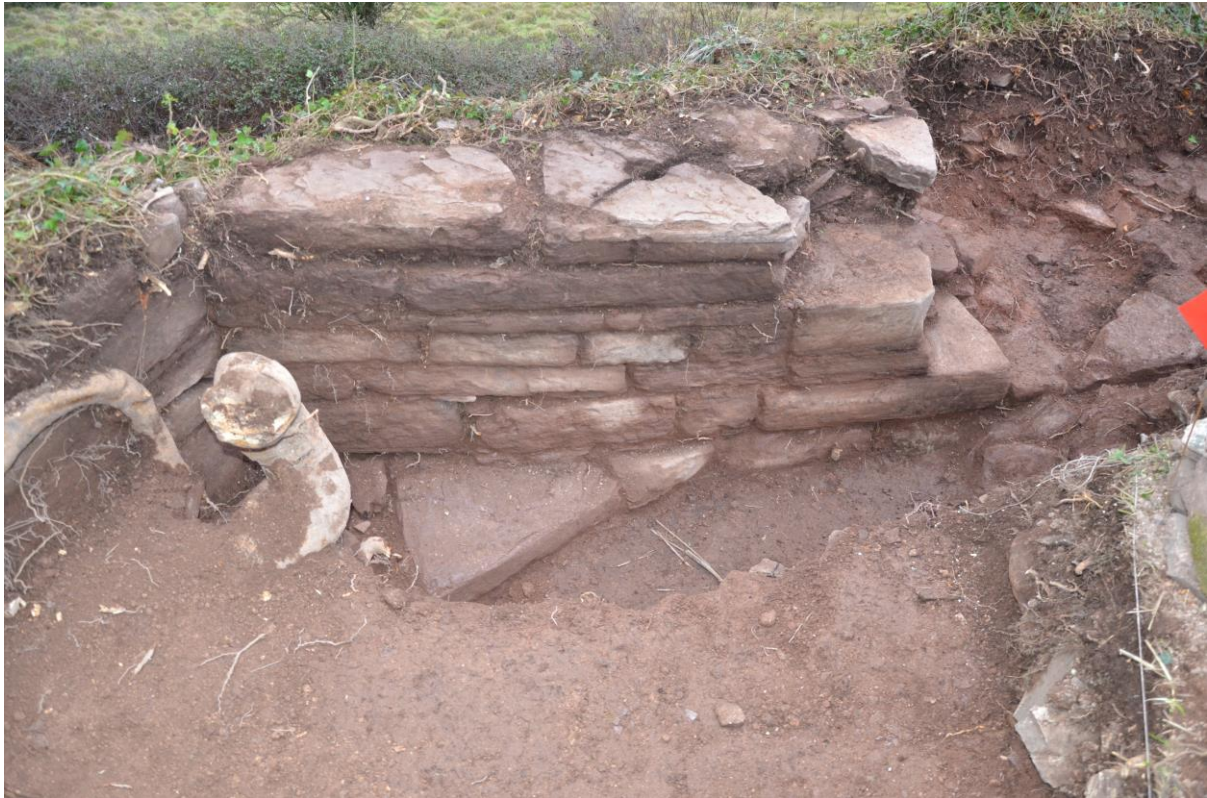
Plate 13: Phase 1 wall line showing under the Phase 2 south face.

Three distinct phases have been identified (see figures 9 & 11). Phase 1 comprises the original angle of the internal wall face and is apparent as a “step” approximately 0.7m below the surviving wall top. The Phase one wall was aligned on a north-east / south-west axis. Only a single course of this wall was excavated.

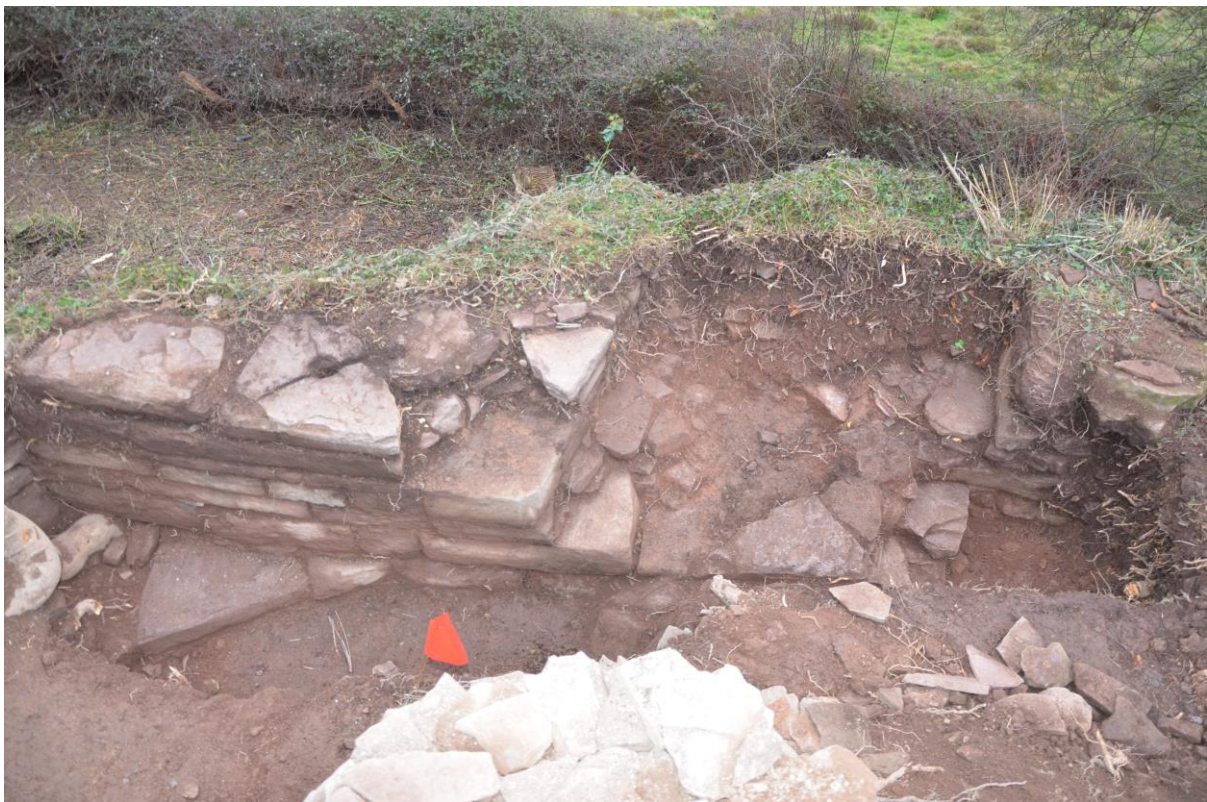
Plate 14: internal south wall face with window opening and Phase 1 wall line.

The Phase 2 wall appears to have been required in order to insert two windows into the bastion, one facing almost due east and one facing south. The south facing window has a

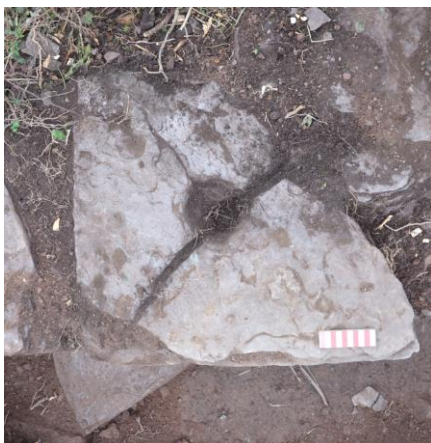
The western Jamb has also been cut back by approximately 0.5m. One of the stones which form the eastern jamb of this window, has a circular hole chiselled into it approximately 3.5 cms in diameter and 7cms deep. The chiselling, or perhaps the subsequent use of the hole, has split the stone.

Plate 15: Detail of stone with hole chiselled into it during Phase 3.
