Archaeological investigations at Clifford Castle, Herefordshire.

February 2018

Herefordshire Archaeology Report No. HAR 373

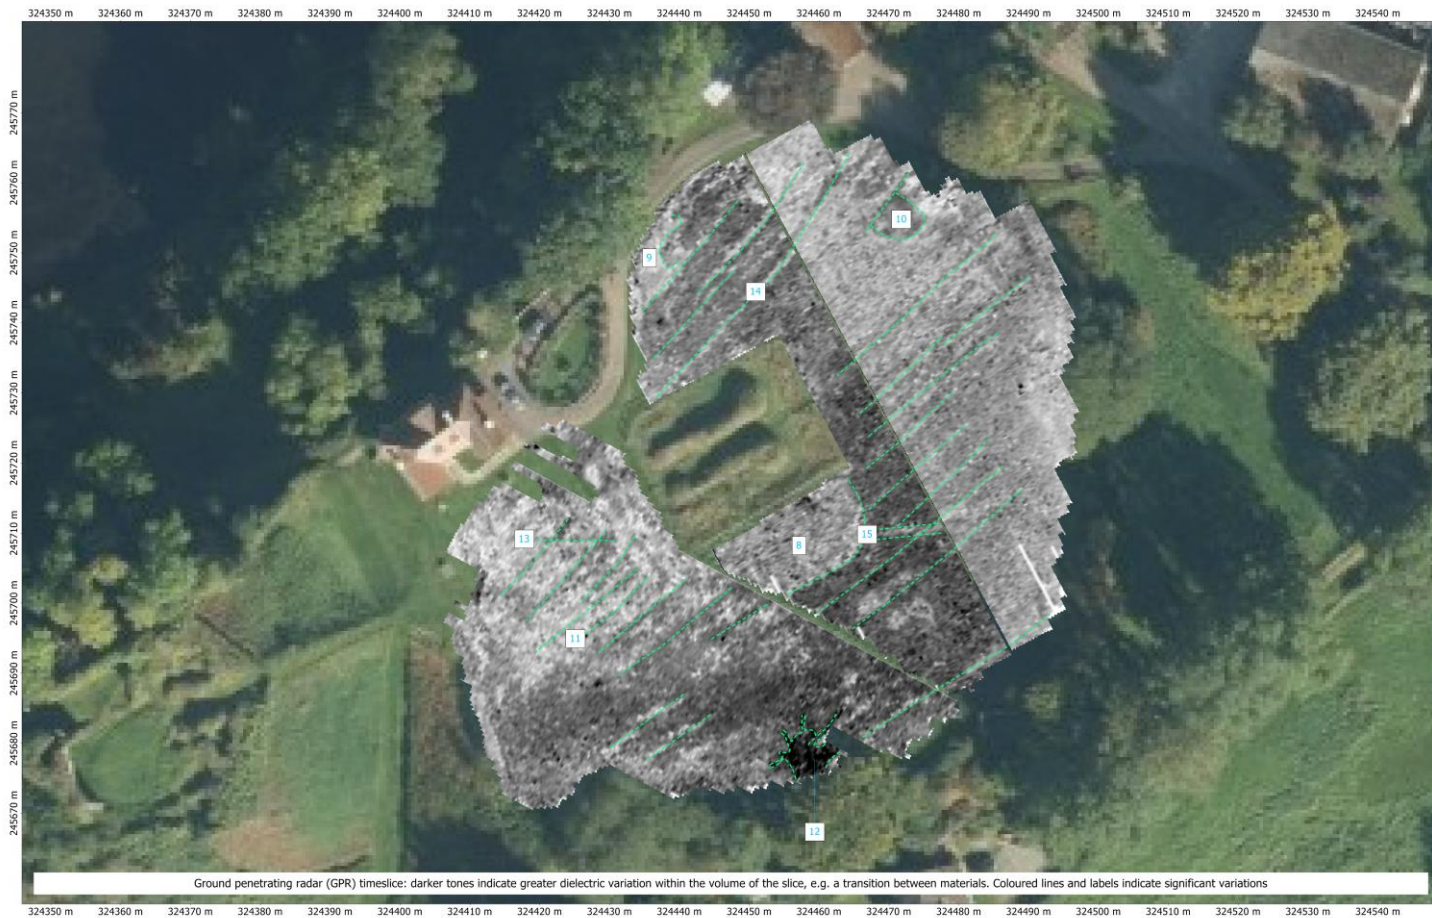
Figure 4: GPR plot showing ridge and furrow / orchard ridging.

The only recognisable features of historic interest which were recorded were the north-east / south west aligned ridges thought to be associated with either late medieval ploughing or orchard ridging, many of these still exist as subtle but visible earthwork features. It was therefore concluded that this type of land use was either masking medieval features or that if ridge and furrow, much of the underlying archaeology had been severely truncated.

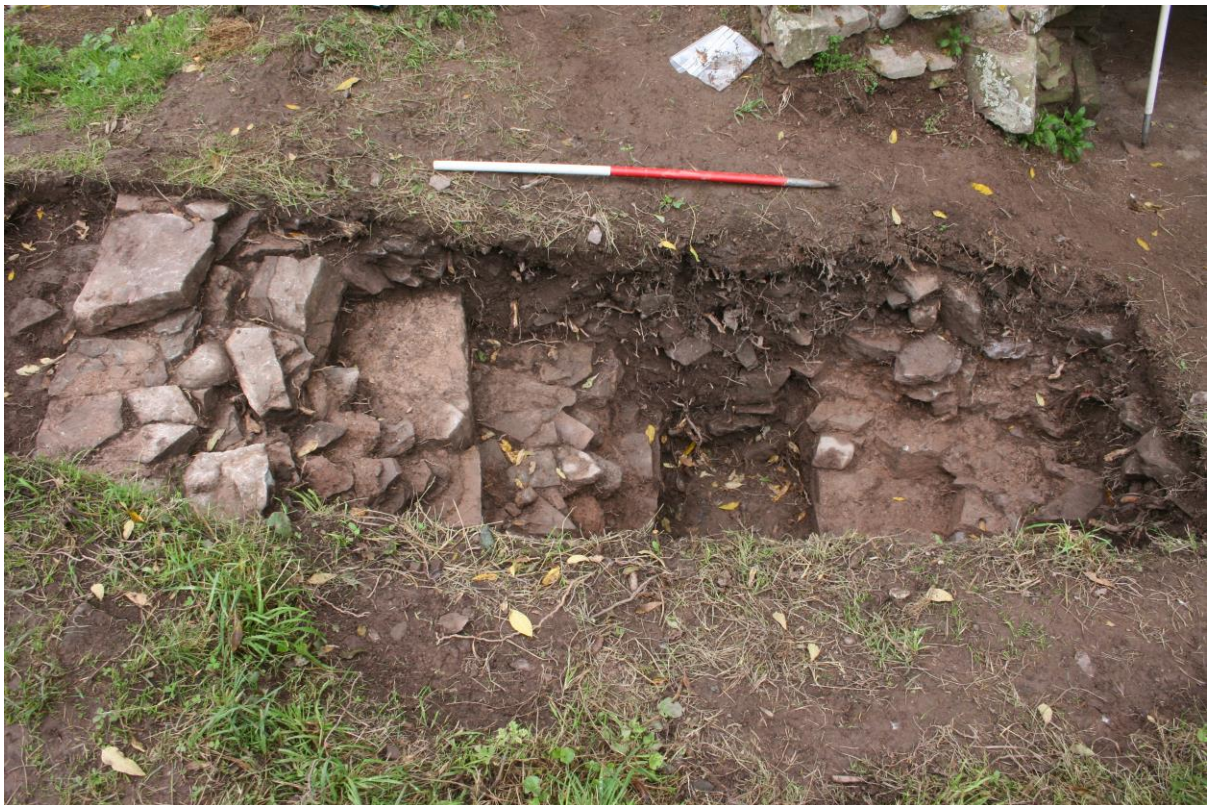
Test Pit 1, looking south. The left-hand wall with footings on three levels is the end wall of the hall/chamber-block undercroft; the right-hand wall is the original exterior end wall of the hall/chamber block, joining the fabric of the NW tower (top right corner)

TP1 was excavated across the line of the suspected passageway. Removal of turf and topsoil (101) exposed the walls (106/107), on the east, closing the end of the hall/chamber

undercroft, and (105), on the west, forming the exterior end wall of the hall/chamber block and making a junction with the NW tower. Having exposed the tops of each wall, the excavation between them continued down to their footings but found only topsoil with occasional small pieces of 19th-century pottery right down to the base of the excavation (103: any original floor surface or sub-floor make-up between the two walls had evidently eroded down the steep slope to the west, or had otherwise been destroyed. The eastern wall – the west end wall of the undercroft – was c.1.6m wide, composed of coursed stone rubble of the kind used throughout the castle buildings. Three levels or tiers of footing were exposed (see photograph); the interior face of the wall was only exposed at the uppermost level as it was intended to leave the deposits within the interior of the hall/chamber undercroft untouched and in situ.

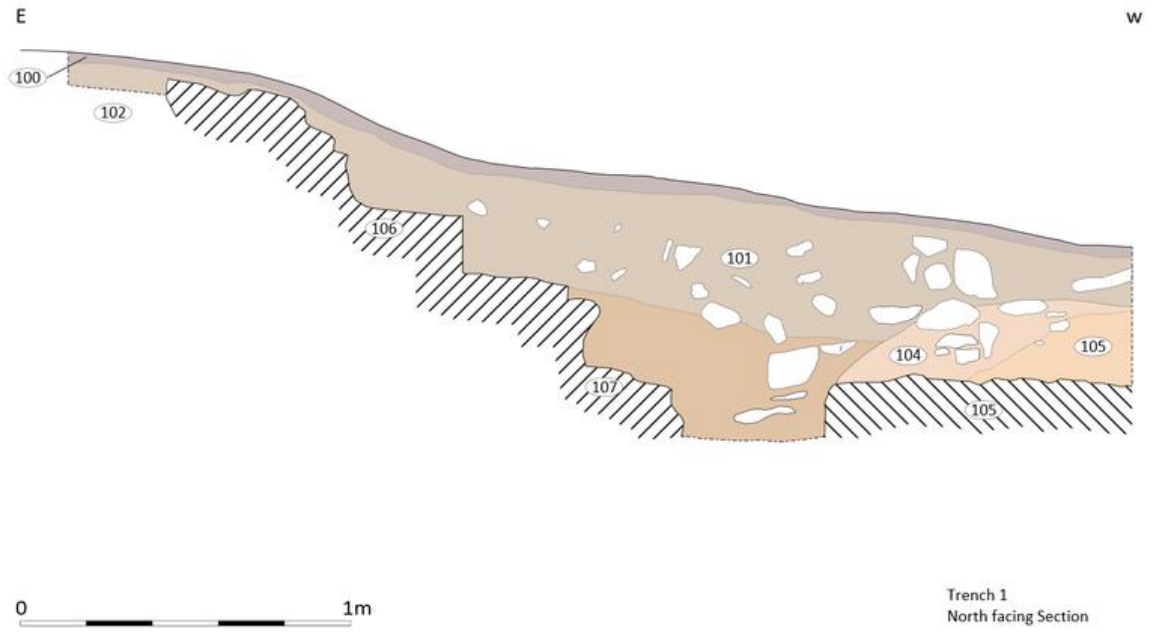
Figure 6: South section of Test Pit 1

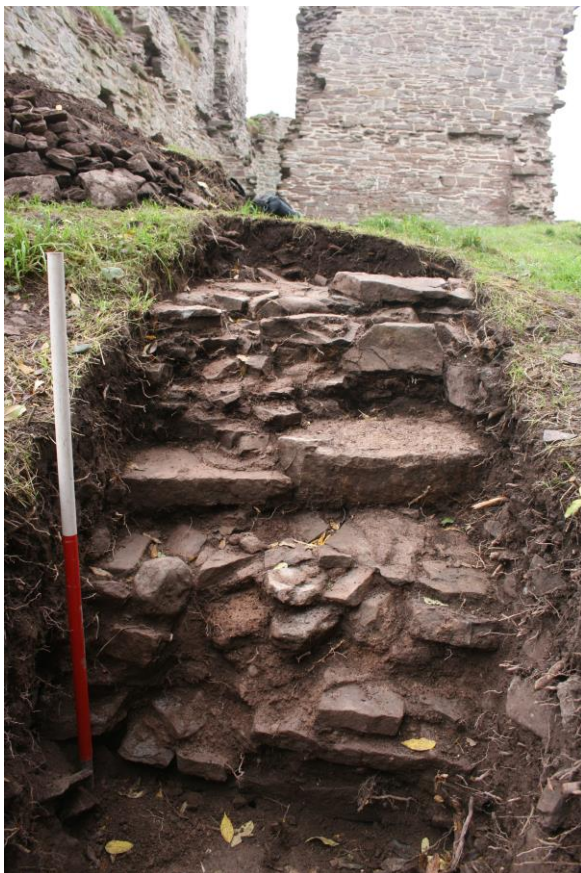
Test Pit 1, looking east towards the hall/chamber undercroft, wall 106/107. 1

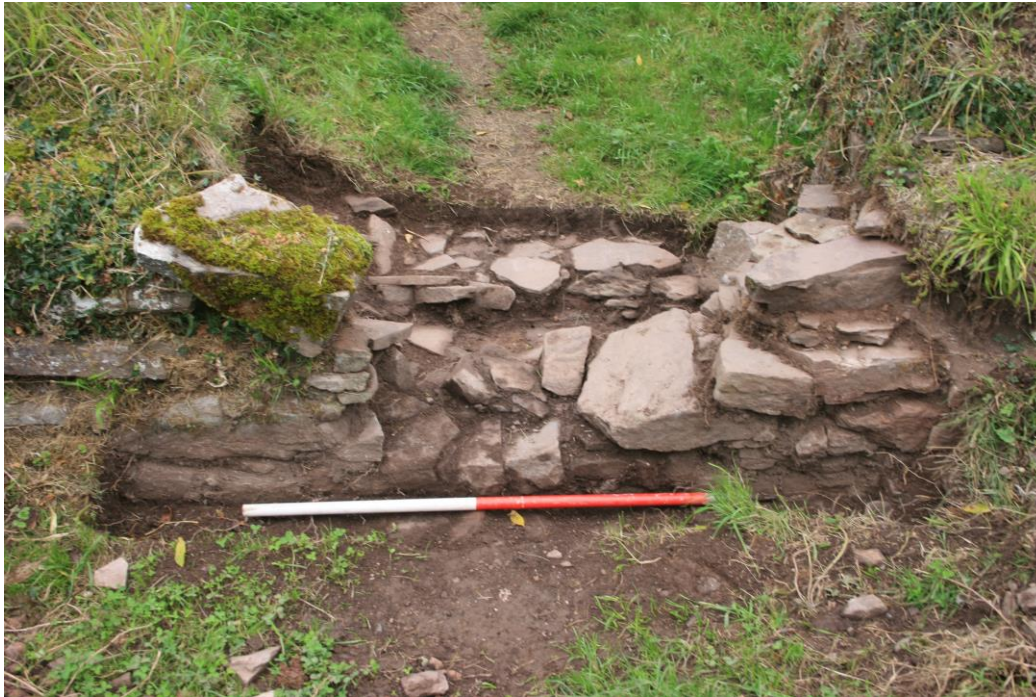
Test Pit 2, looking north towards the undercroft interior showing the base of the south wall continuing across the trench

Test Pit 2 was positioned in the gap in the standing remains of the wall towards its eastern end. Removal of the vegetation and its root mat (201) immediately exposed in-situ masonry and rubble (204). The southern (courtyard) face of the wall was found to be intact right across the base of the excavation, immediately disproving the existence of an original doorway in this position. However, set back from the wall face towards the interior of the wall a reveal was identified at right-angles to the outer face, but not continuing up to it. This appear to have formed the west side of a wall-cupboard or niche (203) whose back wall was broken through to form the present gap in the wall. The identification of this feature as a cupboard or niche is strengthened by the existence of similar features elsewhere in the hall/chamber undercroft space: to the west, in the surviving stub-end of the south wall, and in the east gable end. Without excavation of the interior down to undercroft floor level some doubt as to the arrangement of this space will remain, but from the fragmentary exposures currently possible, it is likely that there were a number of these features in the undercroft interior, reminiscent of recesses that are found in Hereford city-centre domestic

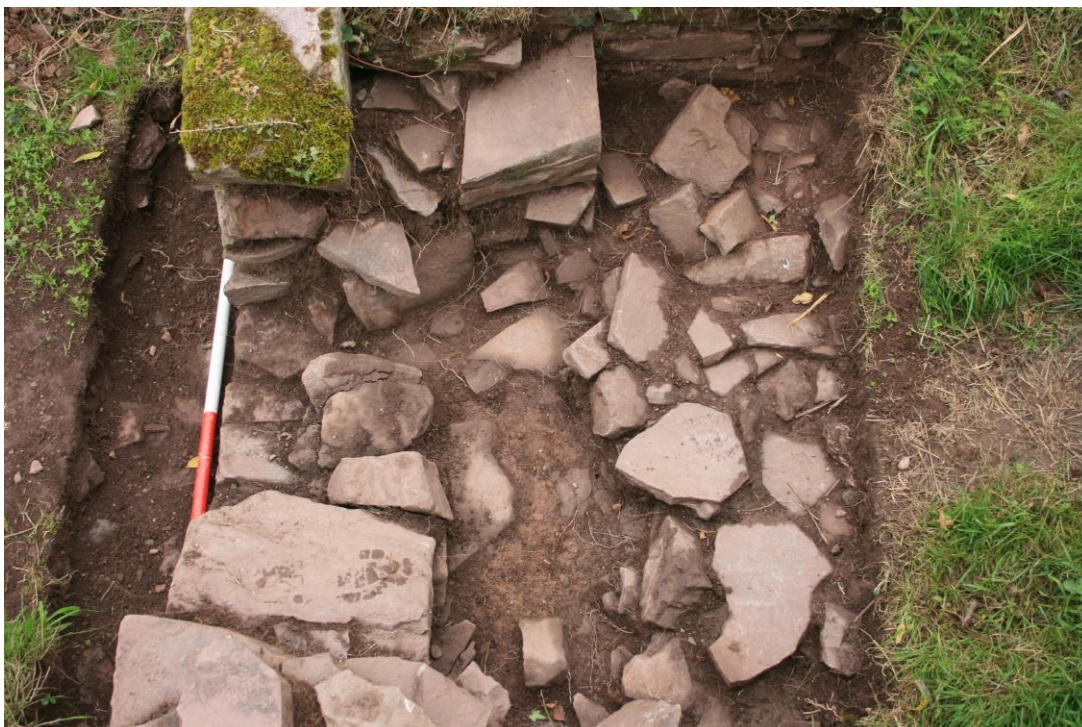
Test Pit 2, looking west, showing the western reveal on two planes of a cupboard recess

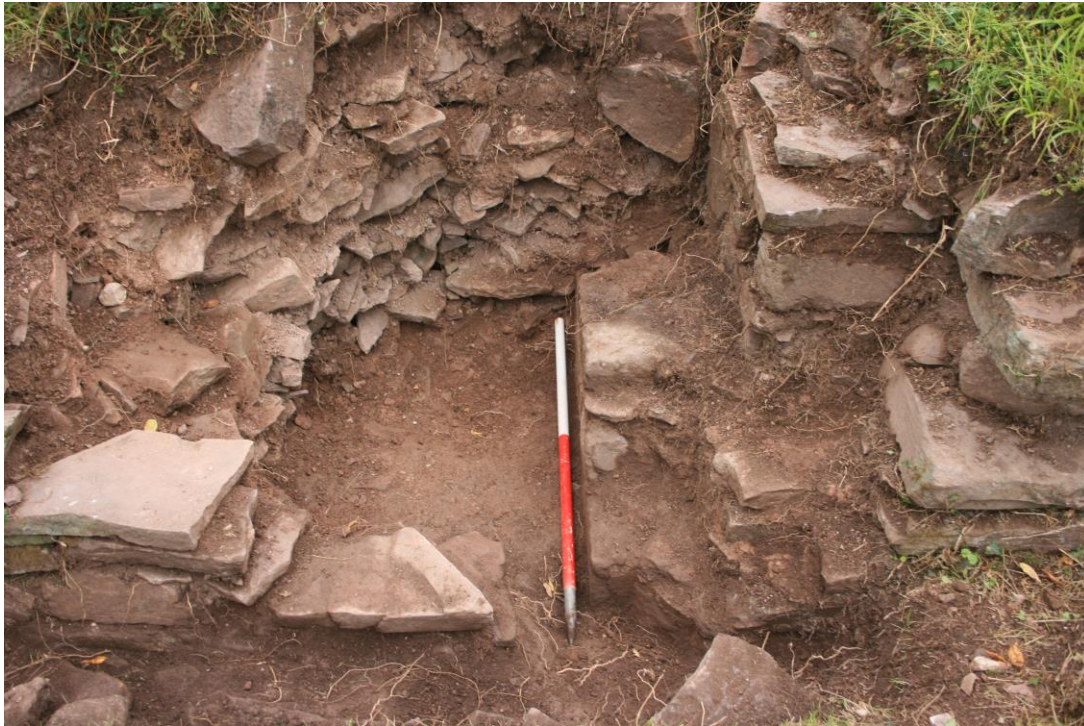
Test Pit 3, looking north, showing eastern reveal of the doorway opening and secondary wall fabric partly closing the doorway

Removal of the rubble (while not excavating much below the level of the present courtyard surface) exposed the eastern reveal of an opening that seems to have passed through the thickness of the wall. The reveal (306) was composed at the base/lower plane of squared sandstone ashlar mortared with a pinkish pebbly mortar, and with traces of render remaining on its surface; a plane above appeared to be a different rubble-based build. The original mortar was consistent with that seen in the corework of the south wall and the NW tower in damage at their junction, suggesting that this opening was an original feature. No western reveal was exposed within the trench, but this opening is interpreted as a primary doorway opening located in the centre of the south wall, giving access to the undercroft from the courtyard. If the interpretation of multiple recesses around its walls is correct, such a door may have been wider than usual to admit bulk goods and barrels.

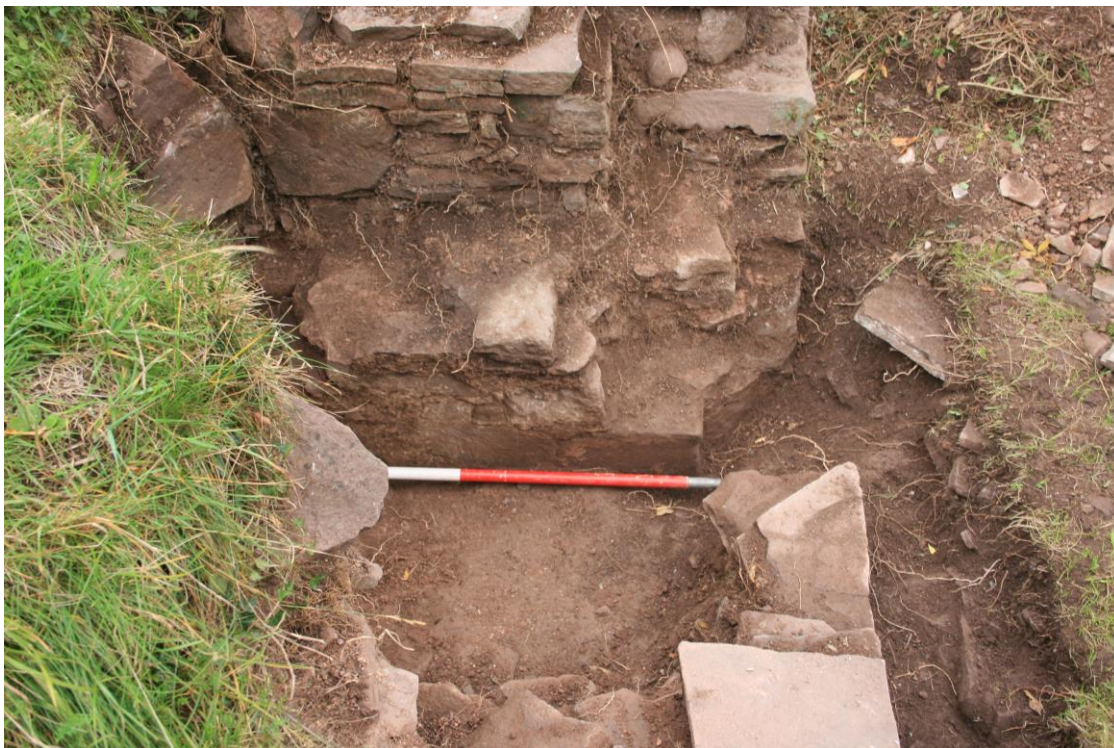
Test Pit 3, looking east, showing the eastern door reveal, with mortared ashlar work visible at the lower level

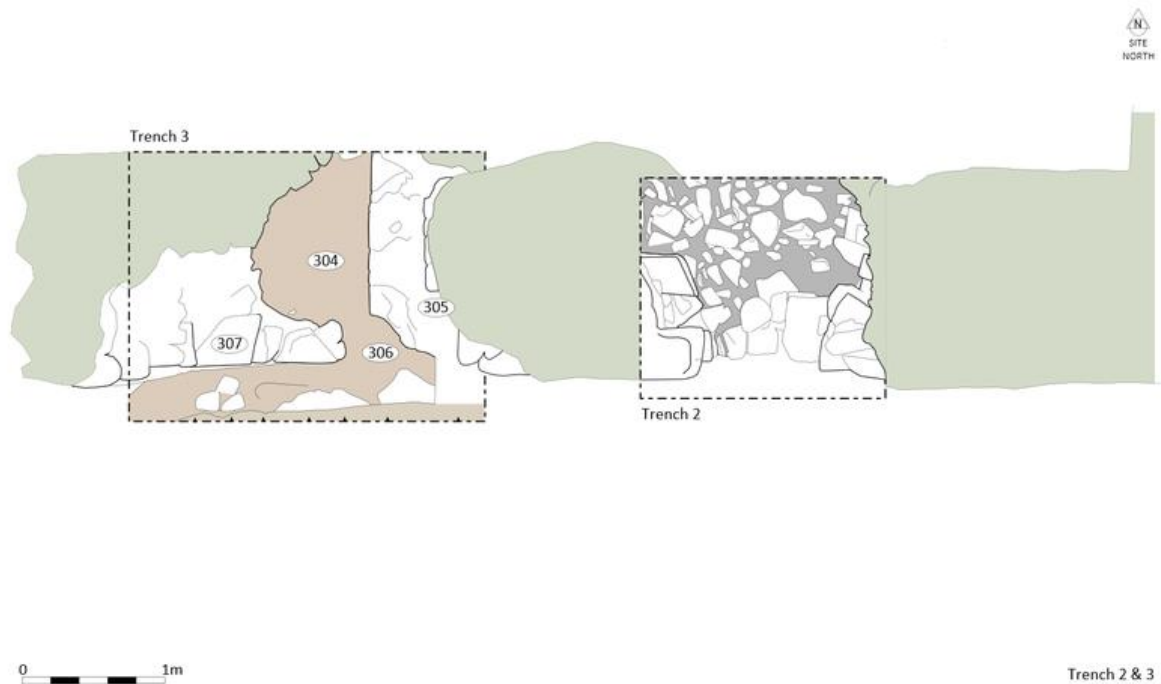
Figure 8: Composite plan of test pits 2 & 3.

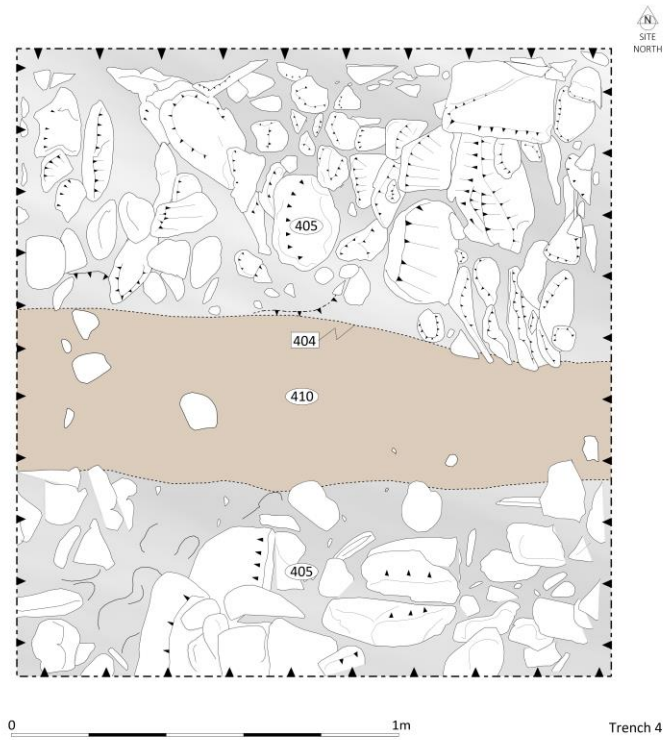
Figure 9: Plan of the upper levels of Test Pit 4

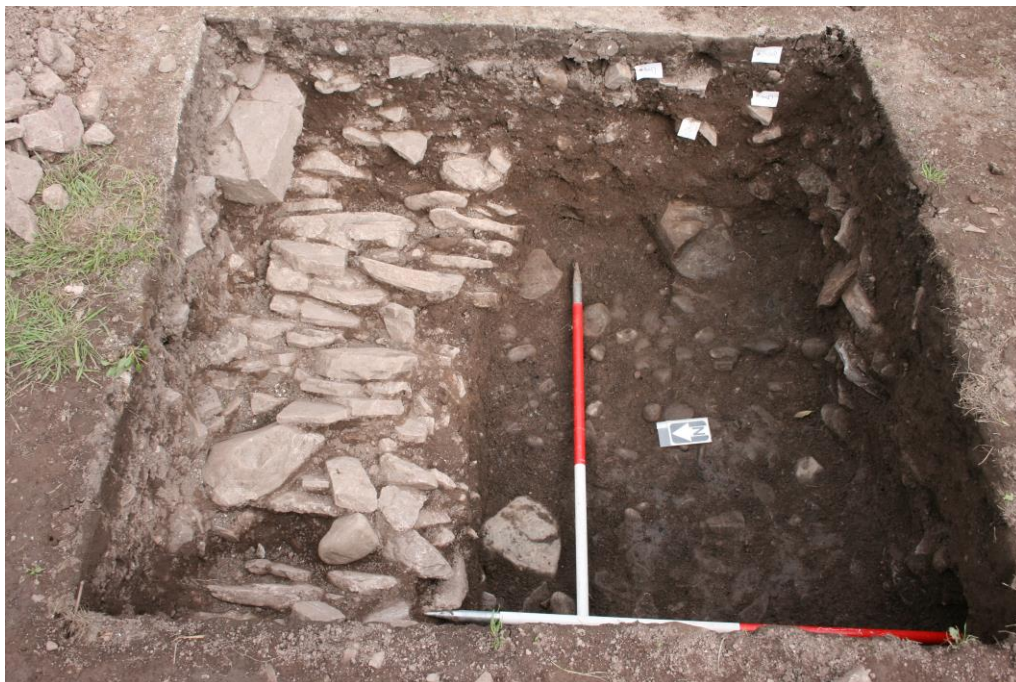
Stacked stones and roof tiles with fragmented cobble surface below.

The linear feature cut through a deposit of large stones (405) within a deposit of mid brown silt containing charcoal, mortar and plaster. The stones were pitched on edge as if they had been collected together for later reuse. Among the pitched stones were roof tiles, evident from the carefully cut peg holes. Within the deposit, pottery was found dating between the 16th and 17th centuries.

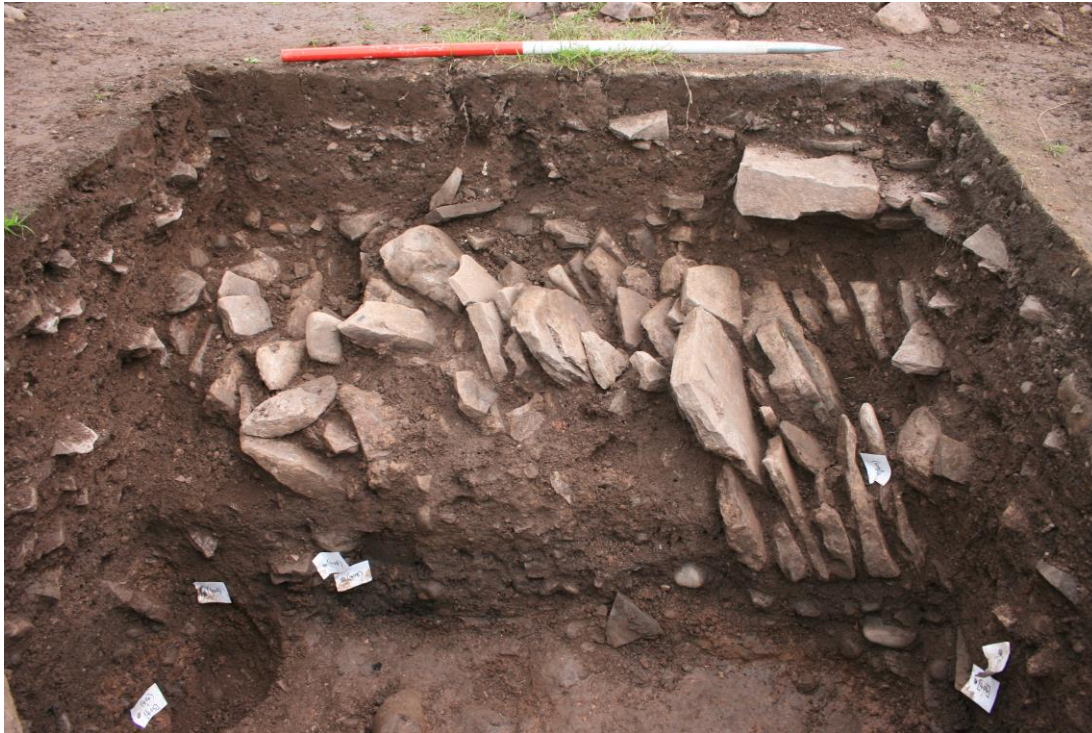
Detail of stacked stones and roof tiles

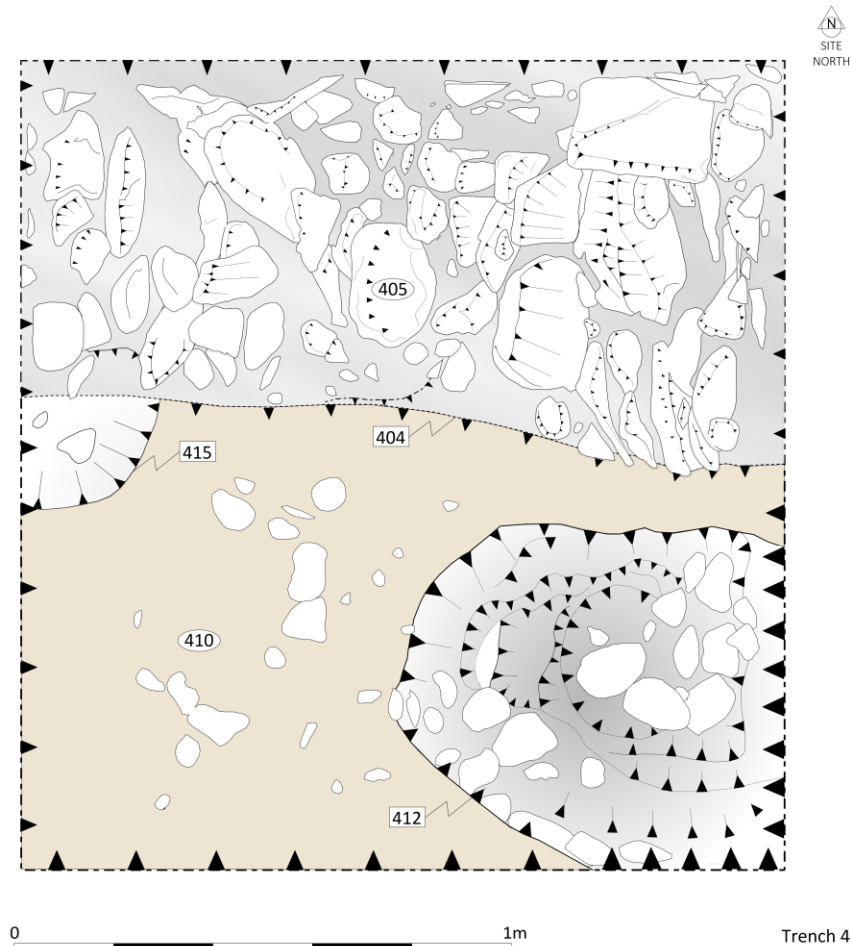
Figure 10: Plan of lower levels of Test Pit 4

Feature 412 was the largest of the features located in trench 4. The feature was a large post hole located in the south east corner of the trench. Assuming that the feature was somewhere near circular, approximately a quarter of it was present within the trench. The exposed sides of the feature sloped at an angle close to 45°. The feature measured 0.80m deep by 0.50m wide by 0.58m long. The feature contained two fills (411) and (413). Fill 411 was the compacted primary fill of the feature and it held packing stones that had once secured a timber post. This fill was greyish red brown silt containing charcoal and possible small lumps of daub. The fill also contained pottery and animal bone. The pottery again dated between the 11th and 13th centuries. The visible dimensions of the fill measured 0.20m in diameter by 0.62m deep.

Located in the north-west angle of the trench was the shallow D shaped half of another post hole [415] with a single fill (414). The edges and base of the feature had been lined with packing stones. The fill consisted of grey blackish brown silt with charcoal inclusions. Finds from within the fill included pottery, animal bone and a small number of iron nails. This feature was much smaller than [412] and is quite different in nature.

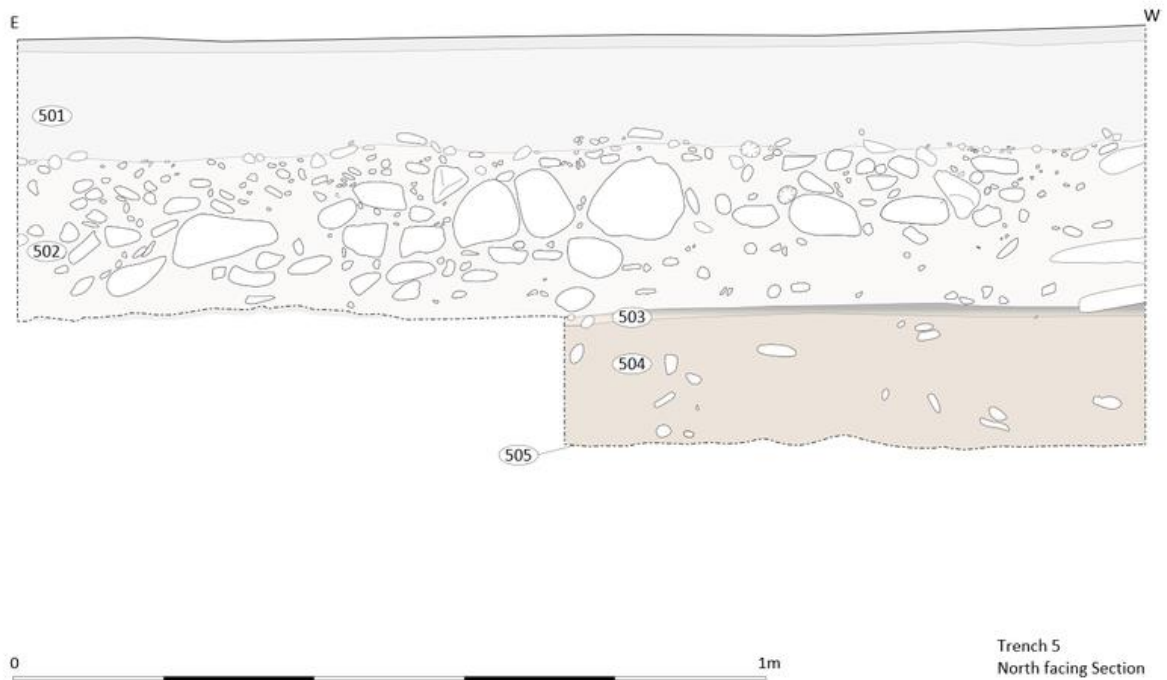
Figure 11: North facing section of Test Pit 5

The trench measured 1.5m long (east – west) and 1m wide. Upon removal of the topsoil (501) it immediately became apparent why the geophysical surveys had been so disappointing. A 0.22m thick layer of glacial gravel covered the trench (502). This appeared to get thinner and or less well compacted to the eastern and western sides of the trench and matched in both scale and alignment the ridges that were picked up on the geophysical surveys and, indeed the few that are just visible on the ground. This confirmed that these linear features were the earthwork and buried remains of orchard ridging rather than the result of ploughing.

Immediately below the gravel ridge was a 3cm thick layer of reddish brown silt which contained charcoal flecks and small lime mortar fragments, (503). This appears to be a thin buried ground surface which has not had time to thicken into a fully formed soil. The character of this deposit together with the fine and “crushed” nature of the charcoal and lime mortar suggests that this deposit had been trampled or walked over repeatedly and had therefore been an exposed surface for a period of time. Within this layer was a large flat stone ((506) on plan) which appeared to have been part of this surface. A 0.75 by 0.5 m sondage was cut through this layer to reveal a 0.15m thick layer of light reddish brown silty loam, (505). This was well mixed and soft with occasional small stones. No artefactual material was recovered from this layer. Immediately below this deposit, at a depth on 0.55m below the present ground surface, was a very hard layer of light red sandy silt with glacial gravels (505). This appeared to be natural.

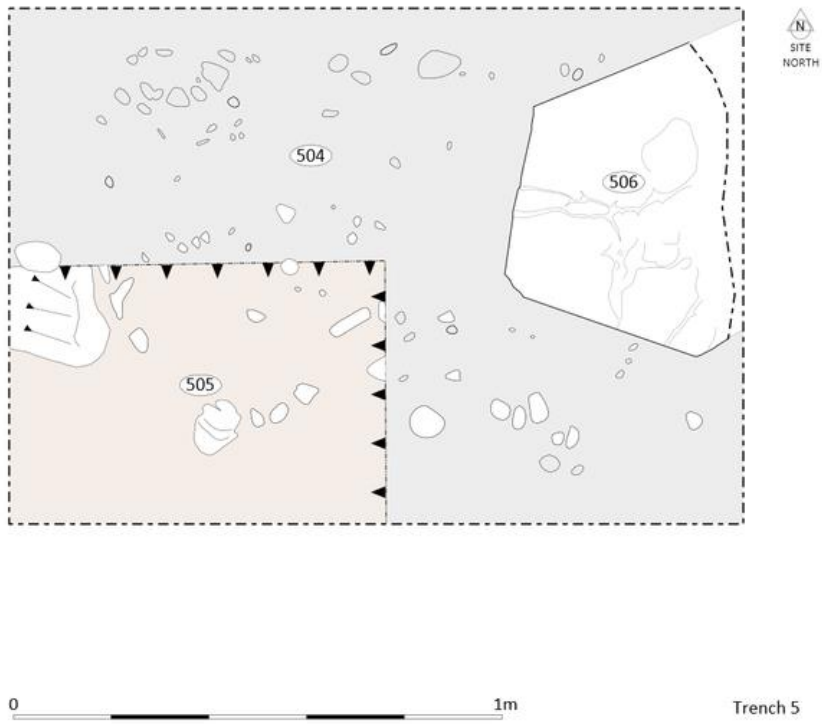
Figure 12: Plan of Test Pit 5

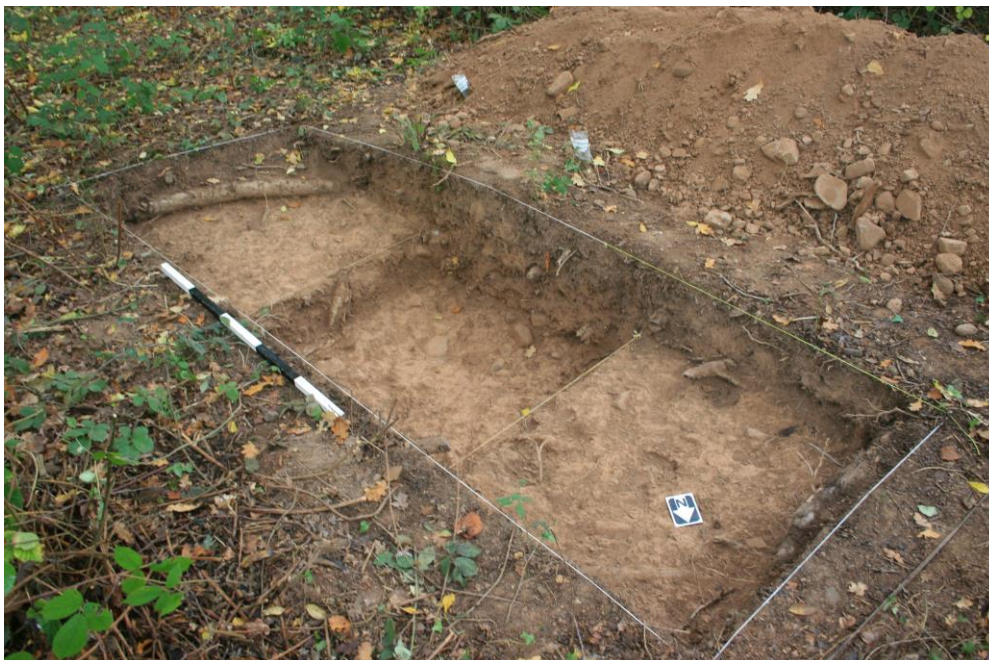
Test Pit 6, looking SW. The central sondage has exposed the top of natural glacial deposits. For location, the wire of the railway fence can be seen on the ground bottom-right

Test Pit 6, just within the railway fence towards the north side of the Hornwork, first exposed a thin and completely dry woodland topsoil, 8-15cms deep and dominated by large roots and mats of smaller roots (601). This faded into a B-horizon type subsoil (602) with further roots and a larger component of compact silt and gravel – again completely dry, without moisture. This in turn faded into a fine compact light khaki silt with rounded (but not polished) pebbles or cobbles at a depth of 0.5m (603). This was interpreted as a natural deposit of glacial origin; its top was reached in a mid-trench sondage, each deposit being exceptionally hard and compact between the extensive root systems. No pre-20th-century artefacts were found.

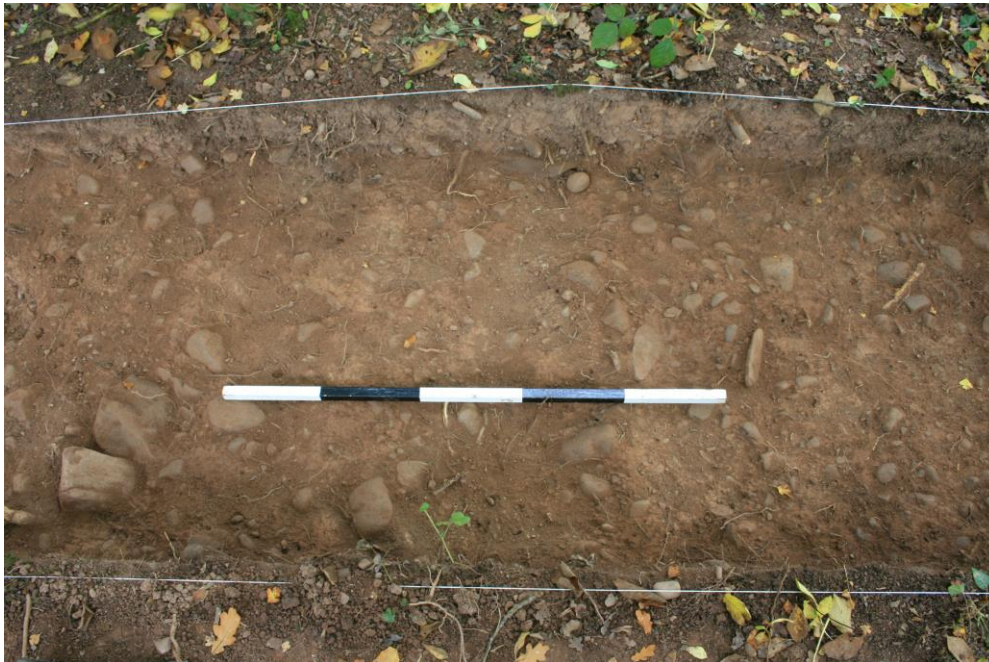
Test Pit 7, surface of 702 with depression 703

Test Pit 7, right on the edge of the steep slope down to the south-west, first exposed a light grey-brown topsoil (701), which produced one piece of worked flint. Removal of 701 exposed a very compact light khaki fine silt with large quantities of small round cobbles, resembling a metalled surface but of natural origin (702); a small depression or hole possibly cut into this (703/704) was interpreted as a small tree throw. The silt-with-small cobbles layer 702 faded into a lower material (705), lighter in colour with cobbles that were inconsistent in size but generally much larger than those in 702. Again, this was interpreted as a natural glacial deposit.
