**Malvern Museum:
Archaeological recording of the Gatehouse
Walls**

Herefordshire Archaeology Report No. 378

This report (WSM 70313), provides an account of small scale structural recording and a watching brief carried out by Herefordshire Archaeology at Malvern Museum, the building was once the gatehouse to Great Malvern's Benedictine priory, and was built c.1480. The gatehouse is a Scheduled Ancient Monument and Grade II* Listed building, (Scheduled Monument No: SM WT 258, HA 100530).

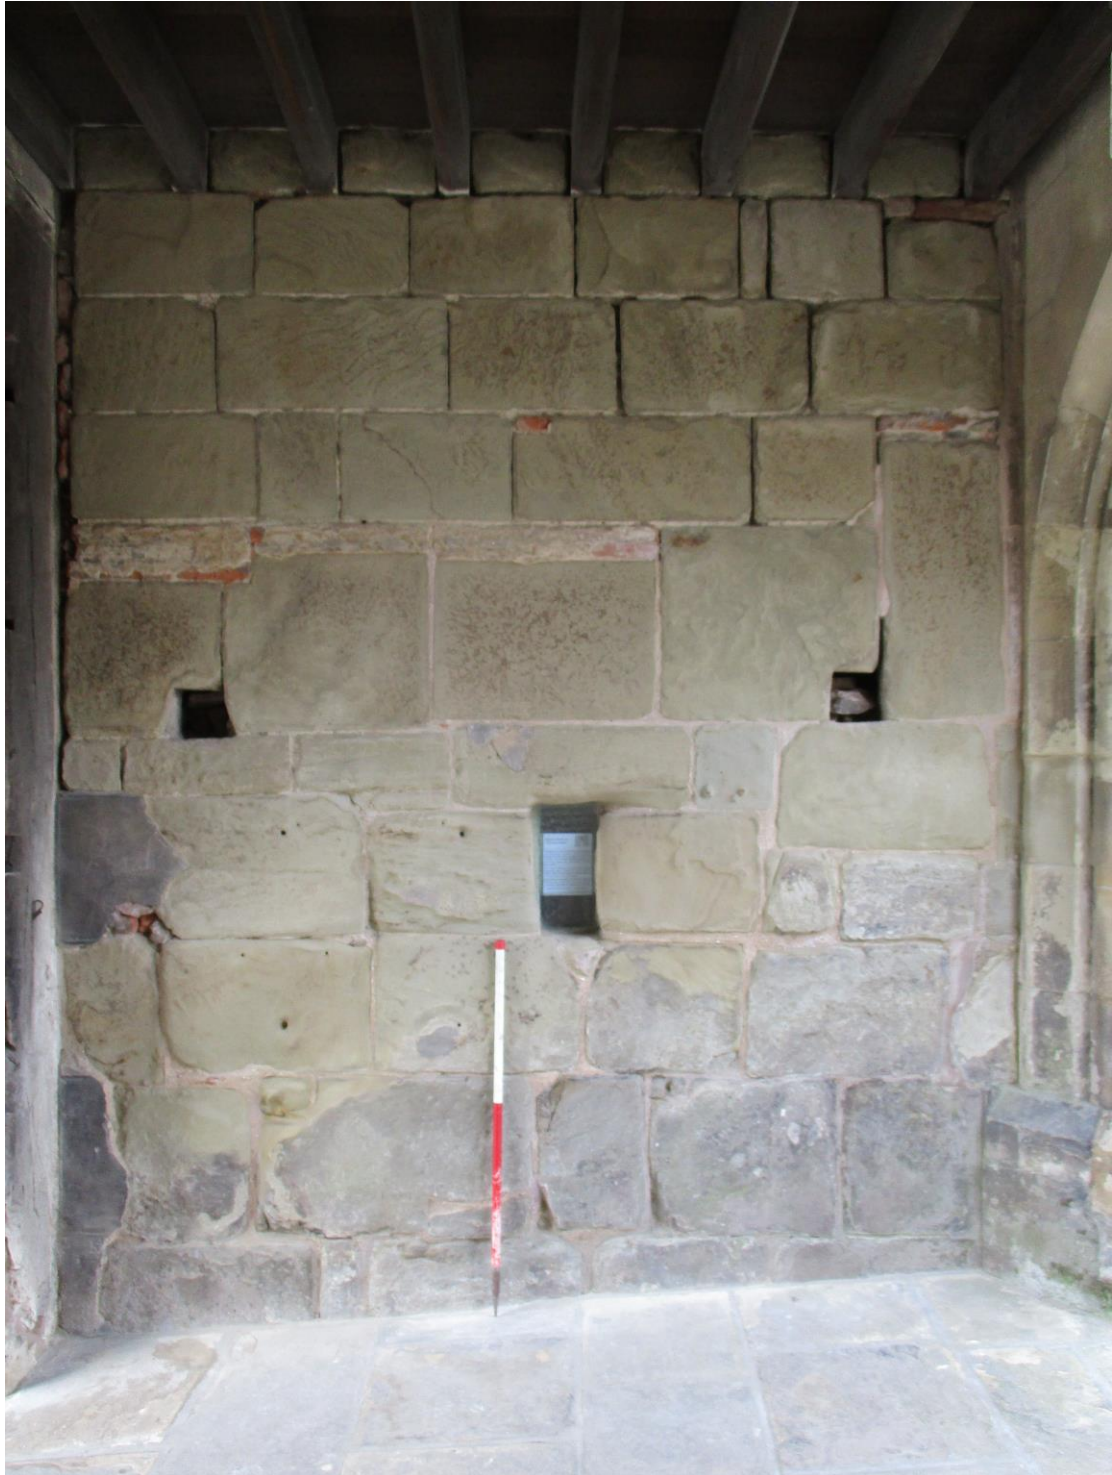
Plate 1: North face of Gatehouse wall

Small scale recording was undertaken at Malvern Museum of the Eastern and Eastern walls of the gatehouse. A variety of materials had been used in their construction included well worked, squared, sandstone, Old Red Sandstone blocks, Tudor brick and even glazed floor tiles.

It is clear that the floor tiles and the sandstone blocks originated from the Priory. The sandstone has been worn and whilst large in size the blocks are not terribly thick suggesting that there were part of the flooring. Four of them have a single corner cut out and it appears that these have been built into the wall and the cut outs used as put-log holes for the construction of the wall.

The brick, tile and sandstone blocks have been used to “level up” coursing. It is suggested that, due to the variety of reused material, the walls were rendered and or whitewashed immediately after their construction.

It is apparent that a wide range of materials had been utilised for the construction of the walls. It is clear that the well squared, grey sandstone originated from the priory and the erosion would suggest that these were originally floor slabs. The right angled holes cut into the corners would therefore have been made to fit around a beam or pillar and were not cut as putlog holes but re-used as such during the construction of the gatehouse. The Old Red sandstone built into the southern wall may also have come from the priory together with the two encaustic floor tiles also built into the southern wall. The bricks within both walls are Tudor in date and match the bricks used in the construction of the western wall of the gatehouse. It is assumed, due to the mixture of materials used and the variety of colours and textures of those materials, that the wall faces were rendered and / or whitewashed in order to give a more uniform and perhaps smarter appearance.
