### **Programme of Archaeological Observation, Investigation and Recording at the Church of the Holy Trinity, Preston Wynne, Hereford, Herefordshire**

**August 2018**

**Herefordshire Archaeology Report No. 380  
Event No. EHE 80370**

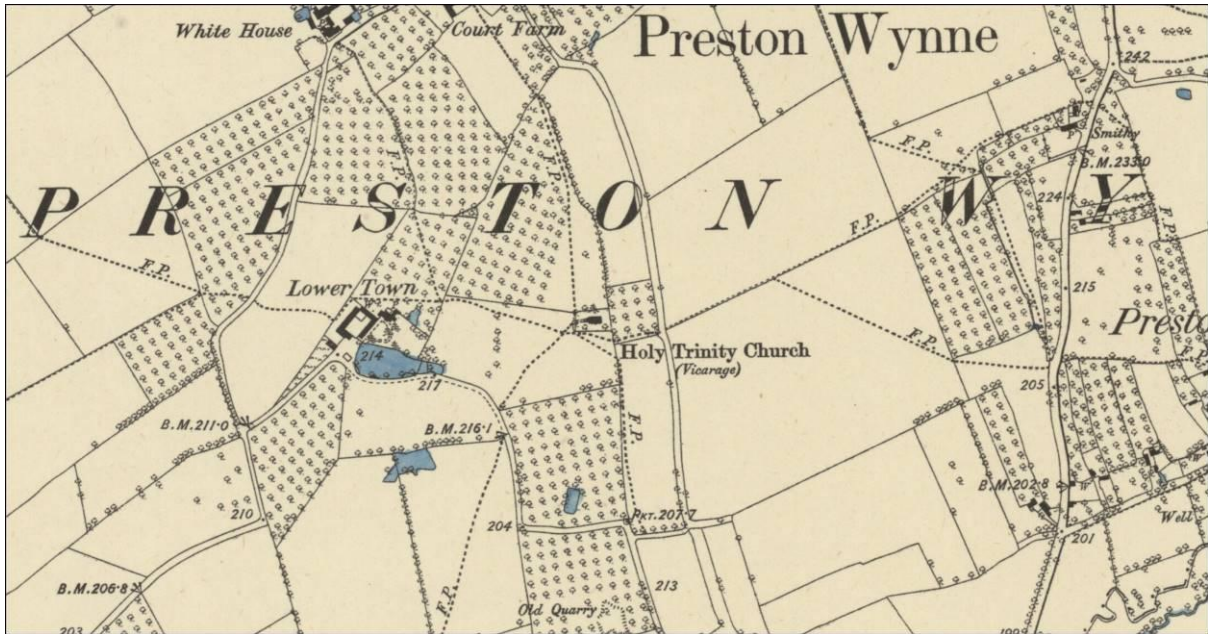
Figure 4: 1<sup>st</sup> Edition Ordnance Survey Map 1886 ©Crown Copyright and database rights Ordnance Survey (100024168)

The 1<sup>st</sup> Edition Ordnance Survey Map, 1887, (Figure 4) shows the extent of orcharding and the five footpaths that converge upon the church. The later Ordnance survey mapping, 2<sup>nd</sup>, 3<sup>rd</sup> and 4<sup>th</sup> Editions show little change, however, the modern mapping when overlaid clearly shows that the church yard has been extended by approximately 4m to the west and 6m to the south. It is not known when this was done but cannot be before the late 1940's as it must post date the 4<sup>th</sup> Edition Ordnance Survey Map. (Hoverd 2017) (See Figure 4)

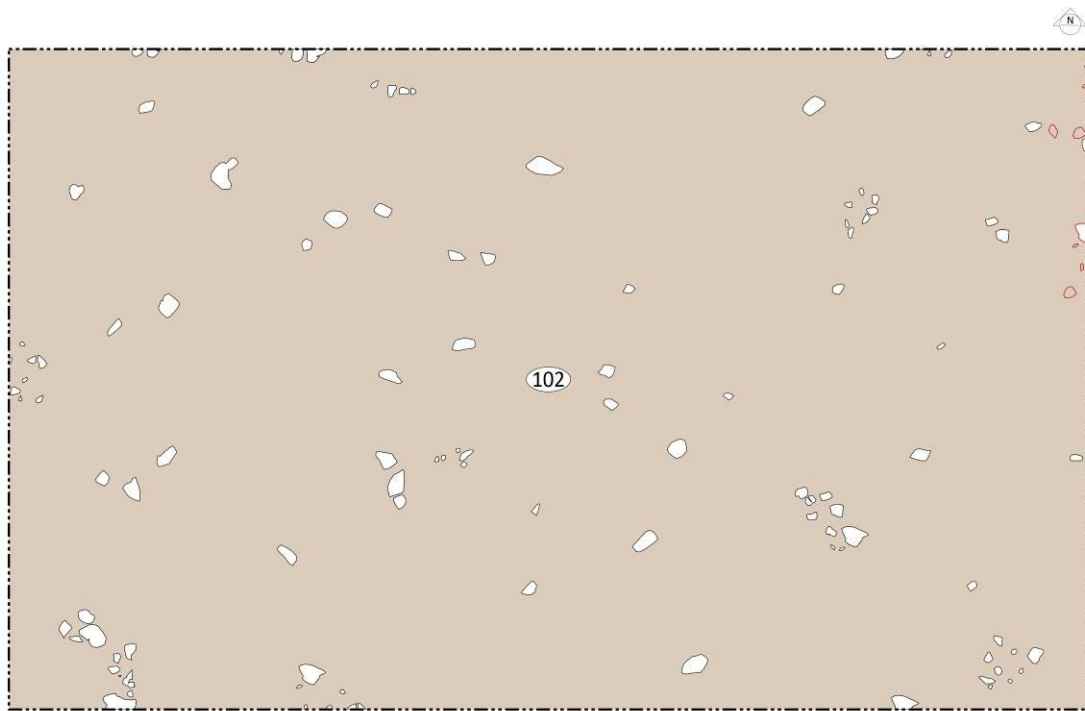
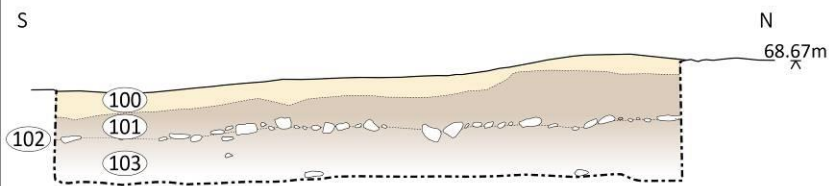
Figure 6: Plan and Section drawings of Trench 1.

Trench 1 measured approximately 4.65m by 2.70m aligned east west and was excavated to a maximum depth of 0.55m and minimum depth of approximately 0.30m. At a depth of approximately 0.30m a deposit of small flat angular stones (102) was observed. (102) appeared to be more concentrated towards the south of the excavated area however the stone deposit was not concentrated enough to form a solid stone surface. It is assumed that this represents the construction ground surface for the church. No features associated with burial practices or evidence for pre church activity within the trench were observed. (See Figure 6 & Plate 1)

TRENCH 1 - Plan

TRENCH 1 - South facing section.

TRENCH 1 - East facing section.

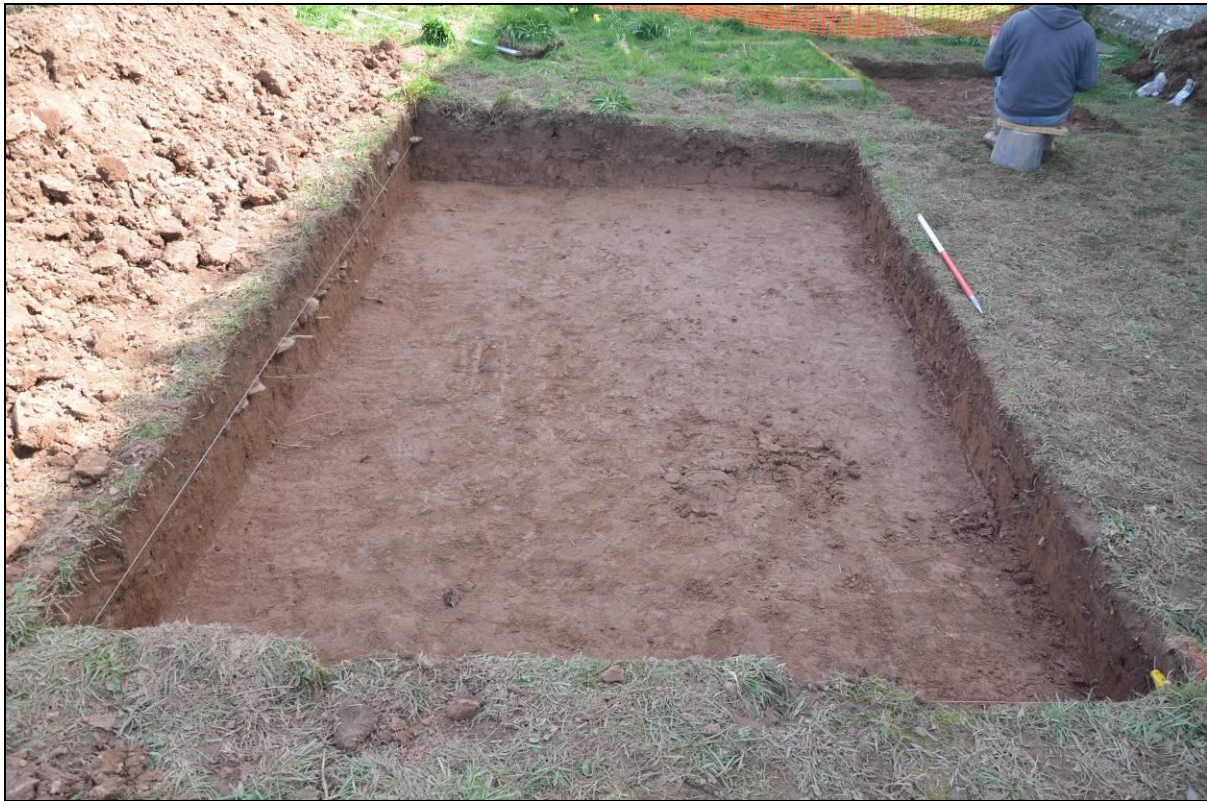
Plate 1: facing east showing extent of trench 1, note stone deposit (102) in section line.

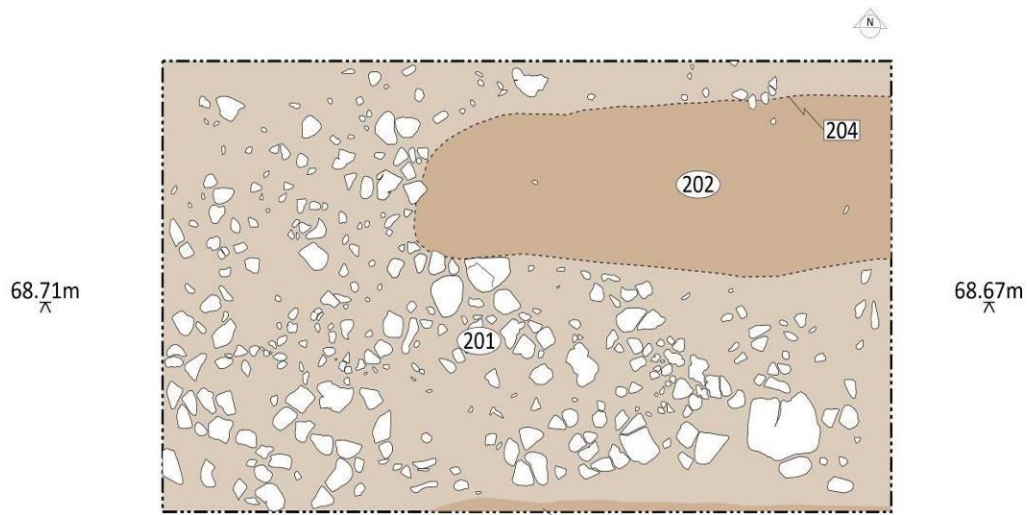
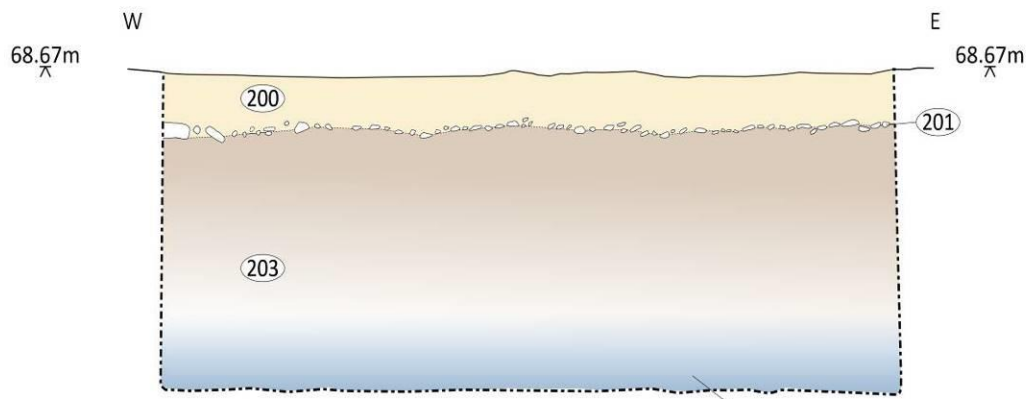
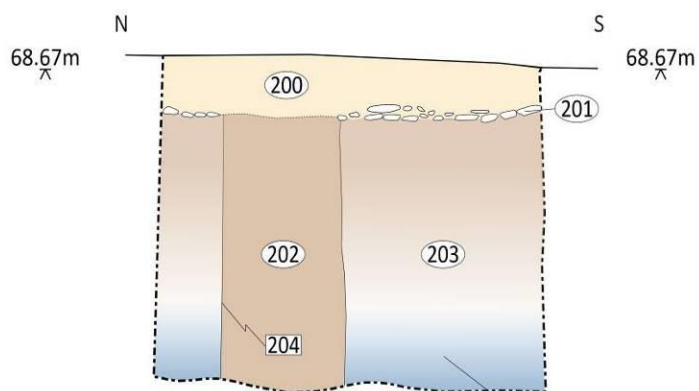
Figure 7: Plan and Section drawings Trench 2.

Trench 2 measured approximately 2.87m by 1.50m and was excavated to a maximum depth of 1.20m. A deposit of angular stones was observed at a depth of approximately 0.30m, the stone deposit (202) appeared to be more concentrated than the similar deposit seen in Trench 1 (102) and contained larger flat angular and rounded stones, particularly towards the south edge of the trench. It is assumed that this represents the construction ground surface for the church. Deposit (202) was cut by a single grave cut ([204]) which had a visible length of approximately 1.85m with an average width of 0.60m, the grave cut was aligned east – west. The grave cut edges were relatively straight however the west end was rounded in appearance.

The finished excavation depth of the trench was approximately 1.20-1.30m, at this level no indication of a coffin was observed, however, the water table was encountered causing observational issues. The excavated trench was completed and left open for a period of time during which the southern edge of the trench collapsed, this was due to a second burial cut ([205]) aligned east west and following the trench edge, within the stone deposit (202) it is possible that the grave cut can be observed in the records however it was not observed during excavation of the trench. (See Figure 7 & Plate. 2)

TRENCH 2 - Plan

Grave cut visible in section line.

TRENCH 2 - South facing section.

TRENCH 2 - West facing section.

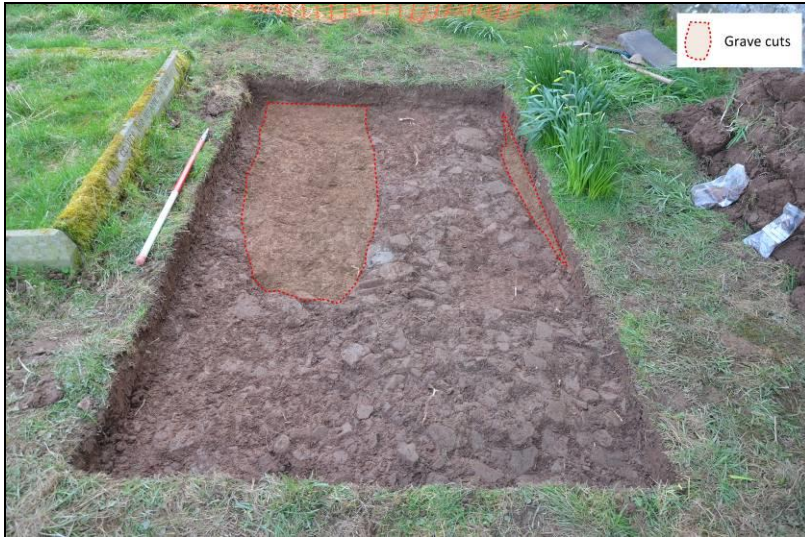
Plate 2: facing east showing extent of trench 2, grave cuts [202] and grave cut [205].

During the ground works two grave cuts were observed within Trench 2, fortunately the required depth of the rain water soakaway tank meant that the burials remained undisturbed.

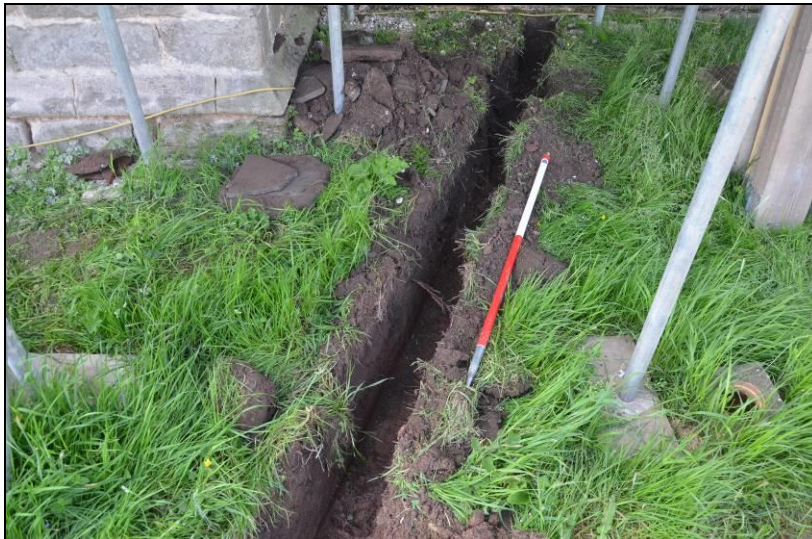
The excavation of the service trench measured approximately 7m with a width of 0.30m and an average depth of 0.40m. the trench was excavated from the north wall of the tower and intersected with trench 1. The maximum depth of the trench was 0.40m, the stone deposits observed within trenches 1 and 2 was not observed within the extent of the service trench suggesting that the stone deposit ((102) and (201)) did not extend further than the extent of the service run. (See Plate. 3)

Plate 3: facing south, overview showing excavation of the Service trench.

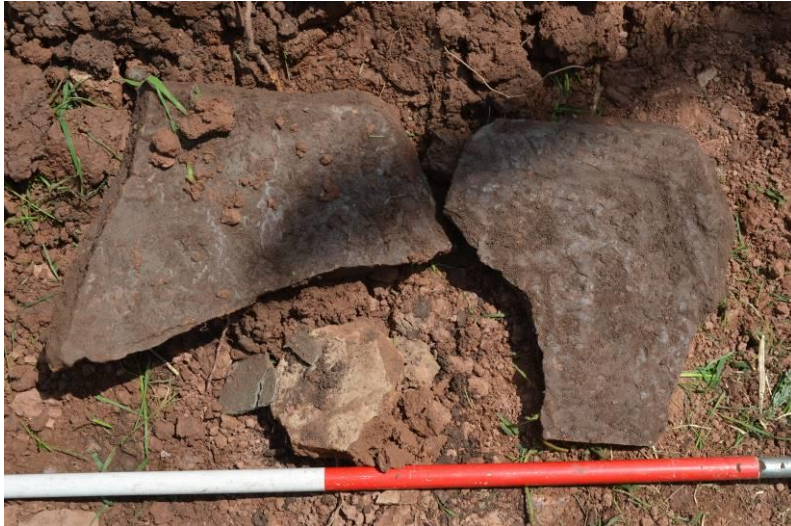
(202) was filled with a mixture of dark grey top soil which contained a mixture of relatively modern debris, including white ceramic and large stone fragments which may have originally formed ledger stones or fragments of stone roof tile. (See Plate 4 and Figure 8)

Plate 4: showing worked stone fragments from (203), possibly ledger stones or stone roof tiles.

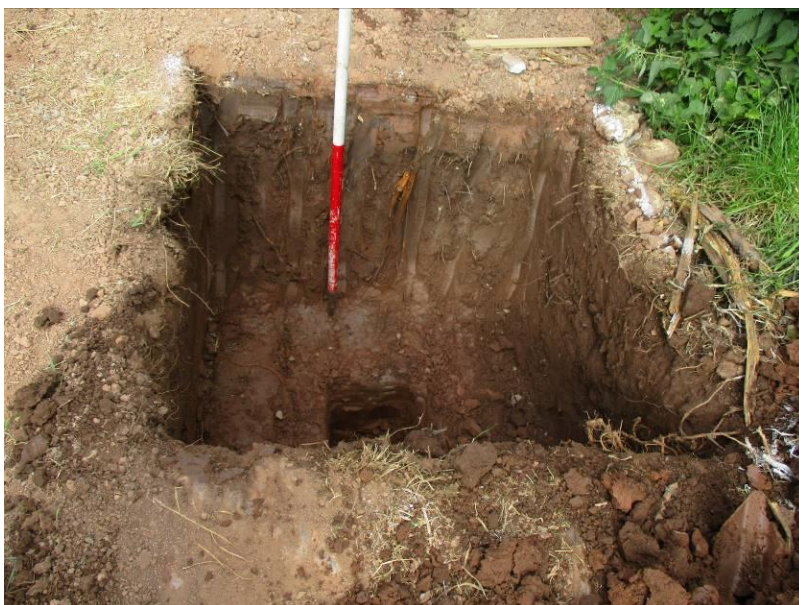
Test pit 4 measured approximately 1.0m by 1.0m with a depth of approximately 1.00m. The stratigraphic sequence consisted of a turf and topsoil layer, (301) overlaying a red brown silty clay (302). No features of archaeological significance were observed. (See Plate 5)

Plate 5: Facing West, overview of Test pit 4.

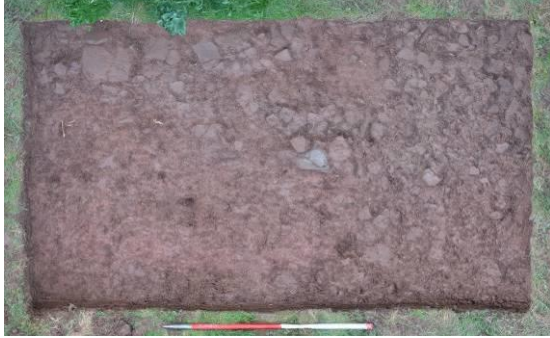
<b>Trench</b>	2

<b>Sample Section Length</b>	-	<b>Excavated Depth</b>	1.20m		
<b>Minimum Depth to level of potential archaeological horizon</b>	0.30m	<b>Maximum Depth to level of potential archaeological horizon</b>	0.30m		
<b>Datum height</b>	69m				
<b>Dimension</b>	2.87m by 1.47m max depth 1.20m.				
<b>Context No</b>	<b>Description (Layer, Cut, Fill)</b>	<b>Dimensions (as appropriate)</b>			
		<b>Diameter</b>	<b>Length</b>	<b>Width</b>	<b>Depth</b>

(200)	Turf and Topsoil, red brown, sharp interface. Occasional inclusions of small rounded pebbles 1%, inclusions of angular small to medium pebbles 10%.	-	<4.65m	<2.70m	0.22m

(204)	Linear cut for grave Fill (202), aligned east – west.	-	1.86m +	0.60m max	0.95m +
(205)	Possible linear cut and fill for burial along the south section line of Trench 2, visible as collapse after excavation of trench.	-	1.80m +	-	-
<b>Interpretation</b>					
Turf and topsoil deposit over subsoil with layer of flat angular stones forming a possible surface or natural spread over geological substrate, maximum excavated depth 0.55m. a single grave cut, aligned east-west was observed during excavation, following the excavation a second grave cut was observed with the south section line of the trench as a partial collapse of the section line.

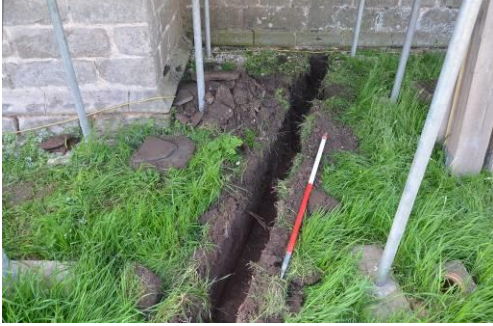
<b>Service Run</b>

<b>Sample Section Length</b>	-	<b>Depth</b>	0.40m		
<b>Minimum Depth to level of potential archaeological horizon</b>	-	<b>Maximum Depth to level of potential archaeological horizon</b>	-		
<b>Datum height</b>	69m				
<b>Dimensions</b>	<7.00m by 0.30m avg, with a depth of approximately 0.40m.				
<b>Context No</b>	<b>Description (Layer, Cut, Fill)</b>	<b>Dimensions (as appropriate)</b>			
		<b>Diameter</b>	<b>Length</b>	<b>Width</b>	<b>Depth</b>
(S100)	Turf and Topsoil, buff grey, silty clay, mouldable, sharp interface. Inclusions of very small angular pea grit 1%, occasional small rounded pebbles 1%.	-	<7.00m	<0.30m	0.10m
(S101)	Subsoil, red brown, sharp interface. Occasional inclusions of small rounded pebbles 1%, inclusions of angular small to medium pebbles 10%.	-	-	-	0.30m
<b>Interpretation</b>					
Turf and topsoil deposit over subsoil, no archaeological features of significance were observed during the excavation of the service run.

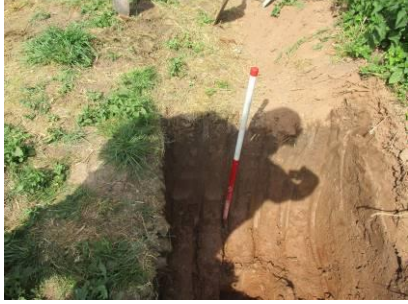
<b>Test Pit</b>	3

<b>Sample Section Length</b>	-	<b>Excavated Depth</b>	1.20m		
<b>Minimum Depth to level of archaeological significance</b>	-	<b>Maximum Depth to level of archaeological significance</b>	-		
<b>Datum height</b>	69m				
<b>Dimensions</b>	1.00m by 1.00m max depth 0.80m.				
<b>Context No</b>	<b>Description (Layer, Cut, Fill)</b>	<b>Dimensions (as appropriate)</b>			
		<b>Diameter</b>	<b>Length</b>	<b>Width</b>	<b>Depth</b>
(TP300)	Turf, Topsoil and Subsoil, red brown, sharp interface. Occasional inclusions of small rounded pebbles 1%, inclusions of angular small to medium pebbles 10%.	-	<1.20m	<1.10m	0.30m
(TP301)	Geological substrata, red brown, silty clay, mouldable. Inclusions of angular stone pebbles, deposit becomes more solid clay at lower levels, gradual change at lower levels.	-	-	-	0.50m
<b>Interpretation</b>					
No features of Archaeological significance were observed during the excavation of Test pit 3.

Test pit 3 measured approximately 1.0m by 1.0m with a depth of approximately 1.00m. The stratigraphic sequence consisted of a turf and topsoil layer, (301) overlaying a red brown silty clay (302). No features of archaeological significance were observed.

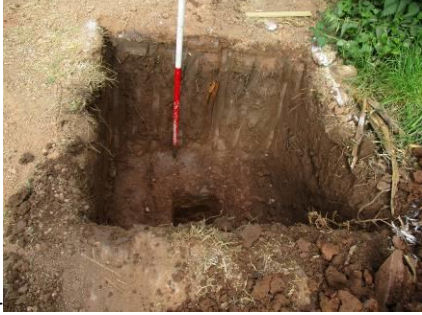
<b>Test Pit</b>	4

<b>Sample Section Length</b>	-	<b>Excavated Depth</b>	1.20m		
<b>Minimum Depth to level of archaeological significance</b>	-	<b>Maximum Depth to level of archaeological significance</b>	-		
<b>Datum height</b>	69m				
<b>Dimensions</b>	1.00m by 1.00m max depth 1.00m.				
<b>Context No</b>	<b>Description (Layer, Cut, Fill)</b>	<b>Dimensions (as appropriate)</b>			
		<b>Diameter</b>	<b>Length</b>	<b>Width</b>	<b>Depth</b>
(TP400)	Turf, Topsoil and Subsoil, red brown, sharp interface. Occasional inclusions of small rounded pebbles 1%, inclusions of angular small to medium pebbles 10%.	-	<1.20m	<1.10m	0.30m
(TP401)	Geological substrata, red brown, silty clay, mouldable. Inclusions of angular stone pebbles, deposit becomes more solid clay at lower levels, gradual change at lower levels.	-	-	-	0.70m
<b>Interpretation</b>					
No features of Archaeological significance were observed during the excavation of Test pit 4.
