# **Pembridge Market Hall Pembridge Herefordshire: A Ground Investigation**

**Herefordshire Archaeology Report No. 91**

*Herefordshire Archaeology investigated the base of Pembridge's 16<sup>th</sup> century Market Hall for the Pembridge Amenity Trust, in order to supply information for its renovation. The specific aim of the work was to establish whether there was, or had been, a man-made floor within the hall i.e. cobble or flagstone.*

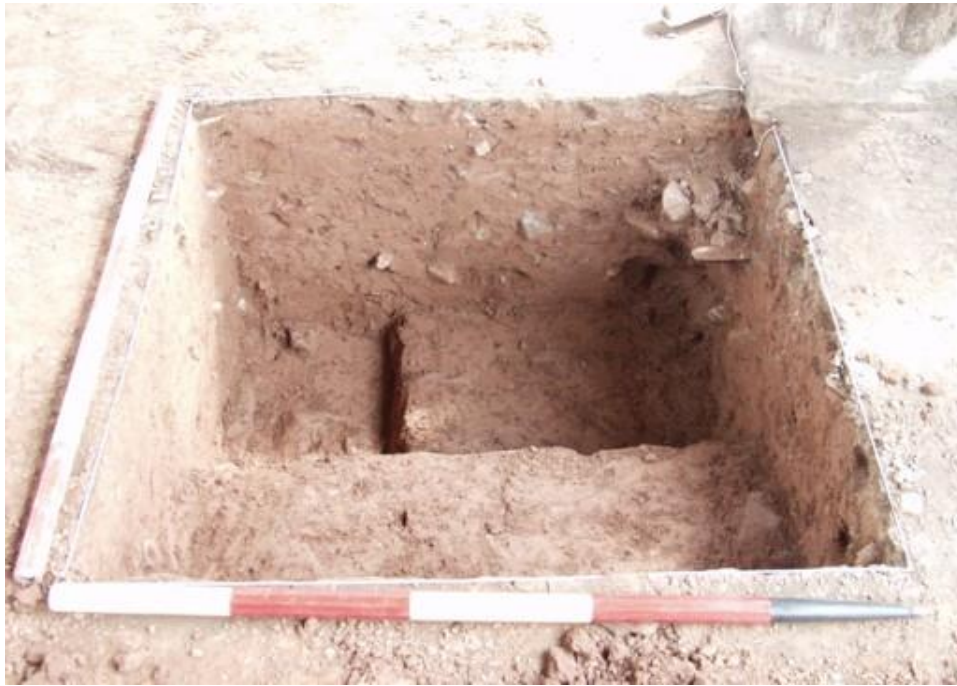
**Plate 1:** South section with pillar base and associated footings in the top right hand corner. It is believed that these are the result of refurbishment in 1927. (© Robert Anderson Marketing Services).

This is the foundation cut for the pillar base. This was excavated (presumably in 1927) to depth of 0.25m; it cuts 001 and cuts into 002 (see Plate 1).

This is the fill of 003. It consists of mainly angular stone (max 0.07m diameter), set in a mix of clay and weak friable mortar. The pillar base stone is set into this deposit (see Plate 1).

Underlying this is un-weathered till (002) with occasional small stones. Cut into this layer was the pillar base foundation cut 003 and its fill 004. It would appear that this is most likely the result of work carried out in 1927. Jack (1929, 34) states that "five other new bases were supplied resting on concrete". He also states that this method of construction was "an improvement, if I may say so, on the original constructor's work" perhaps suggesting that the original pillar bases were laid straight onto the solid till. If this assumption is correct then any floor that may have been laid, would have been flush with the pillar bases. No other cuts or postholes were identified during the excavation.

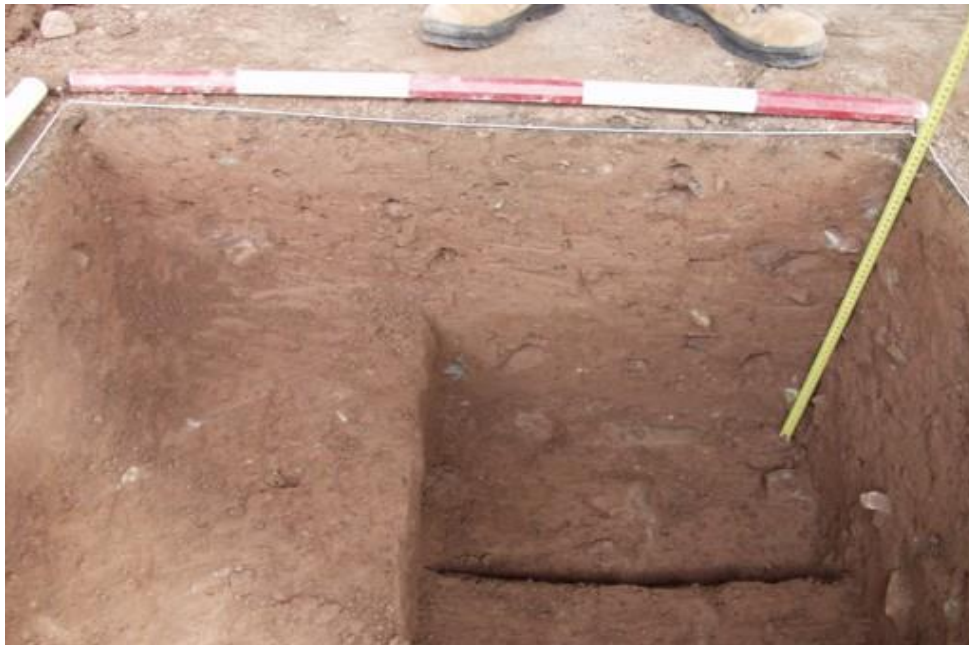
**Plate 2:** East section showing the gradation of stone towards the base, and the otherwise 'clean' profile. (©Robert Anderson Marketing Services).

The base layer (005) marks the point at which the heavier clast sizes begin to fine upwards towards the top of the depositional sequence (Plate 2).
