The Churchyard of the Parish Church of St Deinst, Llangarron: A Topographic Survey

Herefordshire Archaeology Report No. 135

Herefordshire Archaeology Report No. 135
Herefordshire Archaeology, July 2004

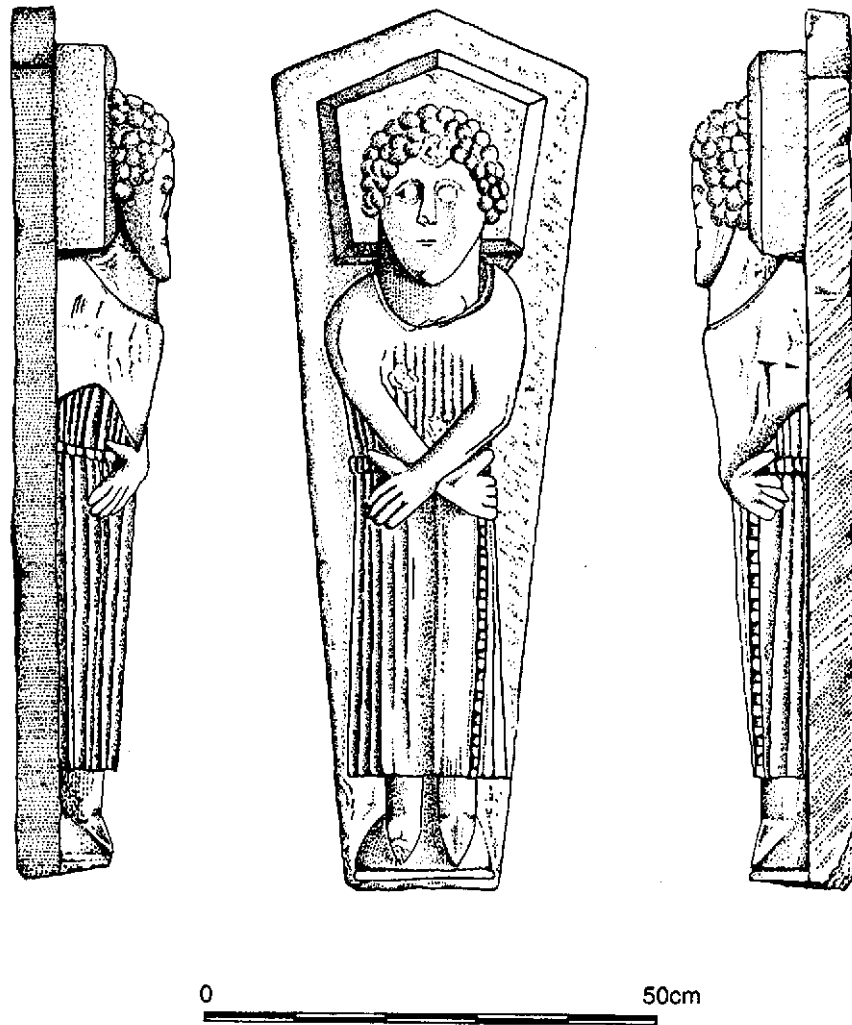
Figure 4. The Llangarron figure. Drawn by Tim Hoverd.
Copyright Herefordshire Archaeology.

Within the parish church of St Deinst, attached to the south wall of the nave, is a sandstone slab bearing the carved figure of a man in high relief (Figure 4.) (also recorded as SMR 6418). The slab, 1m in length and 0.35m wide at its maximum width, has been interpreted as a child's coffin dated to the late 13th or early 14th century (RCHME, 1931: 168). The figure has been reassessed by Keith Ray, based on a stylistic analysis (Ray, 2001a, 2001b).

Dr Ray proposes that the representation is within the known traditions of Iron Age and Romano-British figure sculpture, and he draws attention particularly to the half-round figure sculpting, the tapering proportions of the body, the triangular-cut jaw, and the protruding lentoid-shaped eyes. The hair is represented in the classical and late Roman tradition. The figure is clothed in a simple clerical gown, gathered at the waist with a cord. Dr Ray concludes that this appears to be the representation of a priest of the early British Church, dated to the fifth or sixth century (Ray 2001b: 123-124). It is possible that the slab, onto which this figure has been carved, has been re-cut during the 13th or 14th century in order to make a child's coffin lid.

The final piece of evidence that may link the churchyard of Llangarron with the site of the early British church is the Llangarron figure. The stylistic attributes of the carved stone figure appear to date it to the mid first millennium, and to place it in the context of the early British Church in south Herefordshire.
