Archaeological Investigations at New Weir, Herefordshire, 2004-2005

Herefordshire Archaeology Report No. 188

Archaeological Investigations at New Weir, Herefordshire

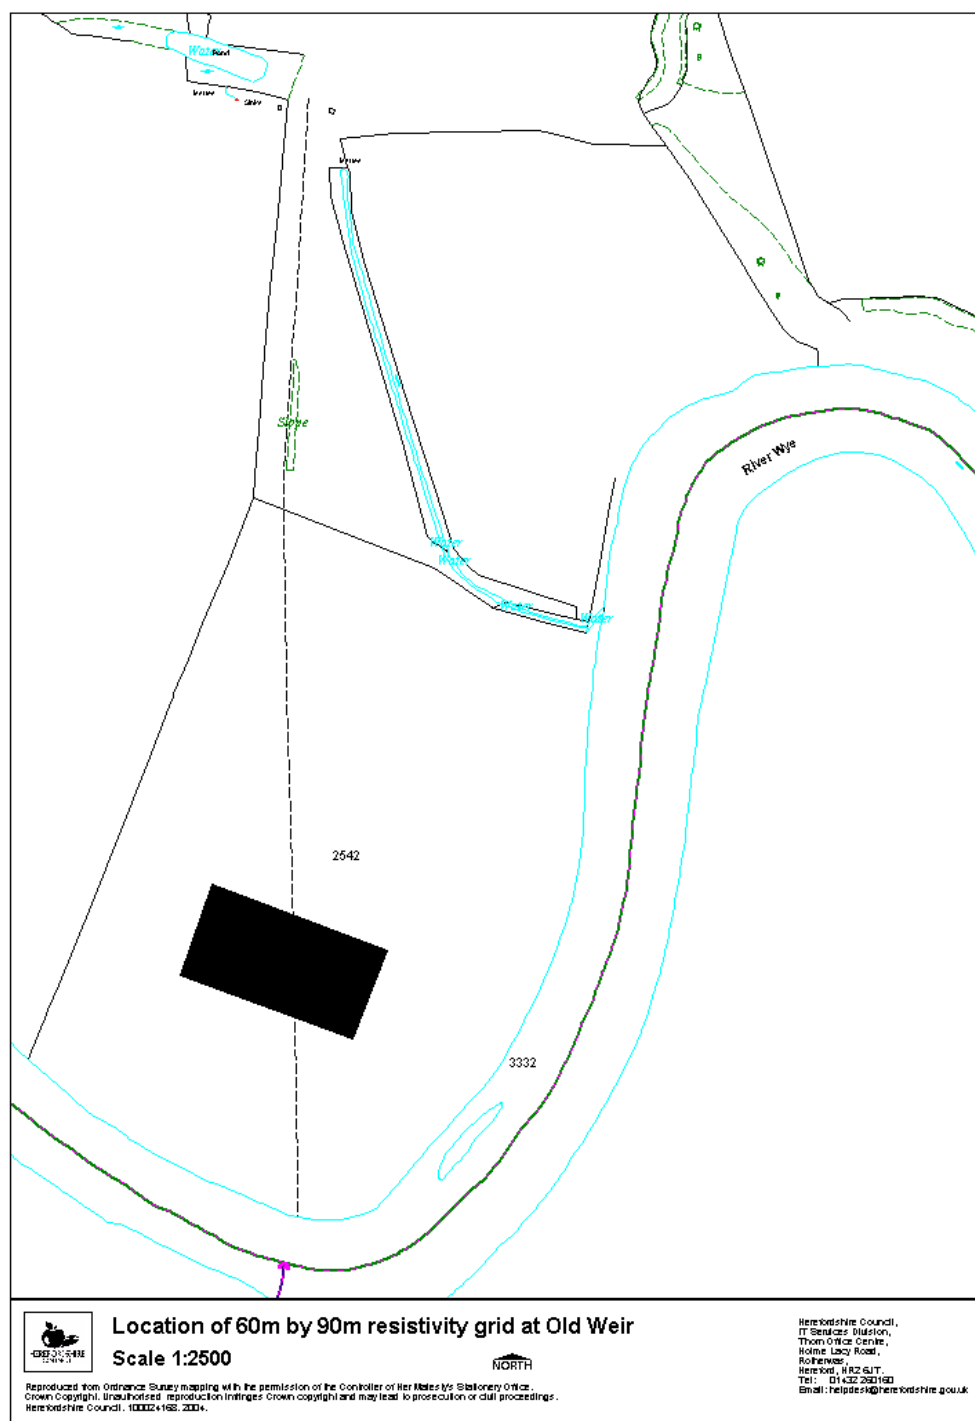
Figure 3: Location of resistivity survey. (dotted line shows centre of Roman Road)

The resistivity data, (see figure 3 and figure 4), indicates that the survey area comprises two distinct areas, east and west of the road. The geophysics sample identifies distinct differences between the area to the east of the road from that of the west possibly suggesting the presence of features here that include high resistance anomalies on the western side of the road. This may represent the location of buried foundations and / or disturbed ground.

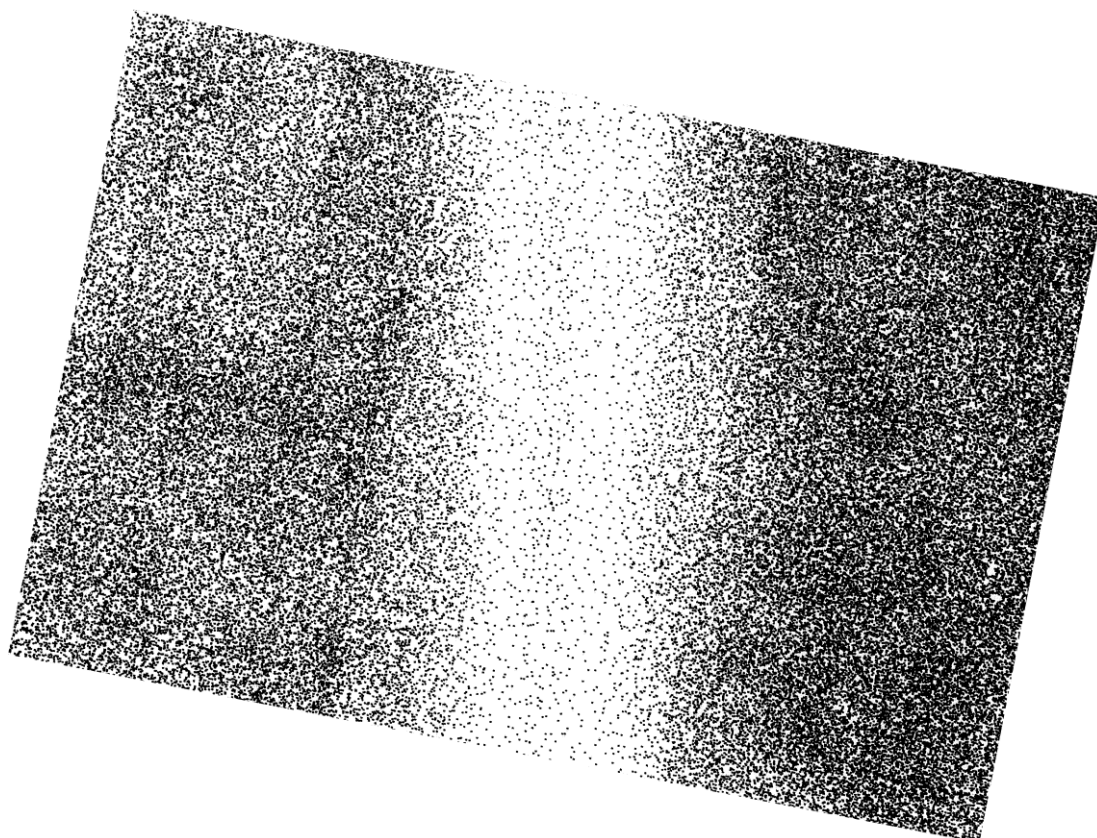
Figure 4: Resistivity survey plot over Roman road (plot size 90 by 60m)

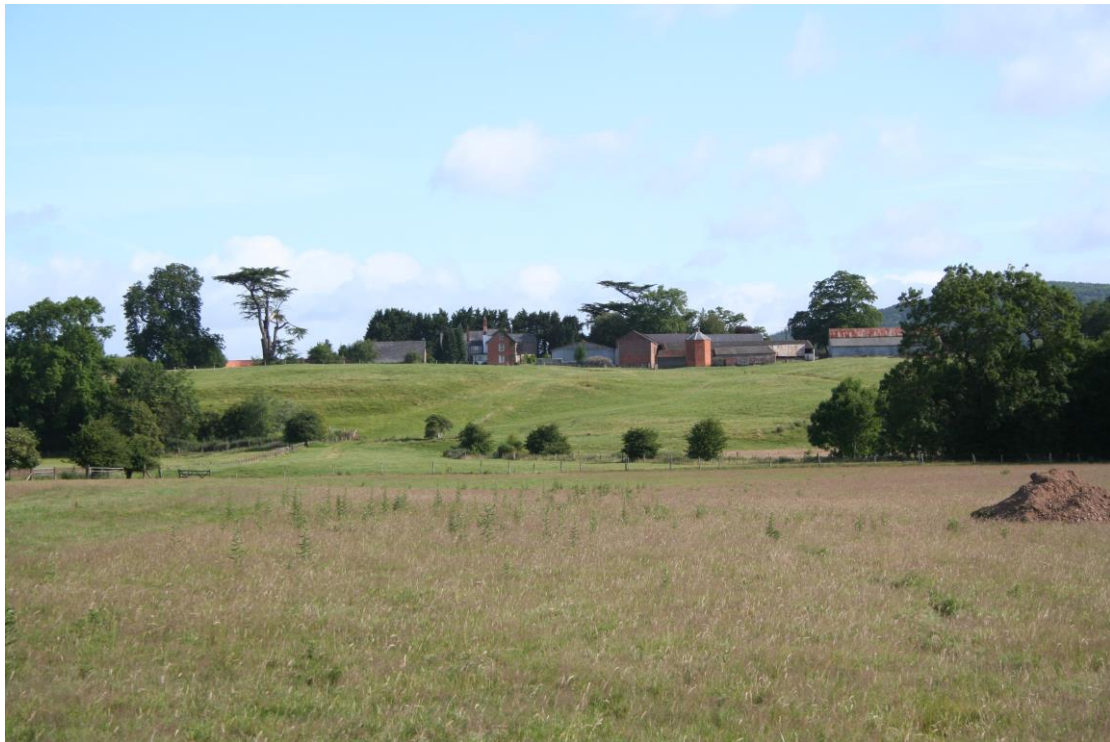
Plate 1: View north from the floodplain of the river terrace and associated features. The buildings on the horizon are part of Old Weir Farm.

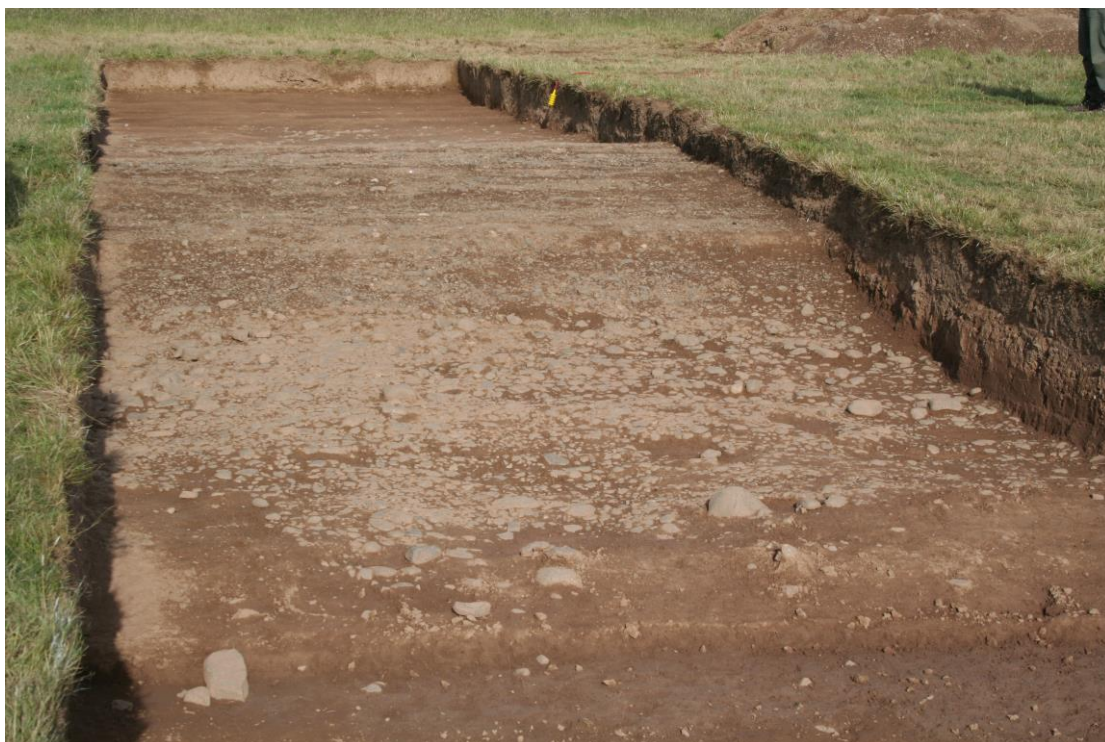
Plate 2: Trench 1 showing both the upper and lower road surfaces

Trench 1 was located directly over the earthwork/causeway of the Roman road and crossed it perpendicularly. Its total (after an extension to take in the complete width of road and causeway) this trench measured 17m long and 4m wide. Upon removal of the turf the top of the gravel made road was visible and this was followed to either side to a depth of 0.5m. The gravel surface road [010] appeared to be in remarkably good condition with only limited plough damage from the very top of the camber. Surface [010] comprised a fine, fairly uniform gravel which was well compacted into a bed of lime mortar and extended for approximately 6m in width. The surviving road surface showed signs of light wheel ruts over its entire width. Whilst its eastern edge was bounded by a shallow ditch or *agg*ar [022], the western edge ran onto a spread of well laid cobbles / large gravel, [065]. This surface appeared lower down in section than [010] and its edge was overlain by the makeup of [010] by approximately 1m. Surface [065] showed signs of heavy rutting and also areas of patching / repair and, like [010], had a total width of approximately 6m. It would appear from the worn state of the cobbles which comprised the surface of [065] together with the deeper and wider sets of wheel ruts that this carriage way had been subjected to significantly heavier traffic than [010].

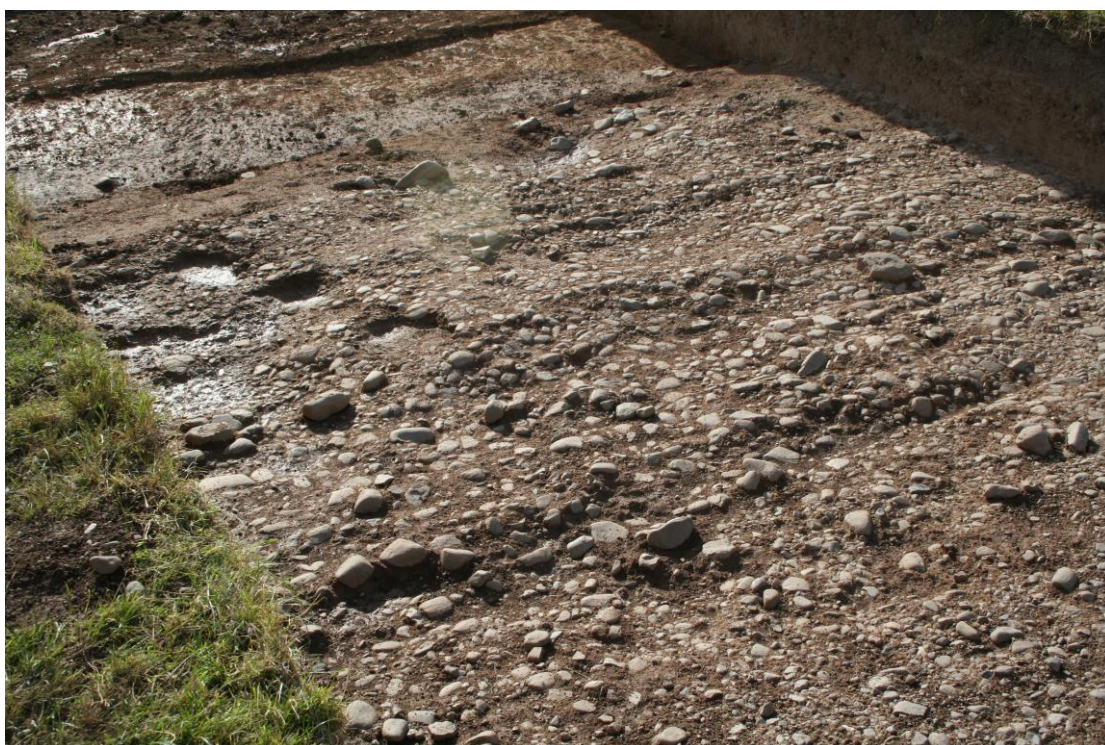
Plate 3: The lower road surface within trench 1 showing heavy rutting.

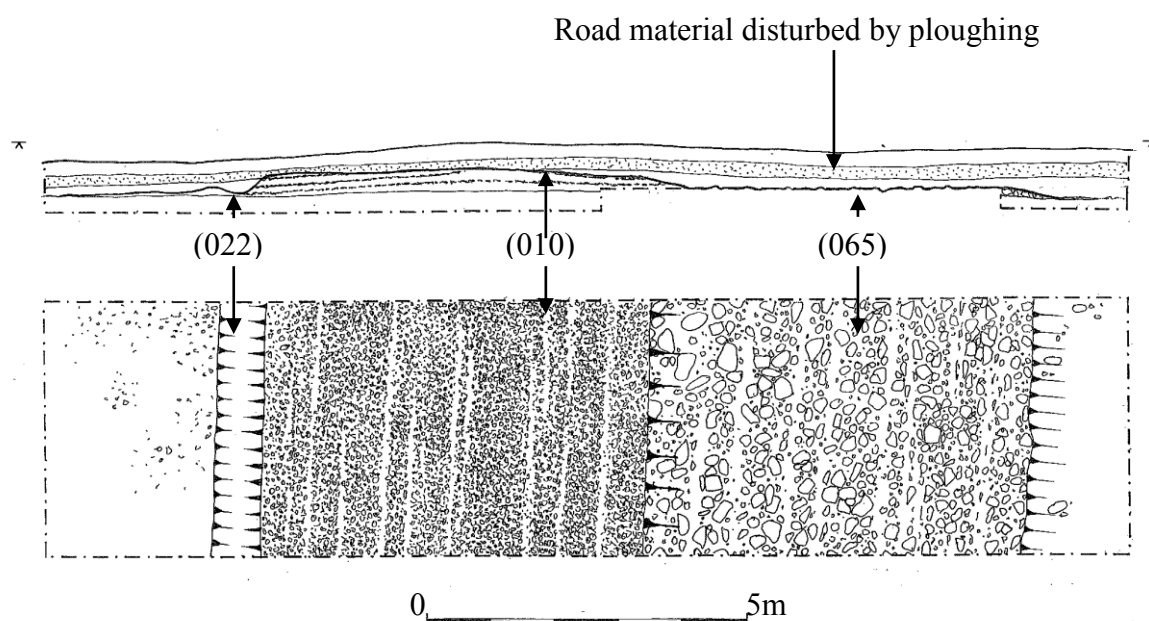
Figure 6: Plan and North facing section of Roads within Trench 1.

A section cut through the upper gravel road way indicated that this had been completely resurfaced on three separate occasions [010], [060] and [063]. Each road surface was properly constructed with successive layers of yellow clay, *opus signinum* followed by a top dressing of gravel. The make up for the primary surface [063] was laid directly upon a layer of fine silty clay [064] which was also evident in trenches 3 and 4 and is understood to be a major flooding event.

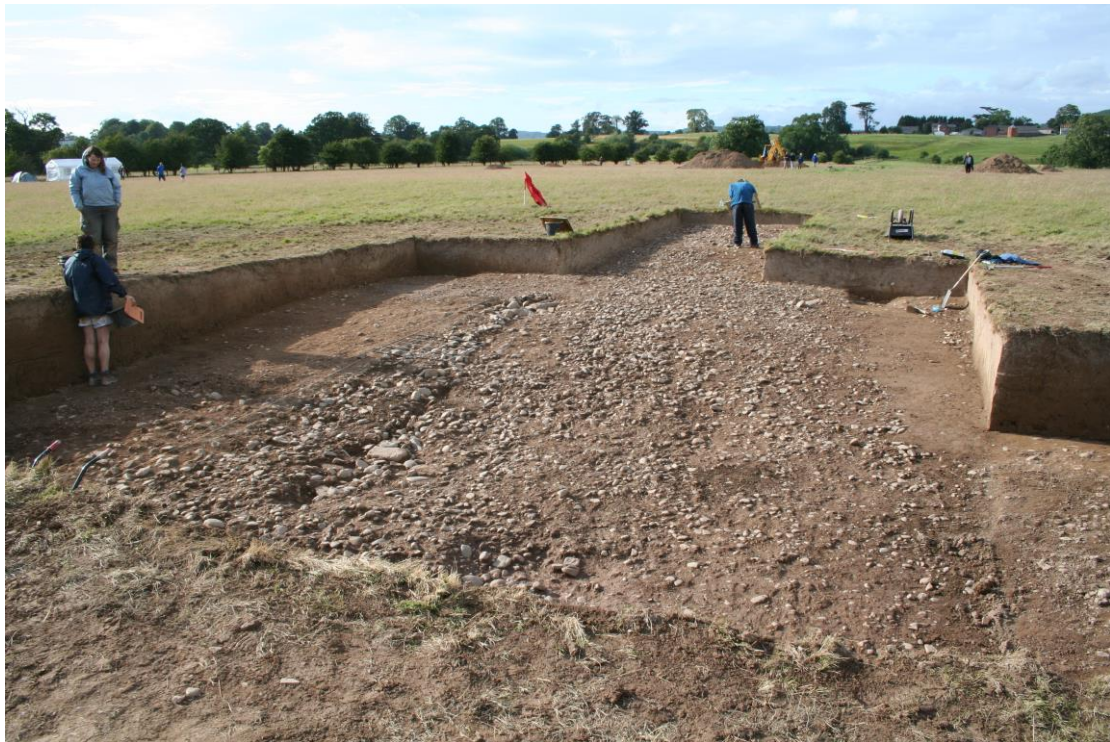
Plate 4: Trench 3 looking north, along the length of the latest Roman road

Trench 3 was located at the point where the road ceases to be a visible earthwork as it dipped down towards the river. This trench was aligned with the axis of the road in order to record the extent, angle of dip and traces of bridge abutment etc. The trench was expanded twice to take account of the width of the overlapping road surfaces encountered beneath the alluvium giving a total length of 15m and a stepped width of 5m at its northern end to 12m at its southern end. The depth of trench 3 varied from 0.3m at its northern end to 1.65m at its southern end, this reflected the angle of dip of the Roman road surface.

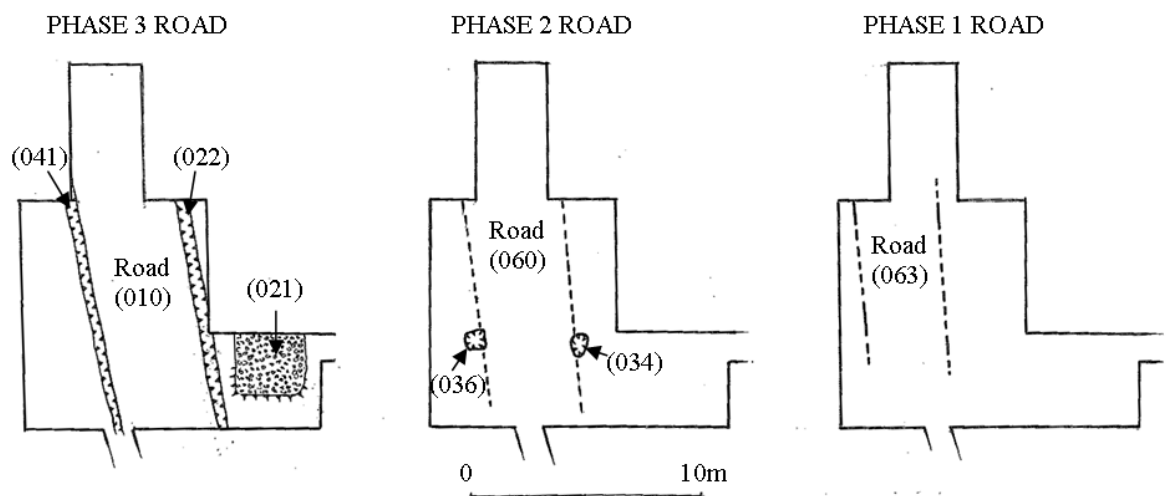
Figure 8: Plan of Trench 3 showing road phases and other significant features.

A similar sequence of road surfaces was encountered in trench 3 to those recorded in trench 1, including the continuation of the eastern *agger* ([022] in trench 1 and [041] in trench 3). However, the three successive gravel road surfaces which formed the causeway in trench 1, did not follow the same line as each other within trench 3 having only a minimal overlap with one-another. It would appear that as the road surface was systematically replaced the point at which it met the Roman river bank successively moved downstream (eastwards) by between 2 and 3m each time.

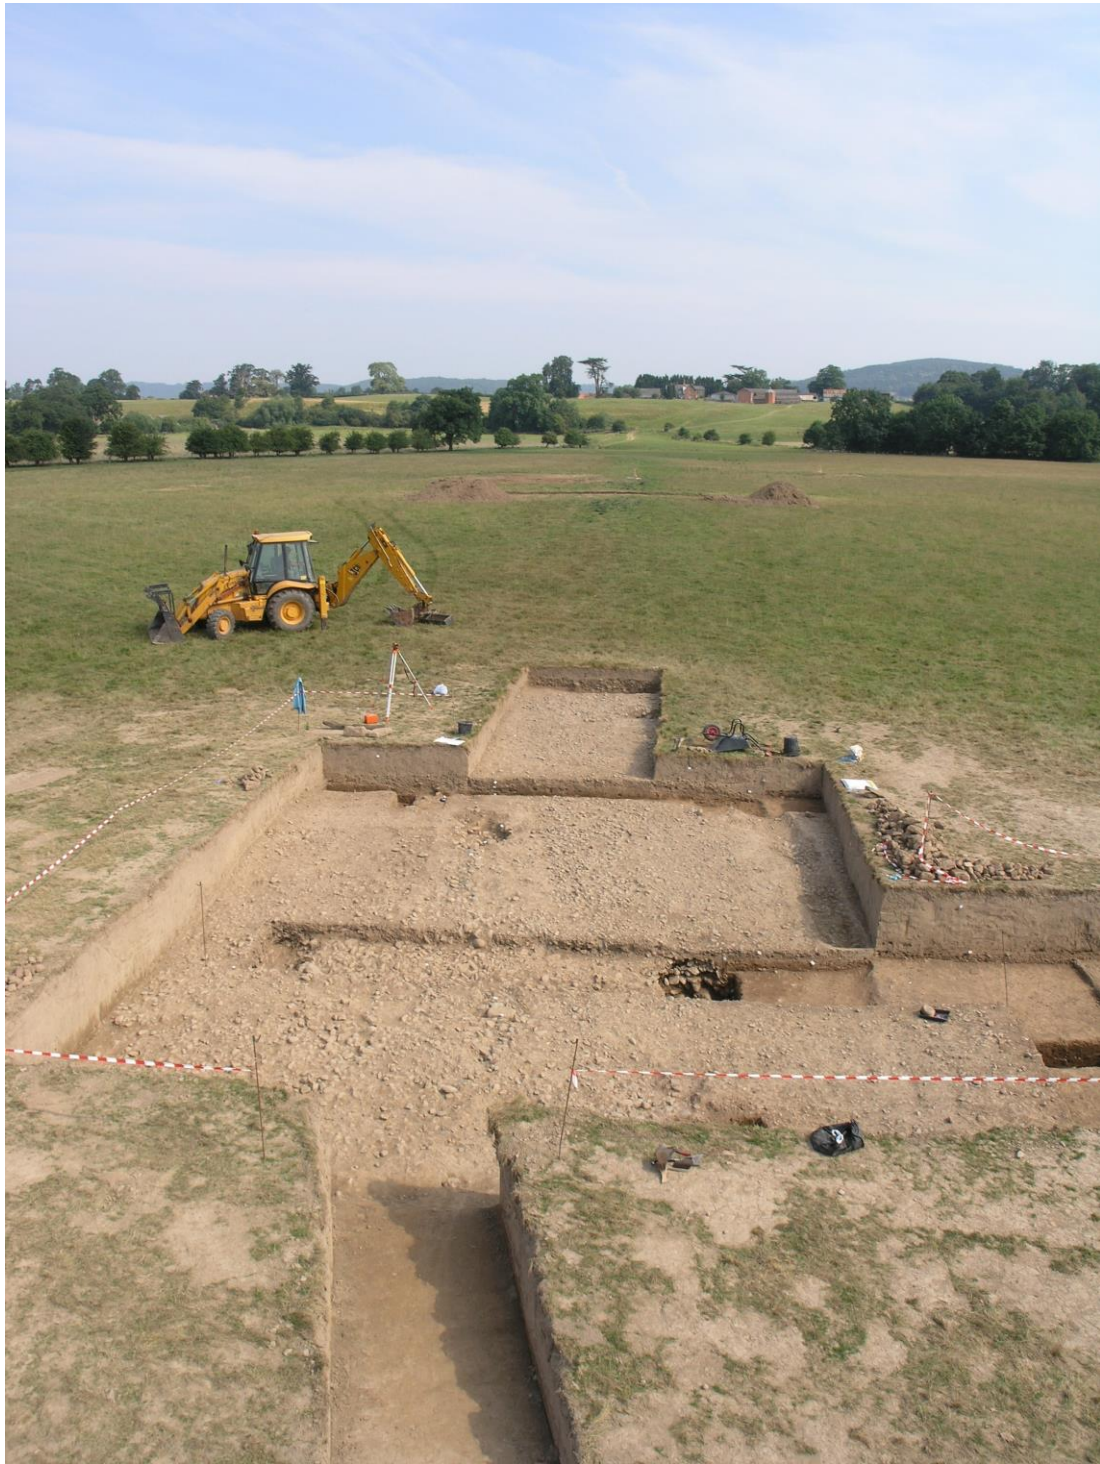
Plate 5: Trench 3 looking north showing the complex of road surfaces.

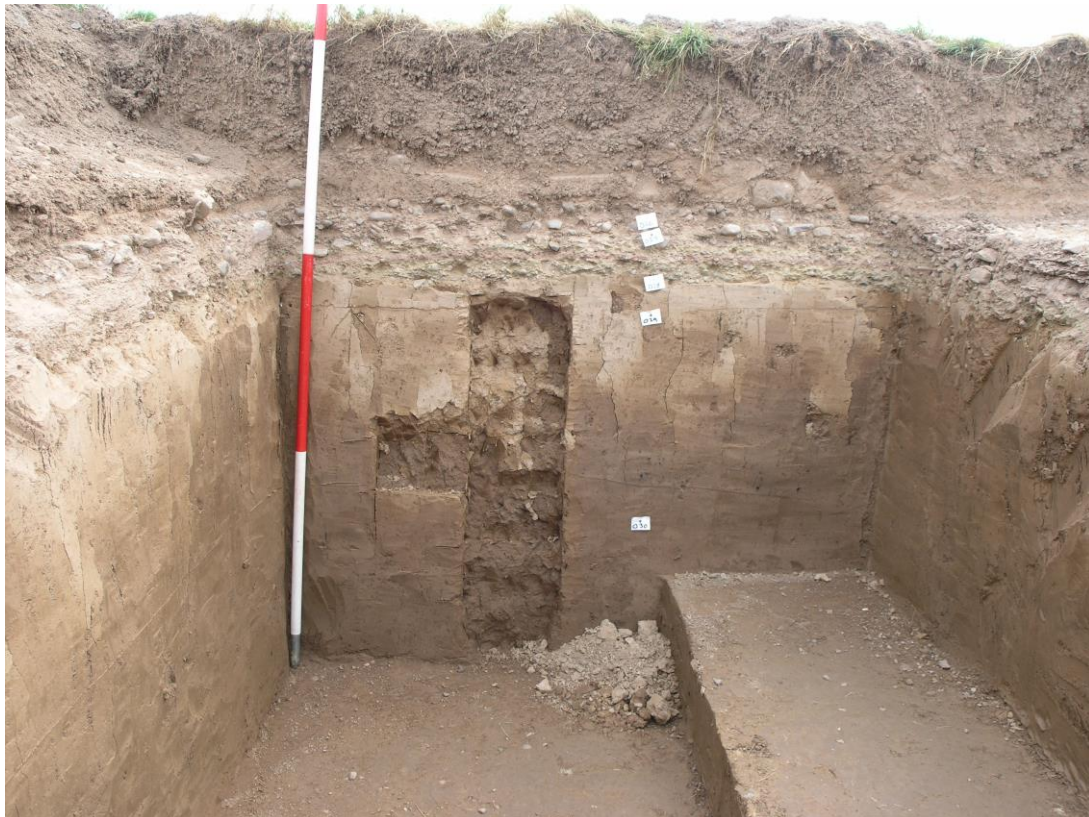
Plate 6: Eastern section of Trench 4 showing depth of alluvium below the Roman road.

A fourth trench was opened some 20m north of trench 1. This trench was designed to clarify whether there was any settlement activity very close to the road itself on its western side, and to examine the alluvial sequence directly beneath the road. The trench measured 8m by 6m and was excavated to a depth of 1.5m. The western edge of the road was sectioned and the alluvium beneath sampled. The alluvium extended down to and beyond a charcoal-enriched horizon [024]. The excavation of this trench confirmed that there were no roadside features or deposits of roman date fronting the road at this point.

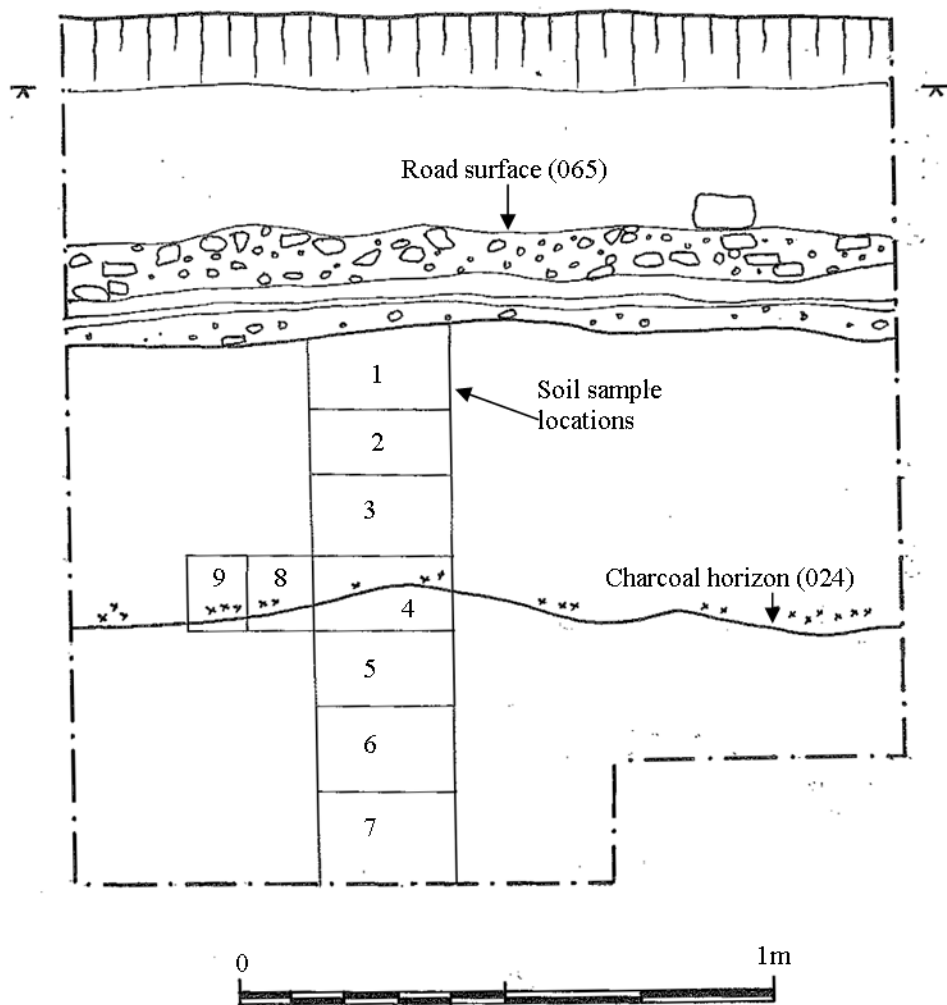
Figure 9: Eastern section of Trench 4.

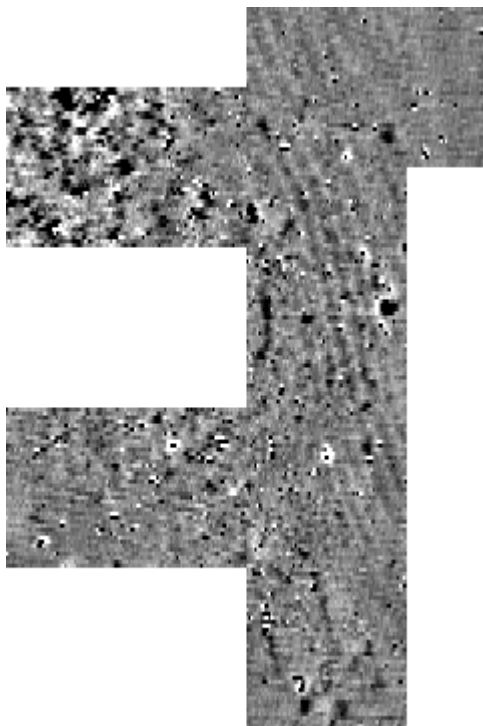
Figure 10: Results from the magnetometry survey undertaken by GSB Prospection Ltd. Clearly showing the ridge and furrow.

GSB Prospection of Bradford carried out geophysical survey before the Big Roman Dig and during its course, on both banks of the river. An initial survey using magnetometry within the loop of the river at Old Weir immediately traced something that was invisible at surface, since coverings of alluvium in the past 300 years and more had obscured it. This was the existence of an extensive 'landscape' of classic 'reversed-S' furlongs on the floodplain. This marked an extensive medieval open field system with associated headlands, one of which was soon found to comprise the 'associated causeway' feature examined in the third trench opened at the site. Attempts were then made to locate buried stonework marking the 'buttress' for the arch of a stone bridge or the foundation for a wooden one on the north bank of the river using Ground Penetrating Radar. The survey produced definite readings at depth indicating solid levels, but no clear structures were definable.
