**An archaeological assessment of the masonry remains
of Lyonshall Castle, Herefordshire**

**Herefordshire Archaeology Report No. 384
EHE80392**

An archaeological assessment of the masonry remains of Lyonshall Castle, Herefordshire

NGR: SO 3315 5633

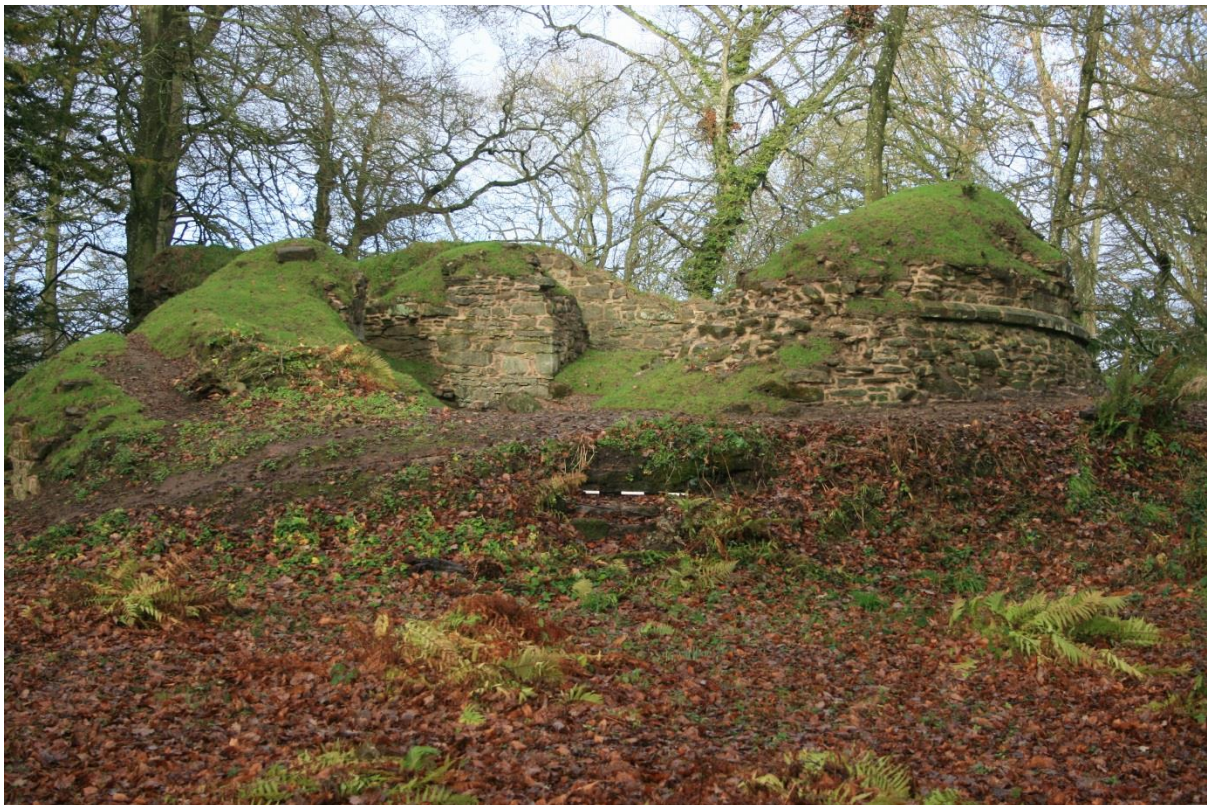
2. The keep from the east: corner of curtain wall right foreground

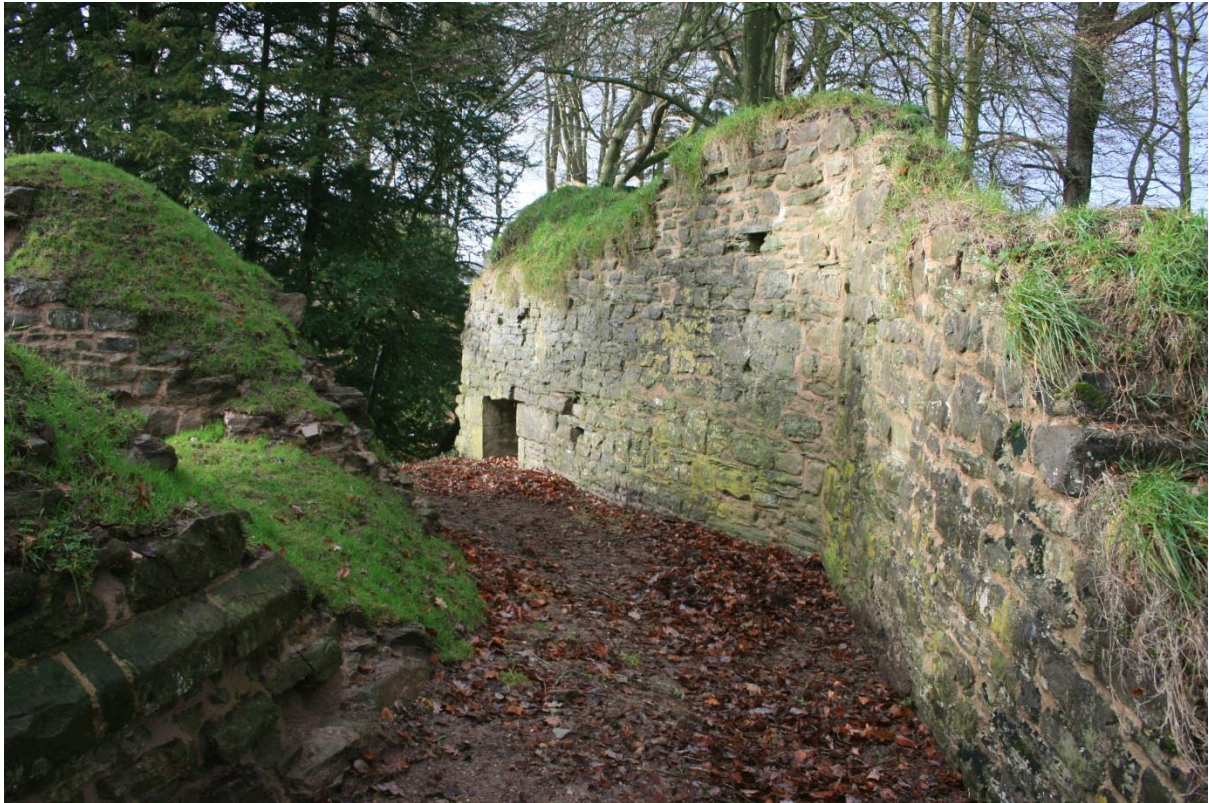
The base of a cylindrical tower keep survives to a visible height of around two metres. It is characterised externally by a substantial battered base capped with a chamfered plinth. These features are present around the south, east and north sides of the circle. On the east side, the chamfered plinth capping the battered courses is about a metre above ground level in the passage between the keep and the curtain wall, which is in turn roughly 2.5m above ground level in the bailey. The batter and plinth is continuous around the back (north side) of the keep but on the west side disappears where the stonework has eroded back and where the base is concealed by a mass projecting south-west that terminates with the south-west facing wall. A small section of wall is visible here ('A' on plan) following the general curve of the keep batter but further out from the wall face than the line that the chamfered plinth might be taken to follow, and it is clear that the battered base was in some way different on this side. The south-west facing wall beyond it contains no readable features and no returns at either end are apparent.

3. The north side of the keep with battered base and plinth, looking west

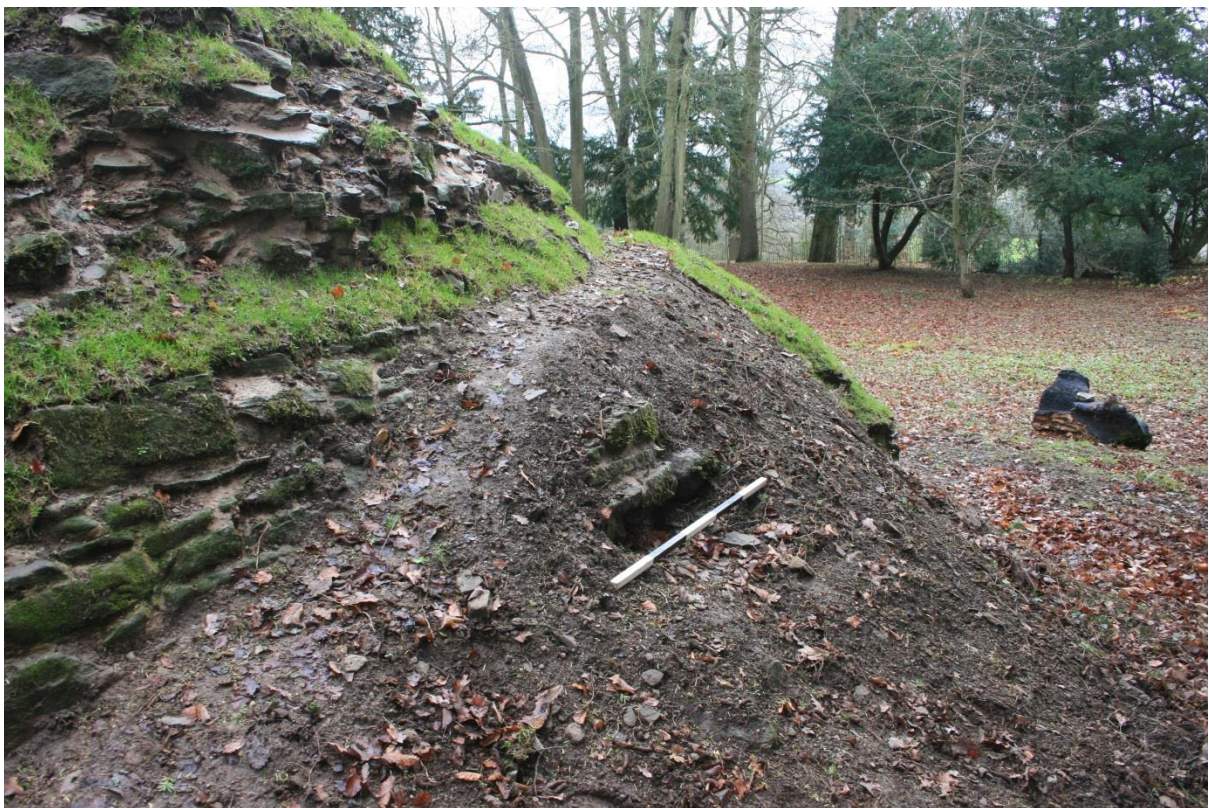
4. Isolated length of wall (A) upstanding from the plane of the battered base, west side

If the polygonal form of the curtain wall running north around the keep has been modified, it seems likely that so to have the walls to its south, which collectively form a seven-sided polygon around the base of the keep. The exposed stretch of wall facing south-west could be interpreted as just one side of a polygonal plinth-like structure from which rose the battered base of the keep. This, however, is probably an over-simplification. At the top of the modern steps approaching the keep from the south-south-east a fragment of vertical wall face is visible (see plan) which could be interpreted in this way – as a low retaining wall around the base of the keep. However, the south-west facing wall section seems much more substantial and is positioned further out from the keep walls. It seems probable that it was the end wall of a building attached to the tower keep, quite possibly the upper-end wall of a hall occupying the north-west side of the inner bailey and quite possibly linked to the tower, which may possibly have been more like a solar tower than a tower keep, at an upper level.

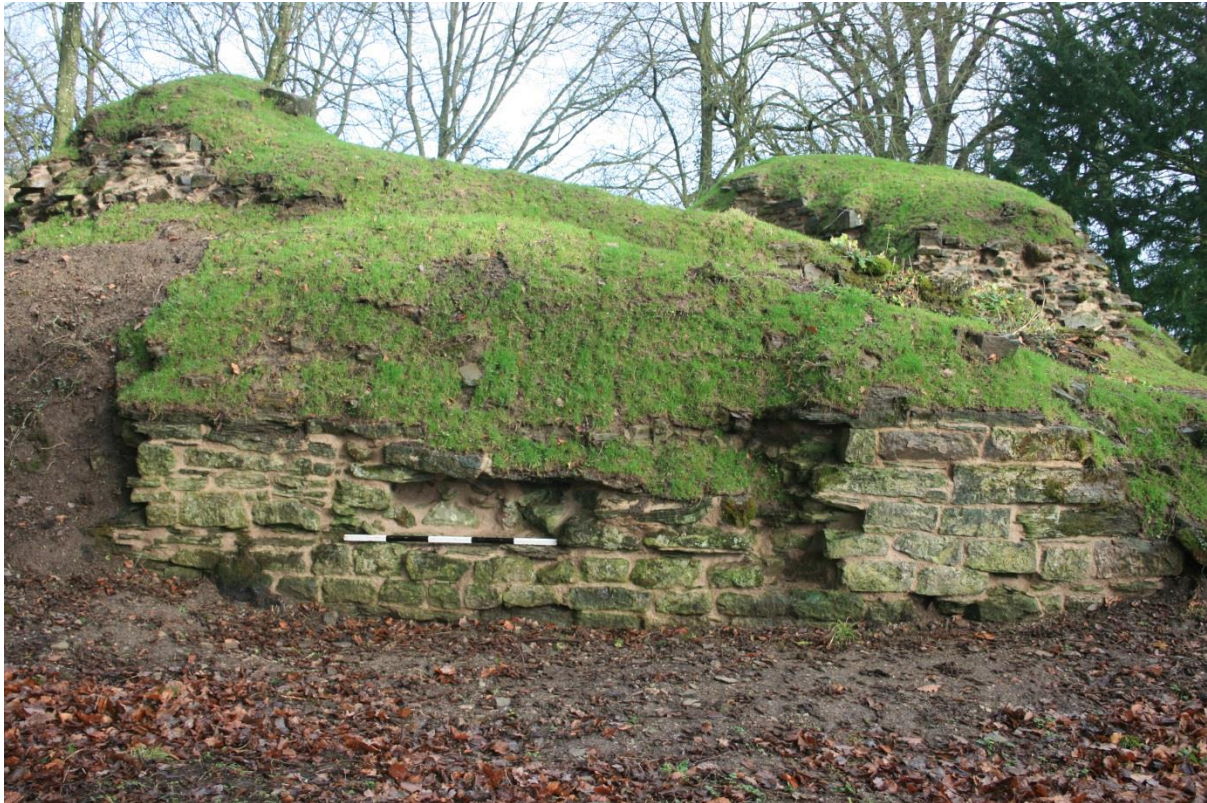
5. South-west facing wall face

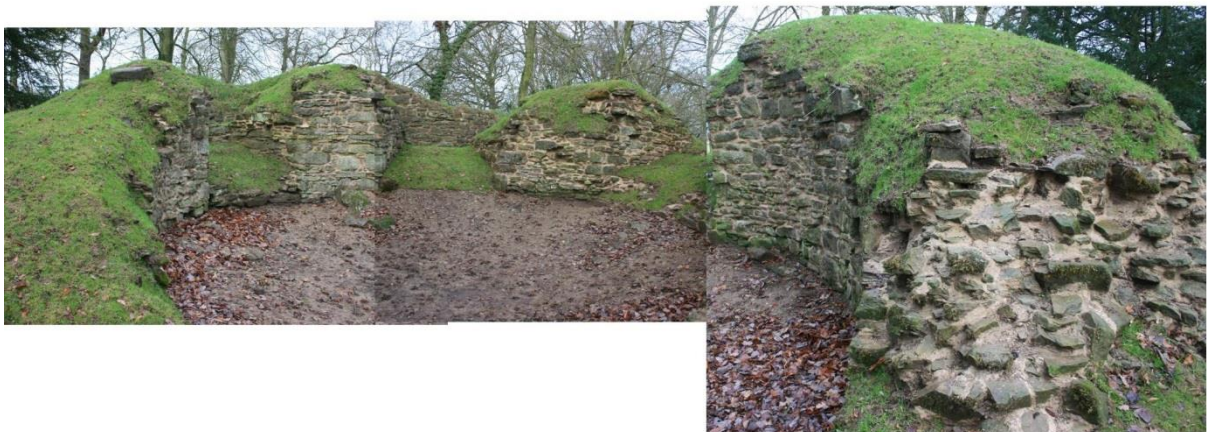
Entry through the 2.5 metre-thick walls is through a gap facing slightly east of south – either an original external entrance or an entrance to the staircase in the thickness of the wall broken through. The width of the opening is slightly less than the internal width of the three surviving splayed windows, so it is perhaps less likely that it is a fourth window broken through post-ruination to form a doorway. The ground level in the interior of the keep is just below the inside sill level of the windows facing west, north-west and north-east. The walls are truncated below the level of any springers to the rear arches over the window openings.

6. Keep interior: composite view from south

Similarly, it seems unlikely that the present entrance through the south side of the keep is an original feature, more likely that it is a gap broken through at a previous internal doorway position, most probably one giving access to the staircase in the wall thickness identified by Crispin Hack (measured sketch plan 2018); this appears to be a new discovery, a feature that was invisible to the RCHM surveyors. If the tower keep was originally accessed via a first-floor doorway, all trace of that has disappeared with the rest of the superstructure. Ground level within the keep is presently more or less at the level of the internal window sills, suggesting that the original internal floor level lies well below the modern ground surface.

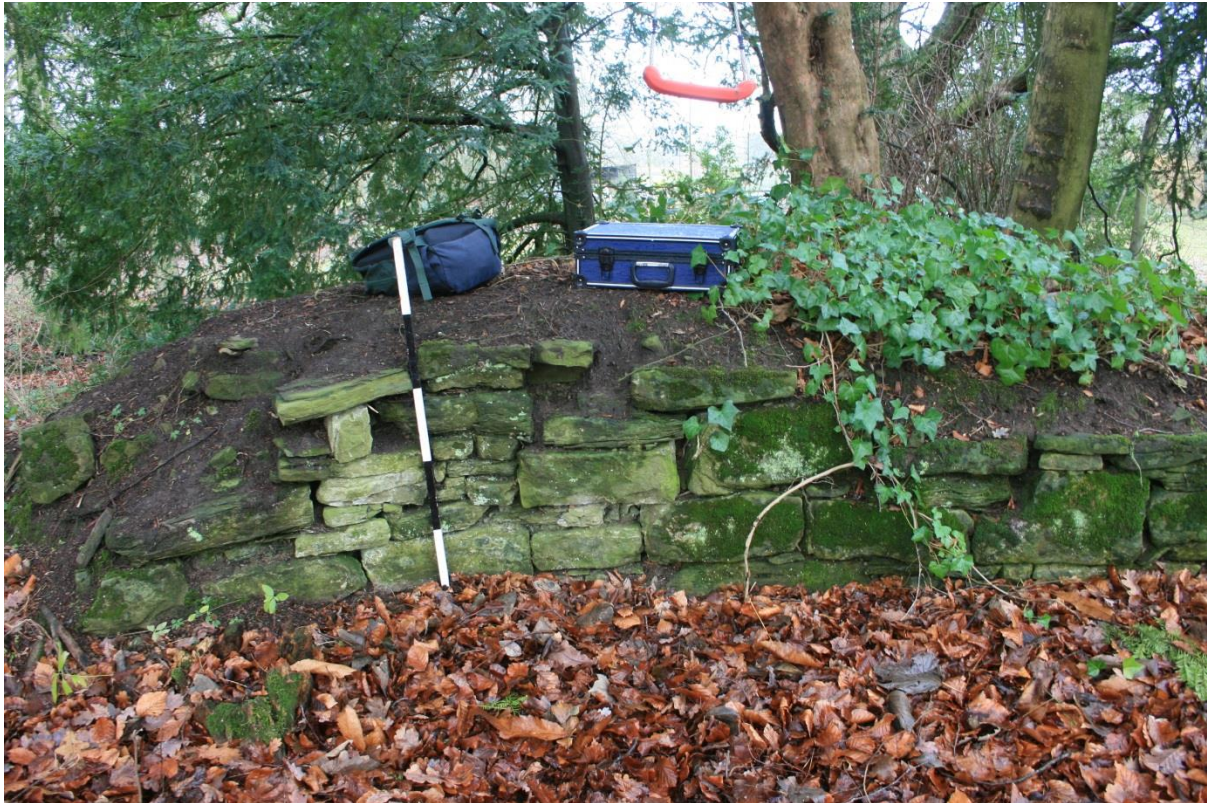
The curtain wall east of the keep is represented by a low (less than 1 metre high) wall, apparently of unmortared stone rubble, little of which appears at first sight to be in situ. However, the north-east angle ('B' on plan) of the polygonal inner bailey is composed of four to six visible courses of squared rubble or ashlar with, crucially, specifically cut, angled stones forming the corner: the masonry in this area appears to be original, as indeed the RCHM plan suggests.

7. The north-east angle of the inner bailey curtain wall showing probably original coursed masonry; the one-metre scale marks the angle

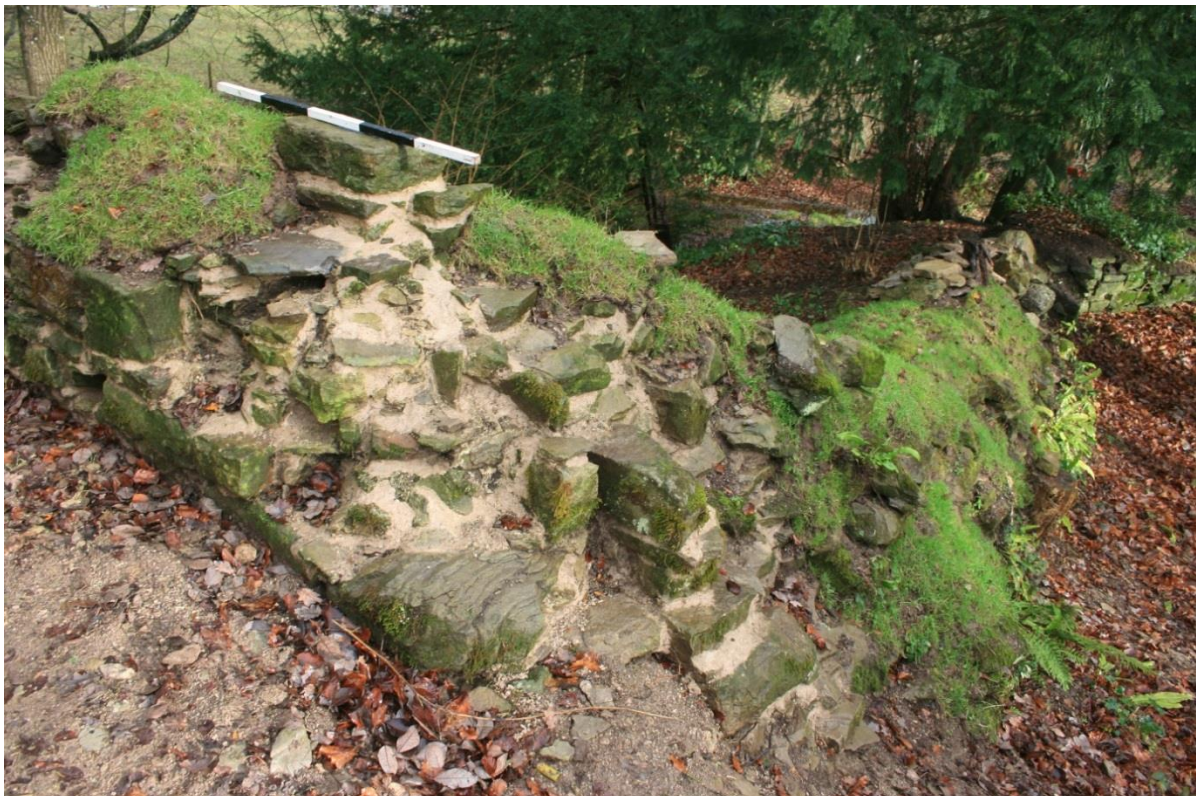
At the right-angled junction of the curtain wall where it turns north to wrap around the keep, Crispin Hack identified a dressed stone face within the thickness of the wall fabric. This is still readily apparent (fig. 8; 'C' on plan); while it can be safely said to represent a thickening-up of this section of wall around the keep, its significance is not fully understood – though elsewhere, the curtain around the keep is demonstrably of more than one phase of medieval work (see discussion, below).

8. Thickening-up of the inside face of the curtain wall at its turn north around the keep

The curtain around the keep was evidently the subject of at least one design change in the Middle Ages. This is apparant from the thickening-up of the wall at the corner east of the keep, and from the taking down of the upper section of wall around the north-west side of the keep and its rebuilding. These events could be related, but whether or not they are, there must have been a stage at which the curtain around the keep was raised in height, rendering the surviving lowest tier of keep windows

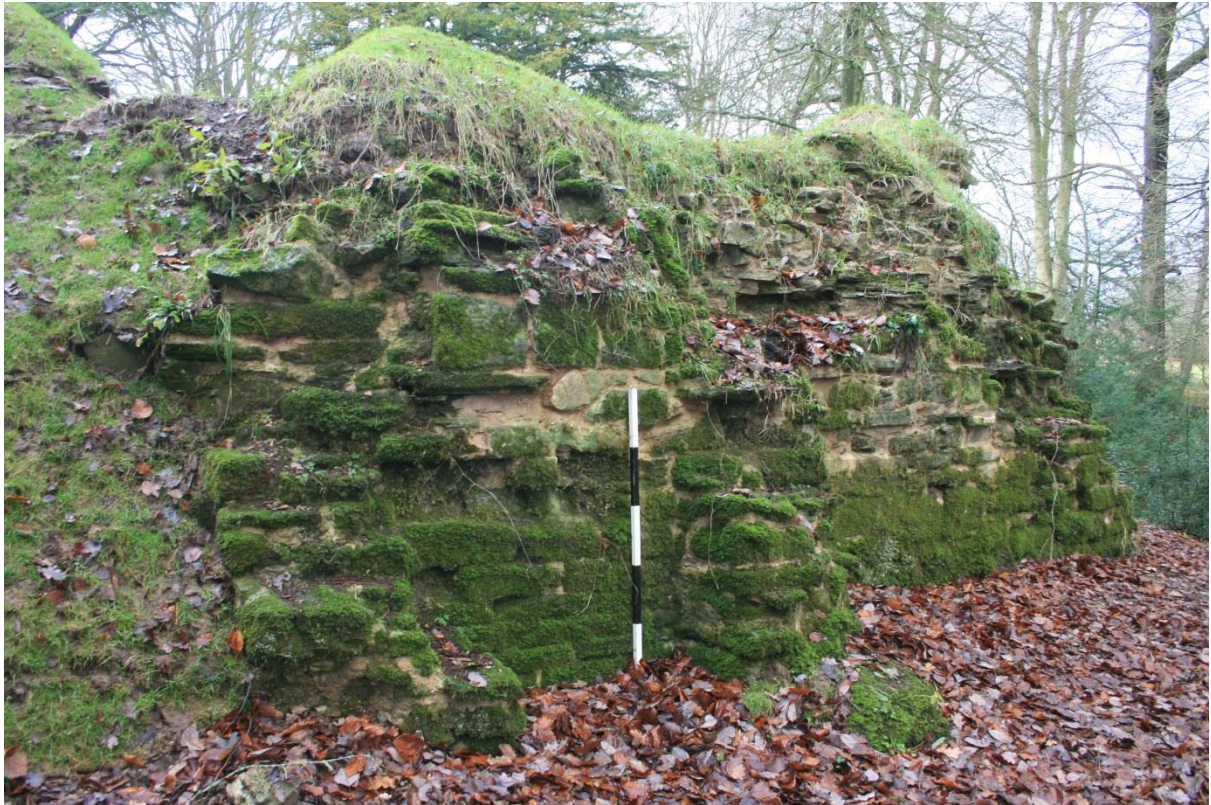
On the north-east facing section of the curtain wall exterior is a pair of projecting buttress-like stub walls ('D') that were interpreted by the RCHM as a probable footing to a projecting garderobe. This feature is discussed further below.

9. The pair of buttress-like features on the north-east face of the curtain wall, the footing of a possible overhanging garderobe

redundant. This is implicit also in the presence of the probable garderobe footing on the north-east exterior. From what would the garderobe chute have discharged? The thickness of the curtain wall does not seem to allow for a passage and garderobe chamber contained within its thickness, therefore it seems a reasonable guess that the 'corridor' around the outside of the keep was floored over at a higher level, at least at a stage in the life of the castle when considerations of active defence were being supplanted by considerations of domestic convenience.

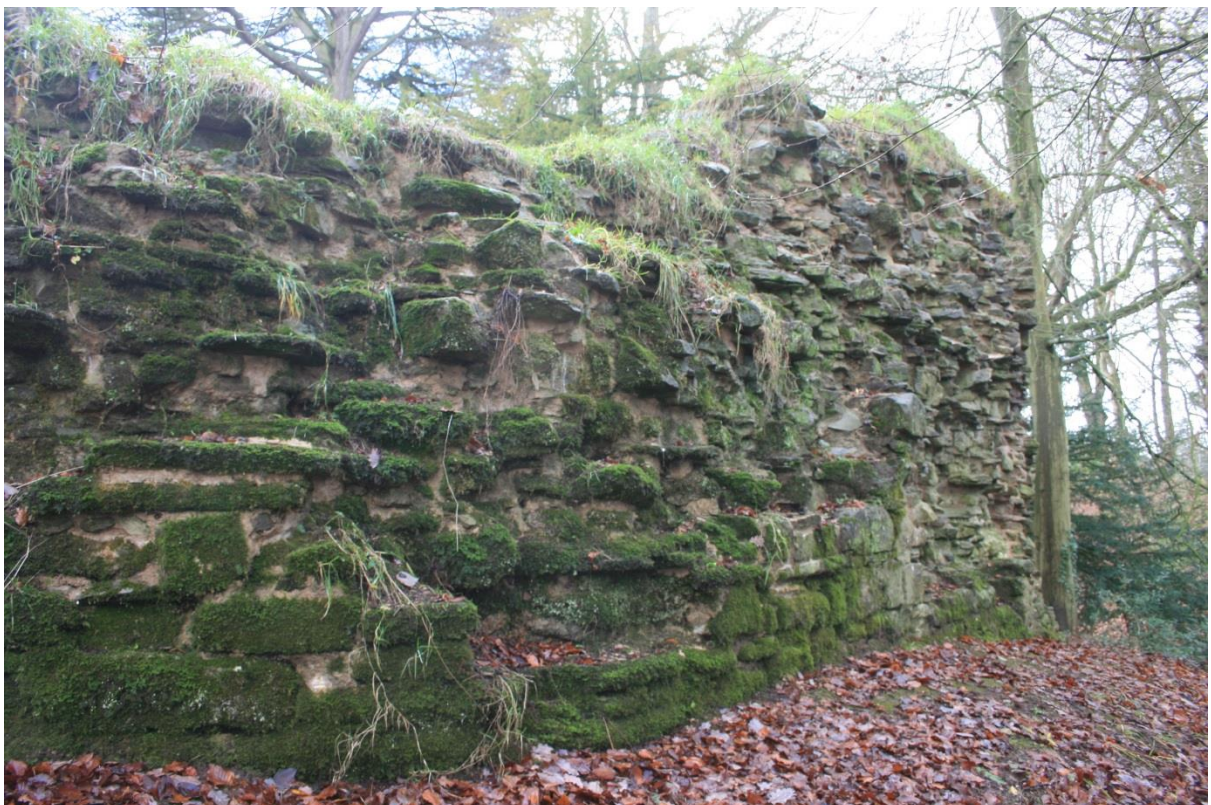
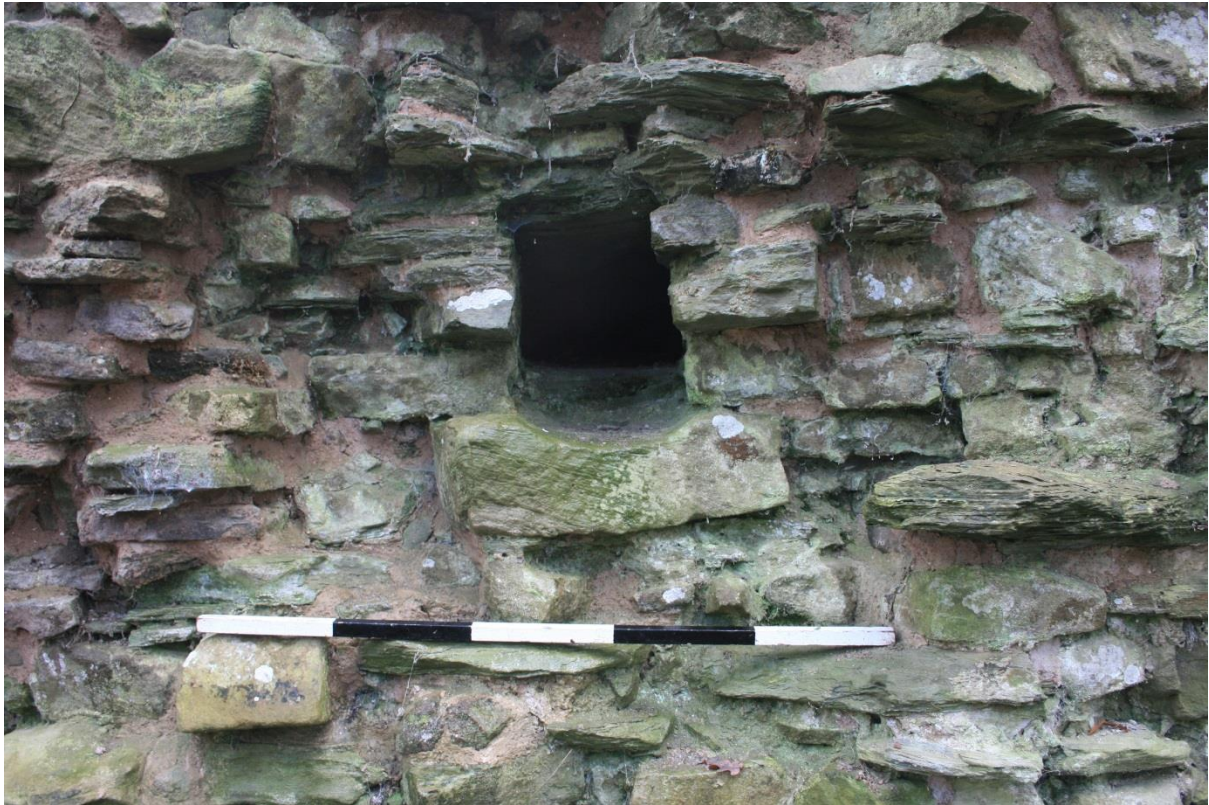
10 and 11: the north-east exterior face of the curtain wall with detail of ?drain

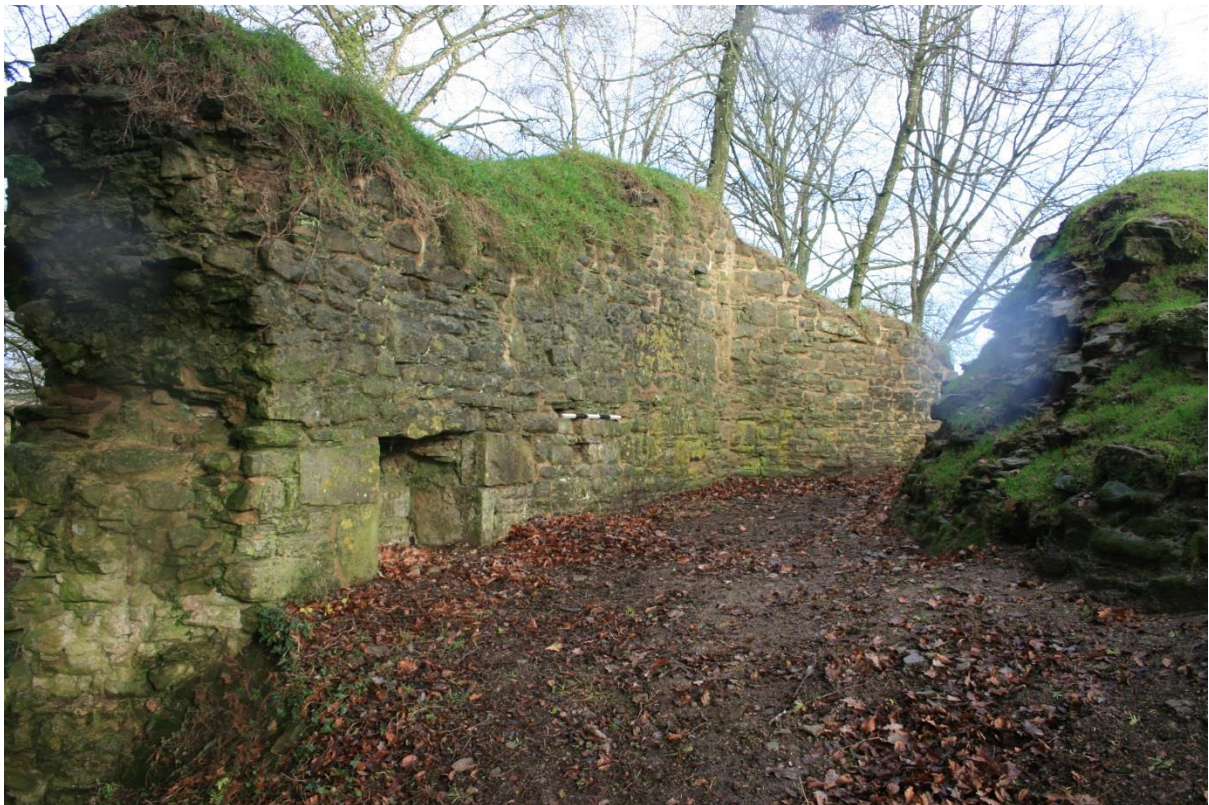
12. The interior face of the curtain wall on the north-west side of the keep. The one-metre scale marks the horizontal junction of two different builds, also noted by Crispin Hack

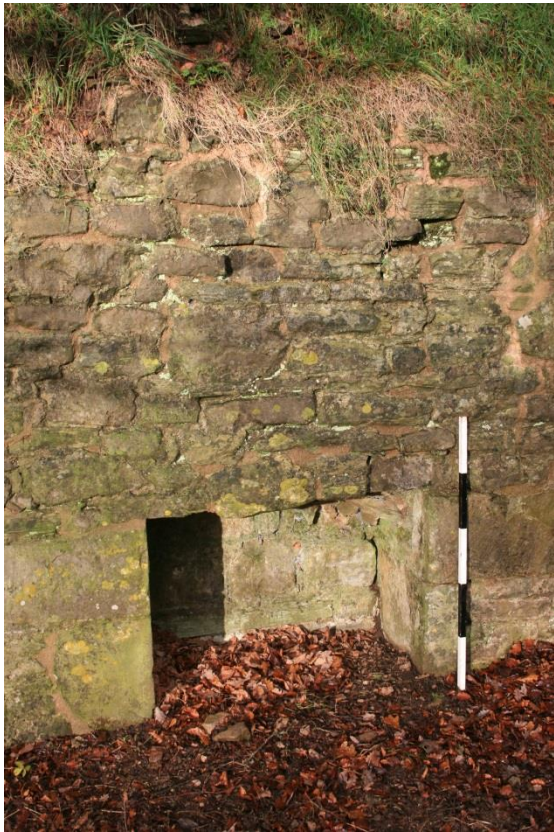
Close to the surviving western end of the curtain wall, a blocked doorway opening is apparent passing through the thickness of the wall. This has side-alternate quoining on the inside face and chamfered jambs on the outside. It has no internal lintel as such, as there appears to be a rebuild in the wall, such that the upper part of the wall – from the level of the existing door head upwards – is of a slightly different fabric, with more casual coursing, to that below. This rebuild was noted by Crispin Hack (2018 annotated section), the lower build characterised by hard red mortar. While the present top of the doorway is probably substantially lower than it was originally, it is also clear that its sill is below the level of the present ground level within the 'corridor' between the keep and the curtain, suggesting that the ground level here has risen.

13. Detail of the blocked door in the interior face of the curtain wall, NW of the keep

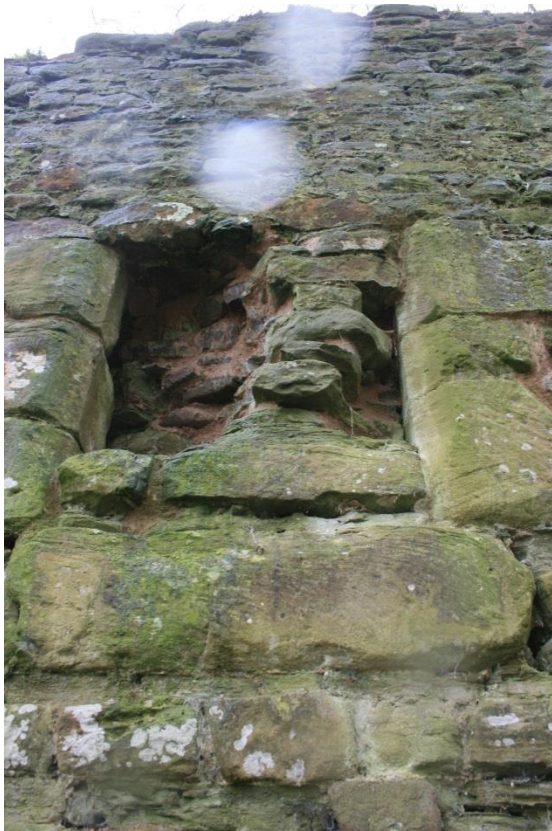
14. Detail of the exterior face of the blocked door in the curtain wall

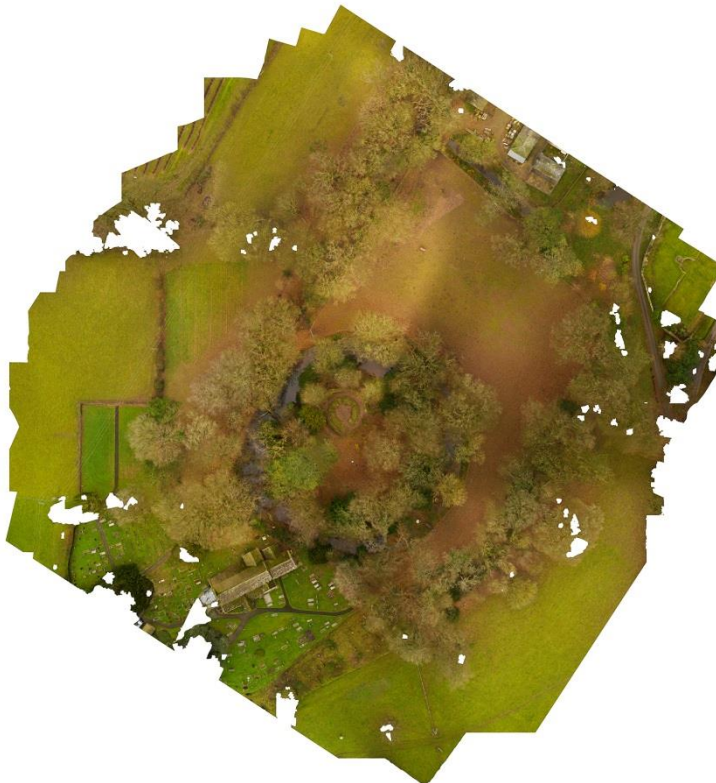
Orthophotograph (plan or map view) of the site

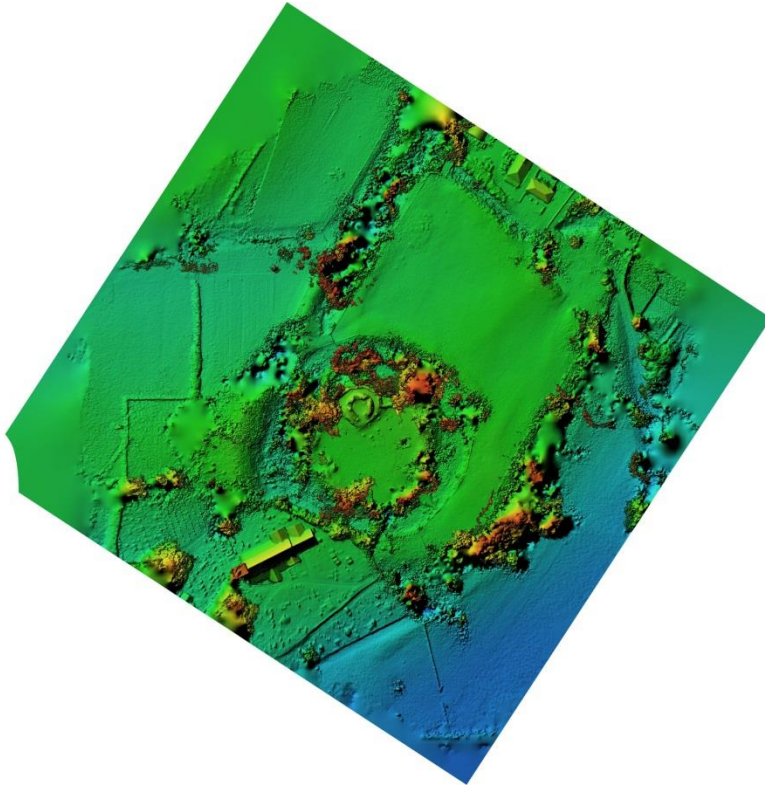
Colour version of the DEM (digital elevation model) of the site
