BACH CAMP, KIMBOLTON, HEREFORDSHIRE

A REPORT ON THE INSALLATION OF A NEW PEDESTRIAN GATE

**Prepared by Tim Hoverd
Archaeological Projects Manager
Herefordshire Archaeology**

Herefordshire Archaeology Report No. 391

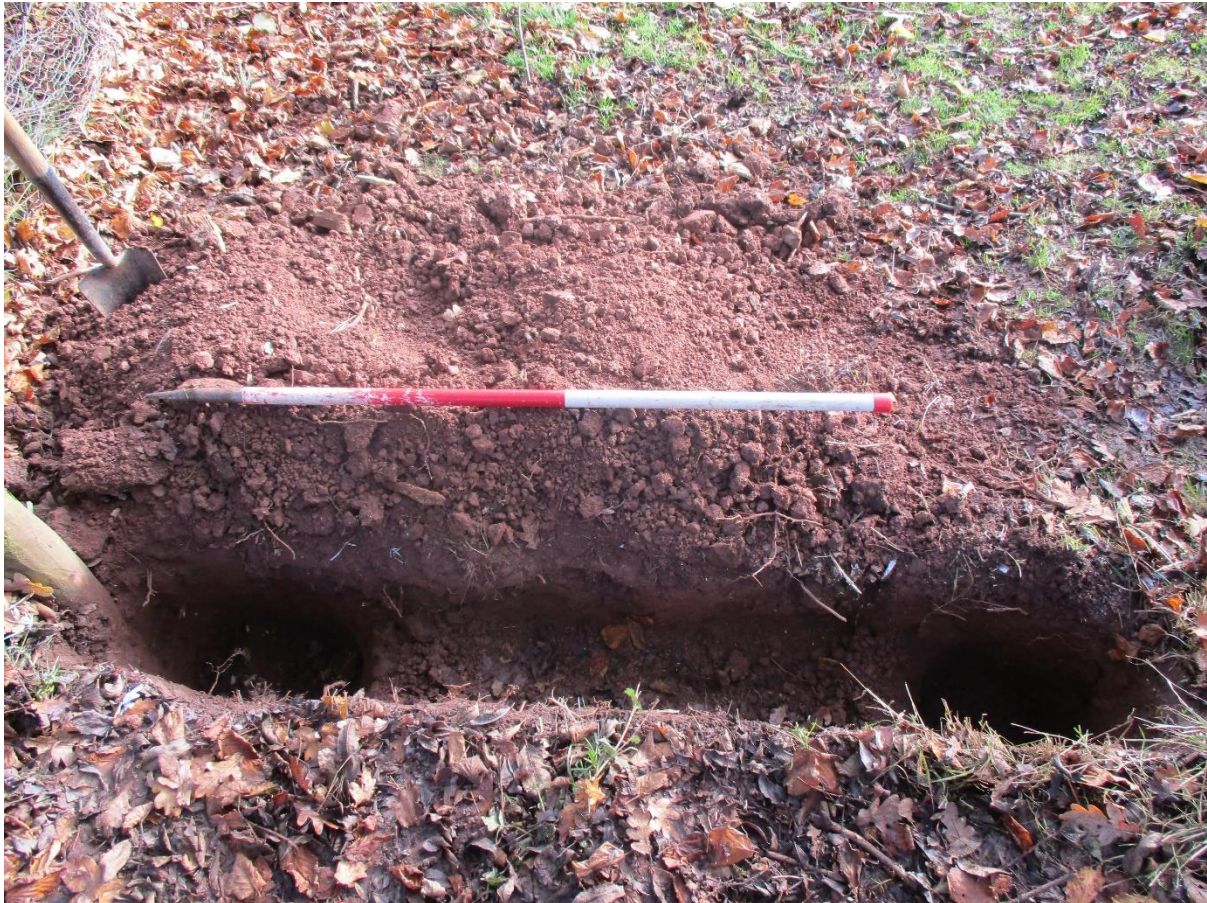
The remains of the wooden stile were removed and the two supporting posts dug out to a depth of approximately 0.6m in order to accommodate the new gate posts. A 0.3m wide trench between the two post holes was excavated to a depth of approximately 0.35m in order to bed in the base rail for the gate. The gate was levelled with compacted stone and clay prior to premixed concrete being poured to ground level. All works were undertaken by hand.

Plate 1: Post holes and base bar trench fully excavated.

The installation works have caused no damage to the monument, the only deposits being disturbed comprising redeposited natural clay from the counterscarp bank.

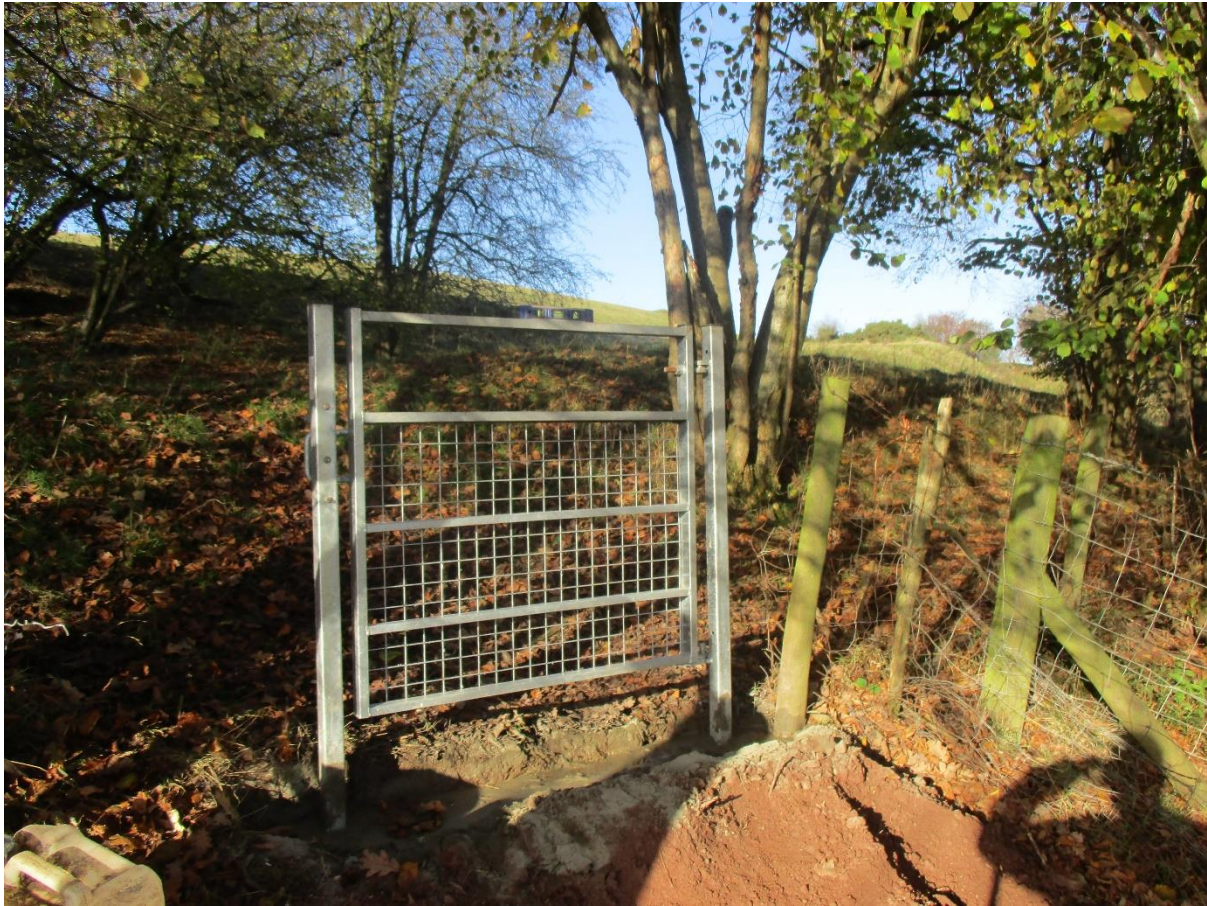
Plate 2: The replacement gate after concreting.
