CPAT Report No. 1293

The School House, Chirbury, Shropshire

ARCHAEOLOGICAL WATCHING BRIEF

Client name: Philip Humphreys Architects
CPAT Project No: 1965
Project Name: The School House, Chirbury
Grid Reference: SO 26212 98543
County/LPA: Shropshire
CPAT Report No: 1293
Report status: Final
Confidential: No

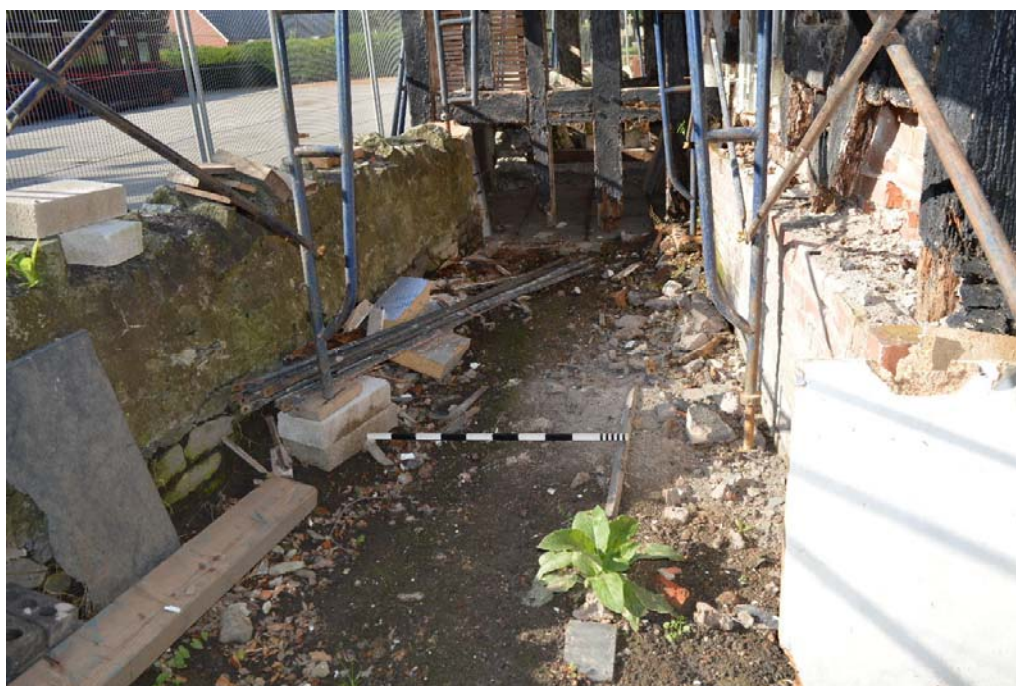
- 3.2 To the north-east of the porch ground clearance had been undertaken prior to the commencement of the watching brief (Fig. 4). A slight reduction in levels exposed a brown loam which later investigation determined was of no archaeological significance and no features or artefacts were noted. No further ground reductions were planned and no additional archaeological work was therefore undertaken.

Fig. 4 The area to the north east of the porch, viewed from the north east.
Photo CPAT 3888-0025

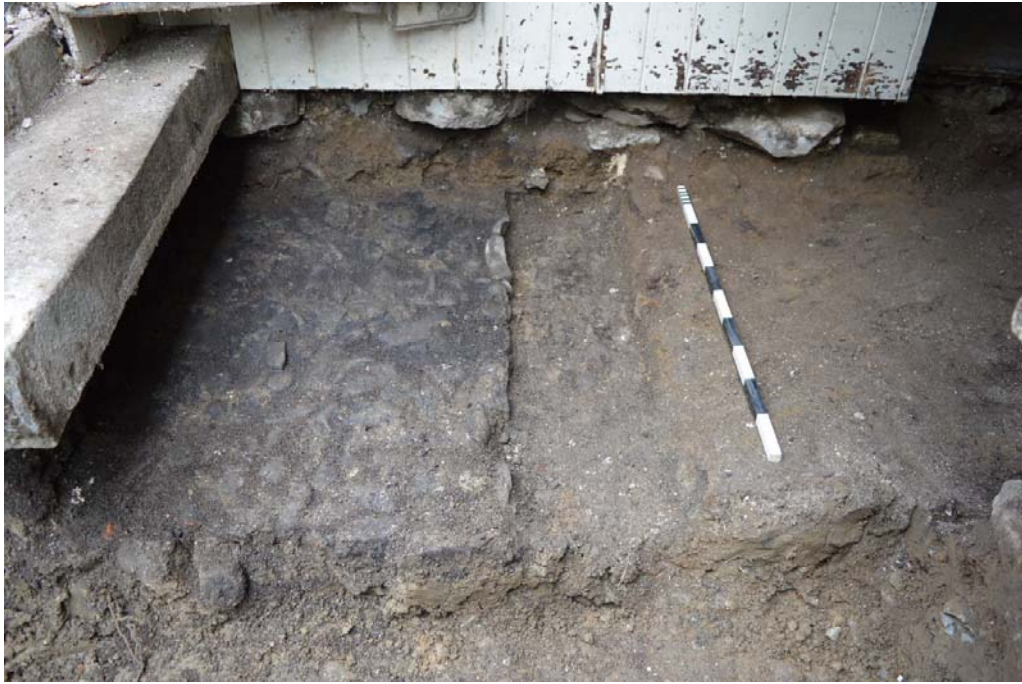
- 3.3 The northern wall of the entrance hall had been removed prior to the commencement of the watching brief, although this area was later subject to archaeological excavation. The careful removal of around 0.25m of fine brown silt in the entrance of the hallway revealed a cobbled surface and an earthen floor, both with associated Mottled Ware and Buckley-type ware dating from the 17th to 18th centuries. These surfaces were divided by a shallow slot, perhaps marking a former partition or doorway, which was 0.3m in width and 40mm in depth, with a fill of loose brown silt, charcoal and clinker. The cobbled surface and the slot both abutted the internal wall of the house (see Fig. 4), respecting the layout of the main room. These features represent an earlier layout within the entrance hall layout which was later modified.

Fig. 5 The hall entrance, viewed from the north-west. Photo CPAT 3888-0002

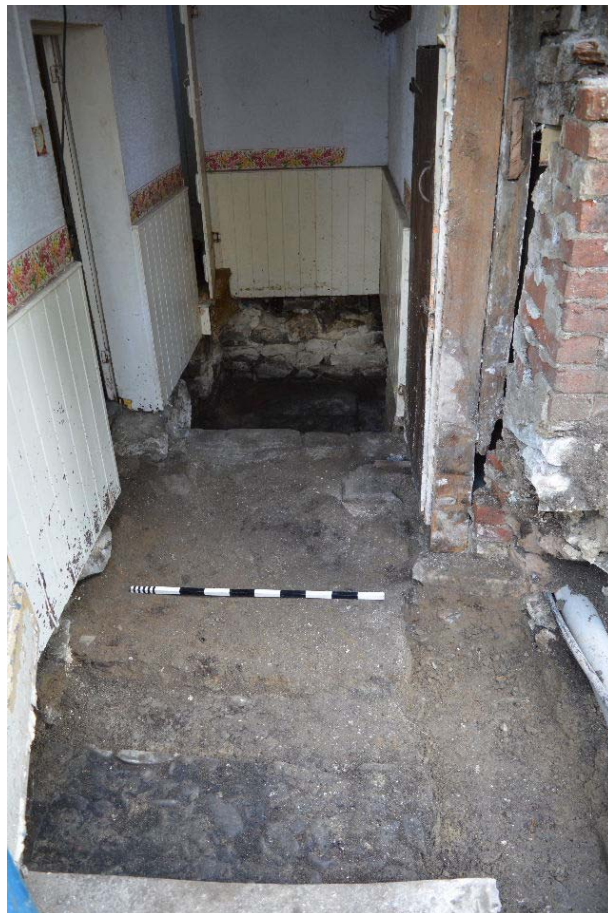
Fig. 6 The hall, viewed from the north-east. Photo CPAT 3888-0021

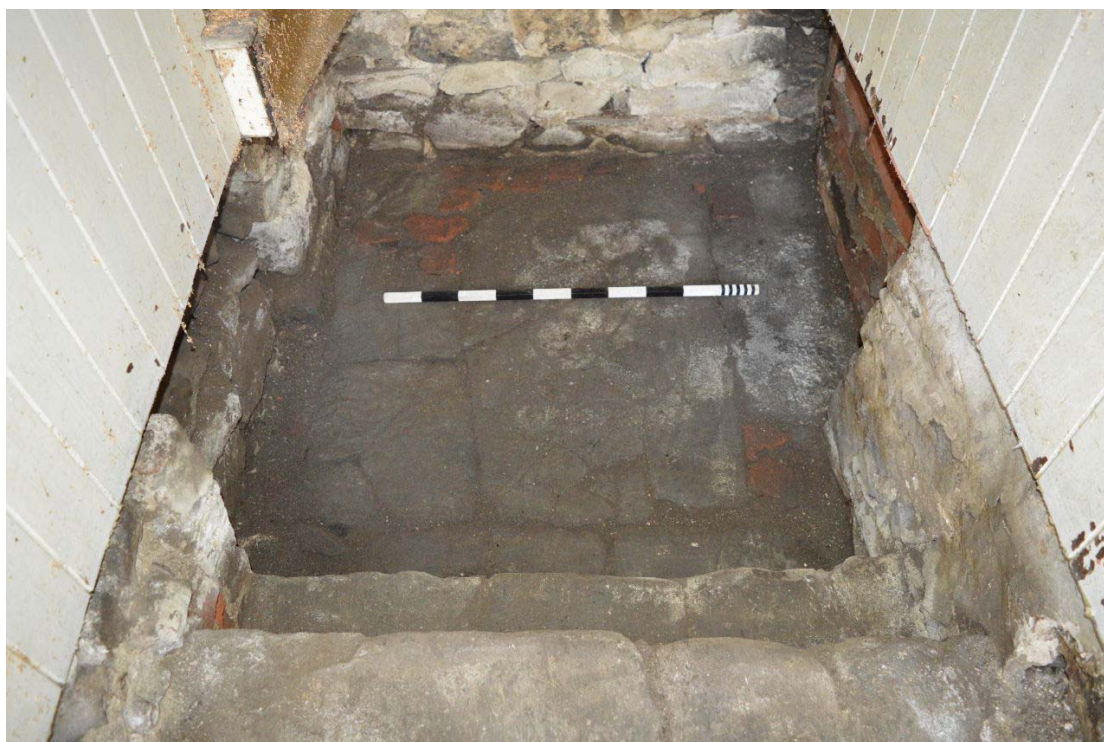
- 3.4 To the rear of the hall a suspended timber floor had been inserted. This was removed to reveal further brown silt, with occasional 19th-20th century china, tobacco pipe stem and bottle glass. The removal of 0.2m of silt exposed two stone steps, each 0.2m high (Fig. 7). At the base of the stairs full excavation of 0.75m of silt revealed a sunken flag stone floor in poor repair, being patched with red bricks, and the base of a blocked arched doorway that originally led to the late 19th-century subterranean school room to the north-west (Figs 9 and 10). The lower infill of the blocked doorway was of red bricks and hard concrete, which was constructed up to the panelling, to act as a retaining wall for the infilling below the suspended timber floor. Other 20th-century upgrades included a new doorway to the adjacent cellar, to the east of the original blocked doorway.

Fig. 7 The stone steps and flag stone floor revealed beneath the suspended floor, viewed from the north-east. Note the blocked doorways to left and right. Photo CPAT 3888-0006

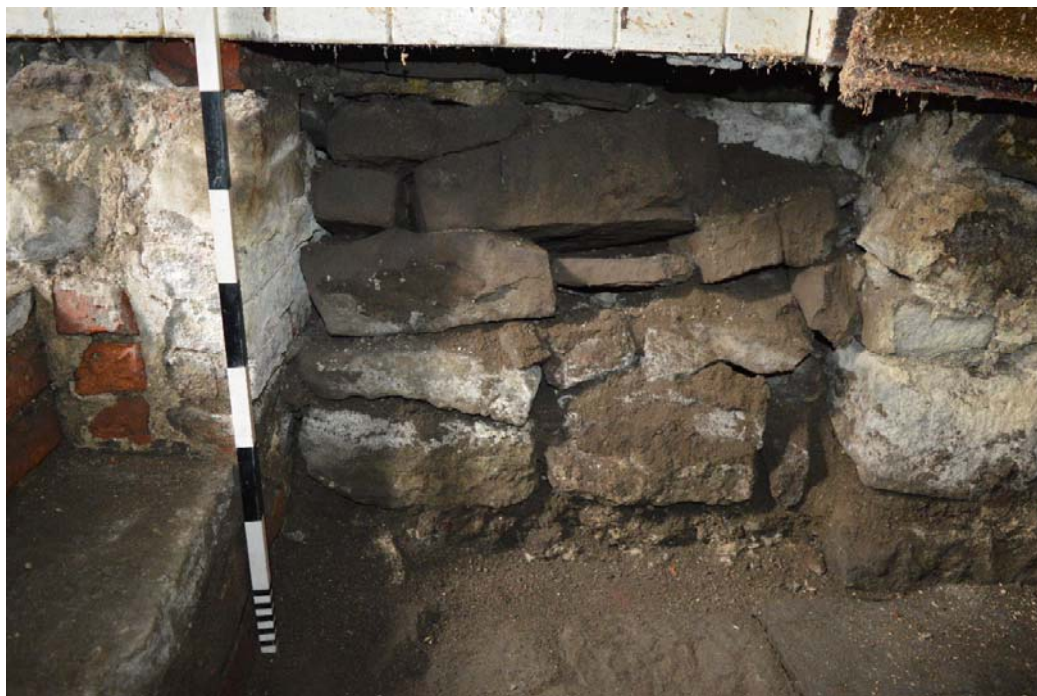
- 3.5 Adjacent to the base of the stairs another passage had been infilled with dry stone walling (Fig. 8). This entranceway, constructed within the stone walls of the house, very slightly curved to the right. It is possible this was part of an earlier staircase, as the present stairs were constructed from the higher level of the removed 20th-century suspended timer floor. This feature was obscured by the boarding above and infill itself.

Fig. 8 The blocked entrance, viewed from the north-west. Photo CPAT 3888-0010

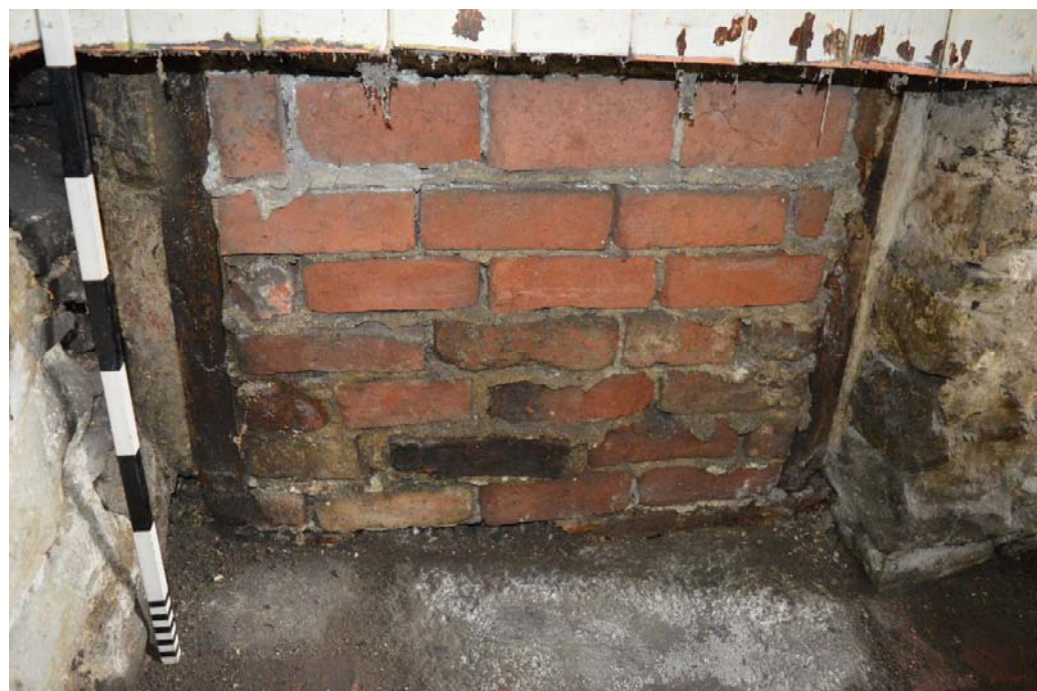
Fig. 9 The blocked original doorway to the 19th-century school room in the cellar, viewed from the south-east. Photo CPAT 3888-0007

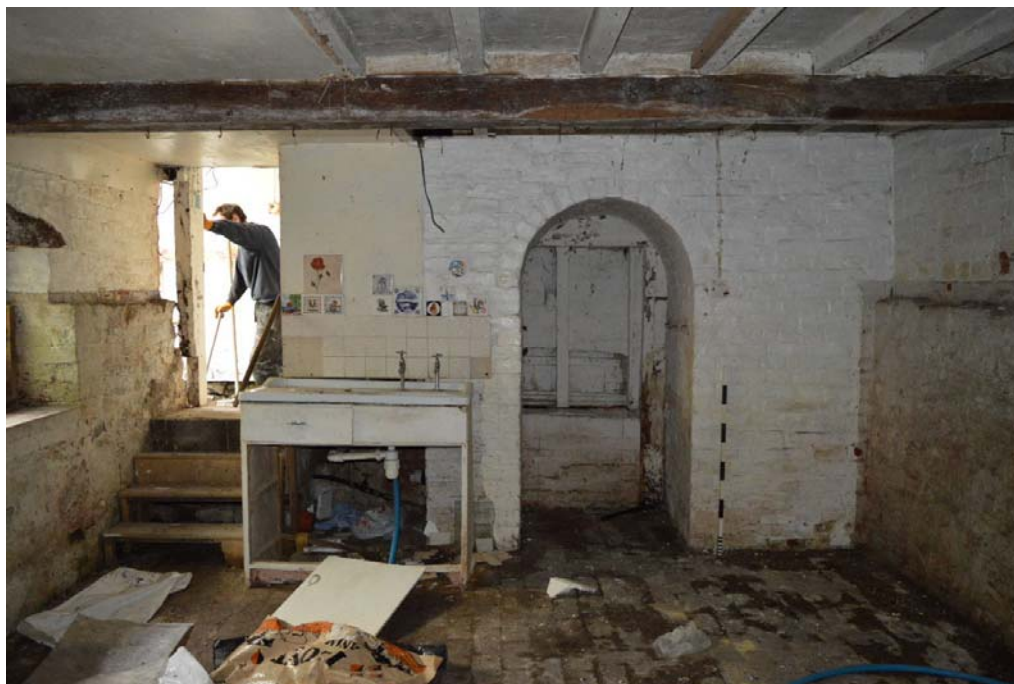
Fig. 10 The blocked original doorway from the cellar, viewed from the north-west.
Photo CPAT 3888-0013

- 4.3 It was also evident that reorganisation of the building during the 20th century included the blocking of the original doorway to the northern cellar room and inserting a new door to the east, modifying the stairs and inserting a suspended floor.
