CPAT Report No. 1346

Legacy to Oswestry 132kv powerline

Cultural Heritage Mitigation Works

Client name: Ibedrola Engineering and Construction
CPAT Project No: 1951
Project Name: Legacy to Oswestry Overhead Powerline;
Grid Reference: SJ 30852 47592 – SJ 30159 31808
County/LPA: Shropshire and Wrexham
CPAT Report No: 1346
Issue No: 1
Report status: Final
Confidential: No

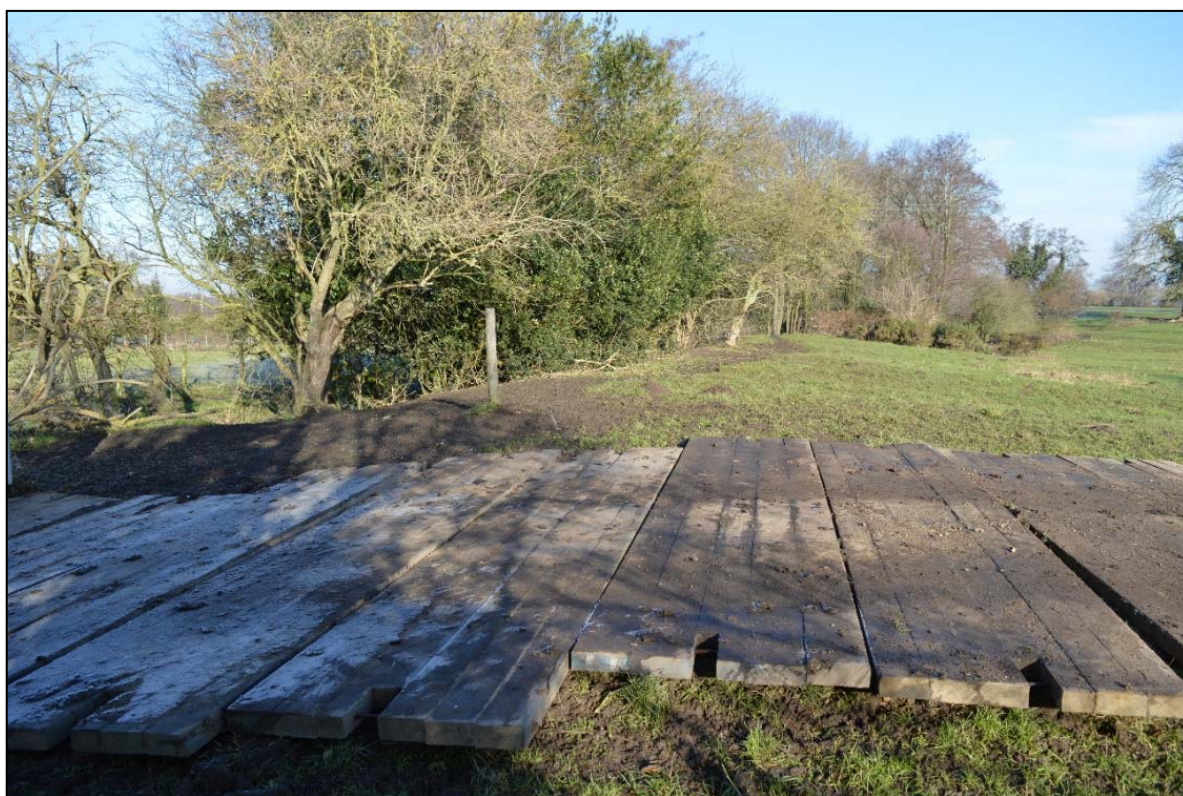
Fig. 2. The bog matting laid over the access track crossing Wat's Dyke (SAM De154) south of Black Brook Bridge (CPAT Photo 3904-0016).

- 2.2. The construction work had the potential to have direct physical effect on a scheduled section of Wat's Dyke south of Black Brook Bridge within the immediate vicinity of pole no. 22 (SJ 32065 45069). The most appropriate mitigation strategy for this section of the monument was therefore considered to be avoidance and micro-siting enabled the pole to be positioned sufficiently far from the monument to avoid any direct effect on the earthwork. This was confirmed by a site visit in early December attended by Will Davies, Cadw Regional Inspector, Mark Ward, Balfour Beatty Environmental Advisor and Ian Grant, CPAT Senior Project Archaeologist. The extent of the scheduled area was established during this meeting and was clearly demarcated with survey pegs and later reinforced by signed fencing along the monument (Fig. 2).

- 2.3. Further mitigation stipulated no vehicular access within or across the scheduled area without prior consent and furthermore, avoidance of crossing the monument where at all possible. In the instances where access across the monument was unavoidable, bog matting was laid on a pre-existing access trackway to protect the monument from further superficial vehicular damage (Fig. 2). The mitigation also stipulated that no machinery should be positioned or operated and no equipment or materials should be stored within the scheduled area without prior consent. All contractors were made aware of the monument's protected status and the restrictions this implied.

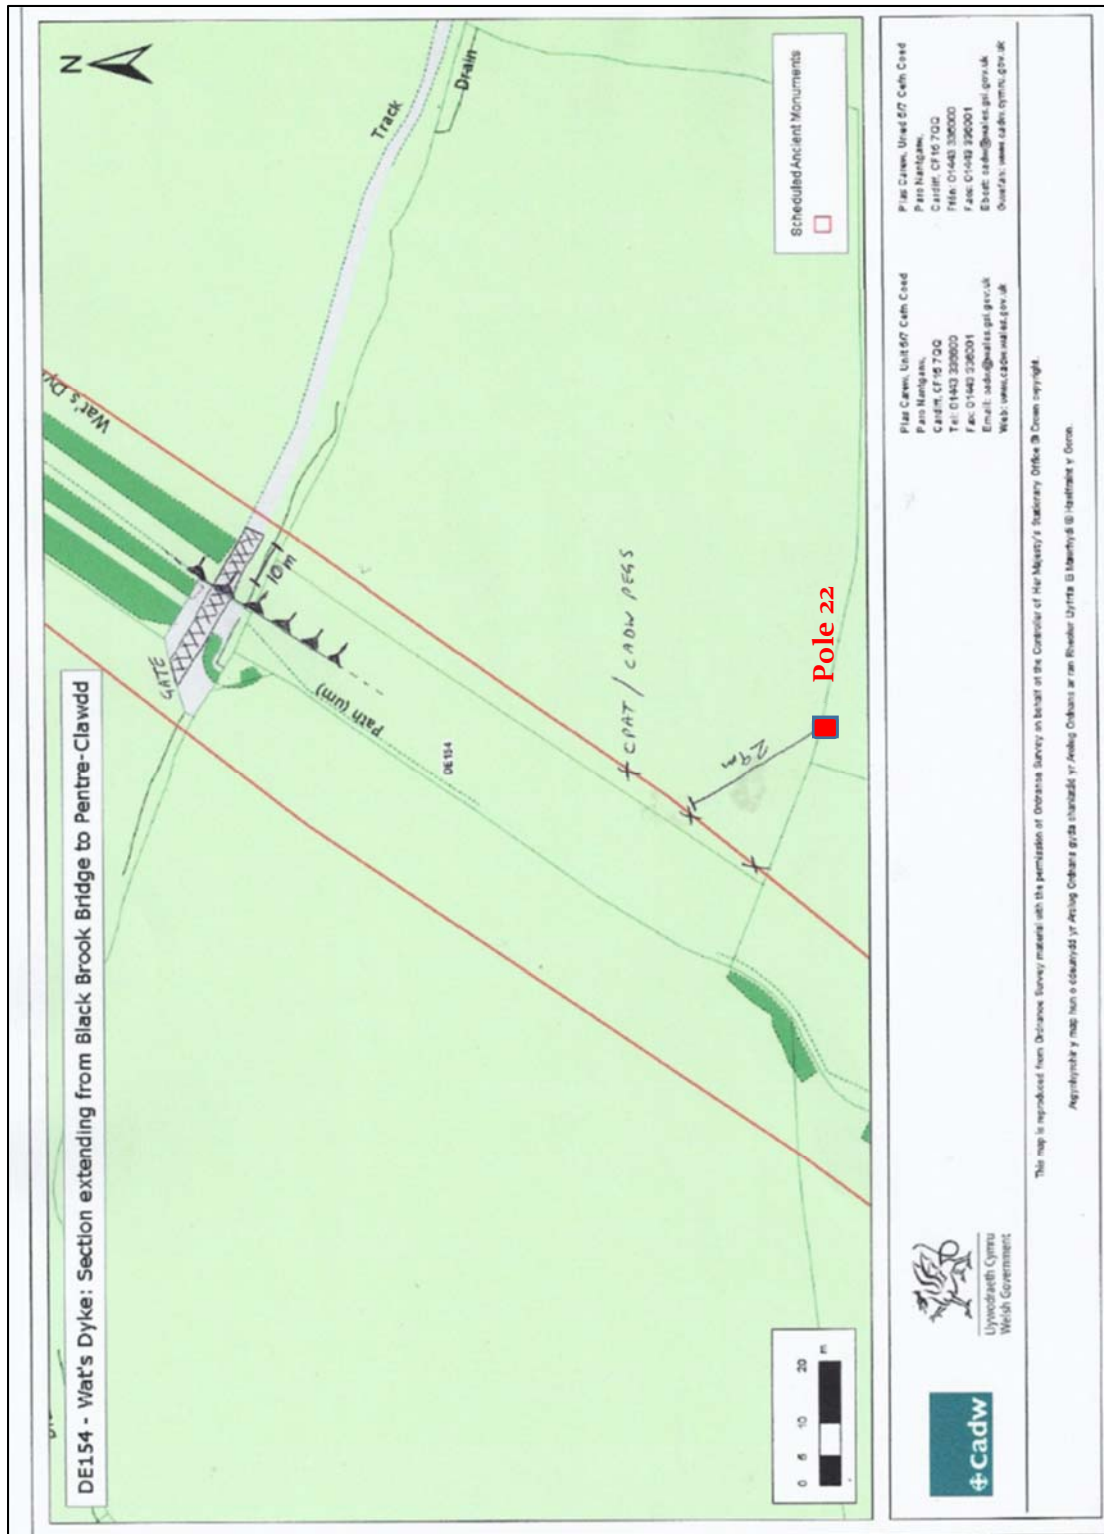
Fig. 3. An annotated plan showing the location of the monument, survey pegs demarcating the bounds of the scheduled area. The length of bog matting laid over the access on the monument is shown as the hashed area.

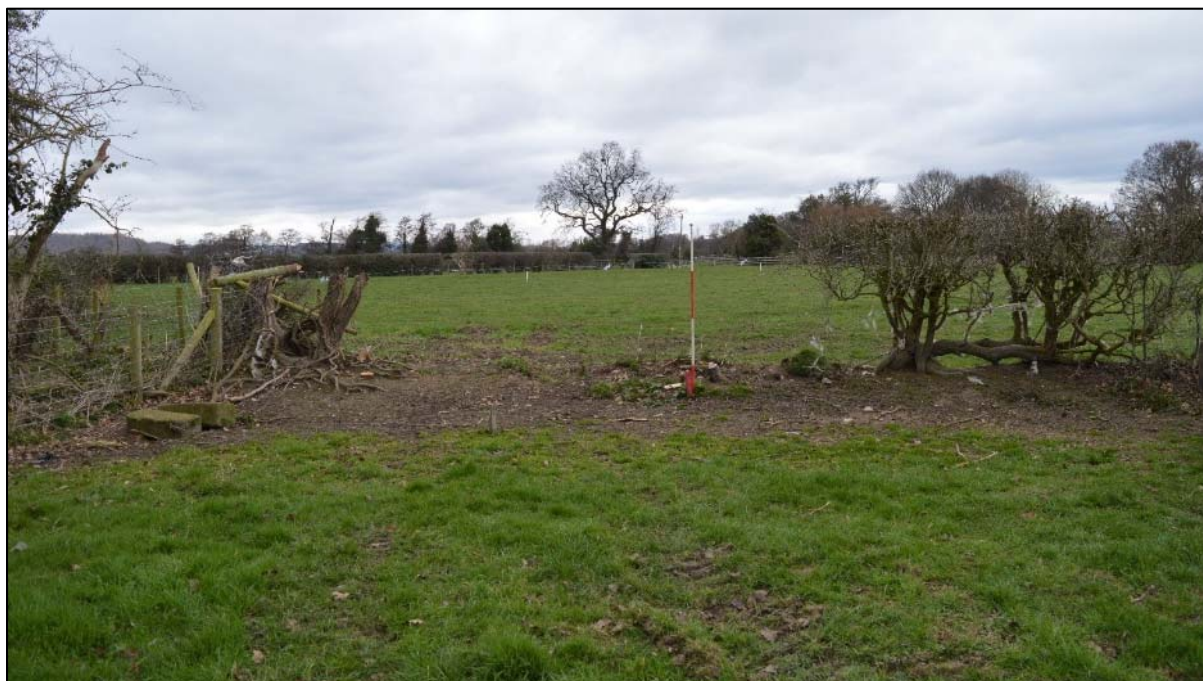
Fig. 4. Overview of pole position 22 showing its proximity to SAM De154; Wat's Dyke, south of Black Brook Bridge.

Fig. 5. The location of pole 22 is indicated by the gap in the hedge and the red and white scale. Wat's Dyke (SAM De154) is just visible in the background as indicated by the hedgerow crossing the field in a north-east/south-west orientation. (CPAT Photo 3955-0088).

- 2.4. Owing to the proximity of the monument to pole no. 22 it was deemed necessary to undertake a watching brief during the erect of the pole (Figs 4-5). The site was accessed from the south-east thus avoiding vehicular intrusion on the monument.
- 2.5. The watching brief was undertaken on the 23rd March 2015 to monitor the machine excavation of a small trench to accommodate the new 'H-pole'. The trench measured 3m long, 1m wide and reached a final depth of 3m. The excavation revealed a sequence of gleyed, mottled sandy silt to a depth of 1.8m overlying a clean, pinkish-brown clay (Fig. 6). No archaeology was observed within this trench.

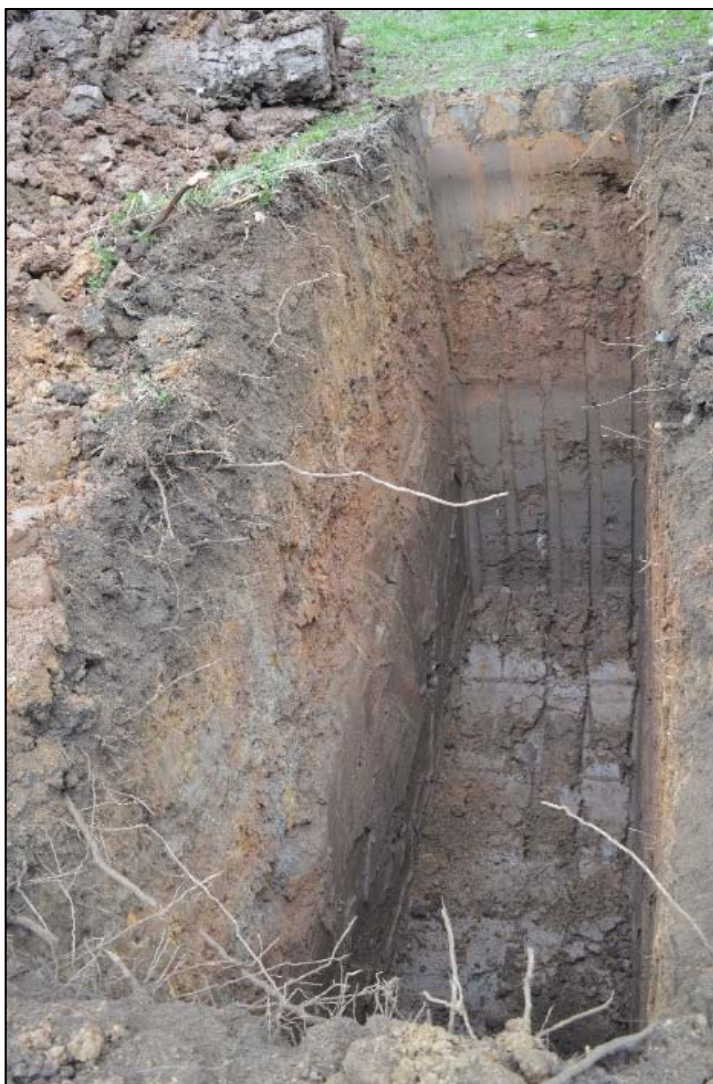
Fig. 6. The sequence of archaeologically sterile and gleyed deposits revealed in the trench for pole 22. The depth of this trench 3m (CPAT Photo 3955-0088).

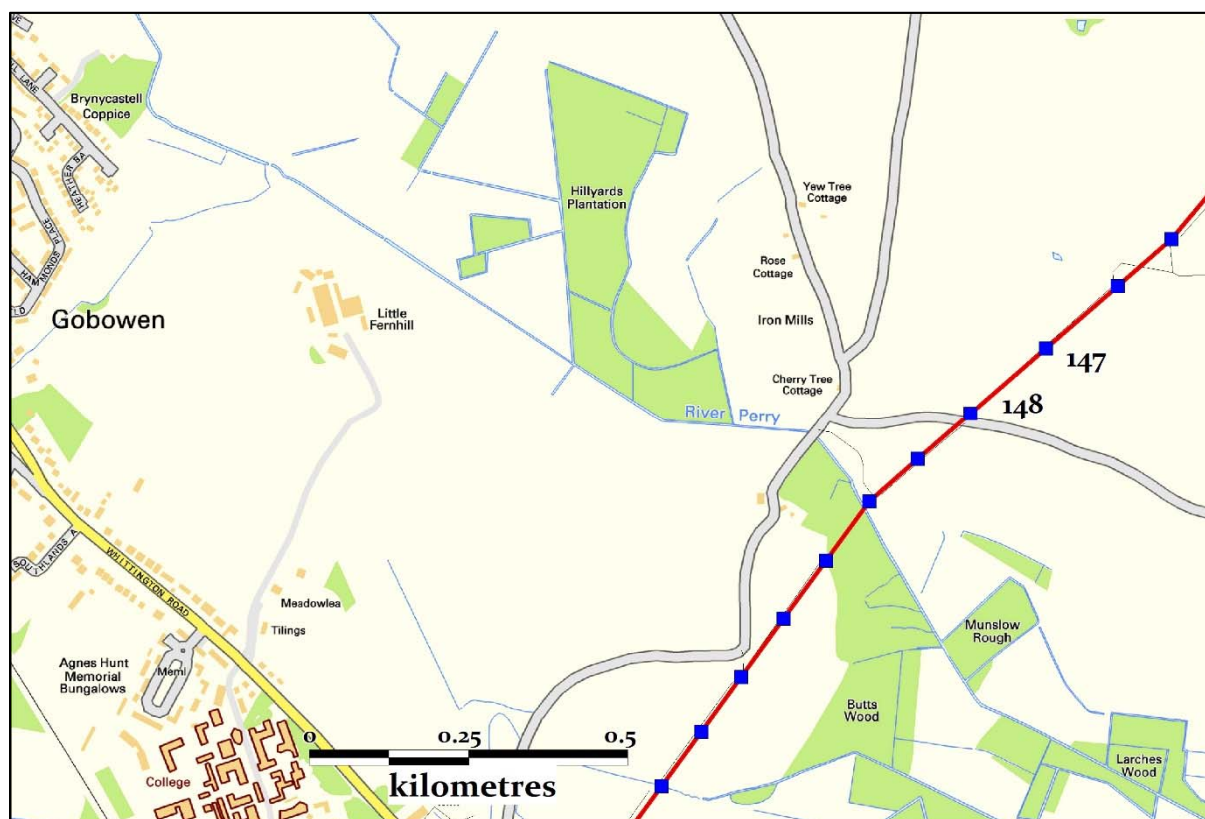
Fig. 9. An overview showing the location of poles 147 and 148 between Gobowen and Hindford.

- 2.13. The watching brief was conducted on the 18th March 2015 monitoring the machine excavation of the post holes. At pole no. 147 the excavations revealed a natural subsoil comprising a grey-brown silt over an orange gravel at a depth of 0.3m. A natural subsoil comprising a grey-brown silt over an orange clay-silt at a depth of 0.5m at pole no. 148. No archaeology was revealed at either location.

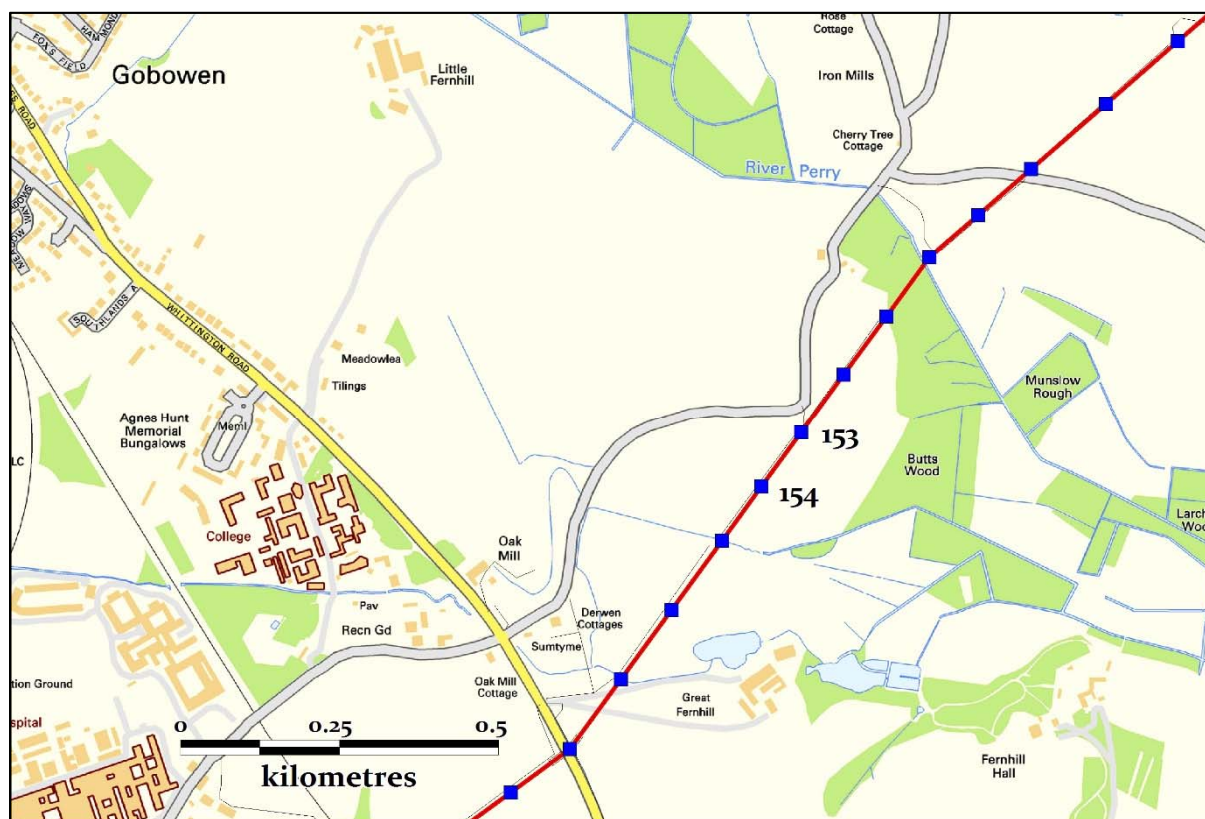
Fig. 10. An overview of pole locations 153 and 154

- 2.17. Cropmarks recorded in this location have revealed a probable Iron Age/Romano-British rectangular enclosure measuring about 30m north/south, by 25m east/west, with double ditches on the west. There is also a possible trackway and short stretches of detached linear ditches, perhaps part of an associated field system in this area (Fig. 10).

- 2.18. The construction works relating to poles 153 and 154 had the potential to have direct impact on any buried archaeology within this area and a watching brief was therefore required in mitigation.
- 2.14. The watching brief was conducted on the 18th March 2015 monitoring the machine excavation of the post holes. At pole no. 153 the excavations revealed at natural subsoil comprising a grey-brown silt over a yellowish-brown clay-silt at a depth of 0.5m. A natural subsoil comprising a grey-brown silt over a dark grey gravel a depth of 0.4m at pole no. 154. No archaeology was revealed at either locations.

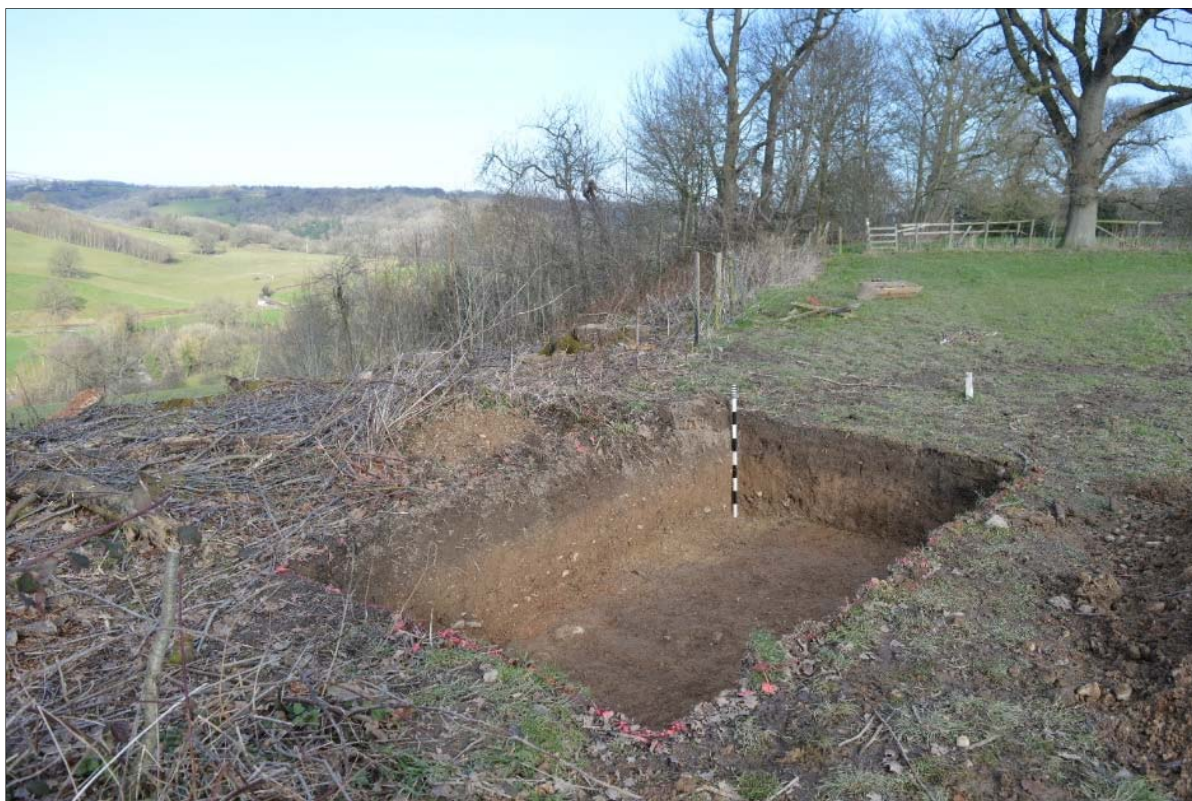
- 3.3 In Trench 1, which was the location for the H-pole, around 0.35m of topsoil (o1) were removed to reveal a 0.4m-thick layer of silty clay (o2). At the north-eastern end of the trench this overlay a thin deposit of light grey, silty clay (o3), while elsewhere the natural subsoil was exposed, consisting of an iron-panned sandy clay (o4) (see Fig. 11). No archaeological features or deposits were identified.

Fig. 11 Wat's Dyke, Shropshire. Trench 1 viewed from the south. Photo CPAT 3904-0022

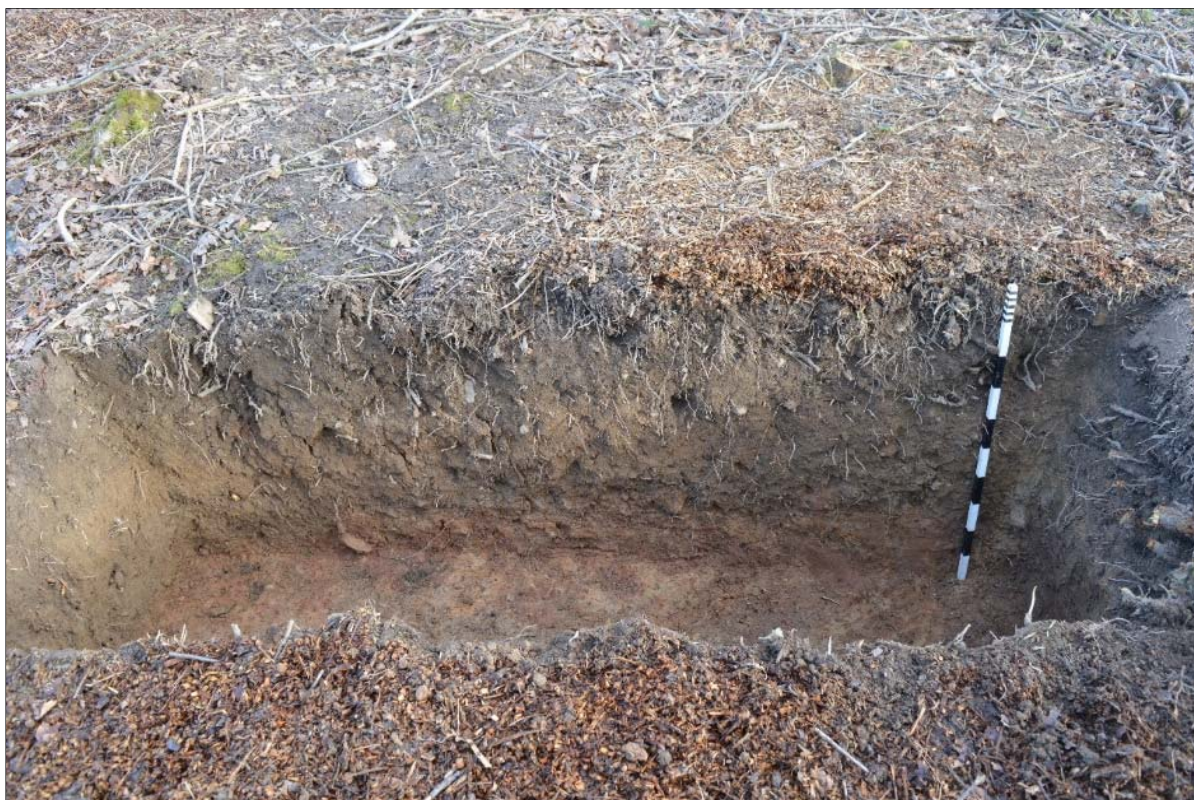
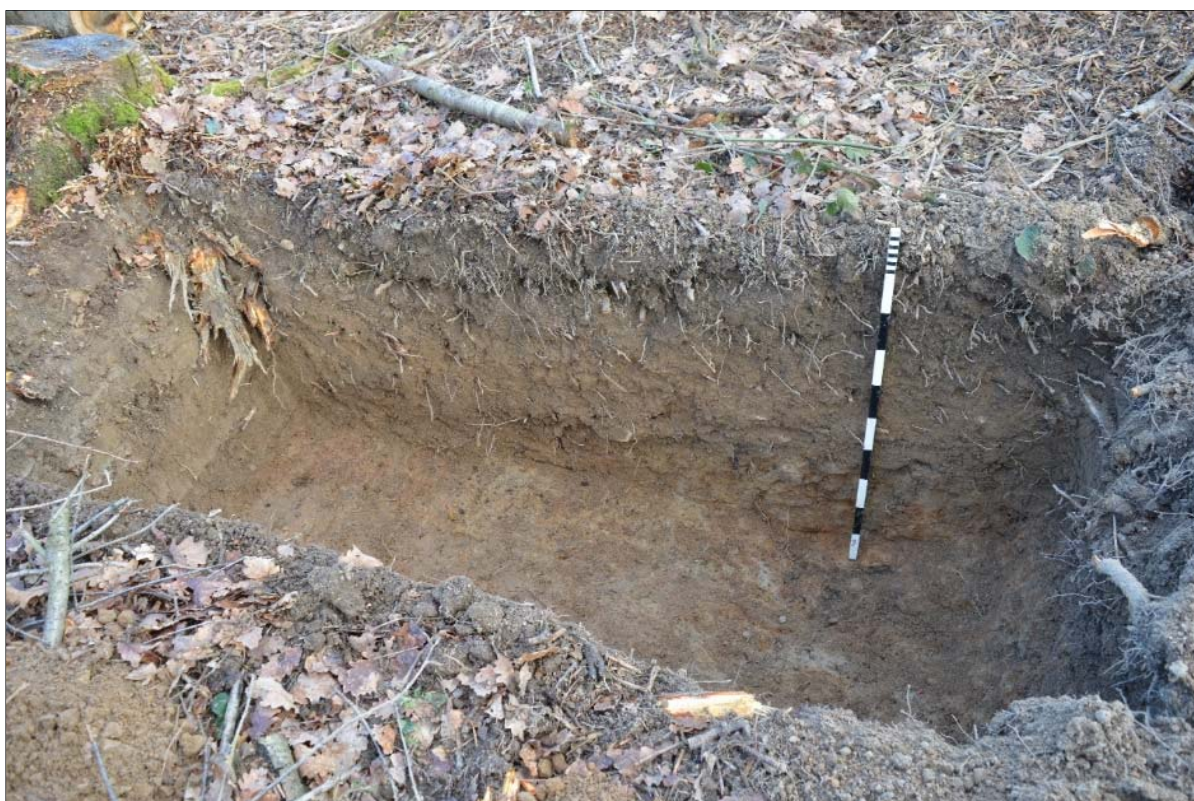
- 3.4 Trenches 2 and 3 contained a similar sequence of deposits (Figs 12-13), again with no evidence for any archaeological features or deposits.
- 3.5 The negative evidence from the excavations confirmed that the erection of the pole had no impact on Wat's Dyke. However, since the position of the trenches was determined by the pole location, rather than in an attempt to evaluate the Dyke, the lack of evidence cannot be taken to suggest that the earthwork did not extend into this area. While no visible traces of the monument were apparent following the felling of trees in this area the possibility remains that subsurface deposits survive. Based on the evidence from the 2003 excavation it seems likely that the Dyke followed the break of slope at the top of the valley side, so that bank may have extended through the area of Trenches 2 and 3, all upstanding remains having since been removed.

Fig. 12 Wat's Dyke, Shropshire. Trench 2 viewed from the north-east. Photo CPAT 3904-0030

Fig. 13 Wat's Dyke, Shropshire. Trench 3 viewed from the north-east. Photo CPAT 3904-0036

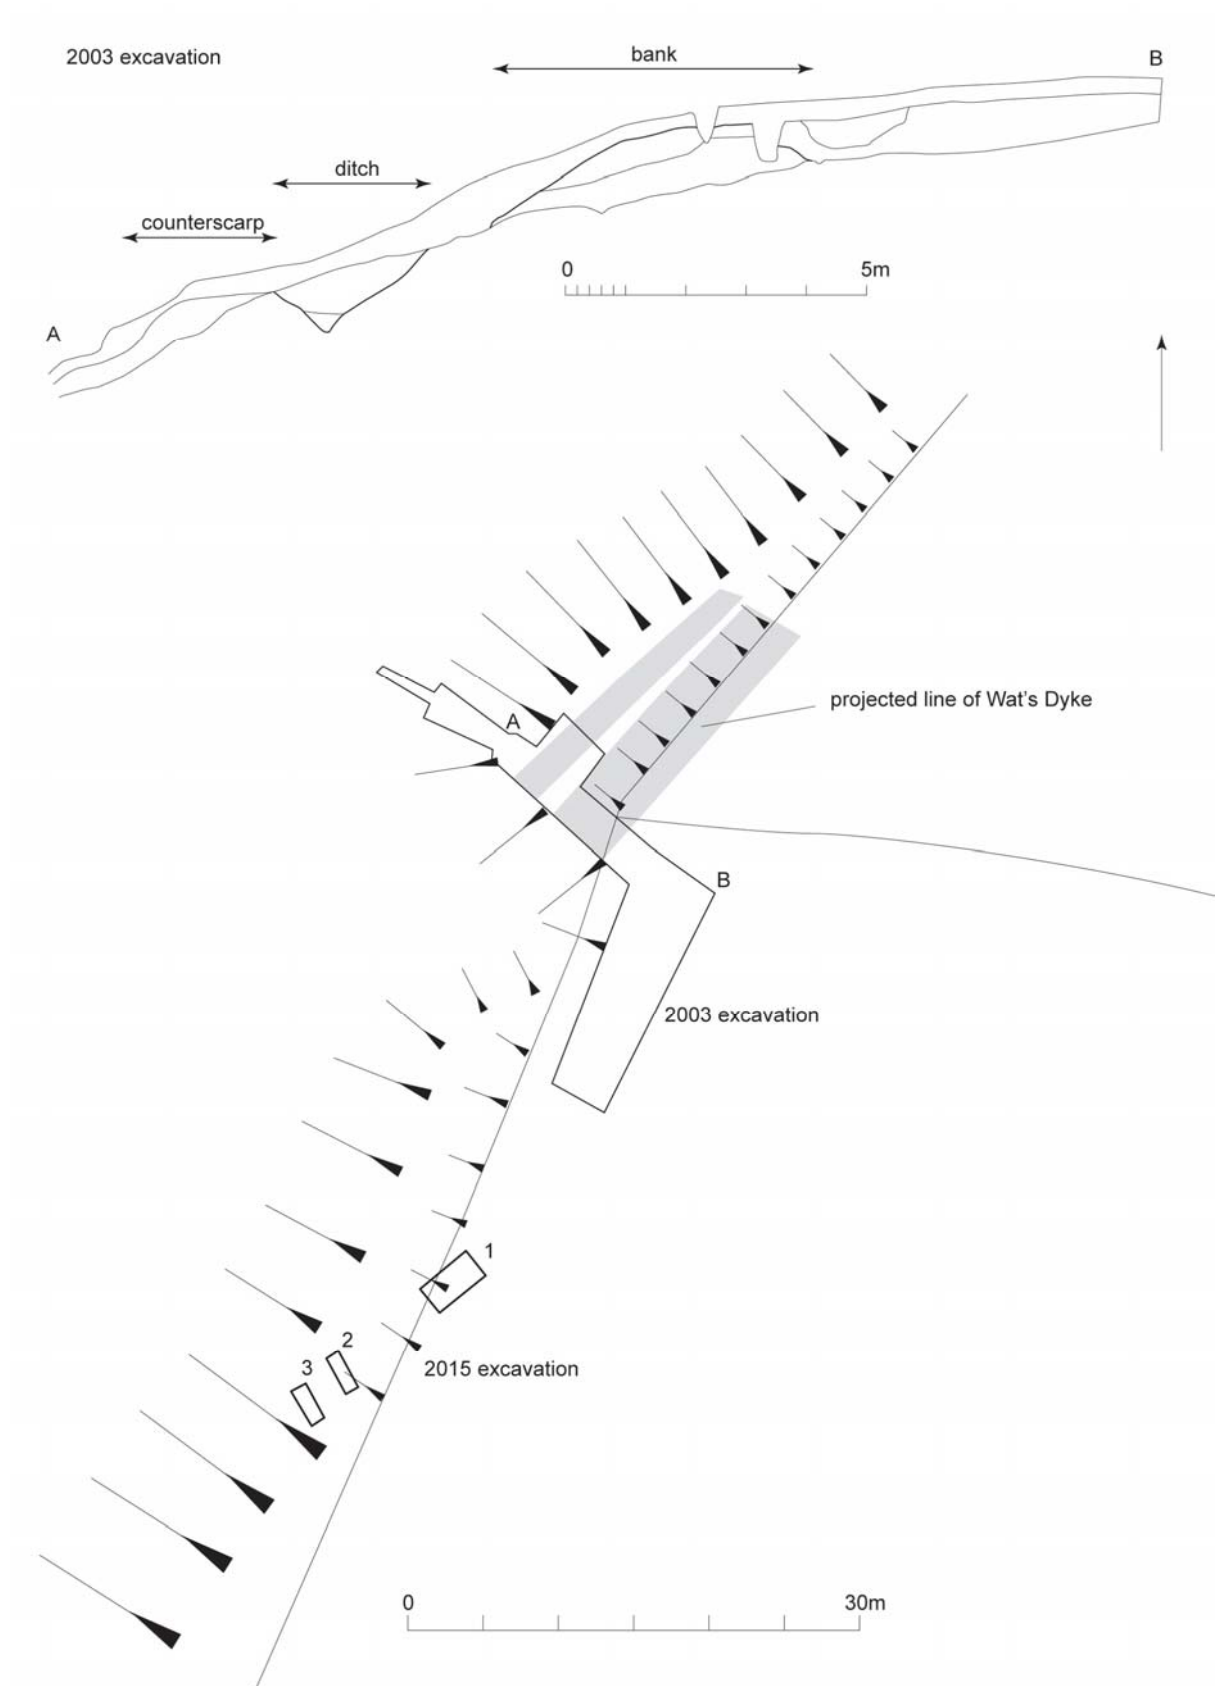
Fig. 14 Excavations along the line of Wats' Dyke. Pole 93 was positioned within Trench 1

- 3.1 Owing to the proximity of Pole 21 to an unscheduled section of Wat's Dyke, near St Martins in Shropshire, the locations of the twin 'H-pole' and its attendant stays were subject to small-scale excavation in advance of construction. The excavations were conducted on 2-3 February 2015 and comprised three small trenches, the location and orientation of which were determined by the client.
- 3.2 In 2003 and adjacent area was investigated prior to the construction of a gas pipeline, confirming the position of Wat's Dyke, which survived as a slight earthwork at the top of the steeply-sloping valley side (Kenney 2004). The excavation identified a V-shaped ditch, around 2.1m wide and 1.1m deep, with the denuded remains of a slight bank on the upslope side and a small counterscarp bank downslope (see Fig. 14).
