## CPAT Report No. 1809

# Pathway resurfacing, Kenilworth Castle, Warwickshire

### Archaeological Watching Brief

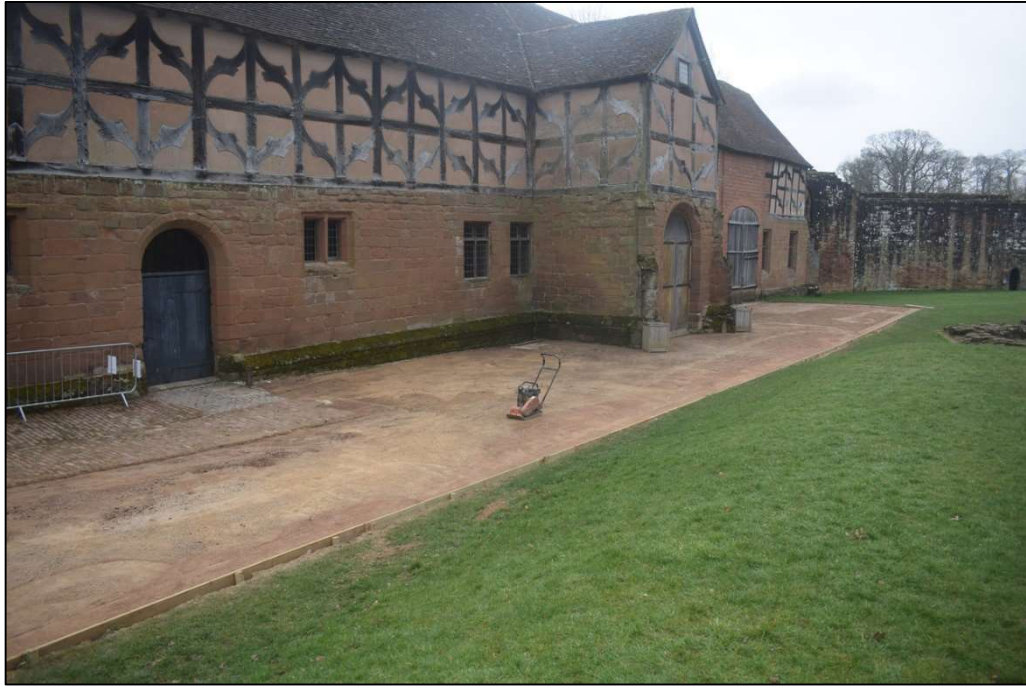
*Fig. 2 Area to the west of the stable following the removal of the surface material, viewed from the north-west. Photo CPAT 4915-007*

- 3.1. The watching brief was conducted between the 17th and 24<sup>th</sup> of March 2021 in accordance with the Chartered Institute for Archaeologists' (CIfA) *Standard and Guidance for an Archaeological Watching Brief* (2020).
- 3.2. The watching brief initially comprised monitoring of the pathway surfacing between the stable, Leicester's Gatehouse and the gardens, located to the north of the castle (Figs. 1 - 3). The modern top dressing (1) comprised a light yellowish brown grit 0.1m thick. Underlying this was a soft mottled orangey brownish black sand deposition >0.1m thick. A blackish fuel waste and stony spread (5) was located adjacent to the north-west corner of Leicester's Gatehouse (Figs. 4 and 5), extending intermittently along the west extent of the building, this was interpreted as earlier path surfacing material.

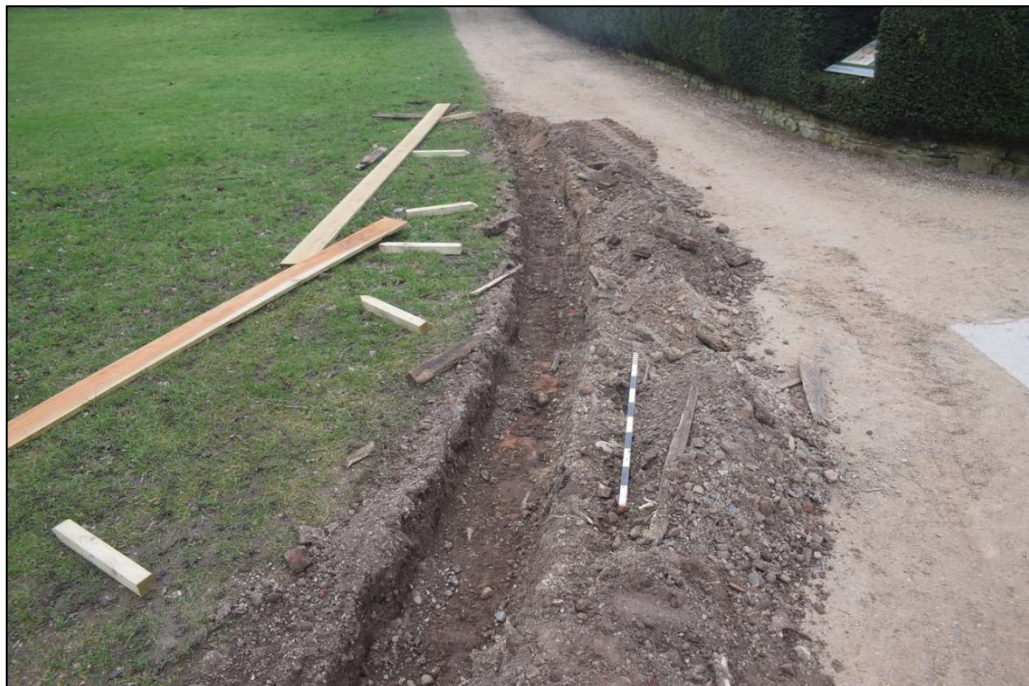
*Fig. 3 Trench excavated for edging boards between Leicester's Gatehouse and the gardens, viewed from the east. Photo CPAT 4915-009*

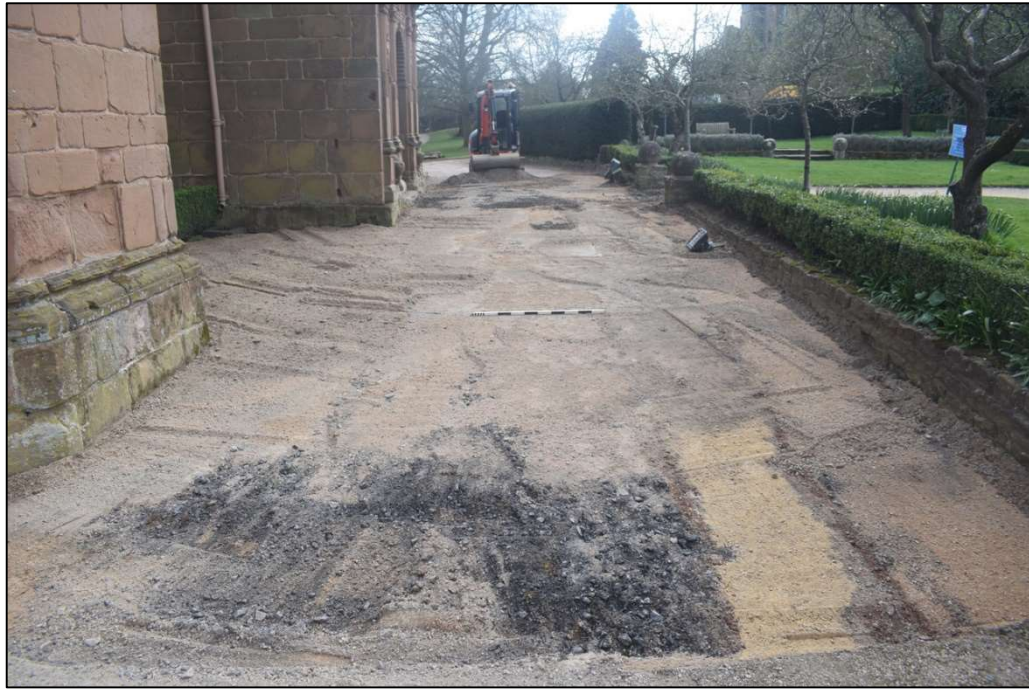
*Fig. 4 Groundworks to the west of Leicester's Gatehouse viewed from the north Photo CPAT 4915-023*

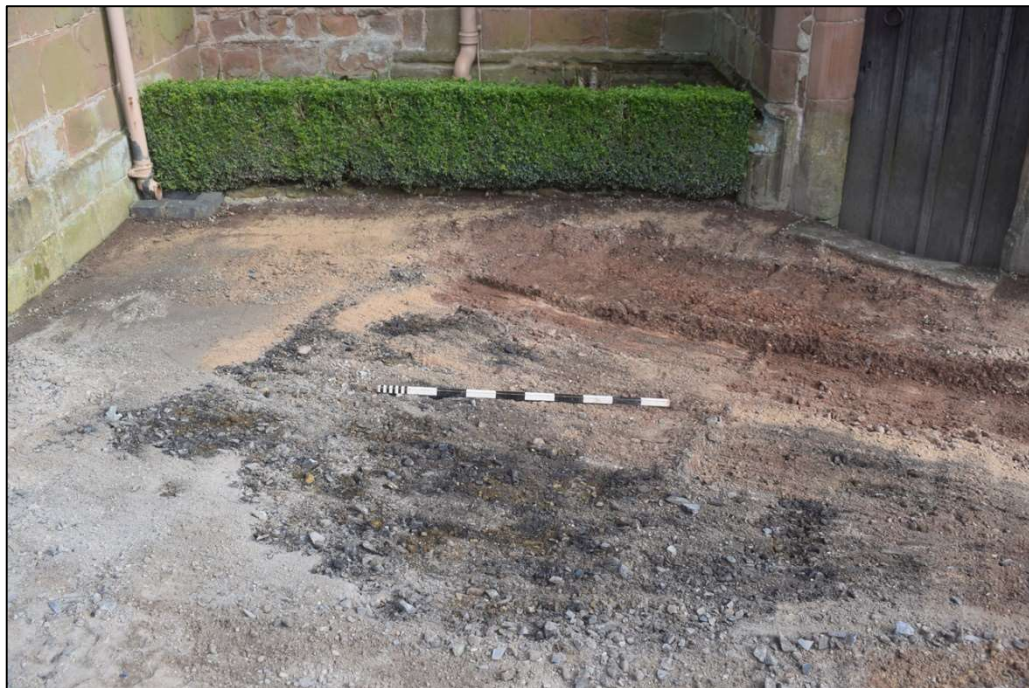
*Fig. 5 Groundworks to the west of Leicester's Gatehouse viewed from the east Photo CPAT 4915-031*

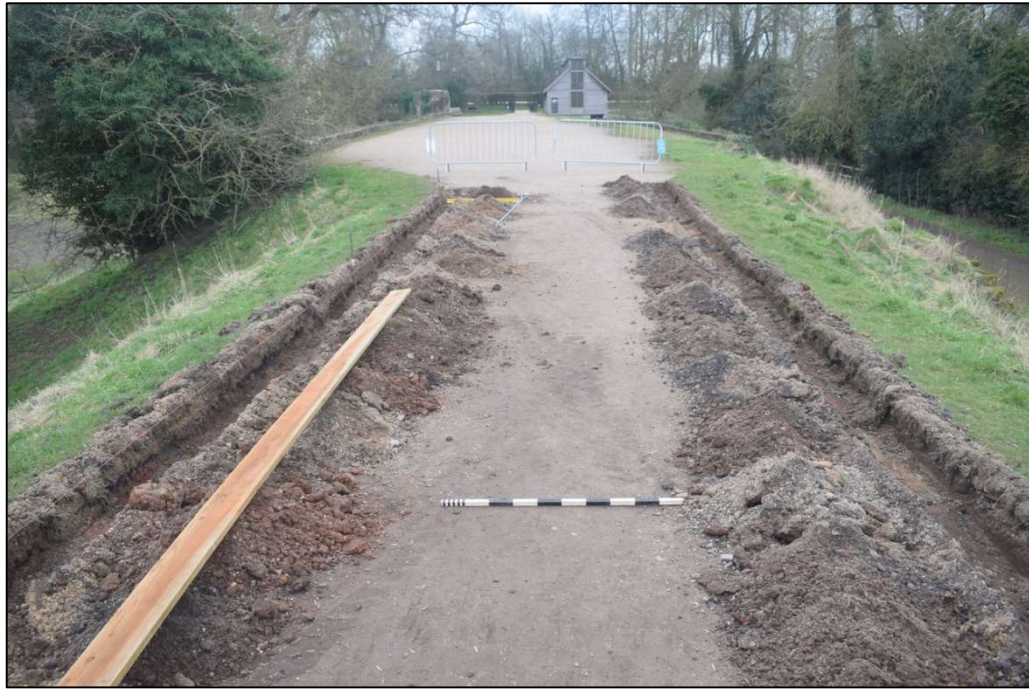
- 3.3. Monitoring of the groundworks at the northern extent of the tiltyard (Figs. 1 and 6) identified a continuation of the top dressing (1) to a thickness of 0.1m, overlaid by a loosely compacted gritty sand topsoil deposit (3) 0.1m thick. Underlying deposit (1) was a moderately compacted mottled mid-dark reddish brown sand (4) containing fuel waste residue 0.12m thick (Fig. 7).

*Fig. 6 Groundworks on the dam/tiltyard viewed from the north Photo CPAT 4915-017*

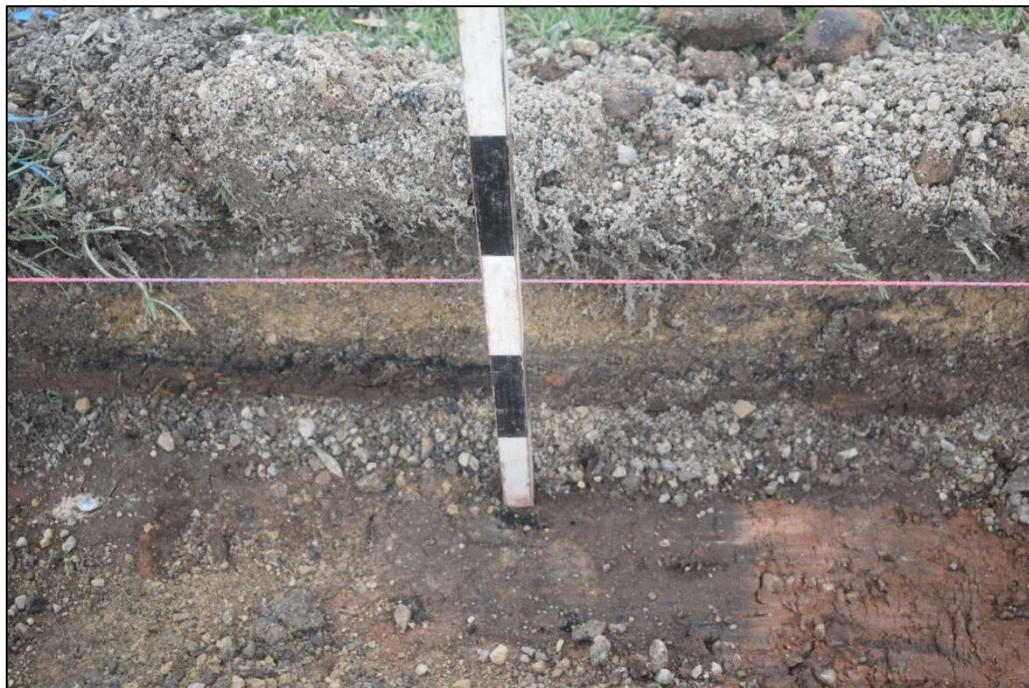
*Fig. 7 East facing section of deposits on the dam/tiltyard Photo CPAT 4915-015*
