Newport Medieval Ship Project Specialist Report: METALS AND SLAG

Report on the Metallographic Examination of Iron Artefacts from the Newport Ship.

Report on the Metallographic Examination of Iron Artefacts from the Newport Ship

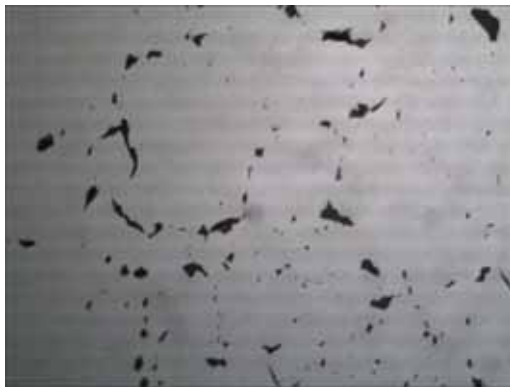
Plate 2 Sample MSG 1239 unetched condition showing a swirl of slag inclusions (black), (WoF 1mm)

A bolt of approximately 30cm long and the shaft is 2.5cm in diameter (Plate 1). A wedge shaped cross-section was removed from mid-length of the bolt. In the unetched condition the section displays some corrosion penetration. There are slag inclusion distributed across the section, stringers are absent and the slag inclusion shape ranges from small round or sub-spherical inclusions to larger angular sub-rectangular inclusions (Plate 2). The majority of slag inclusions are dual-phased, some with iron oxide present. In the etched condition the section showed a varied carbon gradient ranging from near eutectoid steel (0.8%C) degrading across most of the section through pearlite plus ferrite to ferrite plus pearlite to a ferritic microstructure (ASTM Grain Size 3-4, Plates 3-5). The bolt is too big for it to have been carburised from one side, as the distance would have required many days of carburisation. This suggests the bolt was manufactured from a heterogeneous iron. The pearlite is coarse indicating that the bolt had cooled slowly, but widmanstatten ferrite is also present indicating a period of more rapid cooling. Finally, the pearlite shows evidence of breaking up and spheroidising indicating that it was held at elevated temperature. This sequence could be achieved by being repeatedly heated and held at high temperature during the time the bolt was being forged to shape. It was then probably quenched to remove the initial heat, but then left to cool slowly to ambient temperature. The slow cooling would be enhanced by a pile of bolts being left to cool.

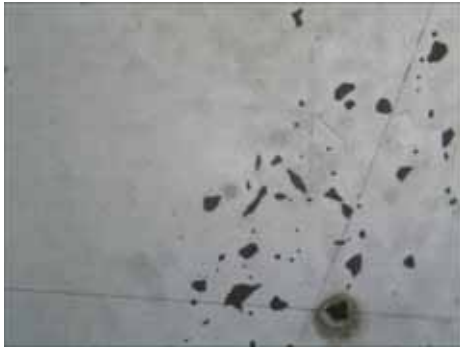
Plate 10 MSG 2368 unetched showing angular slag inclusions (WoF 1mm)

The nail survives as a very short length (2cm) of the shank (Plate 9). A complete transverse section was removed. The section showed heavy corrosion penetration, the surviving metal contained appeared clean of small inclusions but with two prominent bands of slag inclusions running across the section (Plate 10). The majority of inclusions appear as glassy phase with occasional fine precipitates present reminiscent of the glassy phase present in smithing and smelting slags. In the etched condition the microstructure was ferrite grains ((Plate 11), Grain Size ASTM 3-4) with no indication of the presence of phosphorus with one side having ferrite grains plus grain boundary pearlite (ASTM 5-6). The ferrite grains were irregular, but not deformed. There was no evidence of cold working.

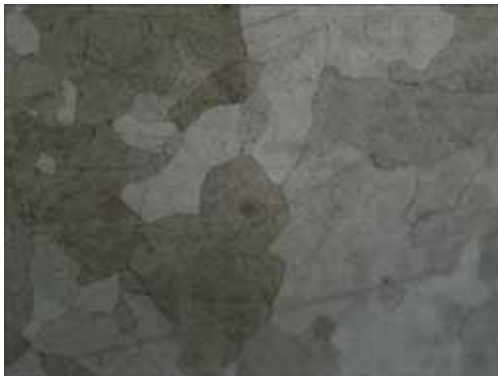
Plate 11 MSG 2368 etched showing ferrite grains (WoF 1mm)

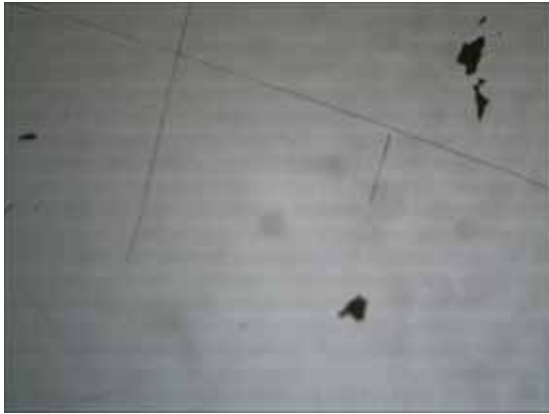
Plate 16 MSG 895, unetched showing angular slag inclusions (WoF 1mm)

The nail survives as a short length (3cm) of the shank (Plate 15). A complete transverse section was removed. The section showed heavy corrosion penetration, the surviving metal contained appeared clean of small inclusions but with a few larger inclusions distributed across the specimen (Plate 16). The inclusions appear to be single or dual phase, probably silicate/glassy phase. In the etched condition (Plate 17), the microstructure was predominantly ferritic (ASTM Grain Size 3-4) with some localised areas showing ghosting, indicating the presence of phosphorus. There is some age grain boundary precipitation or slight intergranular corrosion.

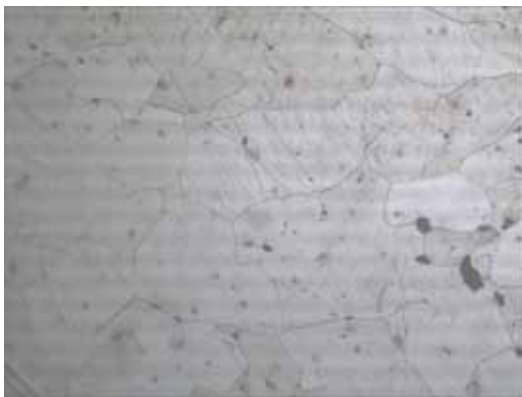
Plate 20 MSG 2177 Etched showing ferrite grains with small carbide precipitate at the grain boundaries. (WoF 1mm)

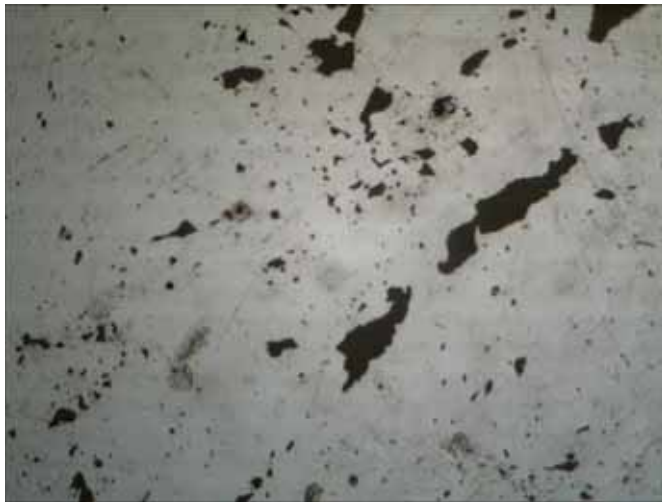
Plate 28 MSG 2690 Unetched showing the heavily slagged nature of the sample (WoF 1mm)

In the unetched condition the section displays some corrosion penetration. There are slag inclusions distributed across the section including lines of stringers, one of which appeared to form a fold in the section. The inclusions ranged from small spheroidal inclusions to larger more angular inclusions (Plate 28). The majority of inclusions were single phased, but with some dual phased inclusions present, none appeared to contain iron oxide. In the etched condition the microstructure was small grained ferrite and pearlite. The carbon content varied between c0.1-0.3% and the grain size was ASTM 6-7, in the higher carbon areas there was an indication of a third phase, possibly a phosphide precipitate (Plate 29).

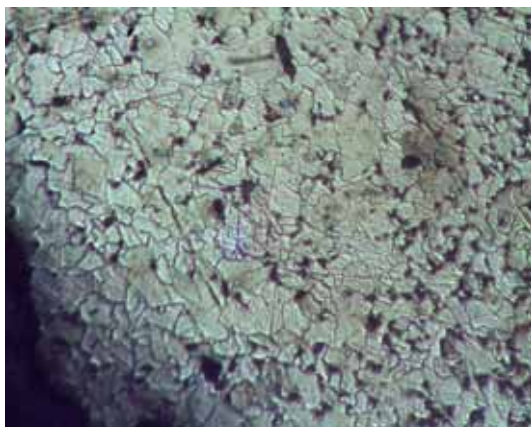
Plate 29 MSG 2690 Etched showing ferrite plus pearlite microstructure (WoF 0.7mm)

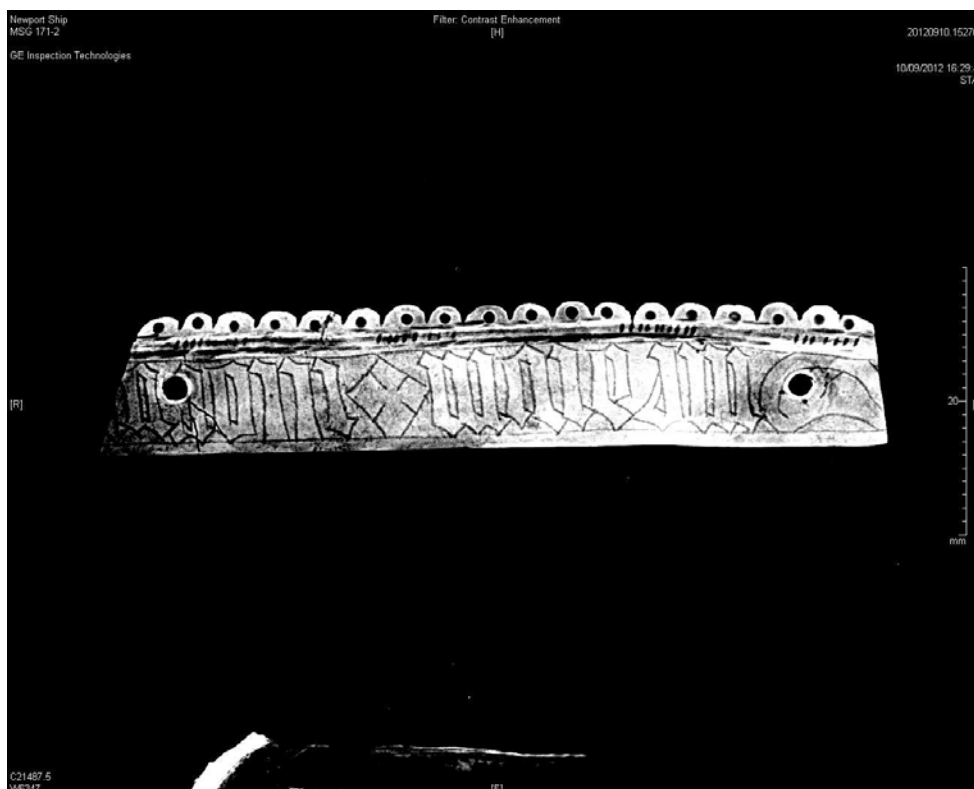
Description: Helmet Strip, engraved. Rectangular in plan, three straight edges and one scalloped edge (18 scallops in total). Two holes present at either end for attaching to plate, 3.2mm in diameter. Two words *MEDIUM ILLORUM* are inscribed, in Gothic textura, separated by a diamond motif. The writing sits between two lines which run the length of the strip. Between the writing and the scalloped edge is a raised ridge, 2mm wide with four sets of notches inscribed at a slight angle. Piece is in good condition and gold in colour. See also Msg 172.

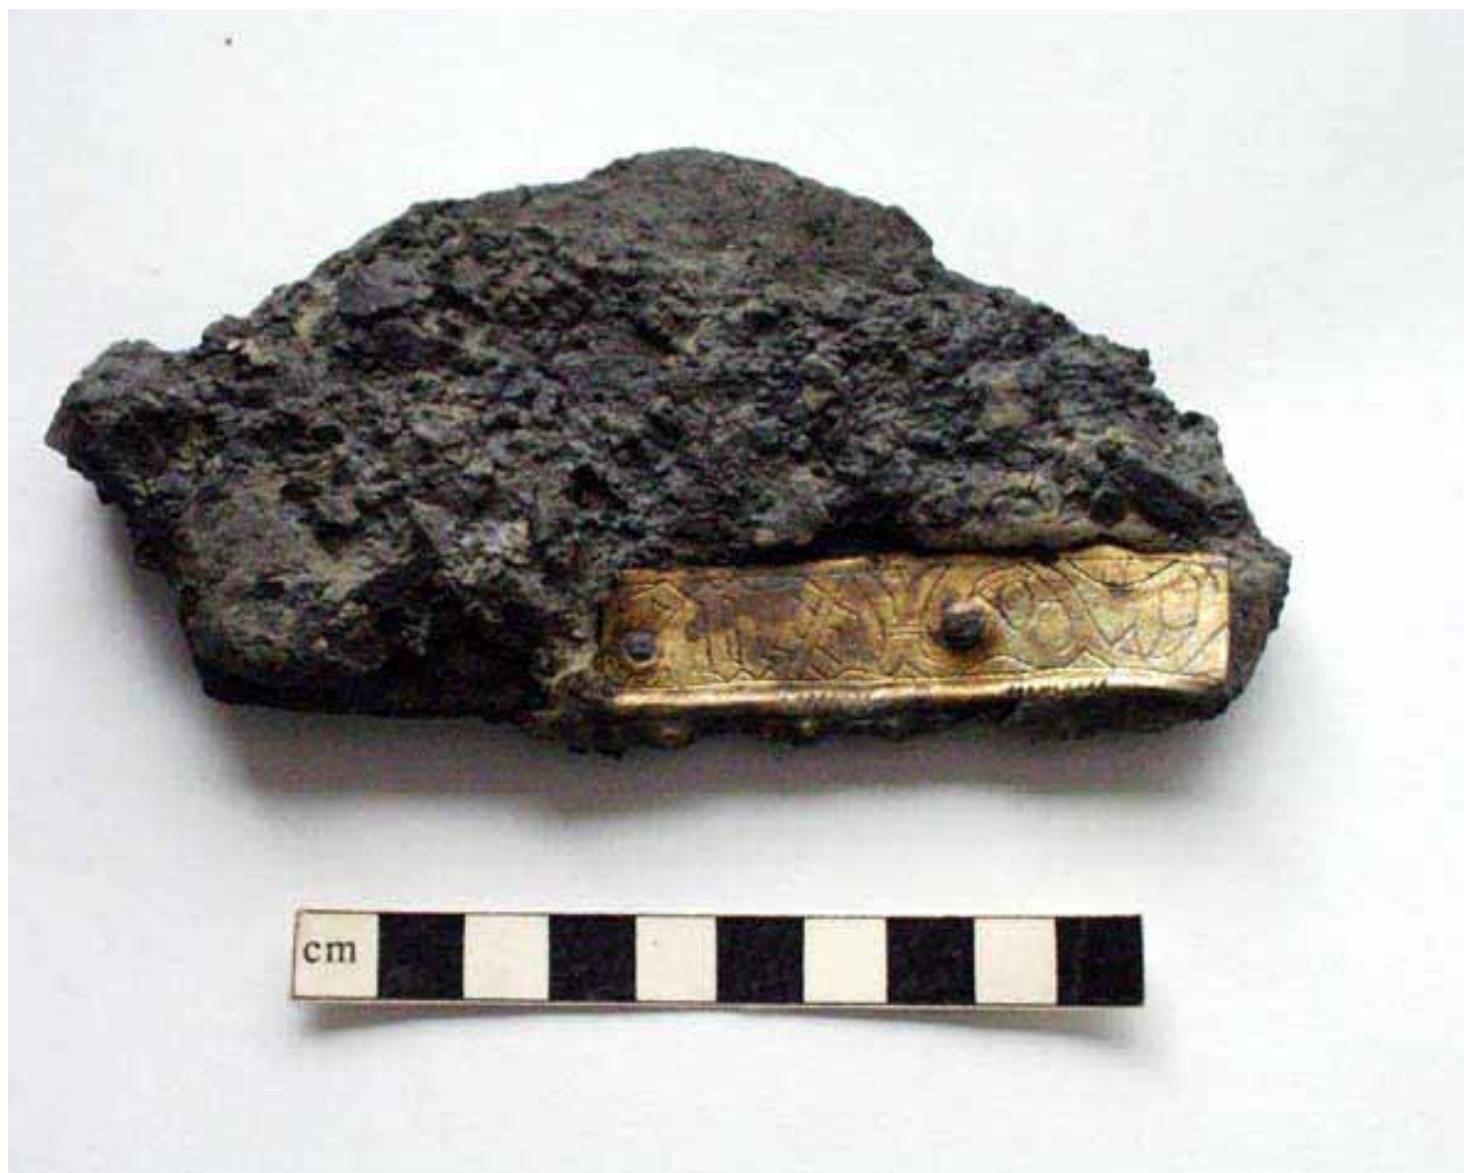
Description: Helmet Fragment. One scalloped edge, three straight and two rivet attachments. It is engraved with Gothic textura (textualis quadrata) script. Inscribed are the letters ENS followed by a foliate/organic scroll, forming a break between words (Redknap 2010) Between the inscription and the scalloped edge is a raised ridge with decorative line motifs engraved at a slight angle. See also Msg 171.

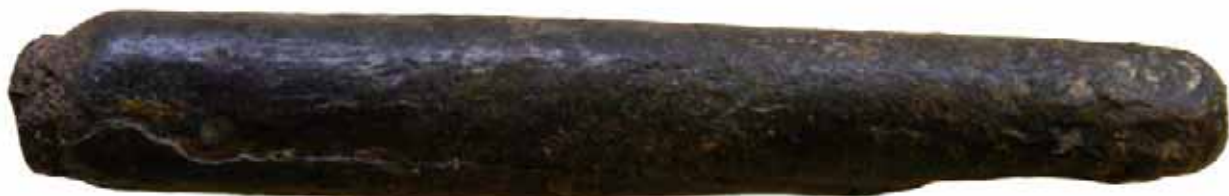
MSG 193

Dimensions: 30mm in length; 1.52mm in diam. 0.53g.

Description: Hooked in shape. Grey in colour. The tip is faceted. Opposite end ie the bent end is damaged. Possibly modern. Cardiff Uni No.:5939-05.

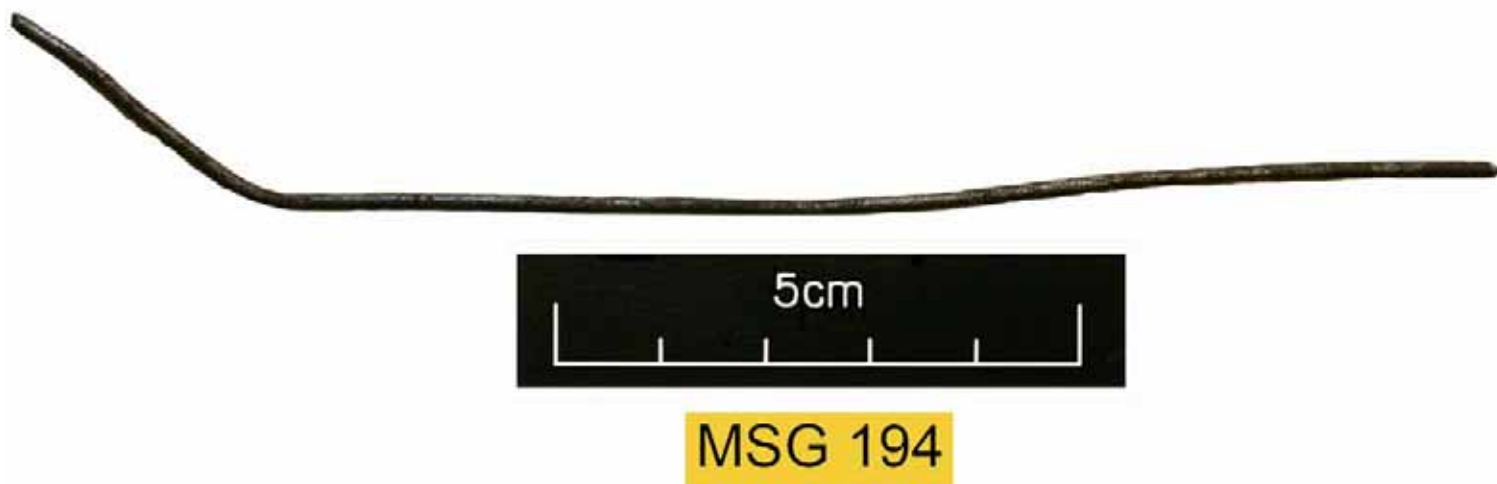
Dimensions: 48.2mm long. 7.1mm-5.8mm in diameter.
7.38g.

Description: Appears to have been rolled with a join running the length of the piece. Concretion at one end. Piece tapers in thickness from one end to the opposite.

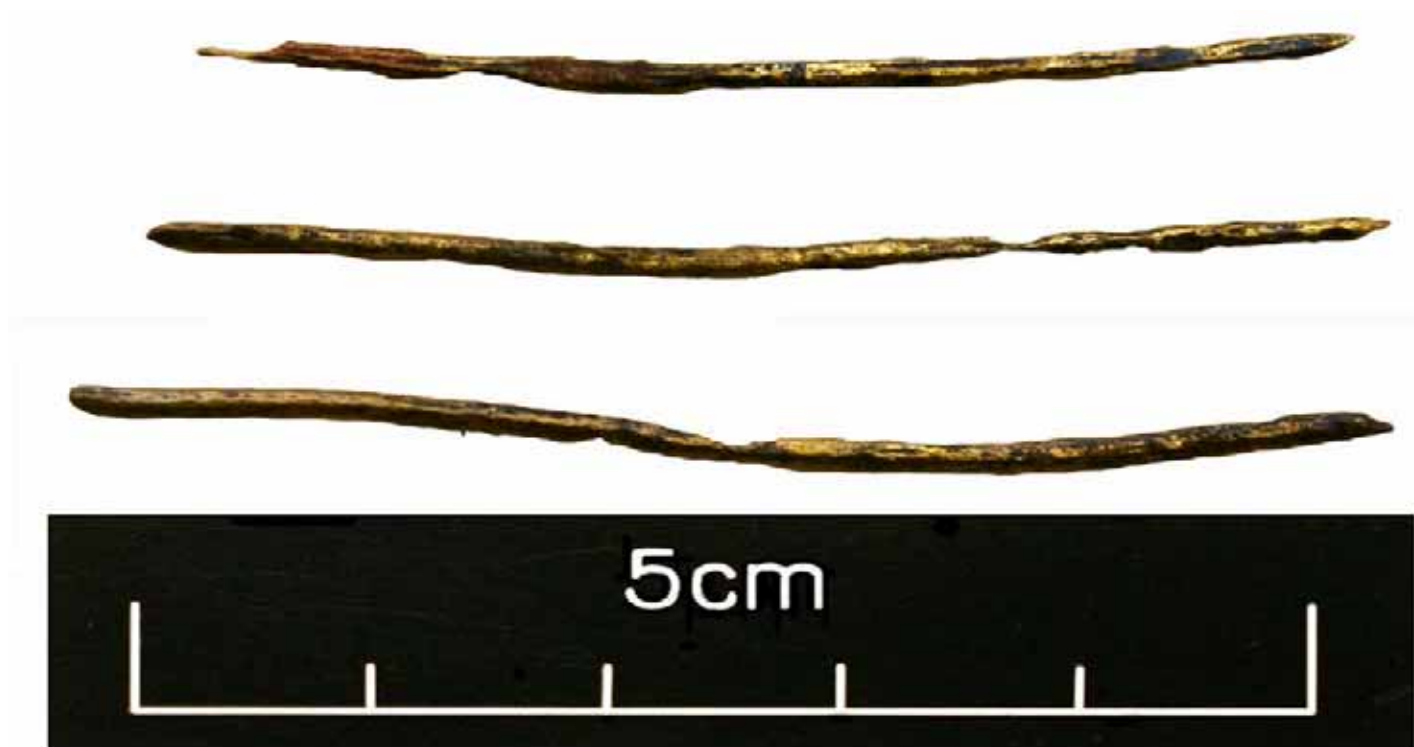
Dimensions: 15mm in length. Diameter of 1.6mm. 2.27g.

Description: Bent close to one end. Each end has been cut leaving two facets. (possibly modern).

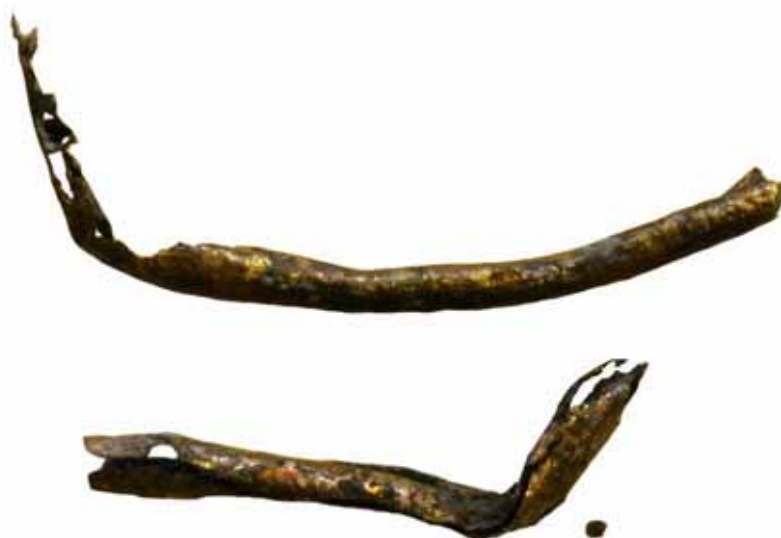
Dimensions: Combined length of 156mm. Diameter is 1.2mm (varies) Combined weight is 1.13g.

Description: 3 pieces Cu Alloy Binding. Gold in colour. Do not appear to be hollow.

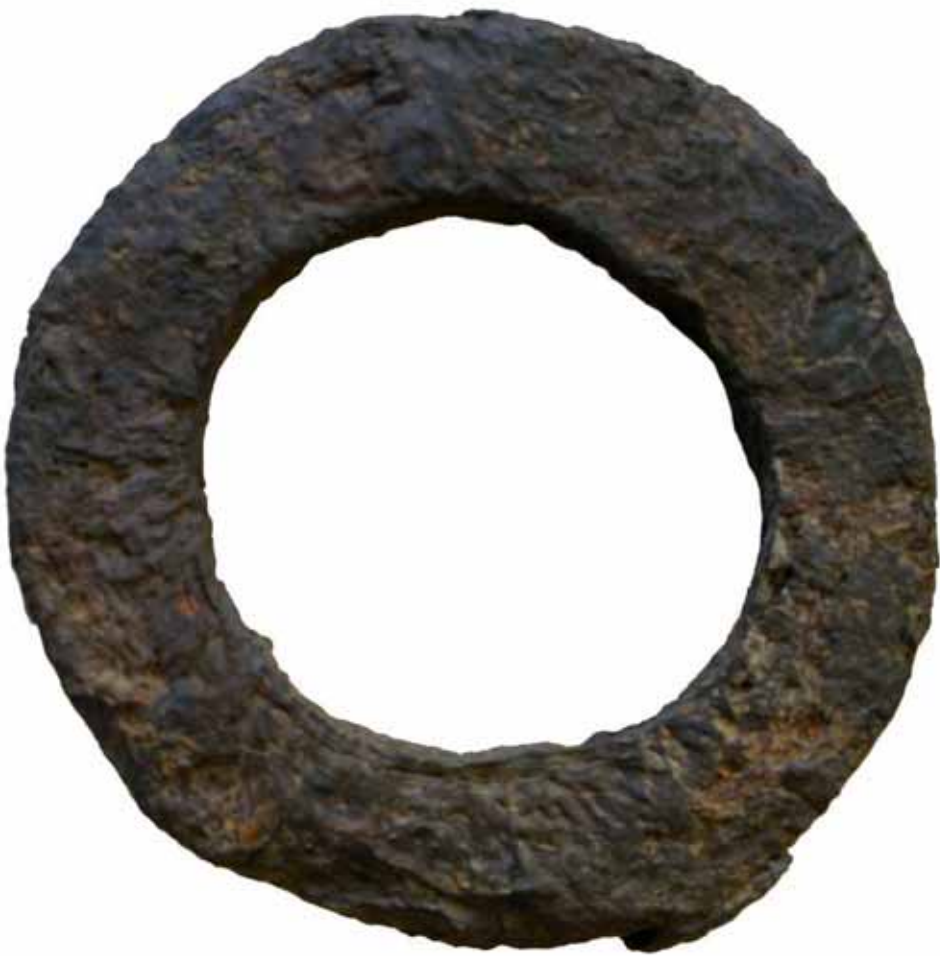
MSG 199

Artefact Type: Washer.	Description: Good condition.
Material: Metal - Fe.	
Context: U/S.	
Dimensions: Outer diam is 58.6mm, inner diam is 33.9mm, depth is 9mm. Weight is 78.67g.

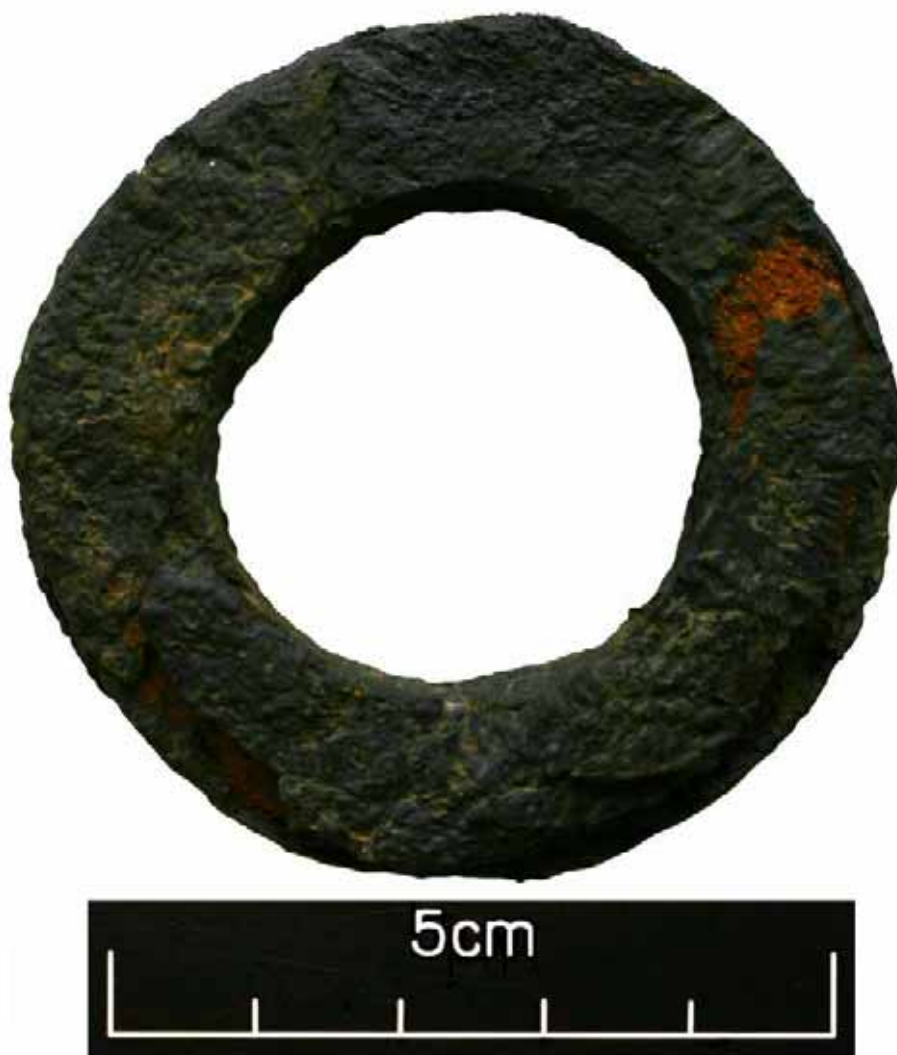
Dimensions: Outer diam is 57.2mm, inner diam is 32.6mm, depth is 10.9mm. Weight is 63.31g.

Description: Grey in colour, good condition. Some cracks present. No contextual info.

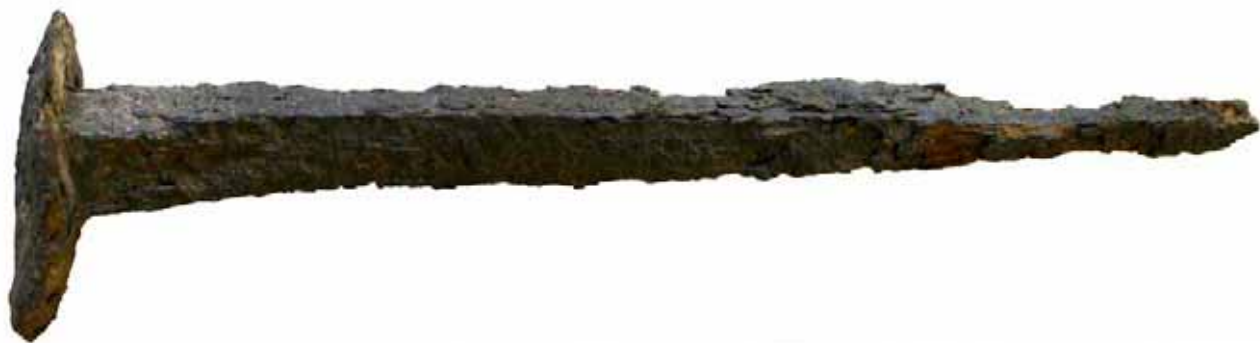
MSG 202

Artefact Type: Nail.	Description: Square in section with some surface damage. Head is flat and roughly circular in shape.
Material: Metal - Fe	
Context: U/S.	
Dimensions: 94.2mm in length. Shaft is 7mm x 7mm at head, tapering to 2.3mm x2 .3mm at the tip. 15.42g.

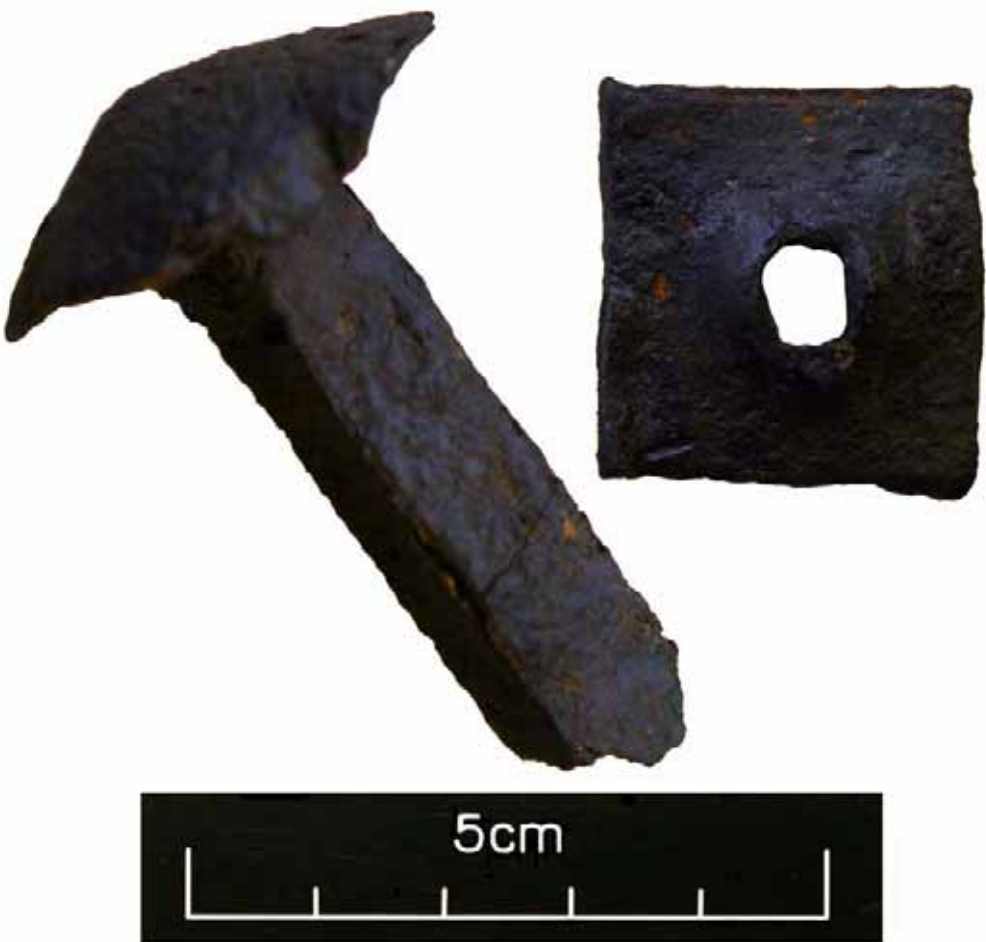
MSG 203

Artefact Type: Nail and rove.	Description: Nail is 64.8mm (including head). Shaft is square and measures 8mmx8mm. Head is sub-circular with a dome and is approx 33.5mm in diameter. Rove is rectangular with a square hole in the centre measuring 7.5mm x 6.9mm. Both have been laser scanned. Note these items were found together however nail doesn't fit through the rove.
Material: Metal - Fe.	
Context: U/S.	
Dimensions: See description.

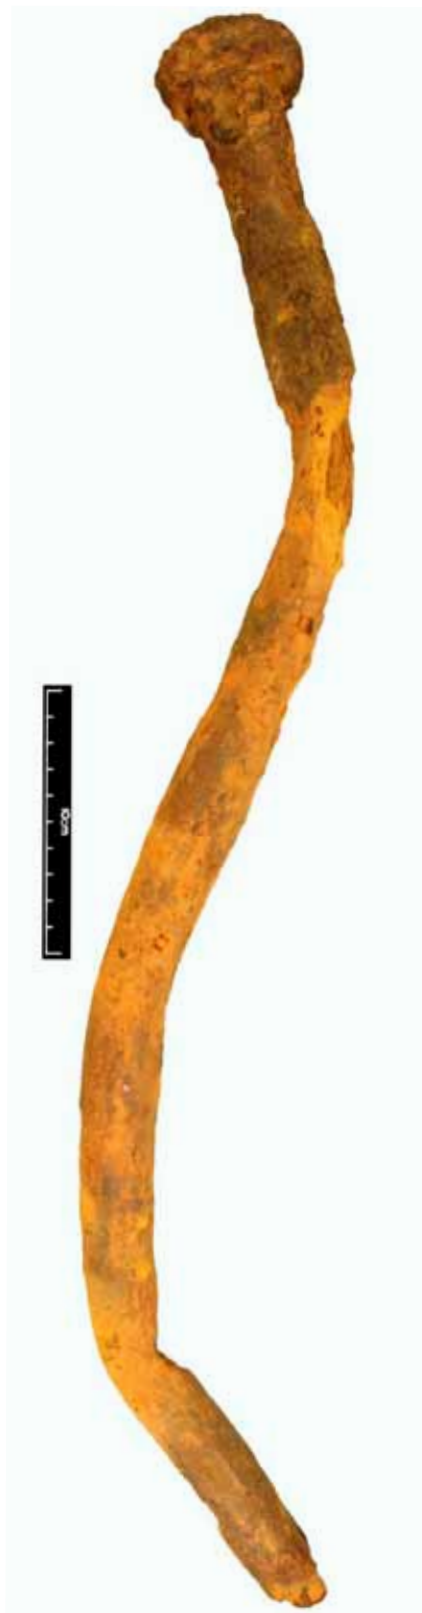
Dimensions: Largest is 75mm x 61mm x 35mm.

Description: Possibly one large bolt head.

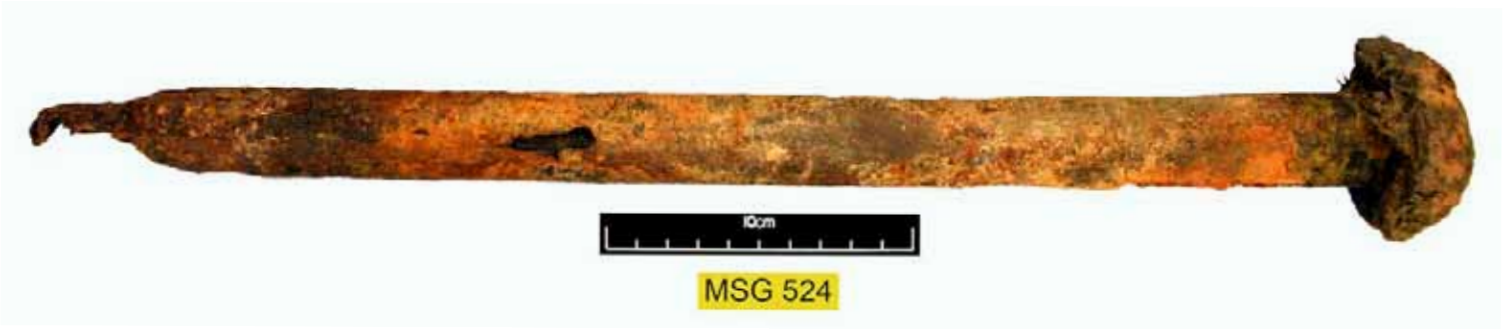
Description
Large Iron Bolt. Sureface concretions, active surface corrosion. Light orange flaky rust.

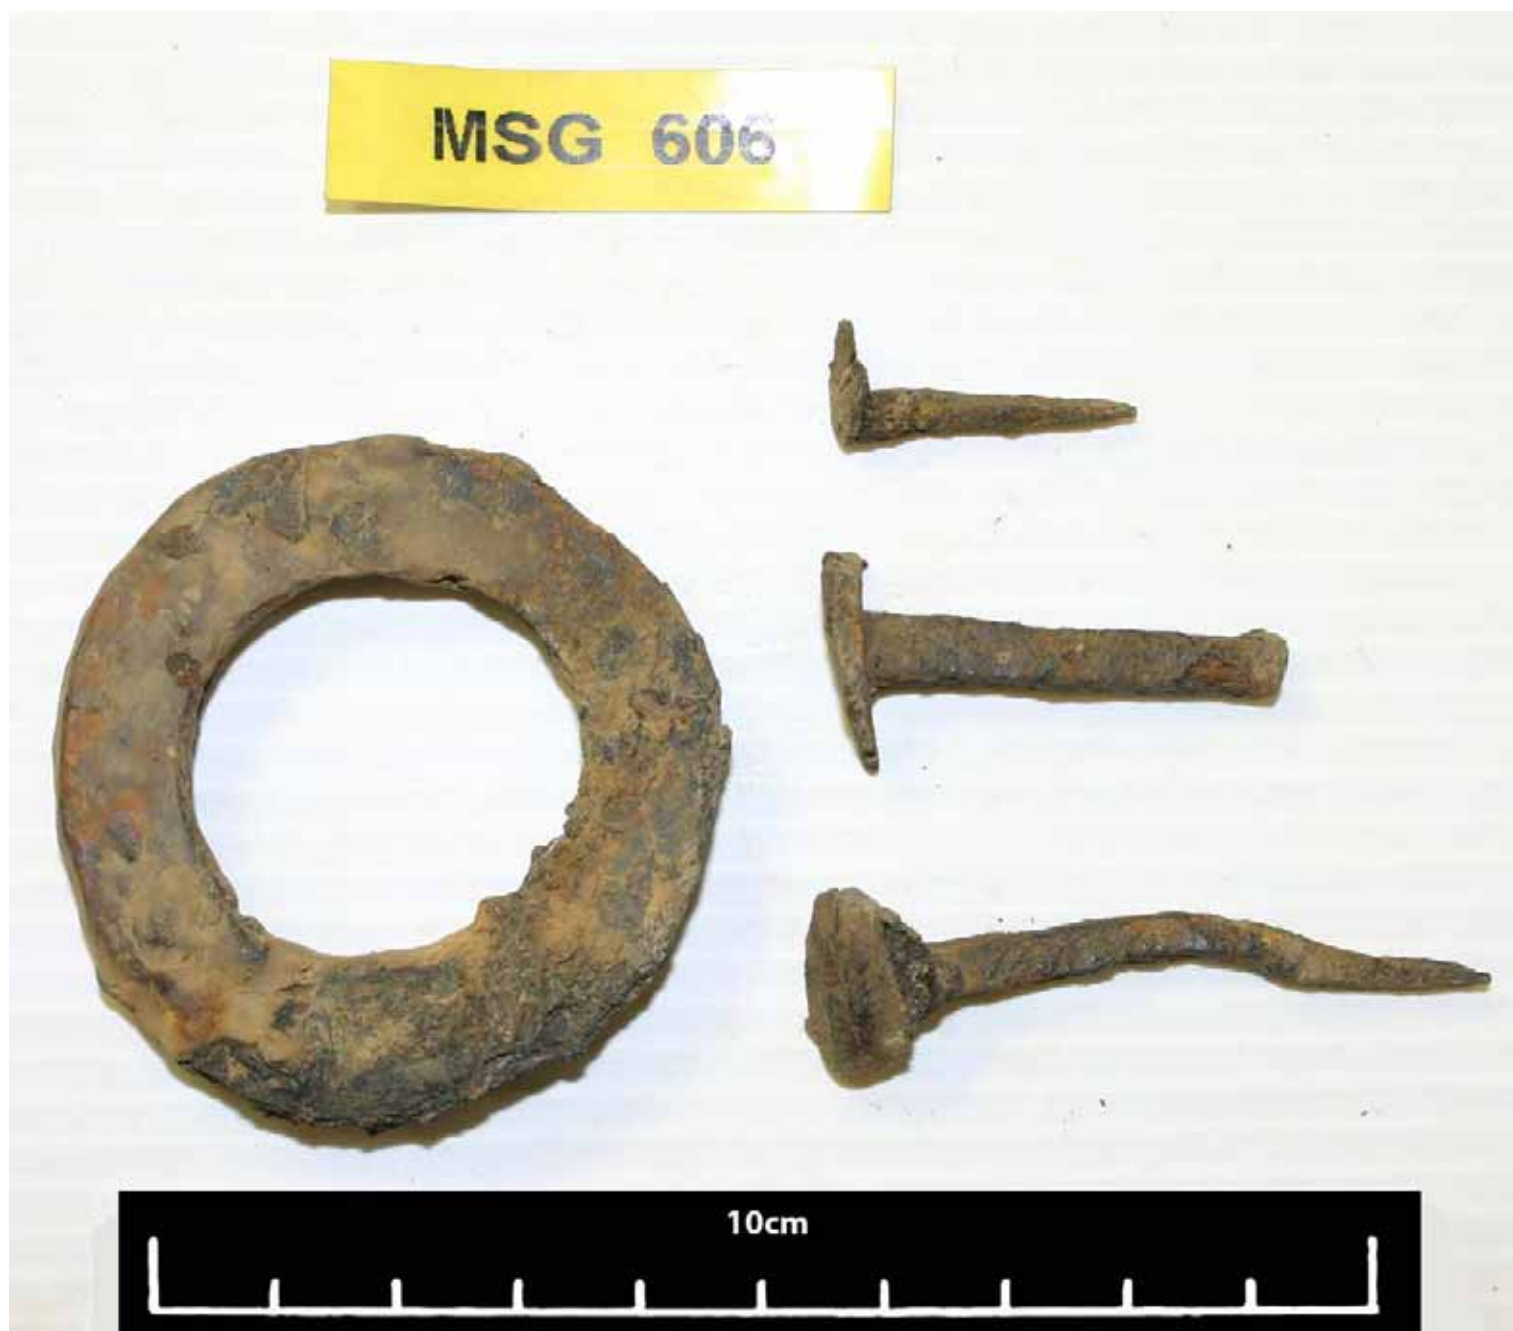
Description: The rove is 17g, 27mm x 27mm x 5mm. Concretion is present. The first nail is 30mm in length, has an irregular head 13mm across. The shaft is 5mm x 5mm and damaged. It's 4g. The second nail is 55mm in length, domed head 35mm in diameter. The shaft is 10mm x 10mm and weighs 21g. The third is 70mm in length, has an irregular head 25mm in diameter. The shaft is 6mm x 6mm and damaged towards the tip. It weighs 21g. The fourth nail is 72mm in length, no head. The shaft is 10mm x 10mm, 4g. The fifth is 45mm in length the head is 11mm in diameter. Shaft is 3mm x 3mm tapering to a point, 4g. The sixth is 30mm in length, the head is 30mm in diameter. The shaft is 6mm x 6mm tapering towards the tip. It is 11g. The 8th is 75mm in length, 15mm diameter head. The shaft varies in thickness, approx 4mm x 4mm and tapers to a point. The nail is bent 10mm below the head. It's 8g.

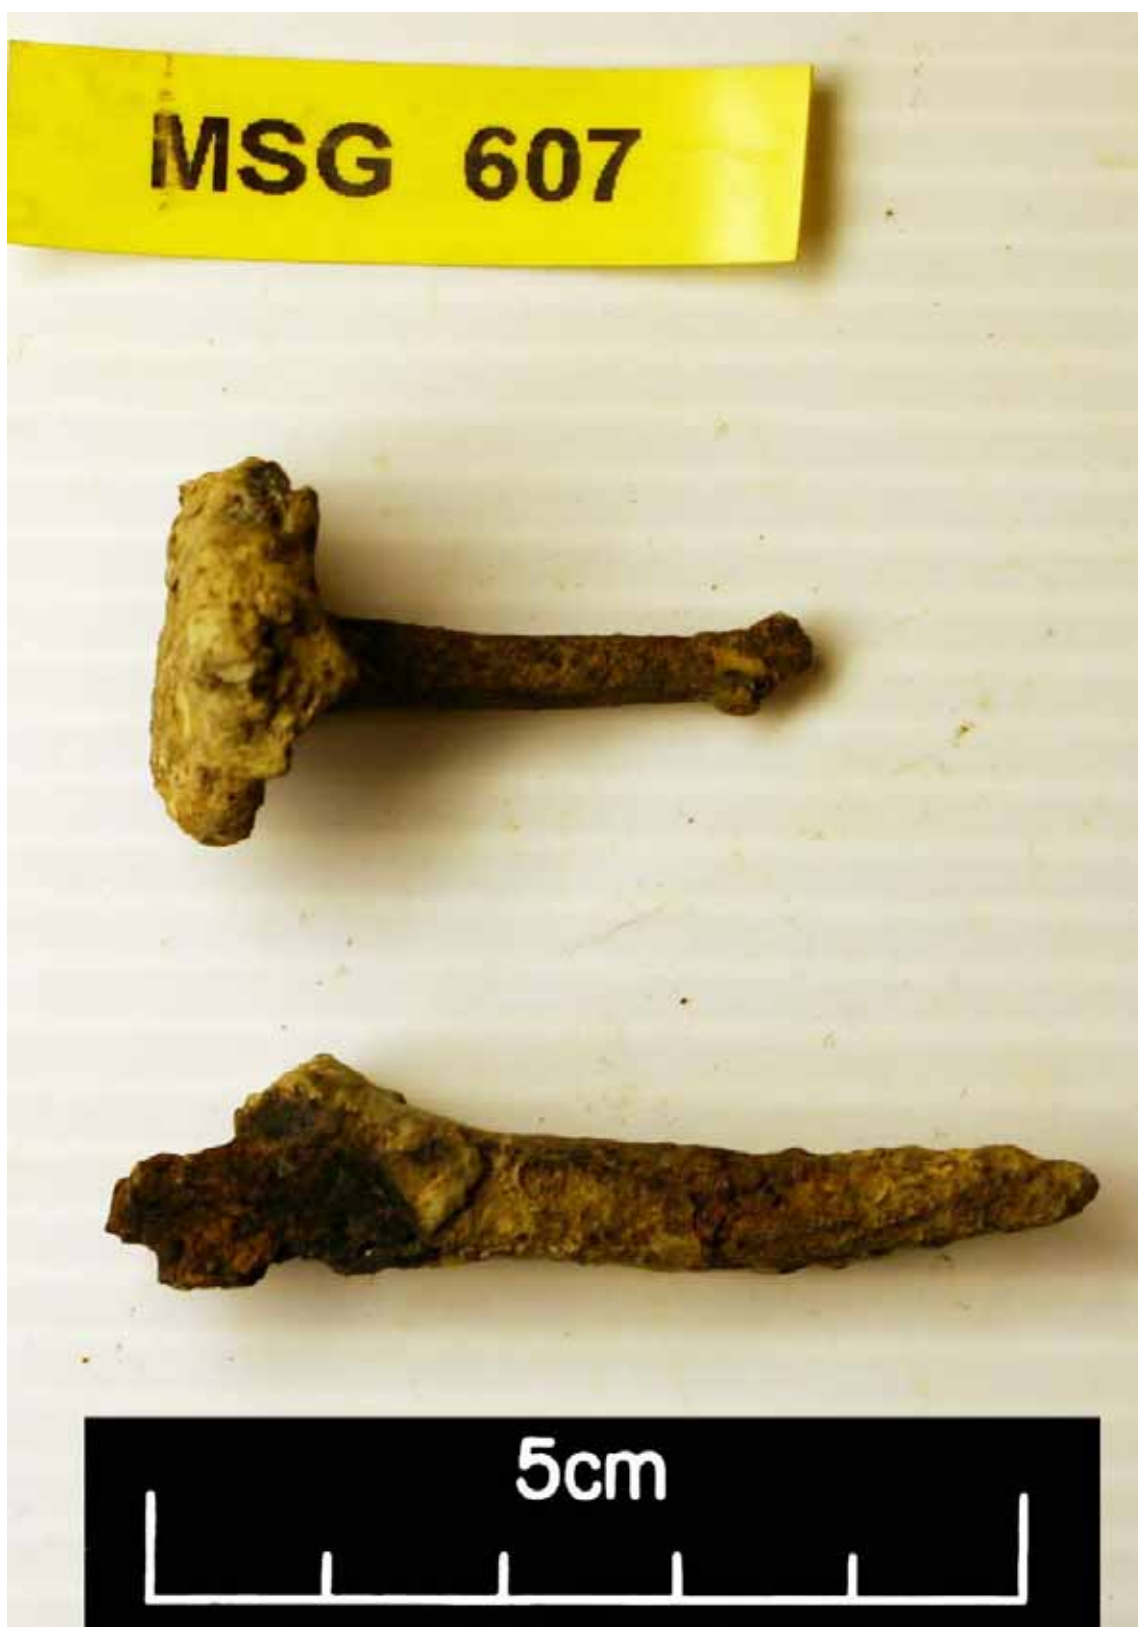
Description: Largest nail is 57mm in length, 6g. Head is circular with a diameter of 15mm. Shaft is 4mm x 4mm and tapers to a point. The smaller nail, 7g is 39mm in length and has a head diameter of 19mm. The shaft is 5mm x 5mm - tapering towards the point. The smallest nail is 1g, 25mm in length. The head is 10mm x 6mm. The shaft is 5mm x 5mm tapering to a point. The smallest nail is 1g, 25mm in length. The head is 10mm x 6mm. The shaft is 3mm x 3mm and tapers to a point. The washer is 68g. The outer diameter is 55mm, the inner diameter is 30mm and is 7mm thick.

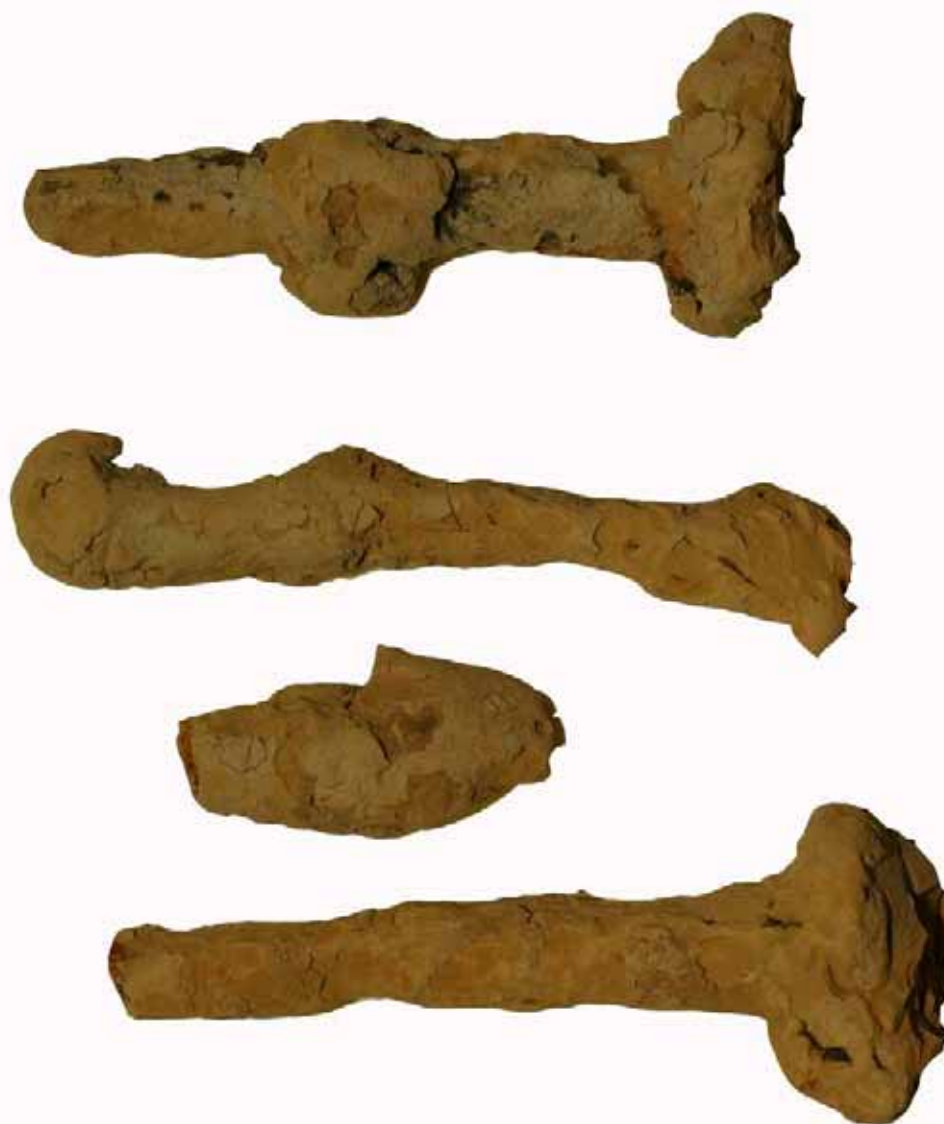
Description: Larger nail, 7g, is 55mm in length. No head. Heavily concreted - approx 7mm x 7mm shaft, tapering to a point. The smaller nail is 7g, 37mm in length. Head is damaged and concreted, appears to be circular with a diameter of approx 22mm. The shaft is 4mm x 4mm and tapers towards the tip.

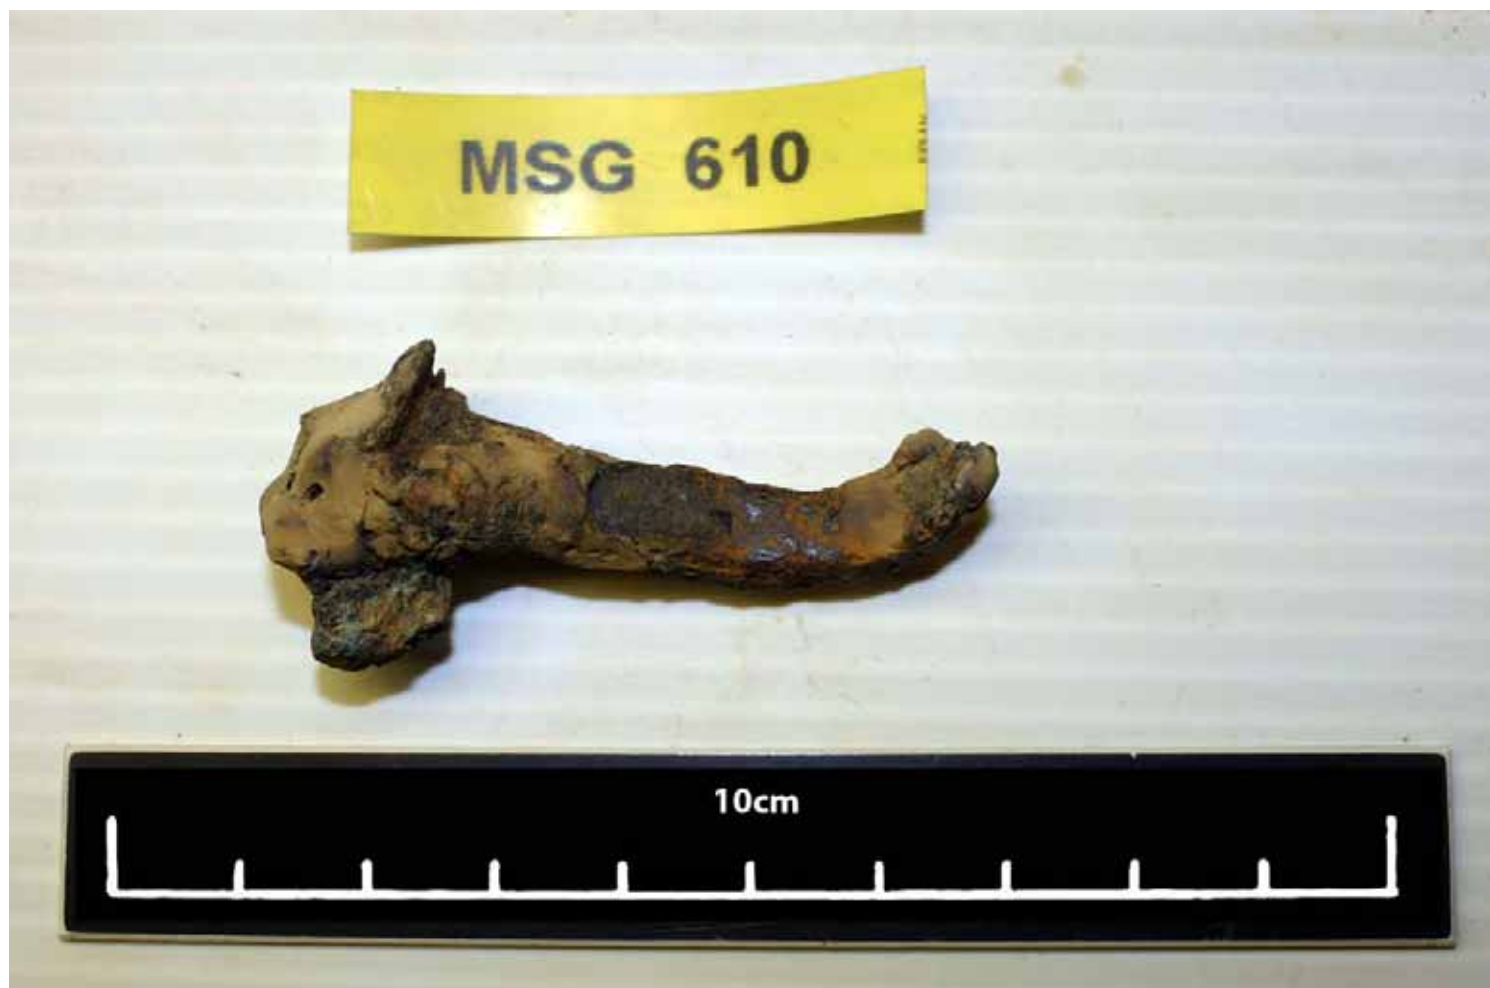
17g. Head is damaged, with a diameter of 20mm. Clenched into a 'U' shape. Concretion present. Attached to 1220. Ferrous. Metallic iron present.

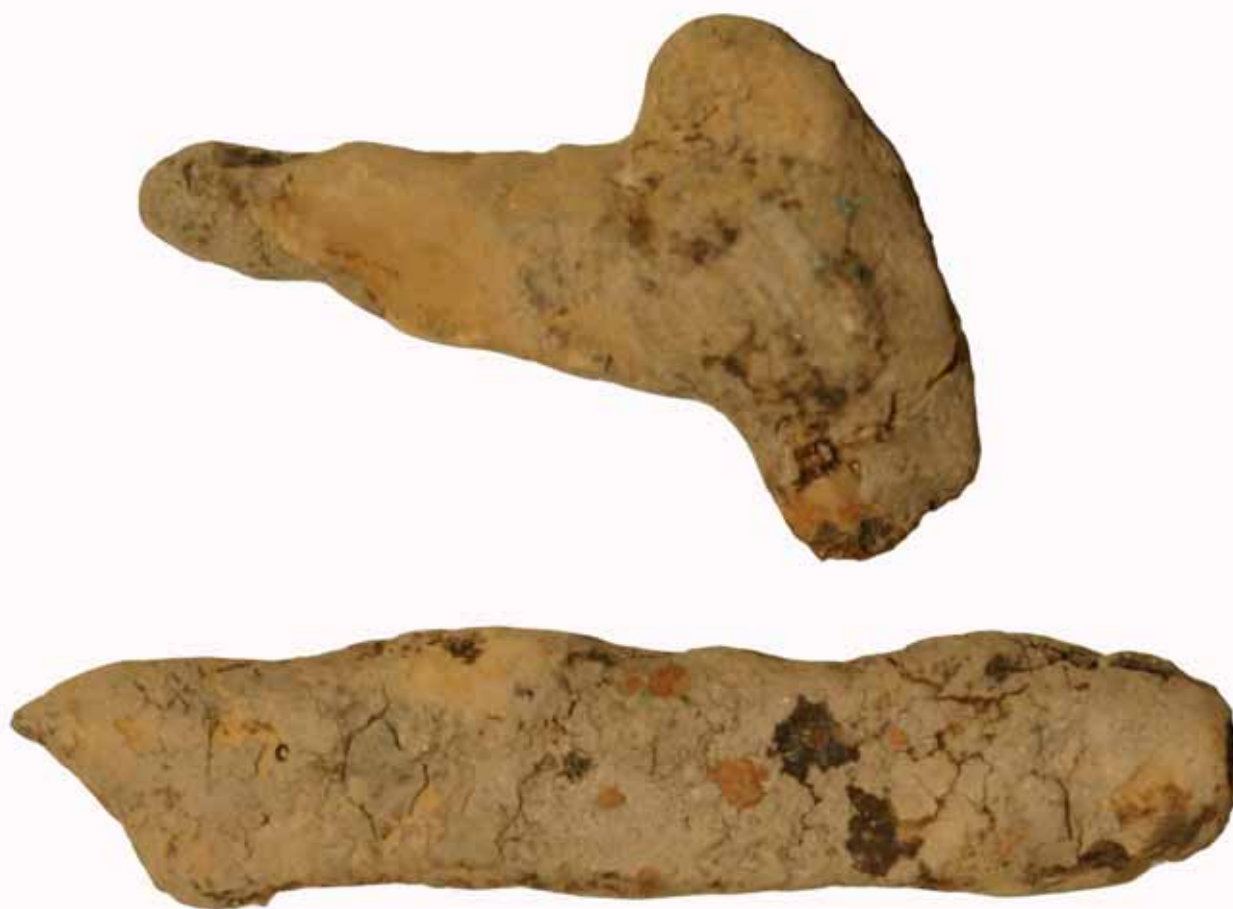
Dimensions: 57mm in length, shaft is 7mm x 7mm. 16g.

Description: Ferrous. Metallic iron present. Tip is slightly bent. The head is concreted, shaft is tapering towards the tip.

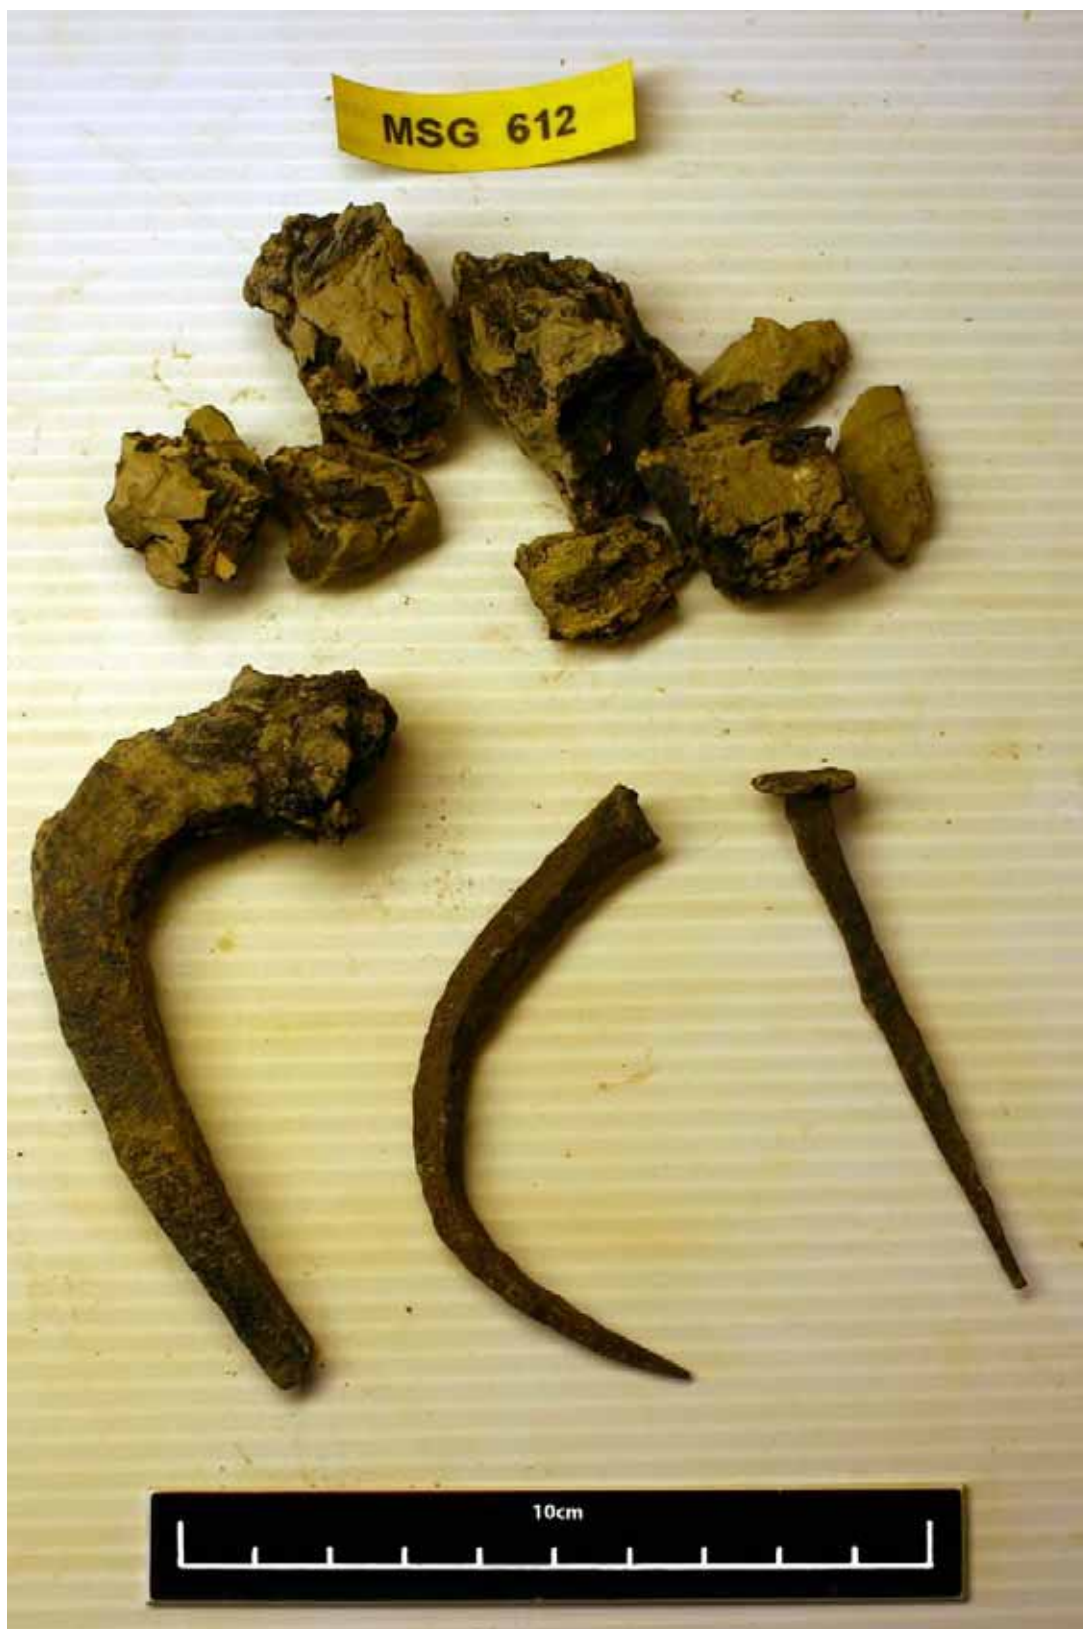
**MSG 611**

Dimensions: 65mm x 11mm x 5mm. 19g.

Description: Piece of iron. Metallic iron present. Rectangular in shape. Function unknown. Second piece appears to be a nail.
