Newport Medieval Ship Project Specialist Report: METALS AND SLAG

Report on the Metallographic Examination of Iron Artefacts from the Newport Ship.

Report on the Metallographic Examination of Iron Artefacts from the Newport Ship

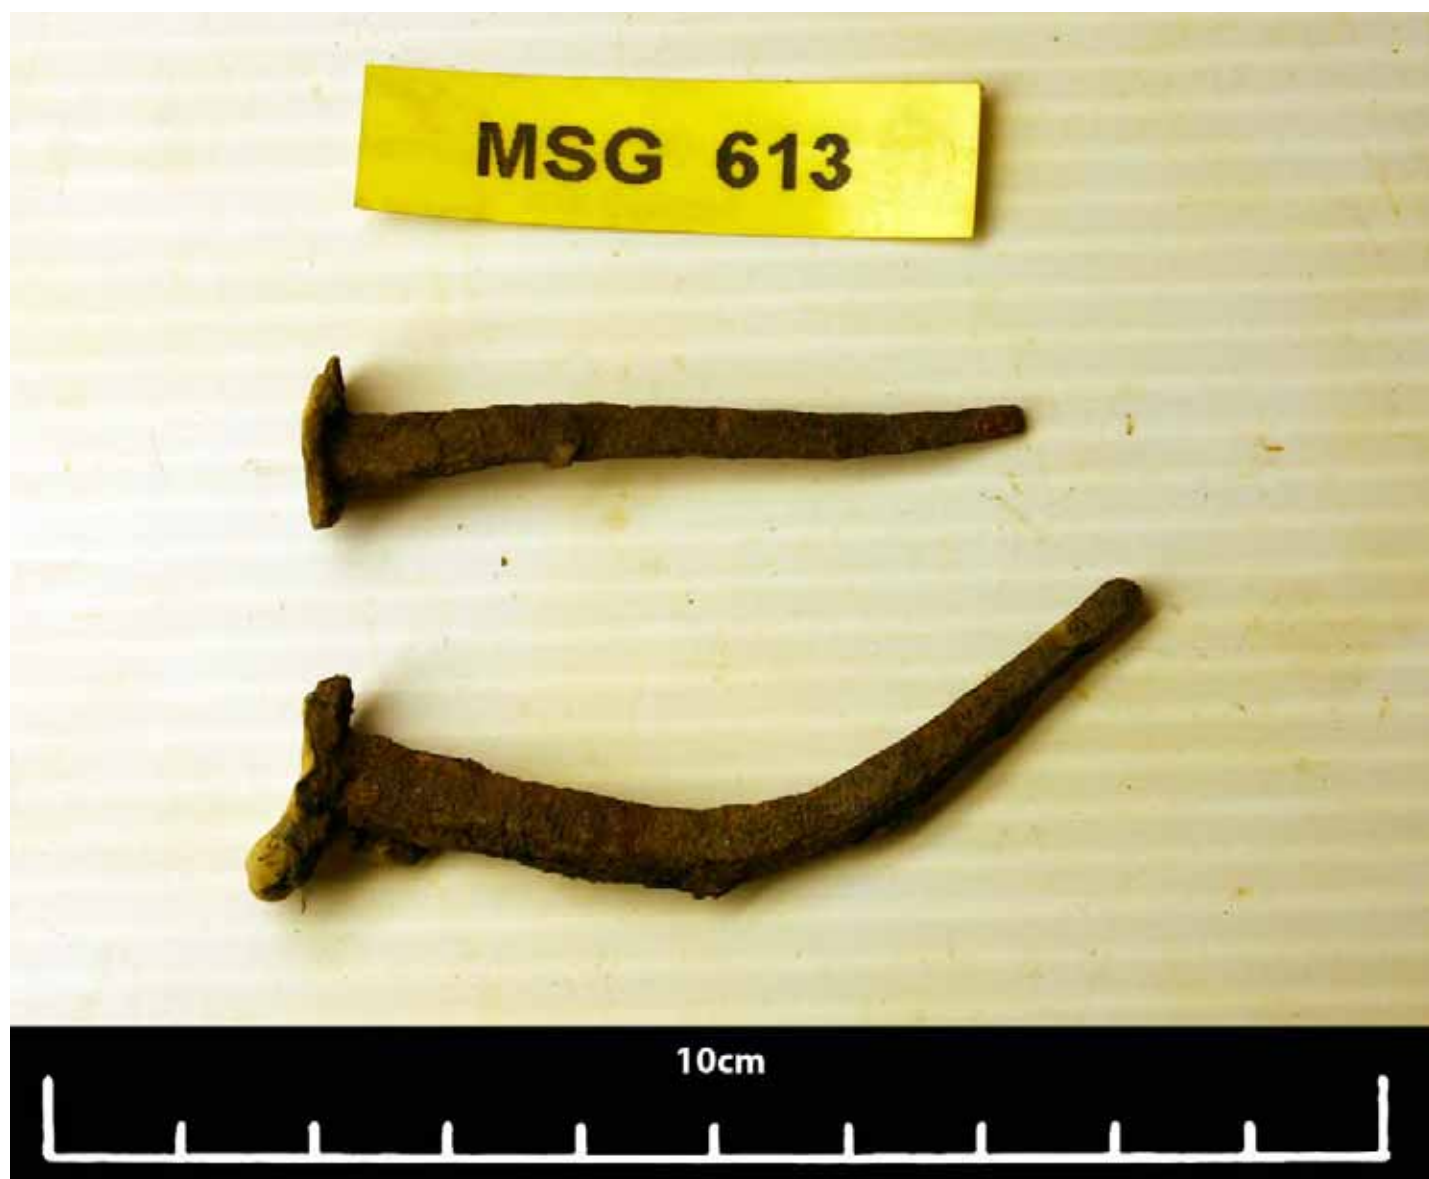
Description: Metallic iron present. Ferrous. Largest is 92g bent into an 'I' shape. Head is concreted and measures 24mm in diameter. Shaft tapers from 15mm x 15mm to 5mm x 5mm. Smaller nail is 18g, bent into an 'L' shape. Head is 10mm x 8mm. Shaft tapers from 7mm x 7mm and tapers to a point. Smallest nail is 7g, straight. The head is subcircular with a diameter of 15mm. Shaft tapers from 5mm x 5mm to a point.

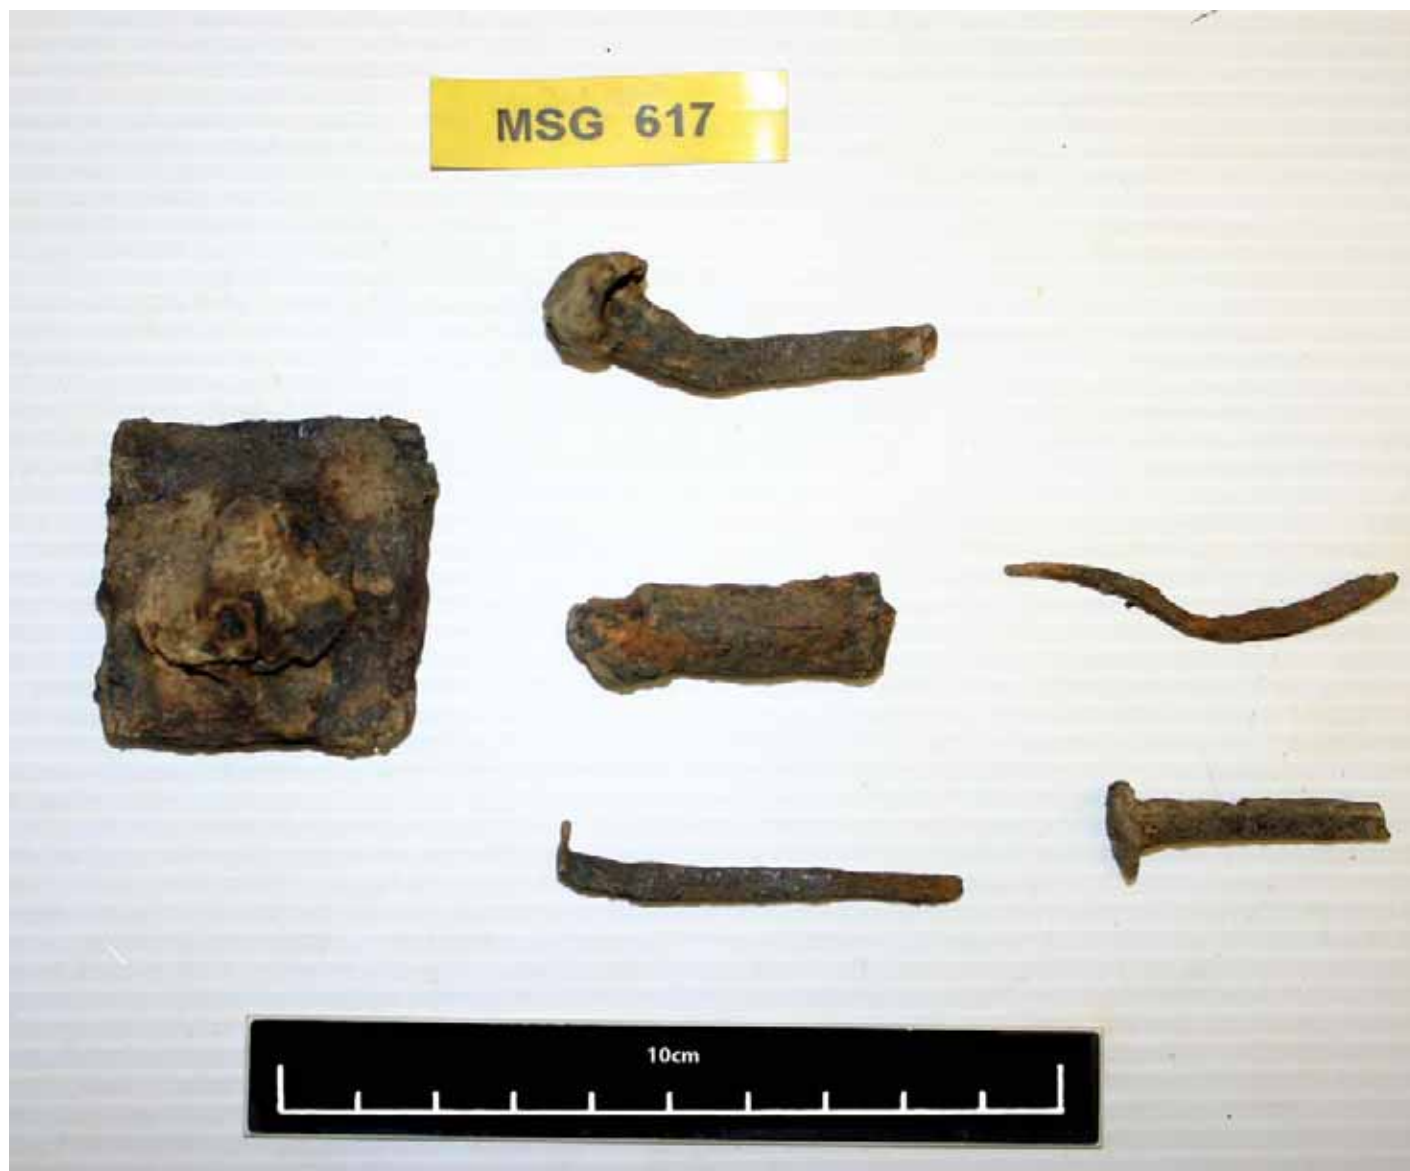
Description: Metallic iron present. Larger is 70mm in length, 7g in weight. Head is damaged and concreted with 18mm diameter. Shaft is 6mm x 6mm tapering to a point. Smaller nail is 6g. Head is roughly square measuring 10mm x 11mm. Shaft is 5mm x 5mm tapering to a point.

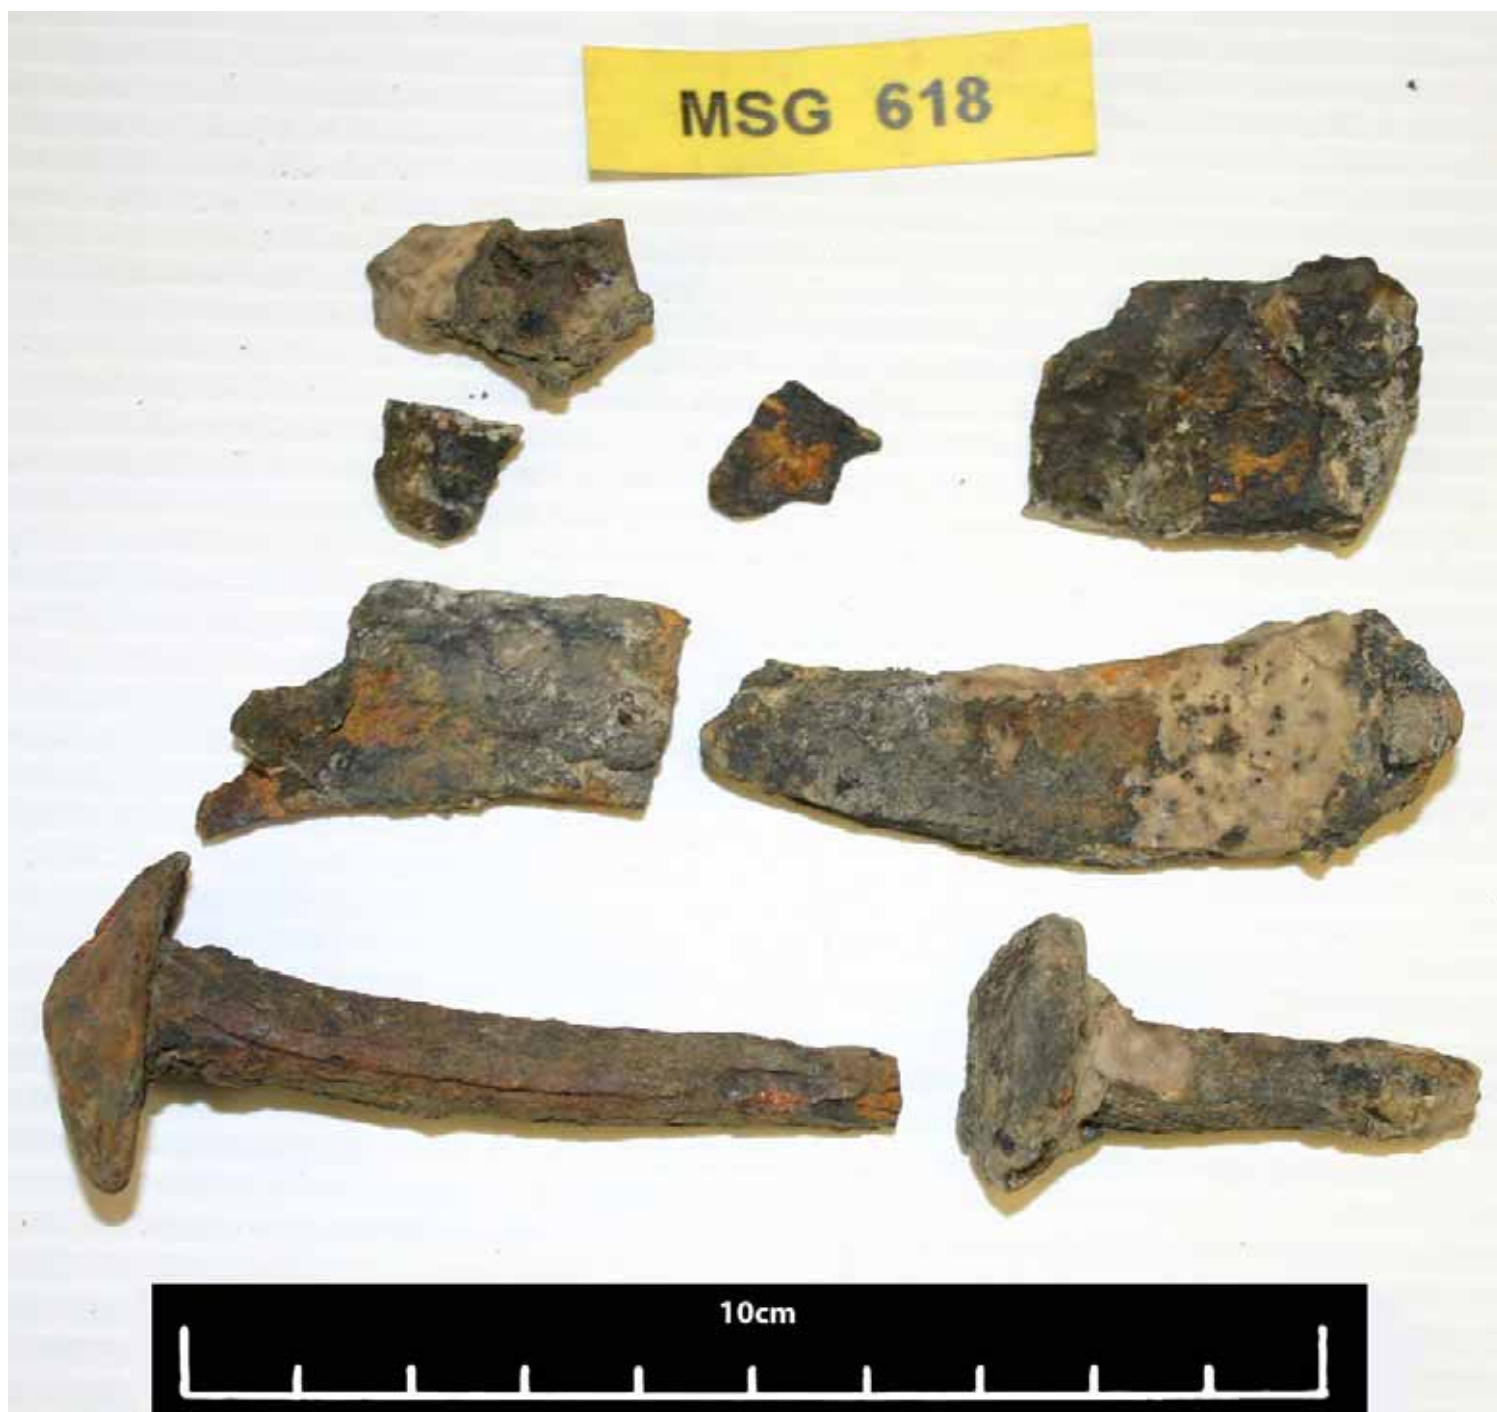
Description: Found in the bow. Metallic iron present. The rove is 39mm x 42mm x 7mm. Heavily concreted. Head and part of the shaft is in situ but concreted. The first nail is 50mm in length. It has a circular but bent head. The shaft is 6mm x 6mm, tapering towards the damaged tip and is bent. It is 14g. The second is 41mm in length and is a shaft with no head. It is 8mm x 8mm and is 16g. The third is 52mm in length, 4g, part of the head remains. Shaft is 4mm x 4mm tapering towards the tip. The fourth is 50mm in length, 2g. No head. 3mm x 3mm, tapering to a point. The fifth is 36mm in length. 14mm diameter head and weighs 2g. The shaft is 4mm x 4mm.

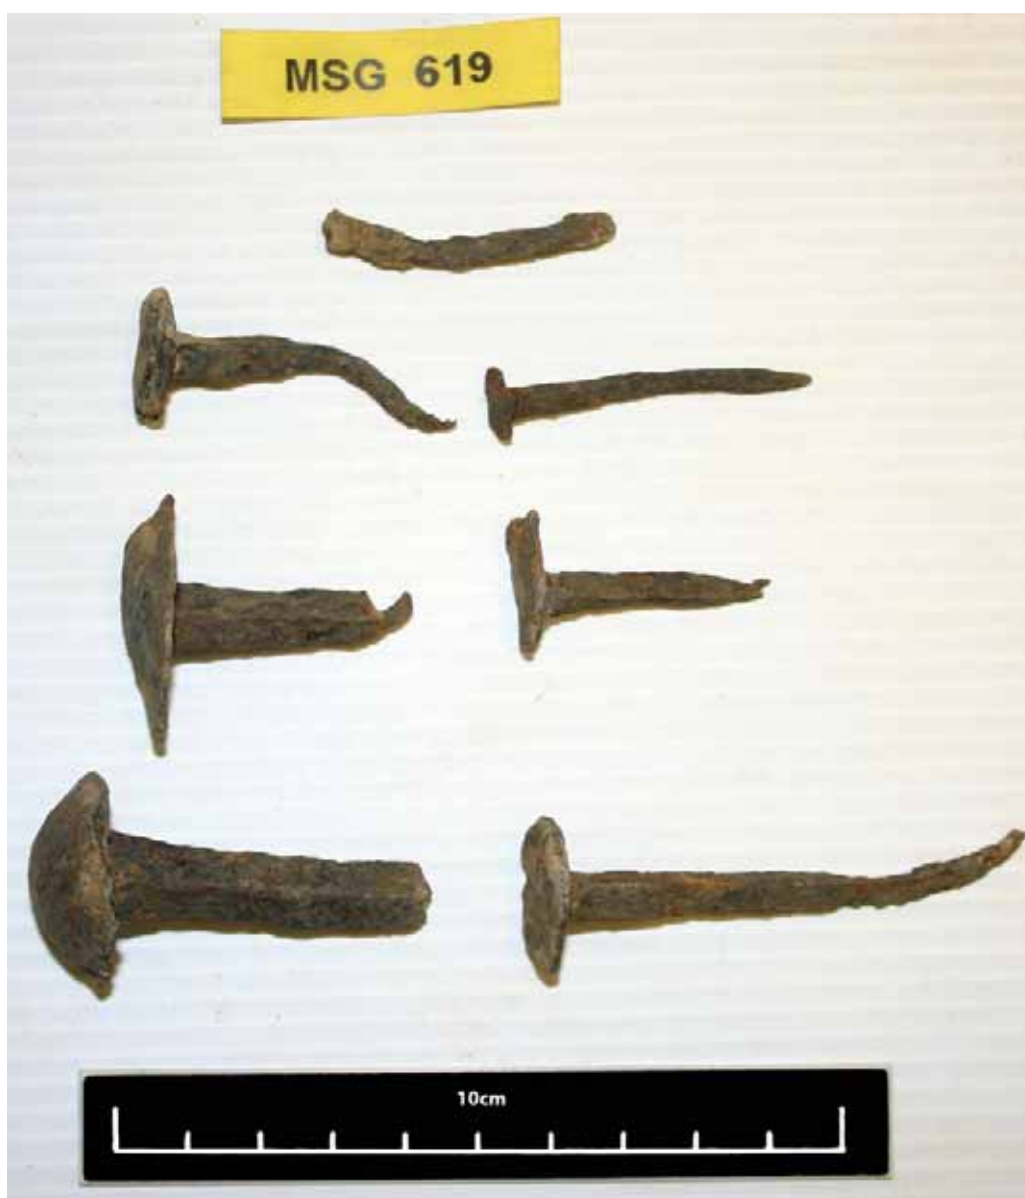
Description: Ferrous. Metallic iron present. Larger nail is 75mm in length, 32g. Head is dome shaped with a diameter of 27mm approx. Shaft is square, 8mm x 8mm, tapering towards the tip. The second nail is 45mm in length. The head is 25mm in diameter. The shaft is 9mm x 9mm tapering towards the tip. Six iron fragments, 65mm (largest) 14mm (smallest) varying thickness, function unknown.

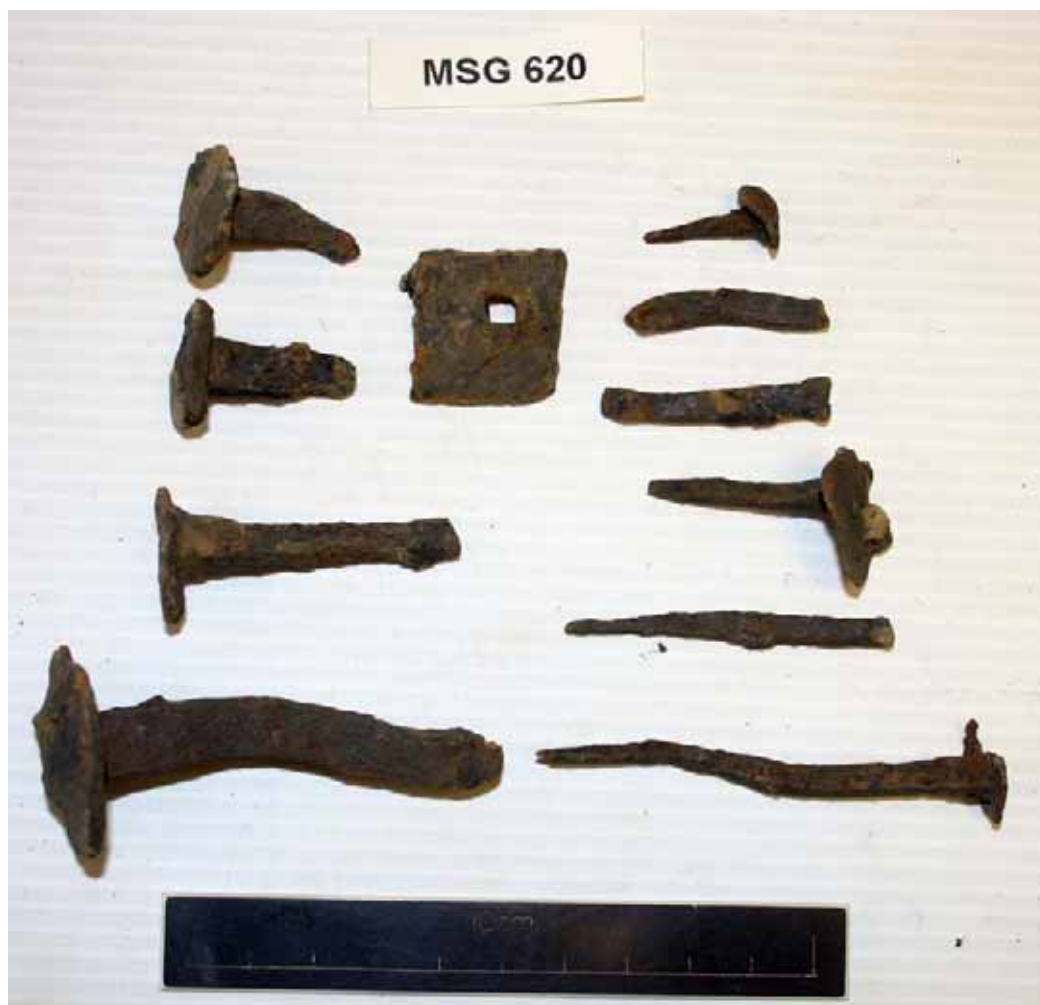
Description: Metallic iron present. The first is 51mm in length with a dome head 30mm in diameter. The shaft is 9mm x 9mm tapering to 6mm x 6mm. The second is 40mm in length, no head with a 4mm x 4mm shaft, slightly bent. The third is 36mm in length. The head is domed and broken with a 32mm diameter. The shaft is 7mm x 7mm tapering towards the tip. The fourth is 44mm in length with a bent tip. The head is six sided, approx 18mm across. The shaft is 4mm x 4mm, tapering to a damaged tip. The fifth is 78mm in length with a subcircular head, 20mm in diameter. The shaft is 5mm x 5mm, tapering to a point. It is slightly bent. The sixth is 44mm in length. The head is roughly circular, 10mm in diameter. The shaft is 3mm x 3mm tapering to a point. The final nail is 35mm in length with an irregular shaped head 19mm x 14mm. The shaft is 4mm x 4mm tapering and damaged towards the tip.

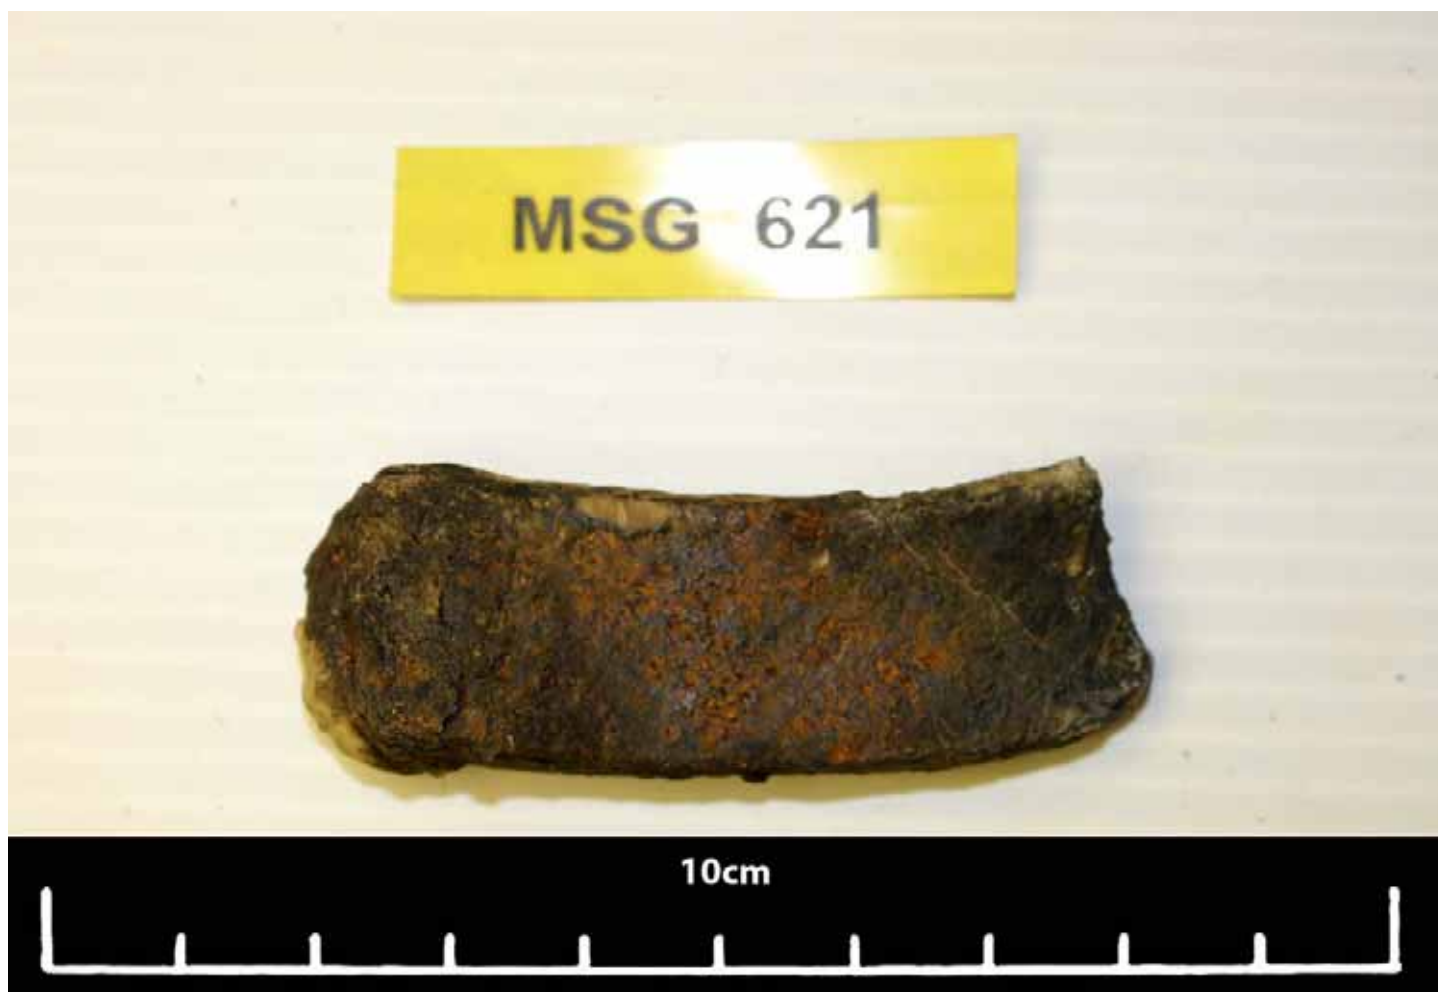
Description: From the bow. Metallic iron present. The rove is 8g, 25mm x 25mm x 1mm. The shaft hole is 5mm x 5mm. The first nail is 70mm in length, the head is 33mm in diameter. The shaft is 10mm x 10mm and bent. It is 56g. The second is 50mm in length, the head is 20mm in diameter. The shaft is 8mm x 8mm, tapering towards the tip. It's 12g. The third is 27mm in length the head is 21mm in diameter. The shaft is 8mm x 8mm. It's 11g. The fourth is 30mm in length, the head is 23mm in diameter. The shaft is 7mm x 7mm. It's 10g. The 5th nail is a shaft with no head, 36mm in length, 5mm x 5mm, 4g. The 6th is 74mm in length with a damaged head, 16mm in diameter. The shaft is 5mm x 5mm tapering to a point. It's 7g. The seventh is 54mm in length, no head. The shaft is 4mm x 4mm, tapering to a point. It's 4g. The 8th is 40mm in length, head is 23mm in diameter. The shaft is 4mm x 4mm tapering to a point. The 9th is 22mm in length. The head is 11mm in diameter, the shaft is 3mm x 3mm, 1g. The tenth is 33mm in length. No head. The shaft is 4mm x 4mm and is 5g.

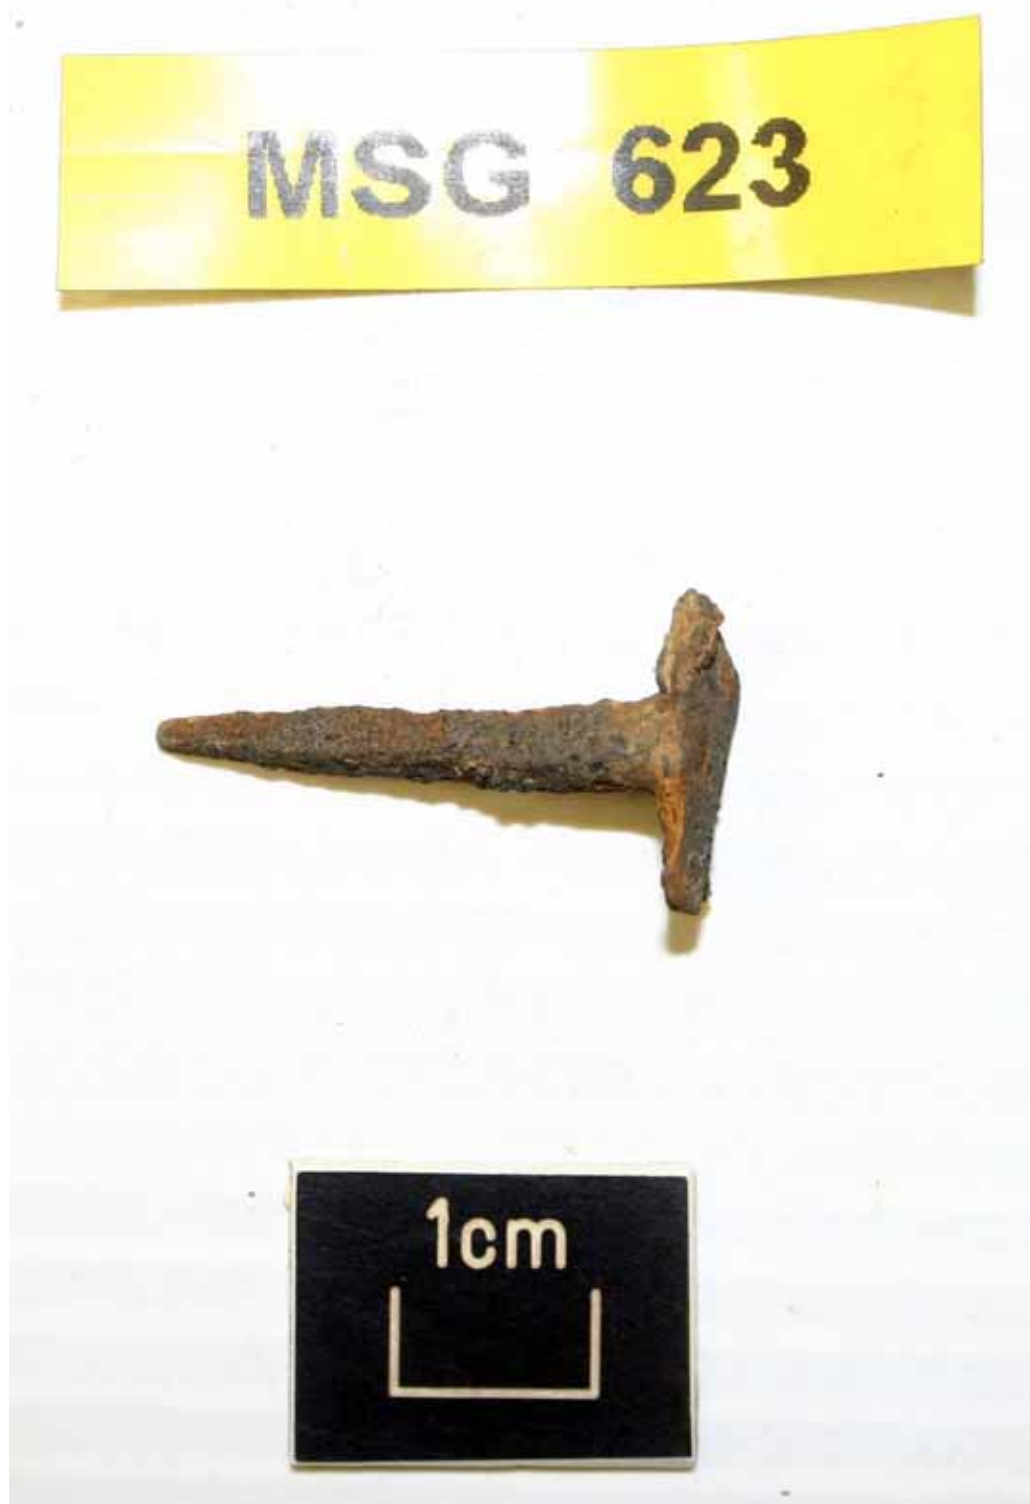
Description: Ferrous. Metallic iron present. First nail is 5g, 61mm in length. The head has concretion. The shaft is 5mm x 5mm tapering towards the tip. The second nail is 20g, 50mm in length. The head is concreted with a diameter of approx 25mm. The shaft is 10mm x 10mm tapering to 5mm x 5mm. The third nail is 3g, 44mm in length. The head is roughly square, 10mm x 10mm shaft is 4mm x 4mm, tapering to a point. The fourth nail is 17g. No head. Shaft is slightly bent and measures 6mm x 6mm tapering to a point. The fifth nail is an 'L' shape. 7g. Roughly square head, approx 8mm x 8mm. Shaft is 5mm x 5mm tapering to a point. The final object is a fragment of a possible horse or oxen shoe.. It is 115mm in length, 34mm wide tapering to 10mm. It's 4mm thick. Three holes, square, 4mm x 4mm, perforate the piece.

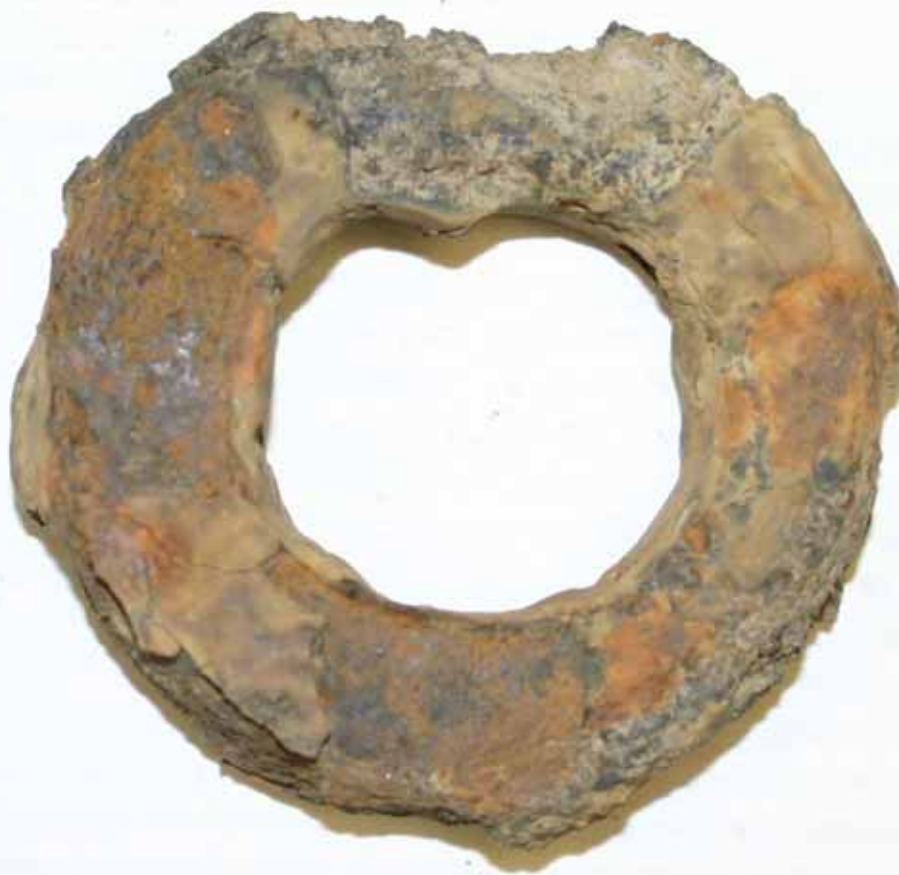
MSG 770

Description: Ferrous, metallic iron present. Nail is still in situ with shaft 7mm x 7mm.

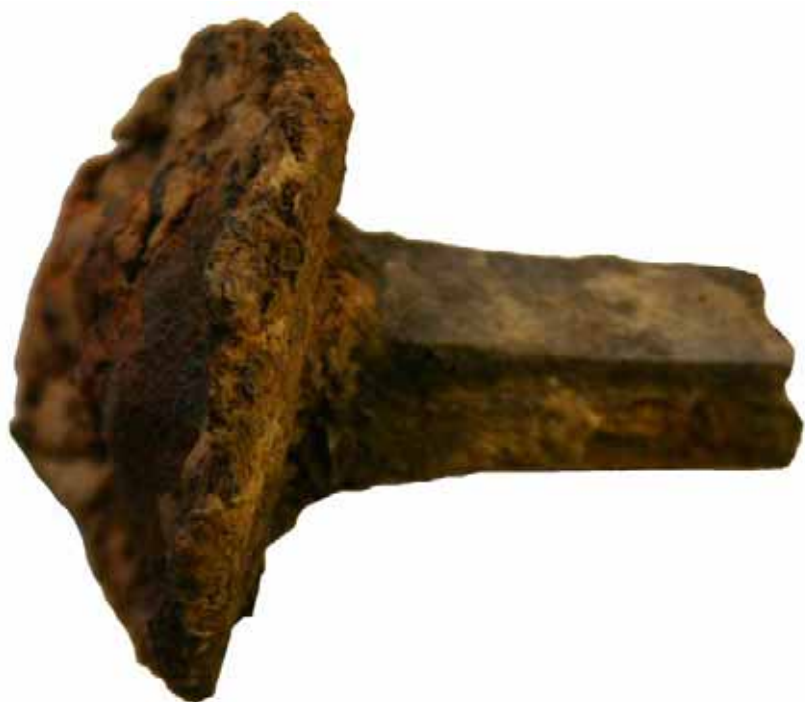
MSG 840

Description: Nail from leather 2 of 2. 6.4mm including head. Shaft is 1.4mm x 2.1mm(diameter x 3.6mm in length. 4g. Broken shaft. Head is slightly concreted and has a diameter of 4.8mm. From leather.

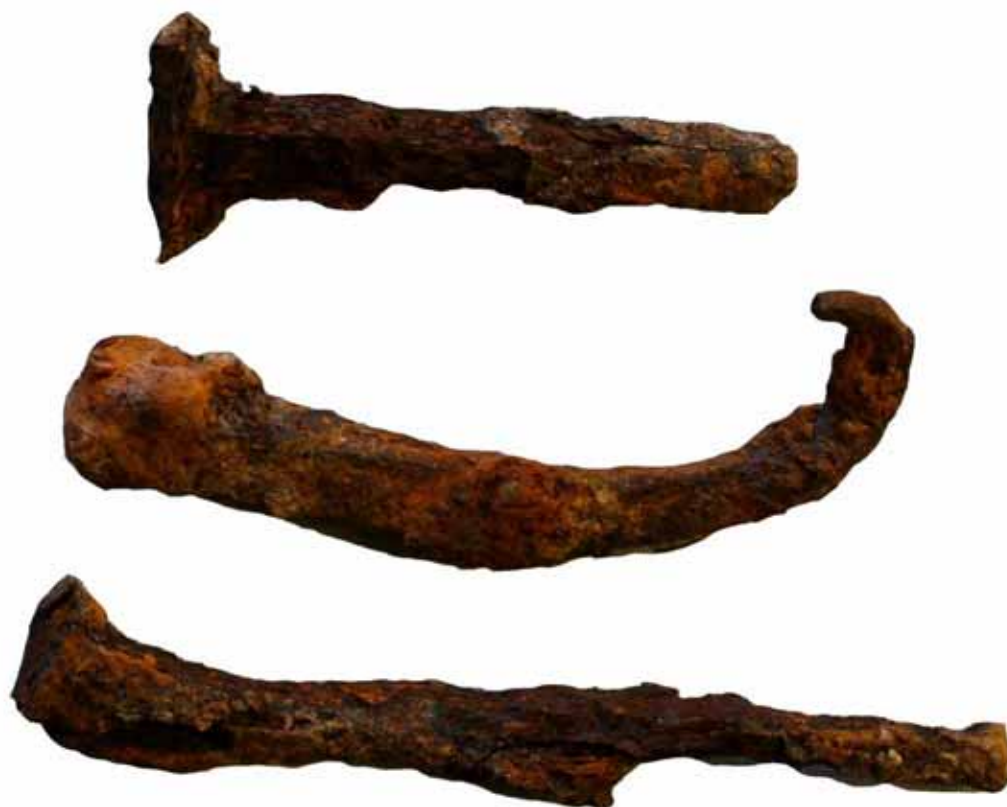
MSG 1072

Dimensions: 49.57mm long (including head. Shaft is 38mm long x 12mm x 12mm. Weighs 58.76g.

Description: Shaft is square. Rove is still in situ with concretion. Rove (including concretion measures 48mmx45mmx6.3mm.

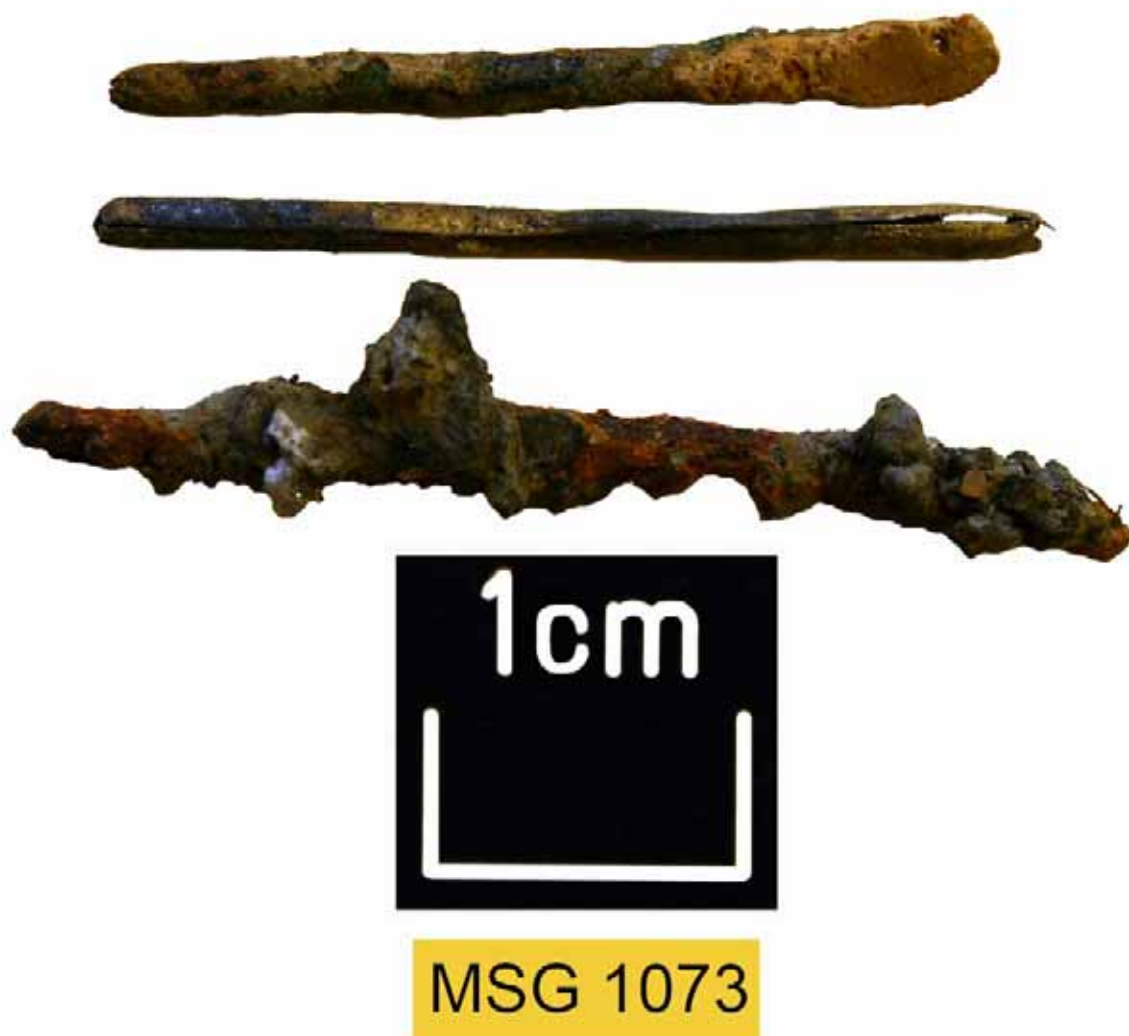
Description: Longest is 60.3mm including head, shaft is 5mmx5mm, 5.32g. The shortest is 38.9mm in length including head shaft is 3mmx3mm and 3.86g. The third nail is 47.2mm in length including head, the shaft is 6mmx6mm and is bent at the tip. All three taper towards the tip and have some concretion.

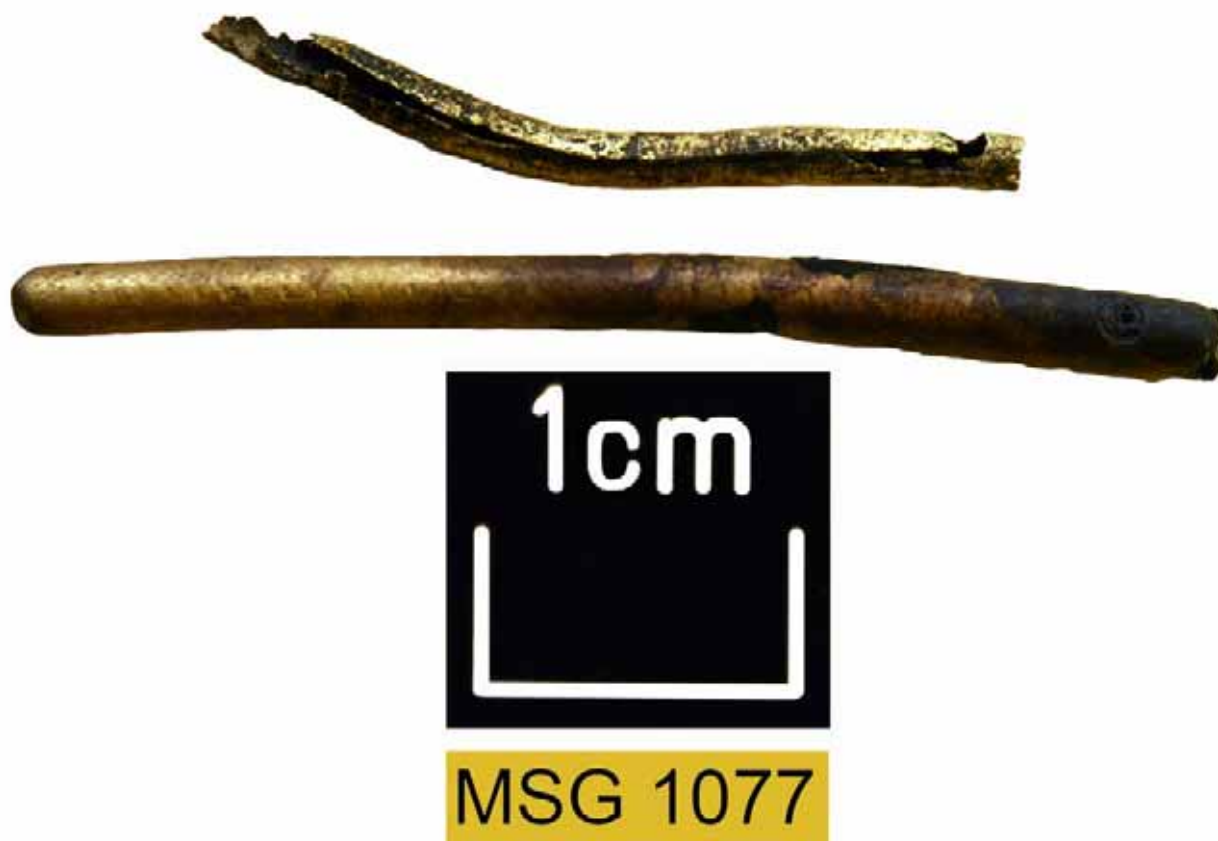
Description: Hollow rod, mostly gold in colour. A join runs the length of the piece. A small hole is visible at one end but doesn't perforate right the way through.

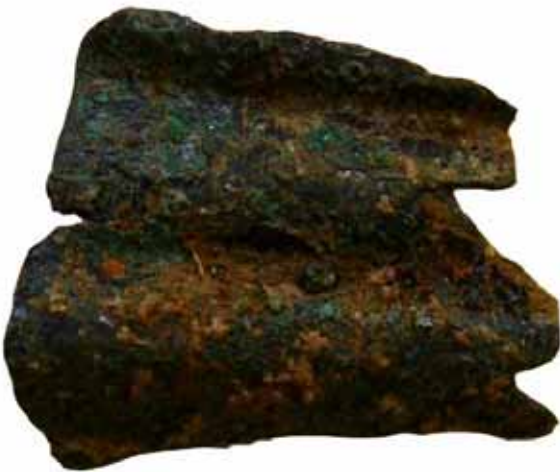
Description: Possibly hollow. Some concretion attached.

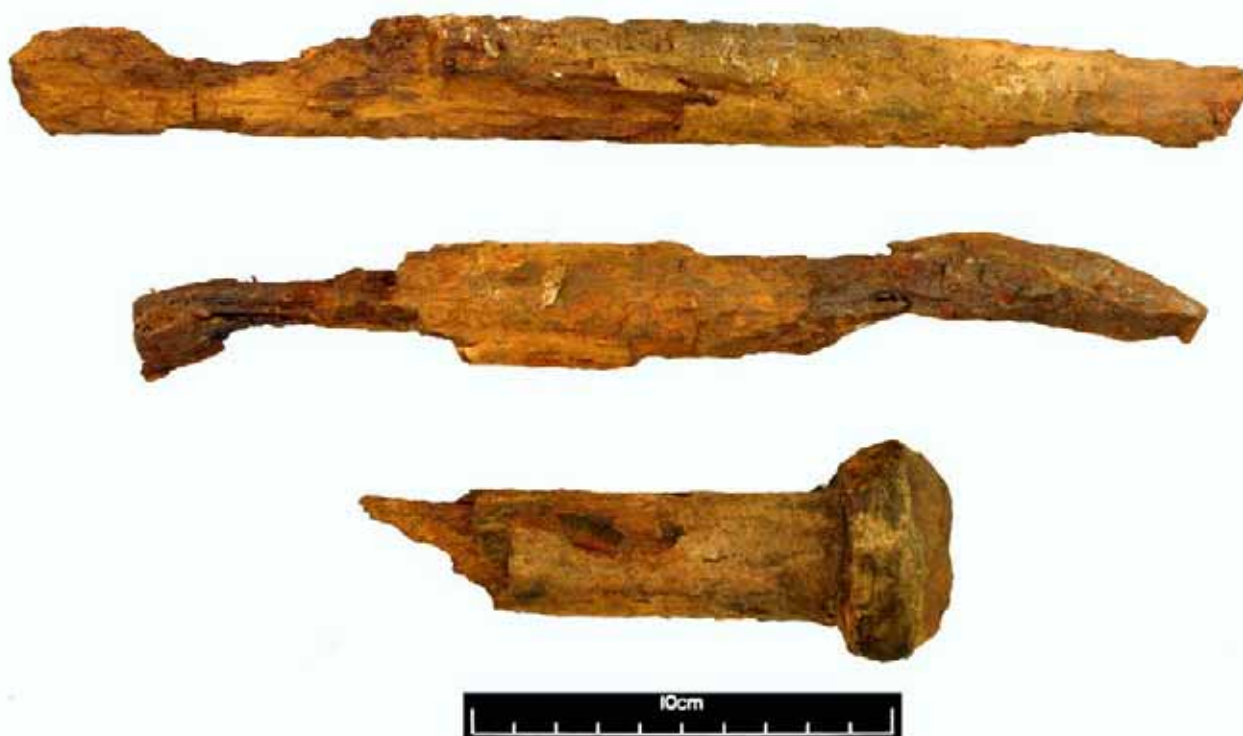
Description: Nail Head and shaft fragment from Rider 3. No metallic iron present. Head is concreted, roughly circular, approx 70mm in diameter. 37mm thick. Shaft is visible and measures approx 13mm x 13mm. Fragment of concreted shaft has broken away from the head.

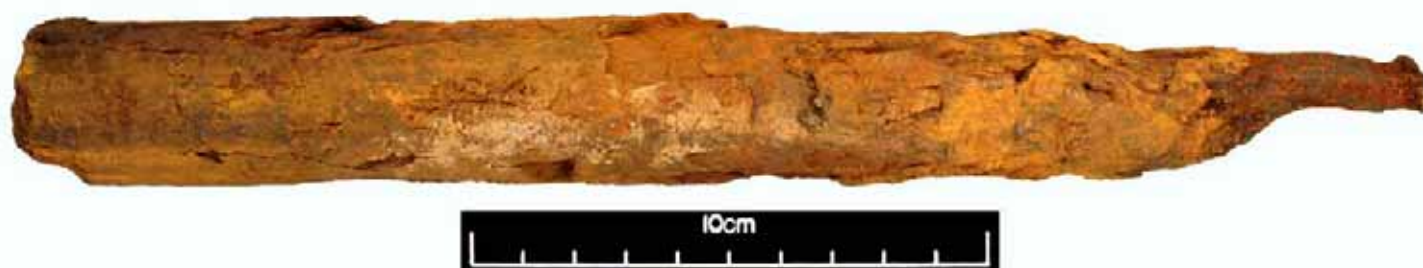
Newport Medieval Ship Metal Artefact Catalogue		MSG 1220
Artefact Type: Bolt.		Description: Iron bolt with head. Ferrous - metallic iron present. Half of head has broken off. Substantial iron core remains intact and measures 21mm x 22mm. Concretion also intact.
Material: Metal - Fe.		
Context: From knee 1629.		
Dimensions: 147mm x 31mm shaft. Head is 57mm wide x 27mm thick. 580g.

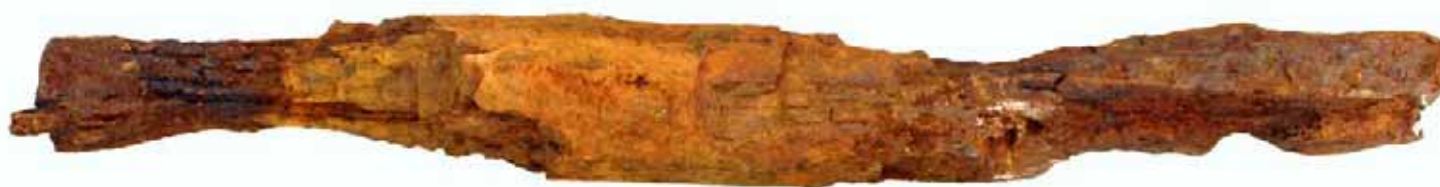
MSG 1236

Description: Cylindrical. Hard iron core covered by corrosion product. Core is approximately 33mm x 27mm. Both ends are broken. Smaller end is slightly mushroomed from removal process. Some wood grain patterns evident on the corrosion products.

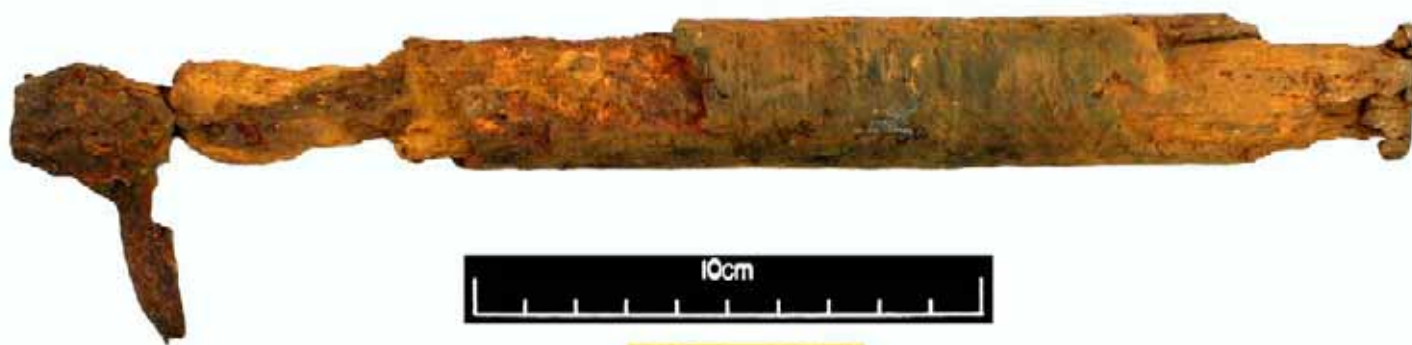
Description: Fragment of iron bolt. Most concretion has been removed leaving the hard iron core. Long grains of iron visible. Original extents of fastener are present in the centre section. Some bent iron grains visibly damaged during bolt removal process. Core measures approximately 14mm x 21mm. MSG 1237 & 1240 & 1220 are all part of the same bolt.

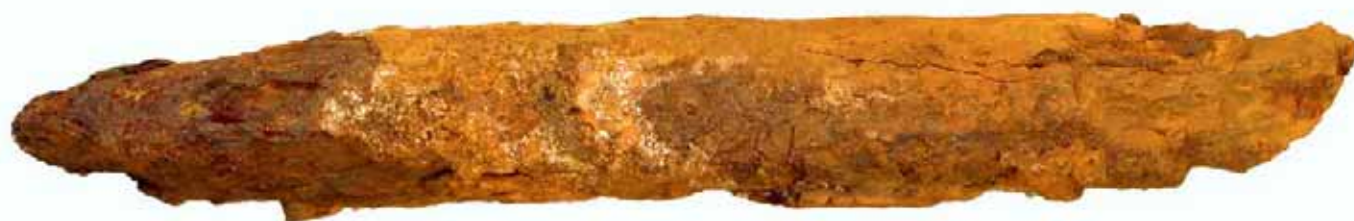
Description: Ferrous. Roughly square hard iron core surrounded by corrosion / concretion. Long iron grain is visible. Modern cut at one end. Core is approximately 17mm x 21mm. MSG 1237 & 1240 & 1220 are the same bolt.

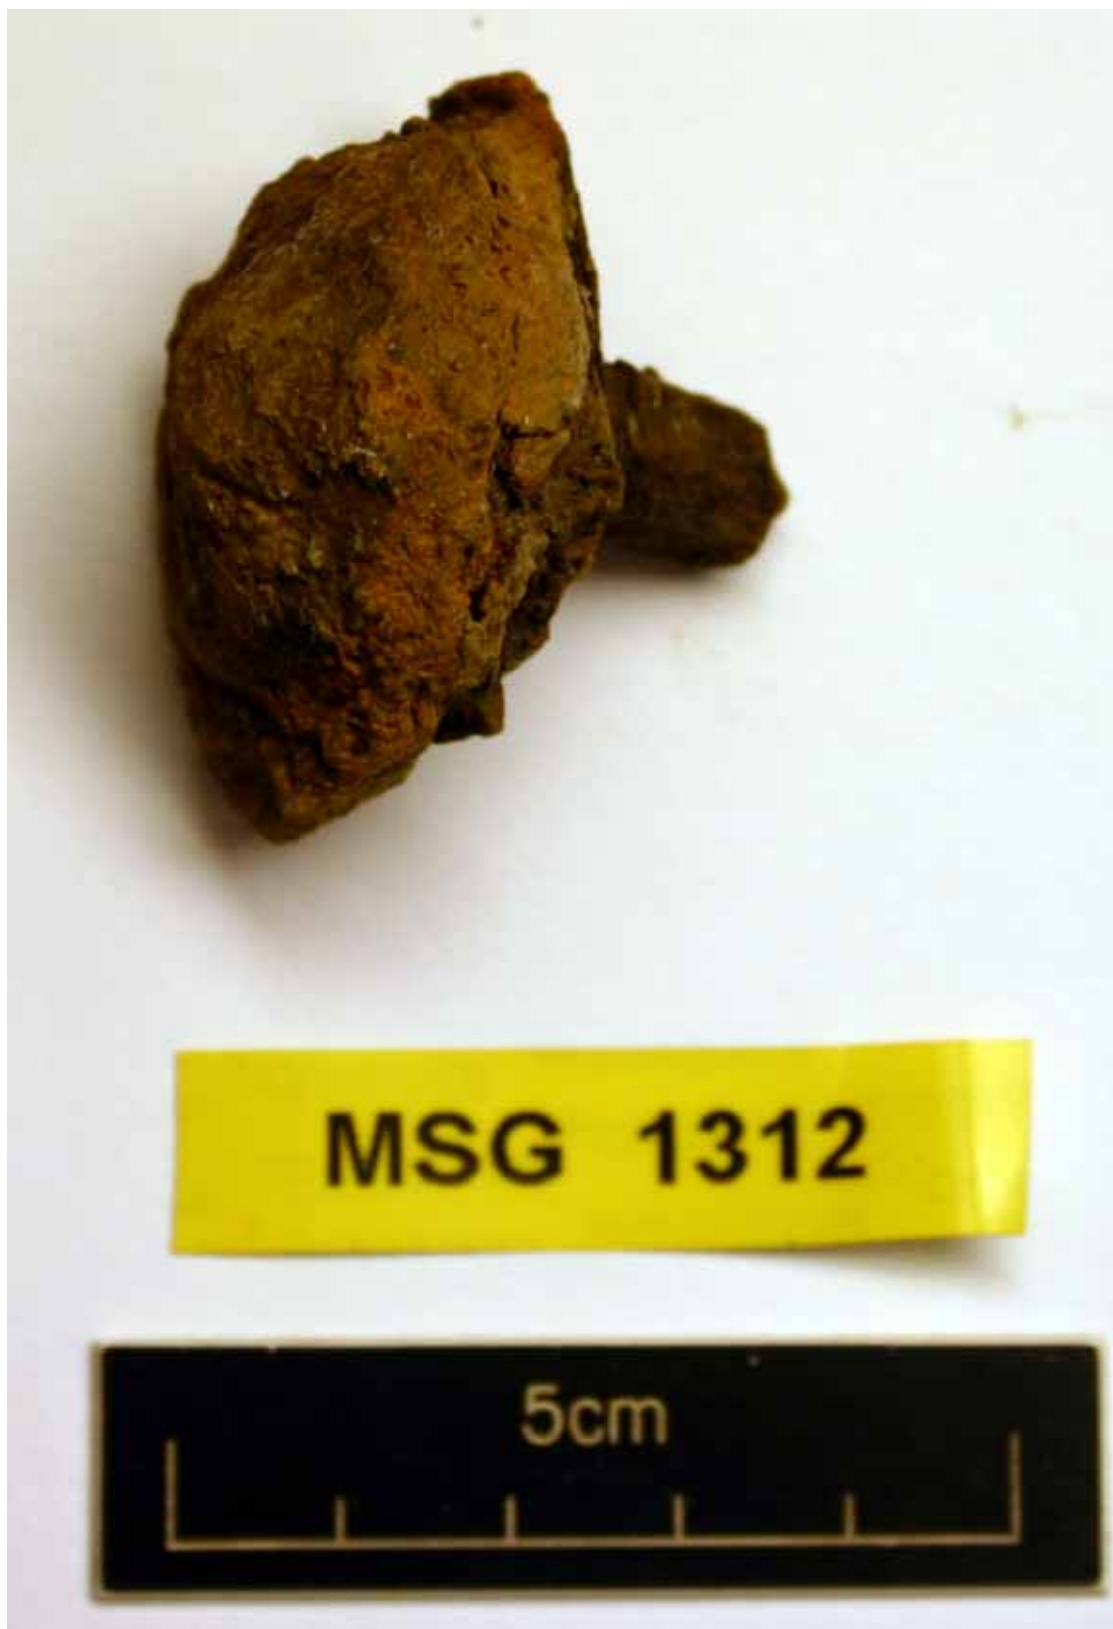
Description: Largest piece from leather MSG557 is 29mm in length x 5mm x5mm square shaft. It is 3.38g. The smaller piece-found in wood chips is 11.1mm in length x4.4mm. 0.2g Associated with 113.

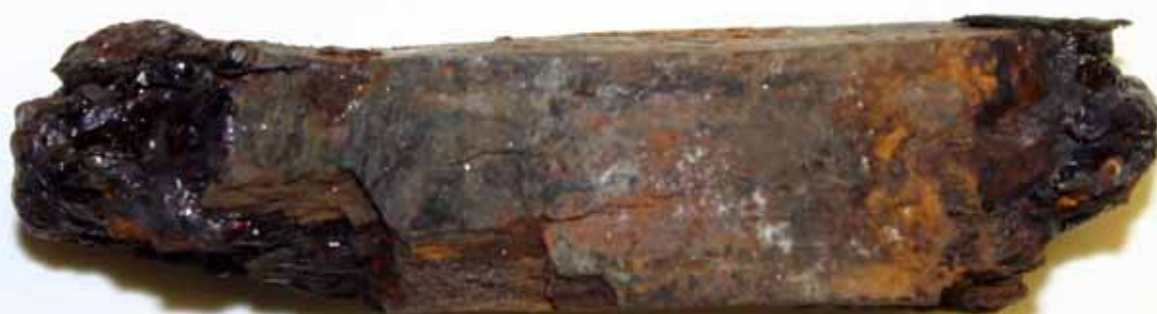
MSG 1313

Description: Concreted nail from CT 2414. 40mm in length. Shaft is square in section 10mm x 10mm. Head is concreted..
