Newport Medieval Ship Project Specialist Report: METALS AND SLAG

Report on the Metallographic Examination of Iron Artefacts from the Newport Ship.

Report on the Metallographic Examination of Iron Artefacts from the Newport Ship

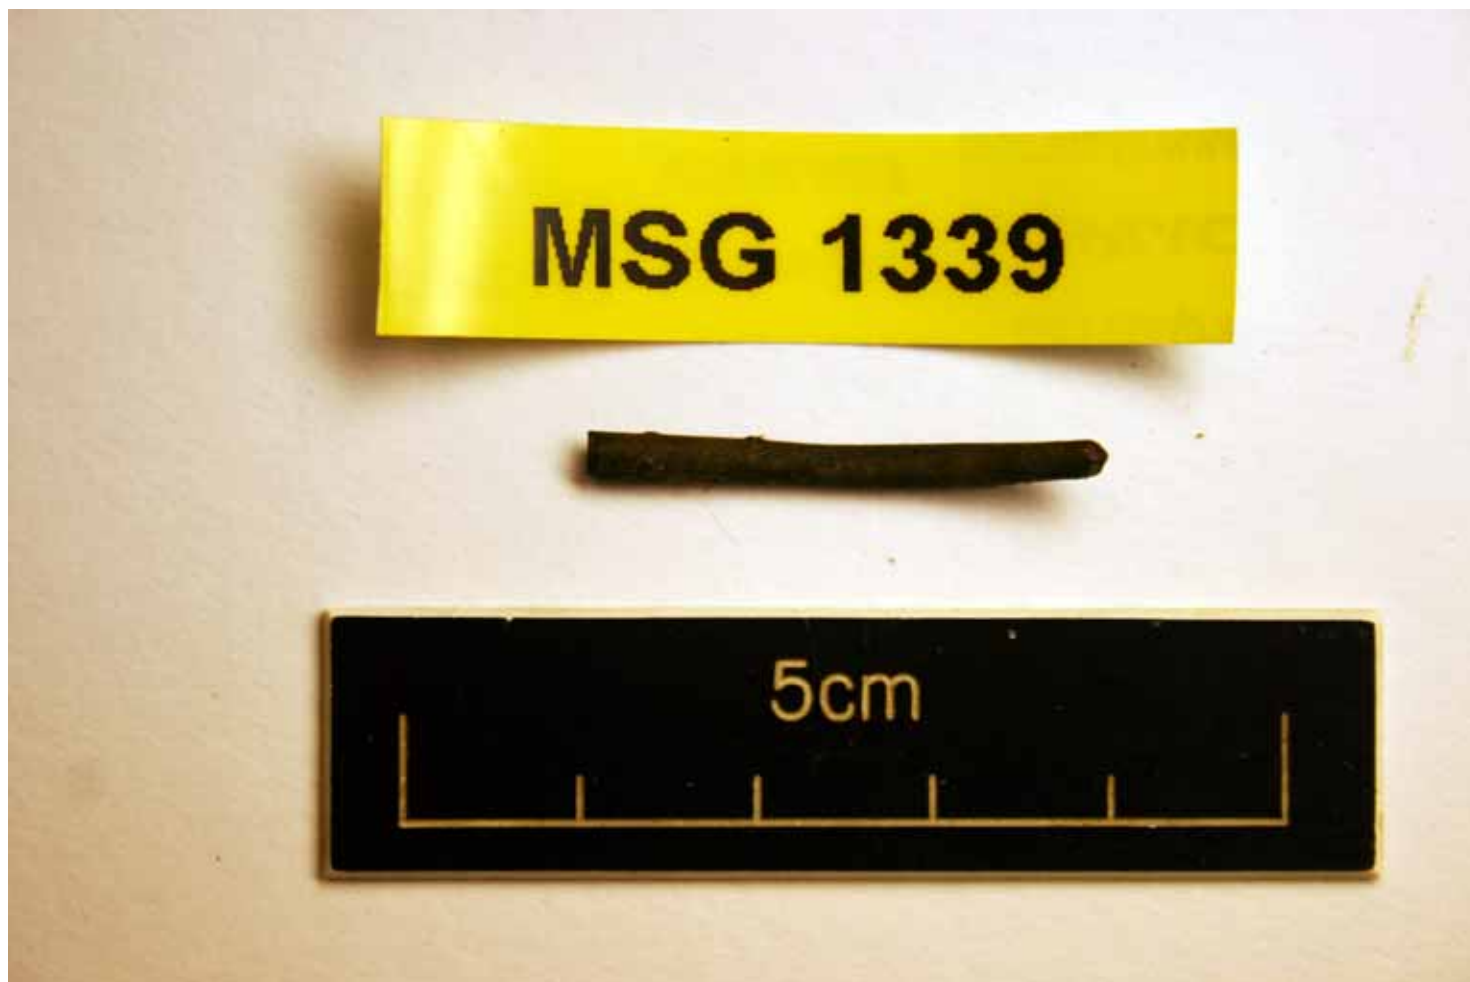
**Description: Nail shaft from STRS 1.1A1
Damaged at both ends. Square in section.**

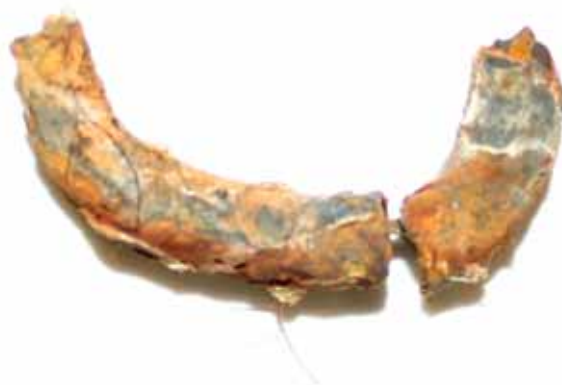
MSG 1341

Description: From Sample 177. Seam runs the length of the wire. It is sealed at one end and open at the other. Black in colour with some gold in patches.
