Oak, orig no. 221, decoded No. **DB 19/05/2010**

Cow Tag **14** Type **futtock fragment.**

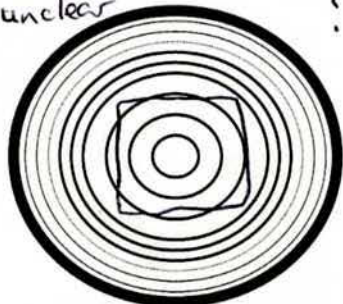
**Description** Poor condition - dry and cracked; 42cm in length  
 Widens from 4cm at one end to 10cm at opposite end.  
 5.5cm thick, tapering to 0.3cm. No metal fasteners. One partial  
 blind treenail. Appears to have a diameter of 2.8cm and depth  
 of 3.3cm remaining. May be some evidence of inscribed <sup>lines</sup> however  
 surface is quite degraded. Large crack, 2cm in length, penetrates  
 the piece. Too small to be part of Newport ship.

**Wood Science:** extreme cracking  
 tree ring structure unclear ?
