Cow Tag 24	Function Code <i>unknown</i>
----------------------	---------------------------------

Brief Description: [timber element, p/s, condition, fragments]
Fragment of ship timber

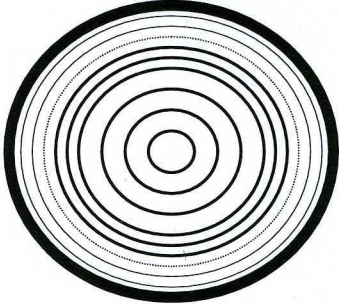
730mm x 95mm x 25mm. Dried fragment of ship timber. Damaged at both ends - possibly by a digger or pile. One square nail hole 10mm x 10mm. Bevel along one edge caulking still in situ.

*Approx 40 rings
 straight grained
 radial.*

Discard.
