Cow Tag

256

Brief Description: [timber element, p/s, condition, fragments]

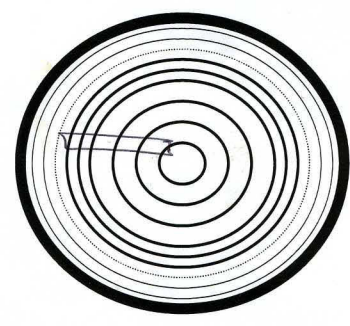
Part of fore scarf missing from Park  
for end heavily damaged

Intermediate at aft scarf.  
Pith beyond upper edge.  
C70 H. ARW ≈ 255 / 70.  
possibly.
