Cow Tag	316	Function Code	519.5
---------	-----	---------------	-------

Brief Description: [timber element, p/s, condition, fragments]

Intact plank

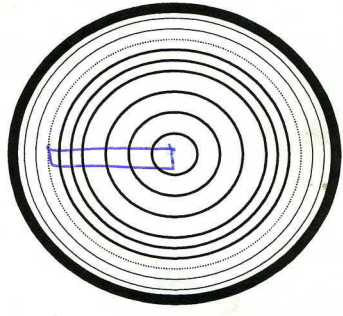
c90H. path uncertain
Radial. ARW = 2160/90
One large tear outboard.

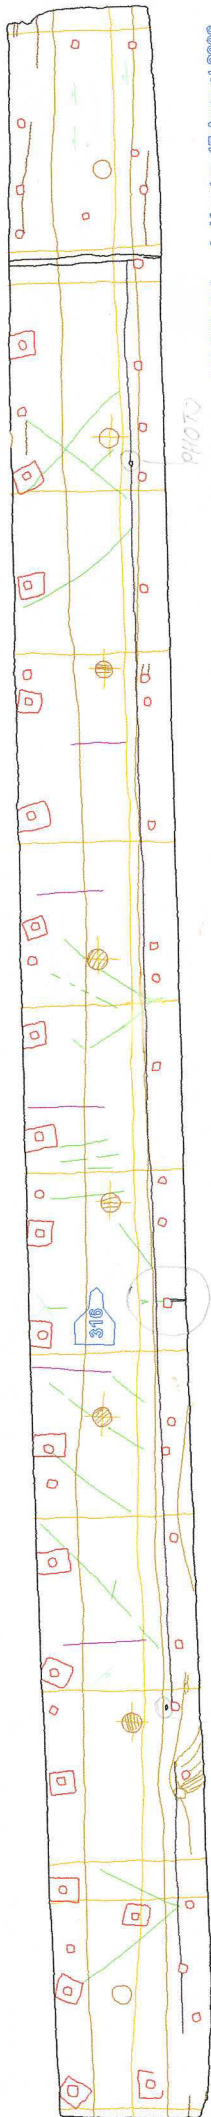
316 S19_5 Angela Karsten 17 August 2006

Inboard: Inscribed lines **T1** **T2** for for

Outboard: Inscribed line in end of of scarf

INBD: - 2 POSSIBLE "STAPLE" MARKS NEAR EDGE OF LAND ~~IN~~ BELOW 2. TN FROM FORW. + AFT END

Photos of trawl head - 3 faceted x 3.
wedged x 2
Try photo of inscribed lines (V) marking step in end inboard for S18) Photo Staple marks
